THE BARN  
CANAGLAZE  
ALTARNUN  
CORNWALL

Heritage Assessment

South West Archaeology Ltd. report no. 230516

South West Archaeology Ltd. was commissioned to undertake a heritage assessment for the Barn at Canaglaze, Altarnun, Cornwall to inform plans to consolidate and convert the barn to a dwelling. This work was carried out in consultation with HEP(Arch) and in accordance with the relevant guidance.

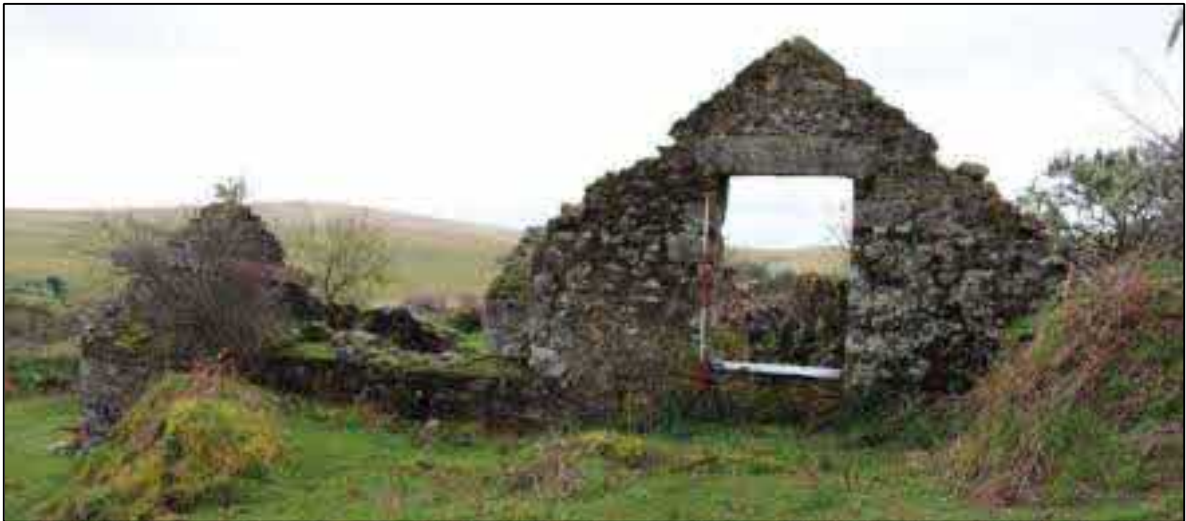
The north-east elevation of the building has five openings: four slit vents and a first-floor loading door. The loading door (D7) has a thin slate sill and heavy granite lintel. The two slit vents at ground-floor level either side of D7 are partly (W9) or wholly (W8) blocked as the ground level has been raised here. The walls of B1c appear to abut B1a, as the quoins of B1a have been partly removed to tie the two walls together.

FIGURE 19: THE NORTH-EAST ELEVATION OF BARN, WITH A FIRST-FLOOR LOADING DOOR TO THE WEST END; VIEWED FROM THE NORTH-WEST (SCALE 2M).

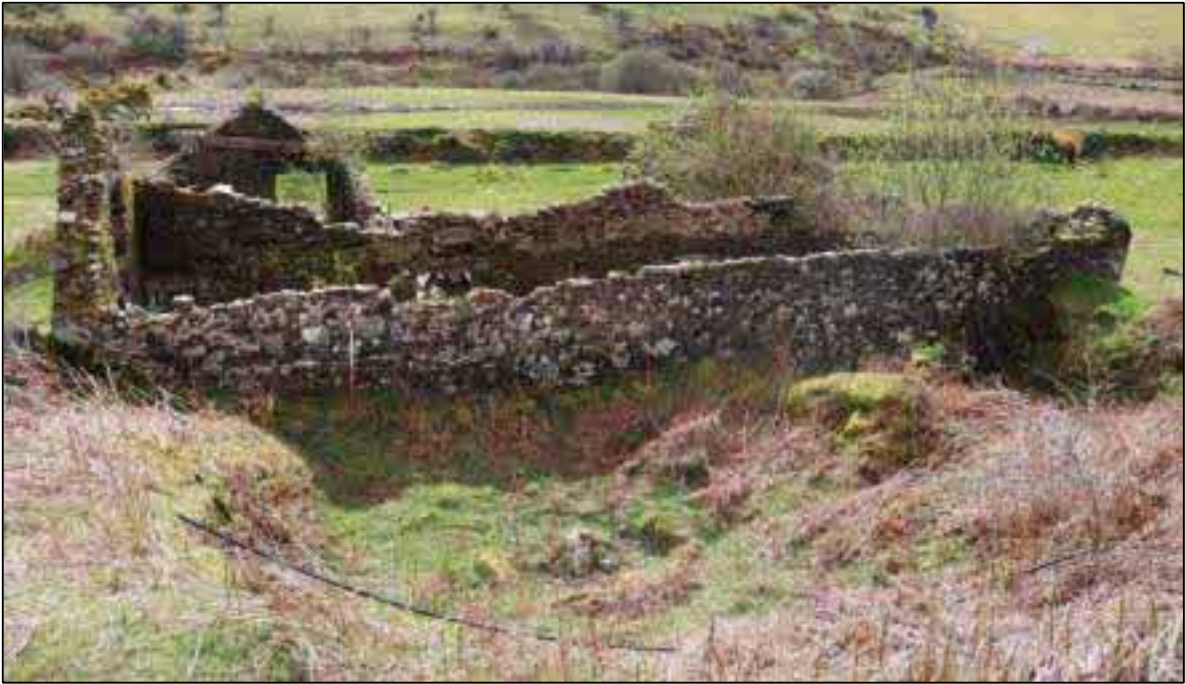
west of the building the slope has been cut back to form a steep-sided sub-circular hollow. This is now identified as the site of a horse whim (MCO19122), but apart from the aforementioned small, ragged hole there is no purpose-built opening for a shaft. To the centre of the hollow is a collection of laid stones/granite rubble.

FIGURE 20: THE NORTH-EAST ELEVATION WITH THE POSSIBLE HORSE WHIM IN THE FOREGROUND; VIEWED FROM THE NORTH-WEST (SCALE 1M).

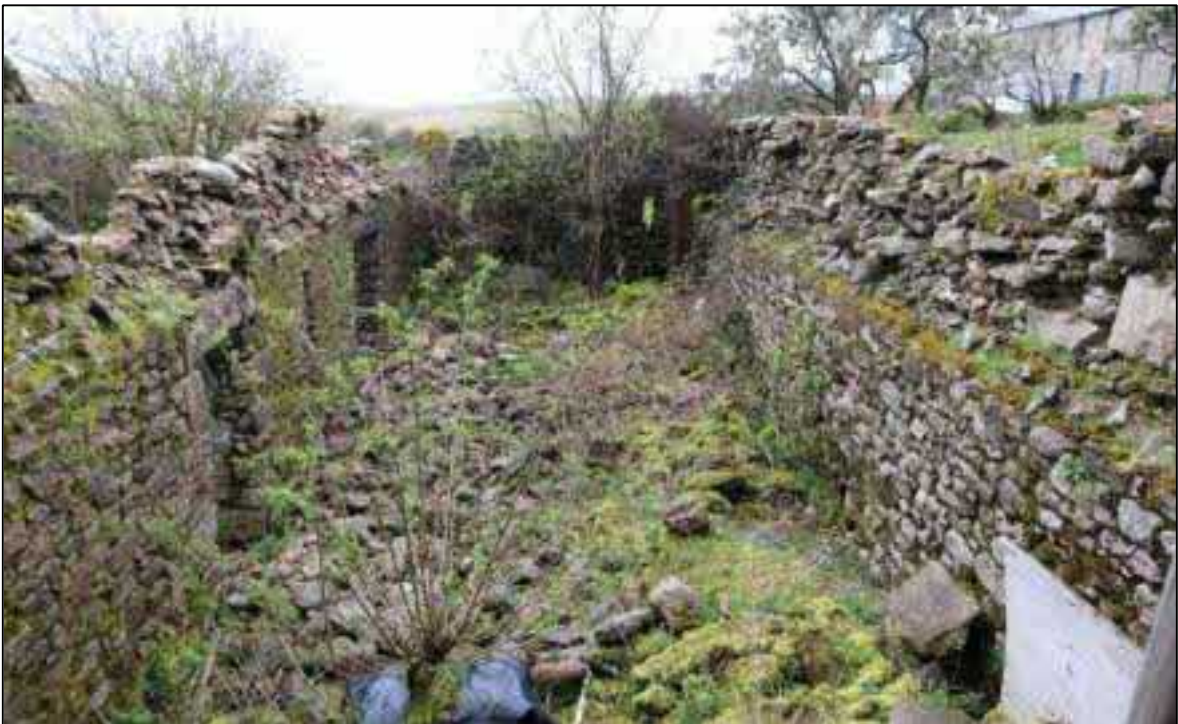
The interiors of the building were obscured by vegetation and fallen rubble. Internally B1a is c.4m wide and c.15m long. Along the north-west wall the floor is raised, probably for a line of troughs, perhaps served from a feed passage accessed from the door in the north-west wall (D6). The lost ceiling was probably carried on common joists sitting on timber lacing in the opposing long walls; the decay of that timber lacing has brought the inner face of each wall tumbling down.

FIGURE 23: LOOKING DOWN TO SOUTH OF B1A; VIEWED FROM THE NORTH-EAST.

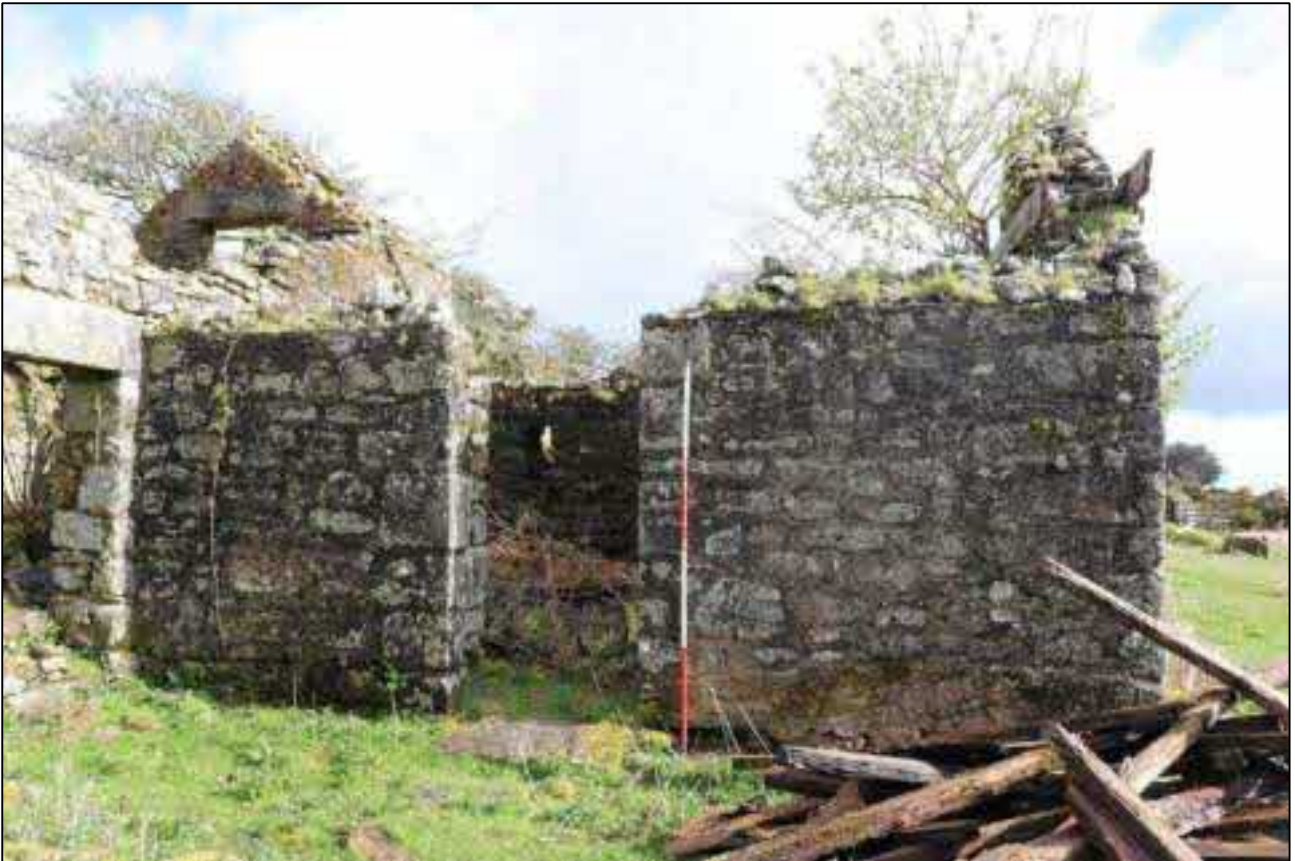
3. D5 LEADING TO B1C WITH DRESSED QUOIN DETAILS; NO LINTEL OR FITTINGS SURVIVED APART FROM THE CARVED LIP; VIEWED FROM THE SOUTH-EAST (SCALE 2M).

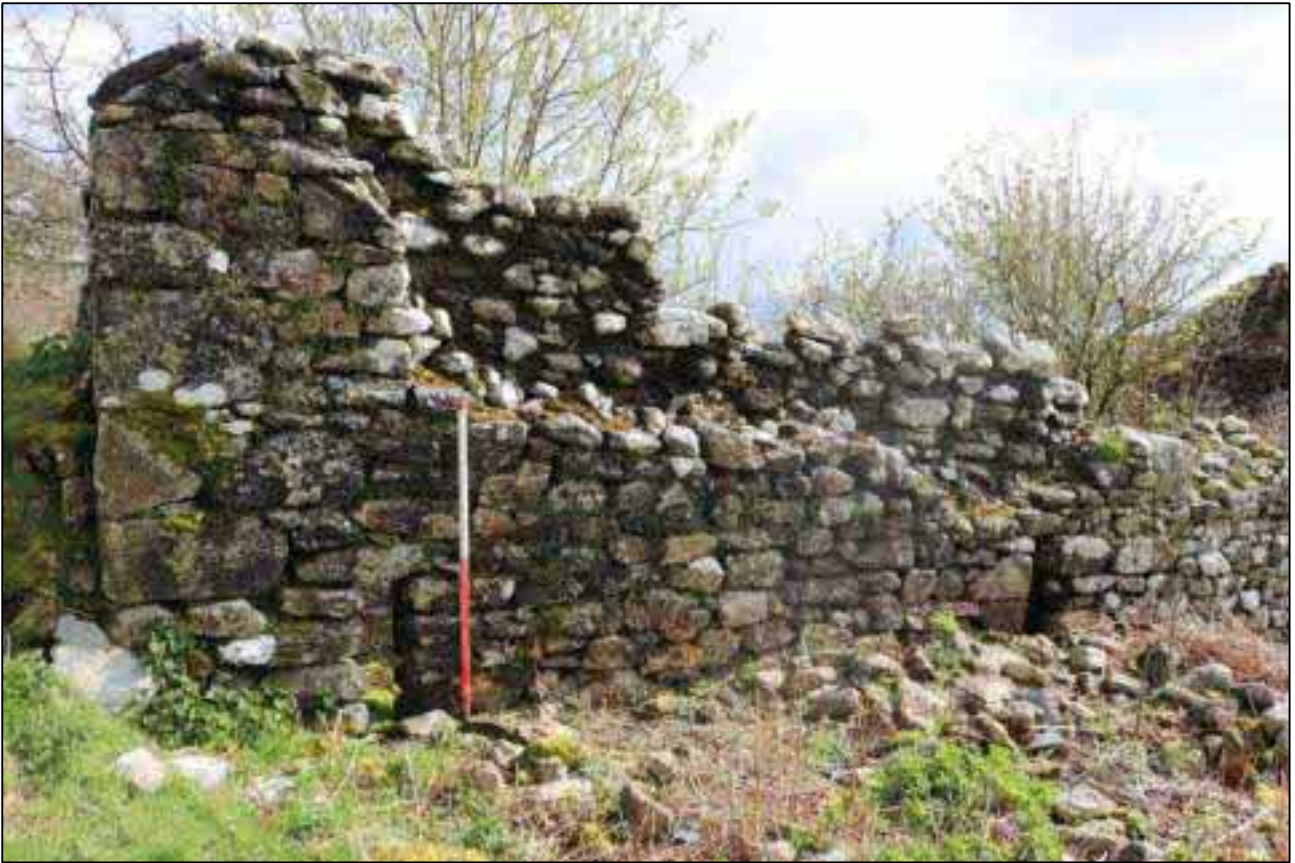
11. GROUND LEVELS CUTTING TWO GF SLITS TO SOUTH B1A; VIEWED FROM THE SOUTH (SCALE 1M).

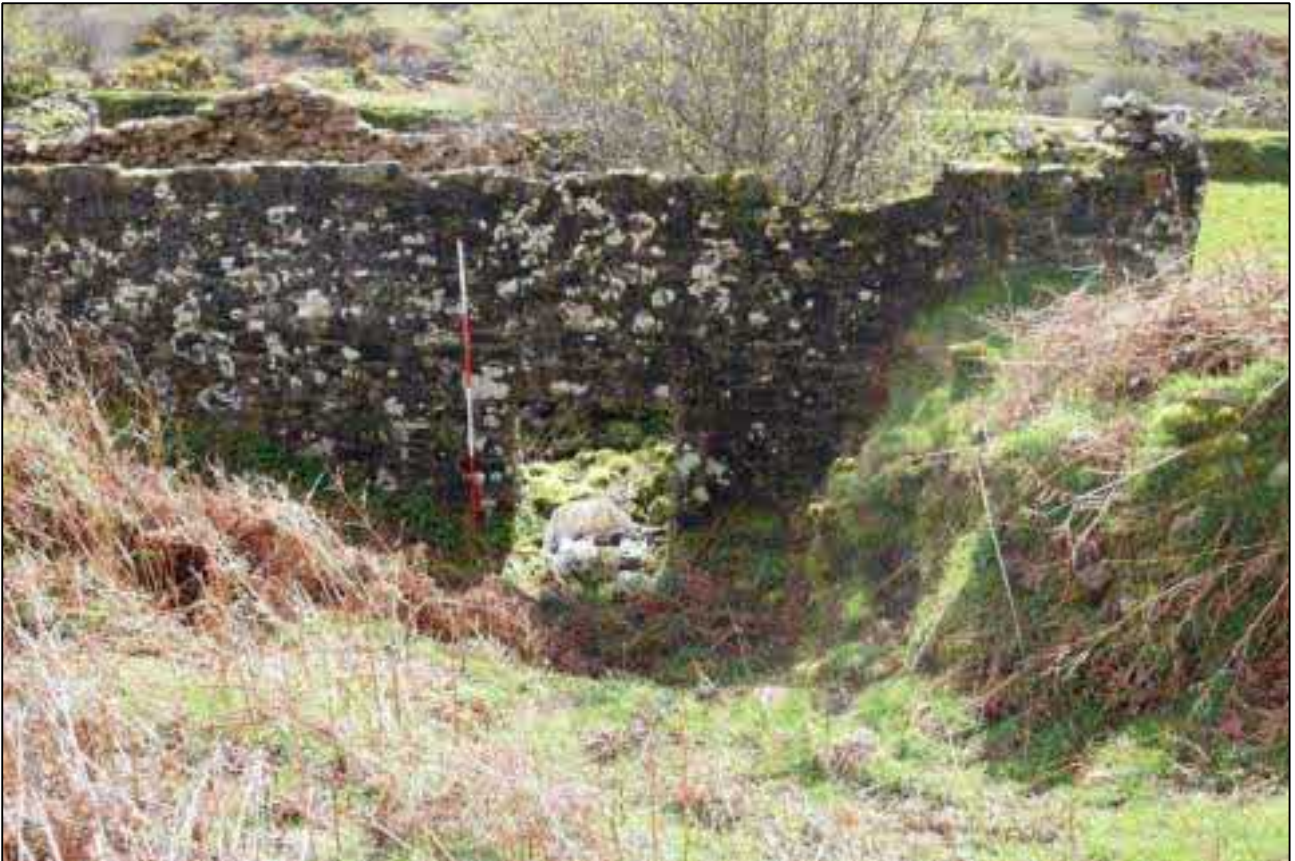
13. POSSIBLE ALTERED DOORWAY TO B1A IN WEST ELEVATION; VIEWED FROM THE WEST (SCALE 2M).

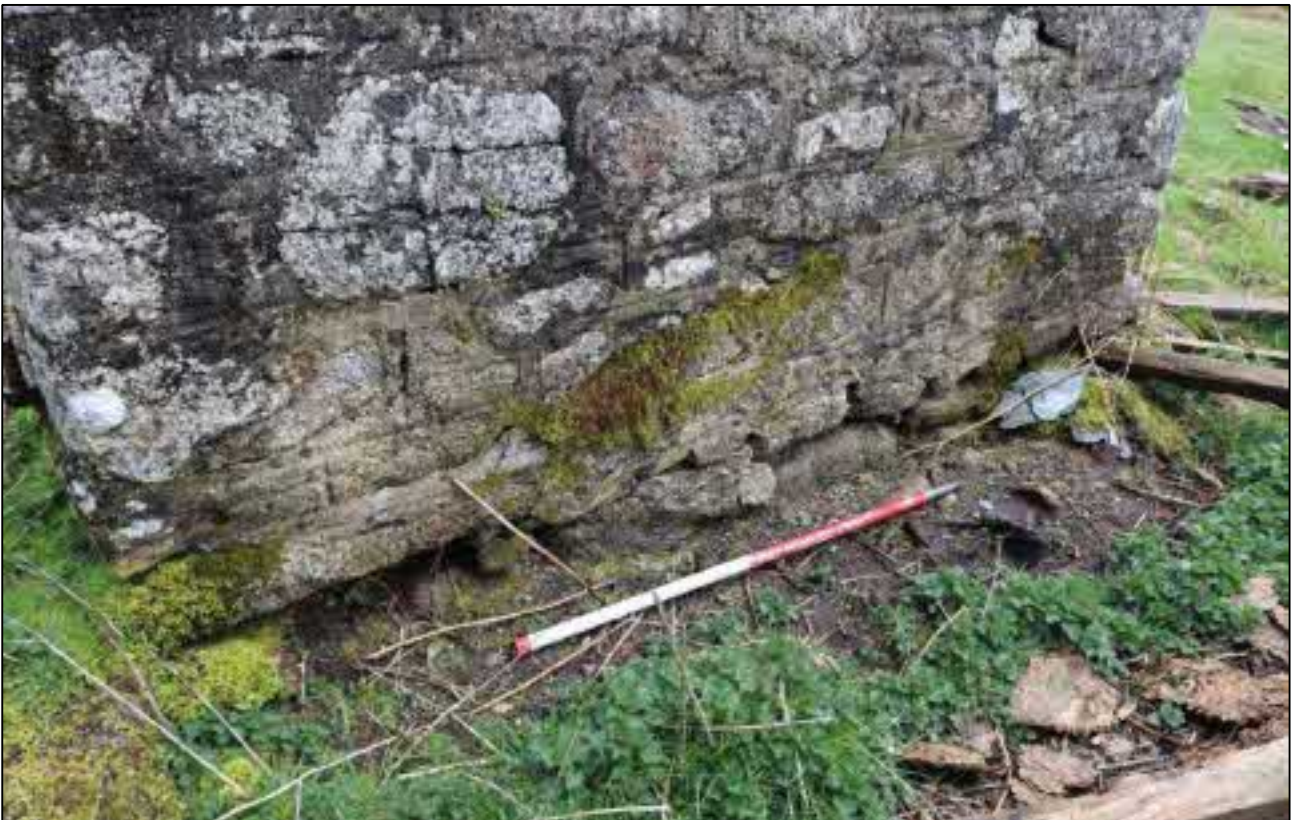
28. THE BASE OF WALL TO B1C LOOKING EXPOSED AND RAGGED, GROUND LEVELS ALTERED AS CONCRETE RIBBON POINTING DOES NOT CONTINUE; VIEWED FROM THE SOUTH-WEST (SCALE 1M).

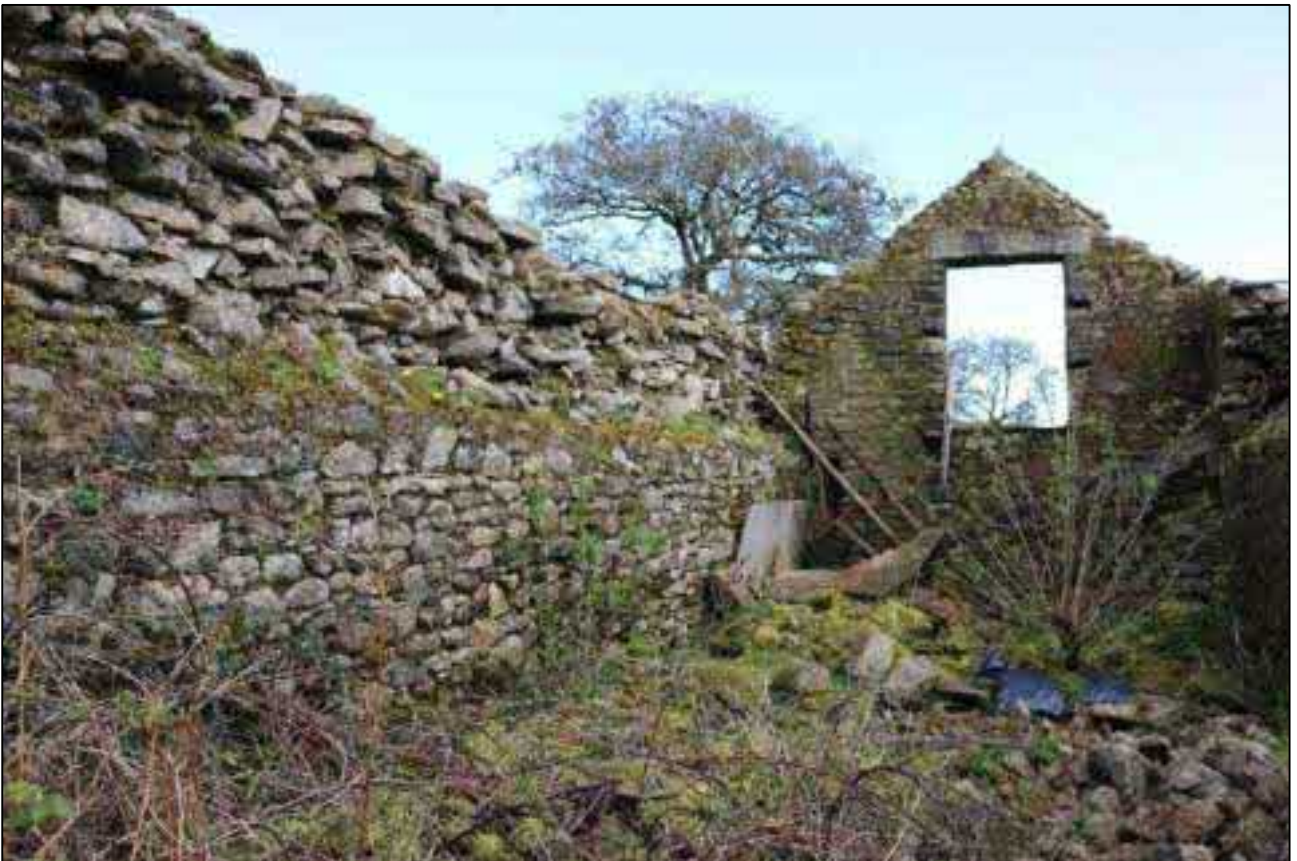
32. THE INTERNAL WEST ELEVATION LEADING TO NORTH GABLE END B1A; VIEWED FROM THE SOUTH.

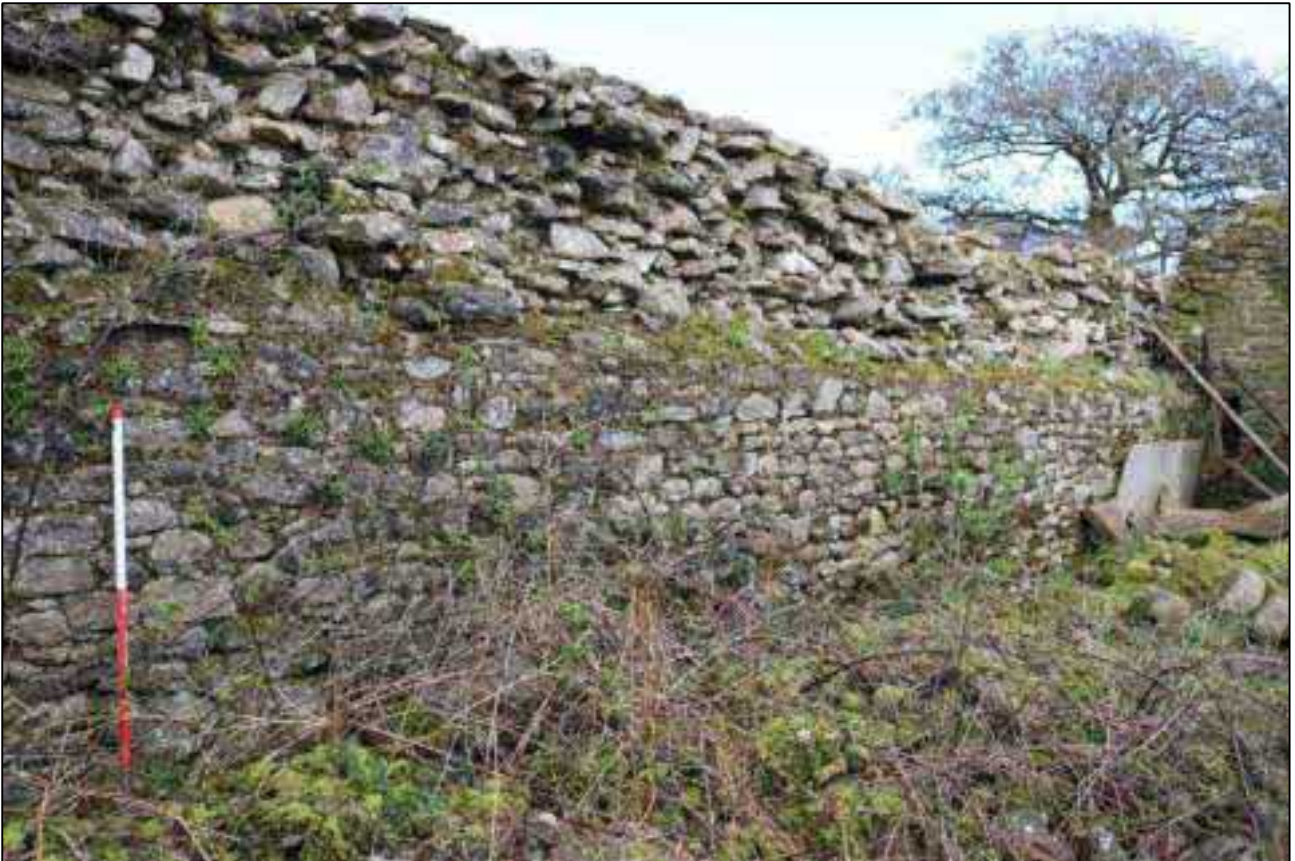
33. THE INTERNAL WEST ELEVATION SHOWING WHERE THE INNER FACE OF THE WALL ABOVE THE TIMBER LACING HAS COLLAPSED; VIEWED FROM THE SOUTH-EAST (SCALE 1M).

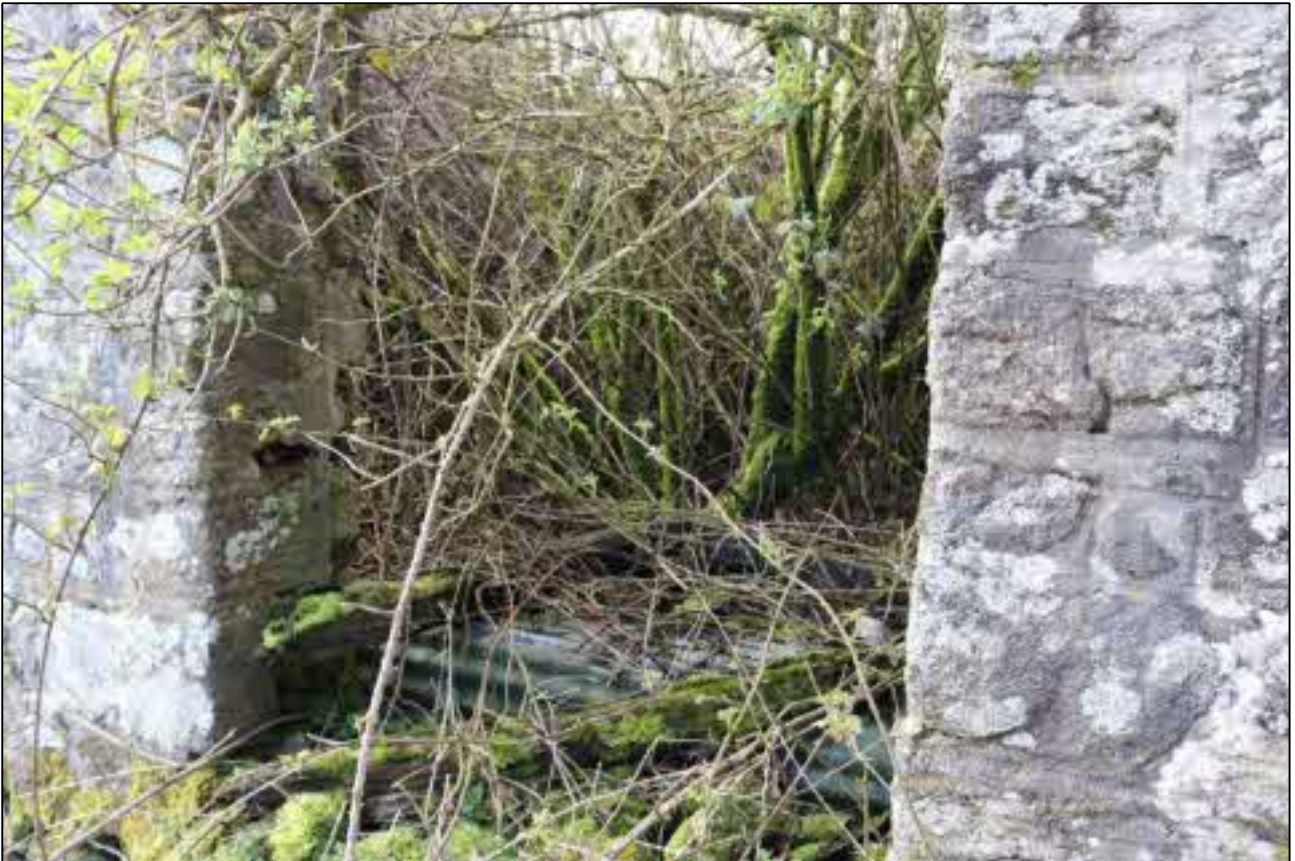
35. D4 OPENING TO B1B, THE DOORFRAME FALLEN OVER BUT IN SITU; VIEWED FROM THE NORTH-WEST.

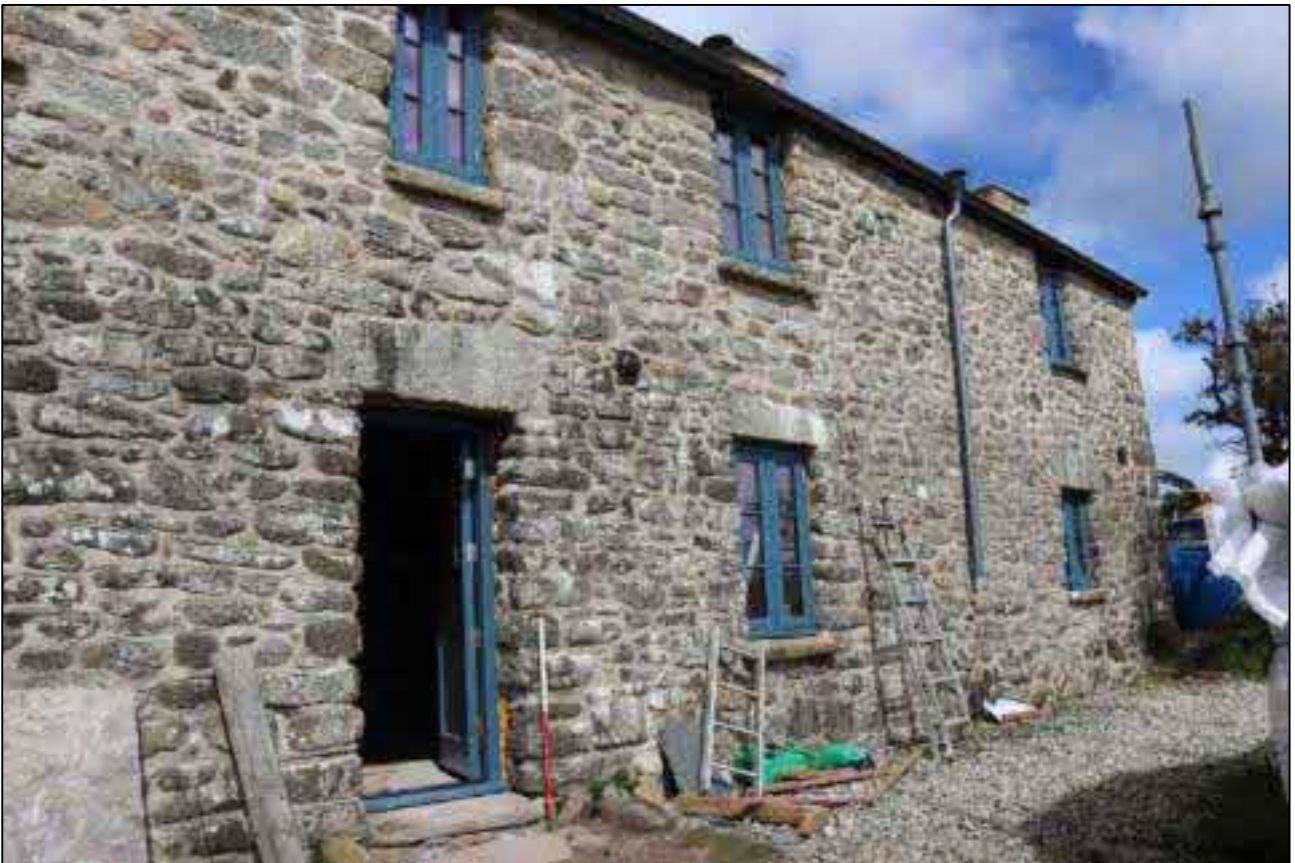
40. THE NORTH SIDE OF THE EAST ELEVATION, REPOINTING OBSCURES PHASING; VIEWED FROM THE SOUTH-EAST (SCALE 1M).

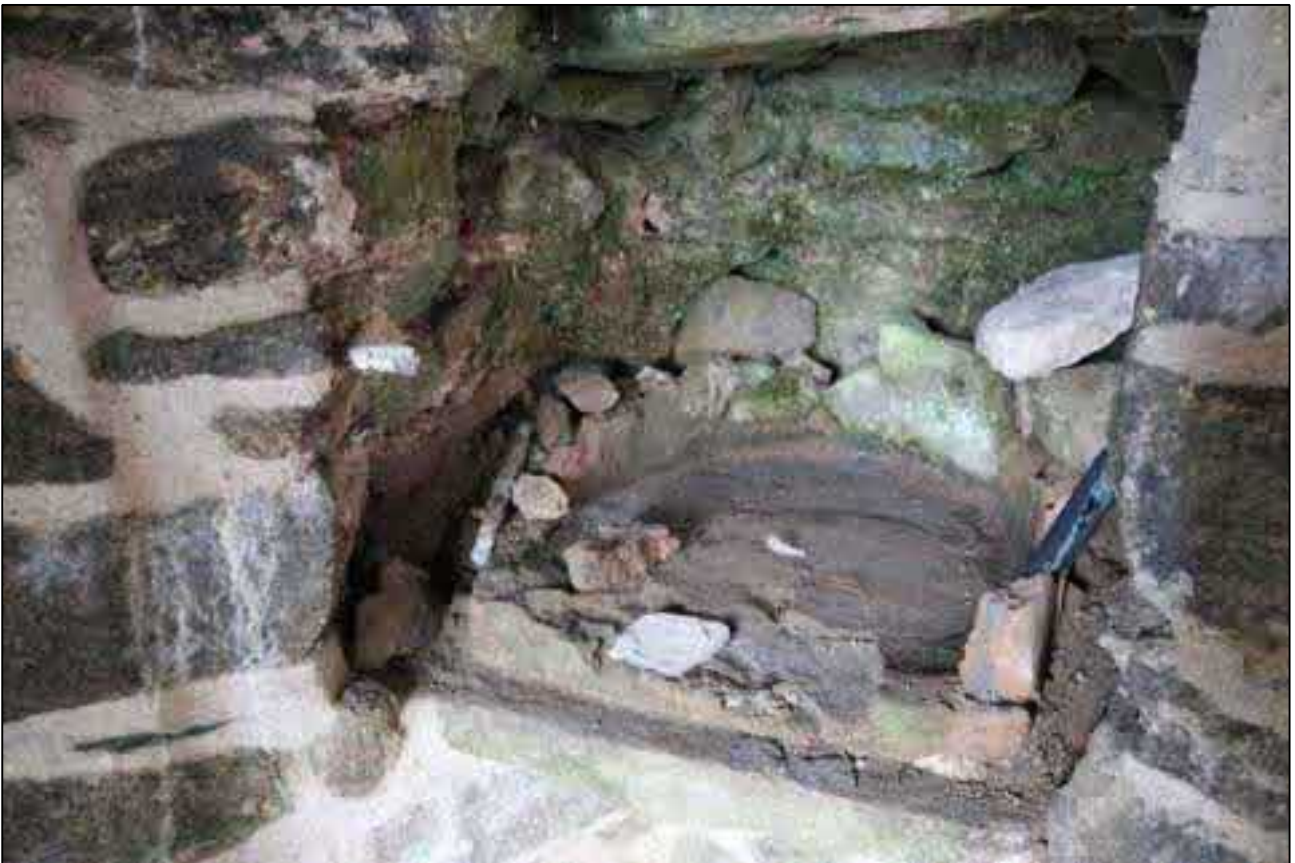
56. THE DETAIL OF DAMAGED CLOAM OVEN.
