General structural appraisal report on

Building at
Canaglaze,
Altarnun,
Launceston,
PL15 7SW

Report reference: 12431_TS_23

08.11.23

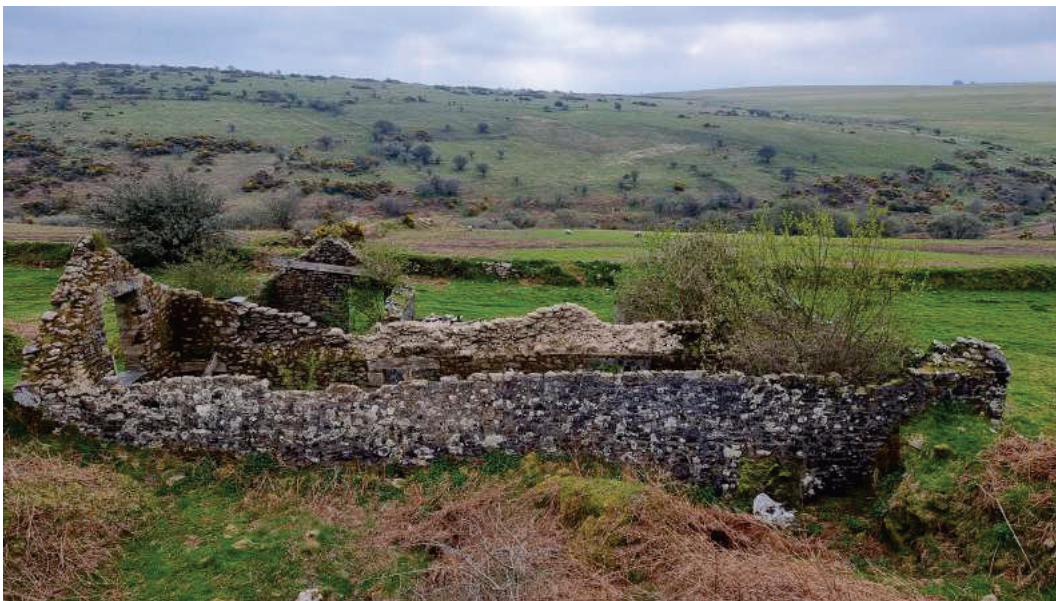
Photograph 1.0 – Lack of roof structure to building

1.1 The building throughout has no roof structure. A new suitably designed roof structure will be required throughout. It would be prudent to suggest a suitably designed concrete ring beam is adopted to cap the head of the existing masonry walls. Typically this would be circa 300 - 400mm wide x 300mm deep with 2No. H12 steel bars to its base and 600x600mm H12 'L' bars to corners (providing it does not need to act as a lintel). The ring-beam would provide additional lateral restraint to the head of the masonry and provide a level bearing for a new roof structure and wall plate.

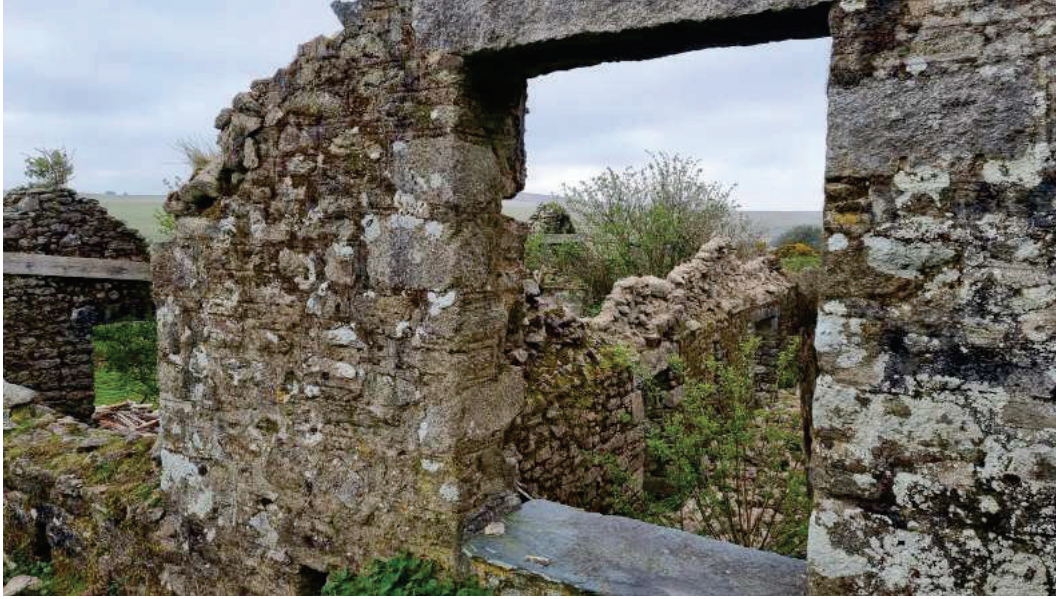
2.1 The walls throughout are formed from mass rubble stone in the order of 450 - 500mm. Traditionally this would have been built from an outer and inner skin of facing stone with a random rubble and lime earthen mortar core. The quoins, doors and window jambs are formed from larger granite stones.

Photograph 2.0 – Granite quins, jambs and lintels

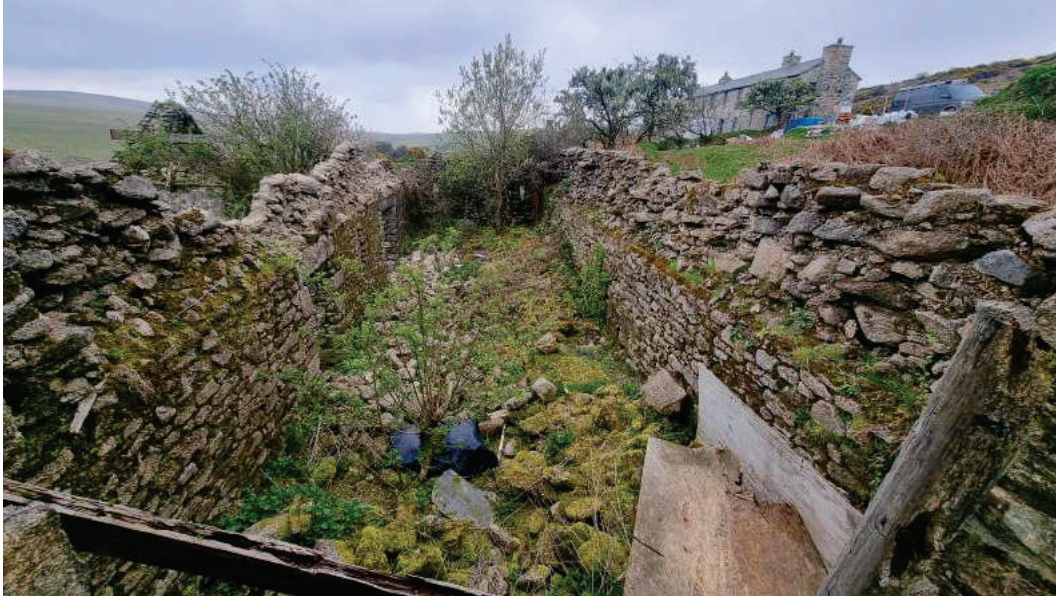
Photograph 3.0 – De-lamination of masonry to flank walls

2.3 The masonry to the front and rear flank wall is in poor condition and appears to be unstable. Close inspection due to this was not made. The masonry here should be taken down to a level where the masonry is stable, anticipated to be approximately 1.5m above existing ground levels. The masonry should then be rebuilt up its height locally. Ensure any new masonry is well tied into the existing.

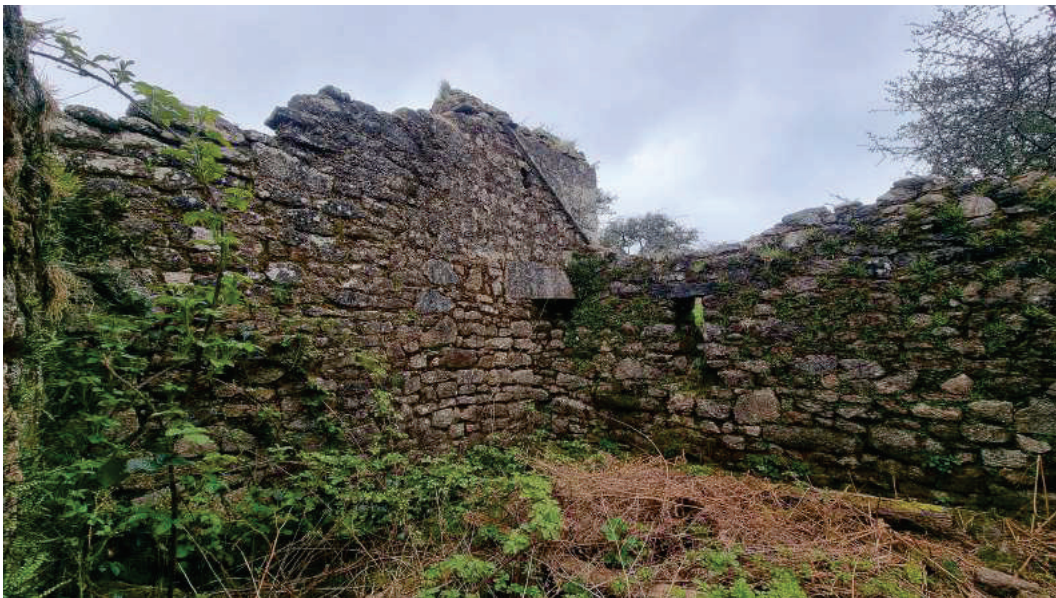
Photograph 4.0 – Exposed head of masonry throughout building

2.2 In general the masonry appears to remain in good condition. However, due to the lack of roof structure the head of the masonry throughout is exposed to water ingress to the central rubble core. Over time this can lead to de-lamination of the external and internal stone skins. It is considered that the head of the masonry throughout the building should be closely checked for condition and stability. Where concerns arise, the top courses of masonry can be locally rebuilt, or remedially tied with 'Cem' ties by Helfix. The gable walls to the front elevation have a minor outward list. These could be retained with extensive strapping to the new roof structure. However, it would be prudent to consider their removal down to eaves level. This will allow a new ring beam to be continuous around the structure. The gable walls can then be re-built like for like.

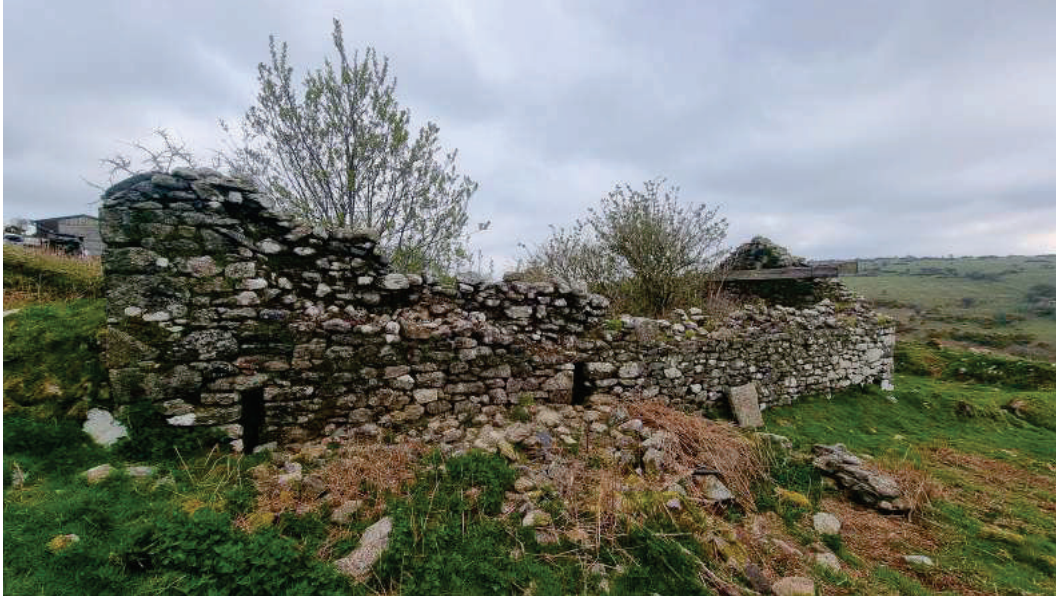
2.4 The masonry to the south western quoin is in poor condition. The head of the masonry has de-laminated and the mortar is very damp and easily friable when raked. Areas of the mortar internally have visible moss and foliage growing from the majority of the mortar joints. It is considered the head of the masonry will require re-building. The stability of the wall should be closely assessed once safe access is available to ensure de-lamination of the masonry is not occurring.

Photograph 5.0 - Outward collapsed masonry near south western quoin

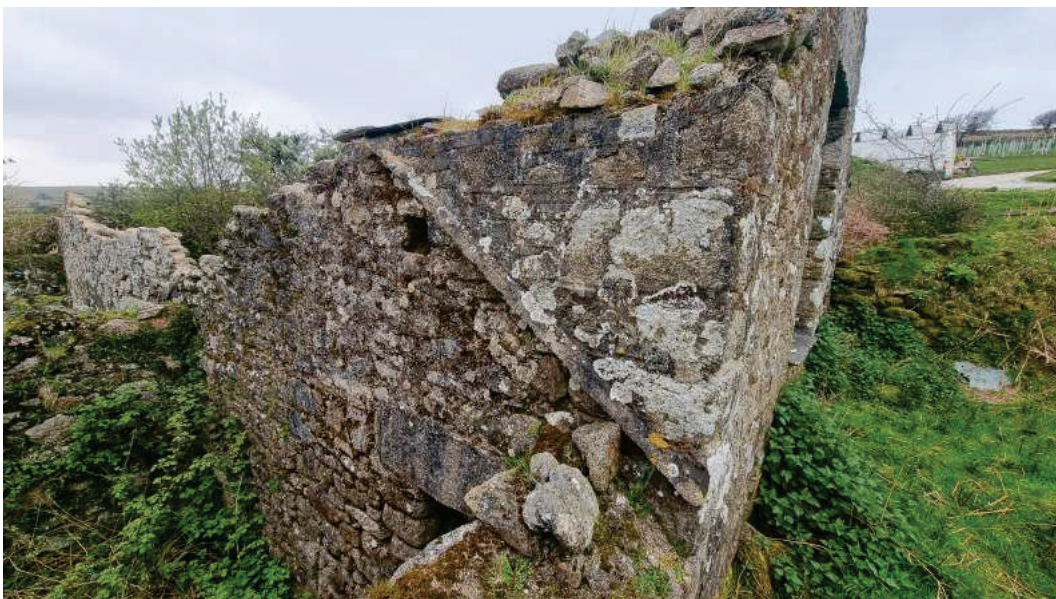
Photograph 6.0 - Cementitious mortar and flashing

2.5 Generally the mortar throughout the building is poor. In some areas such as the rear flank wall the mortar appears to be a later cementitious mortar. Cement based mortars are unbreathable and should not be applied to a stone substrate. It is suggested all wall panels will need to be raged over and the majority of all bedding joints of the stonework raked out and re-pointed using a suitable natural hydraulic lime (NHL) mortar. Further advice in respect to any re-pointing work should be sought from a suitably experienced stone mason or lime mortar specialist such as the Cornish Lime Company (01208 79779).

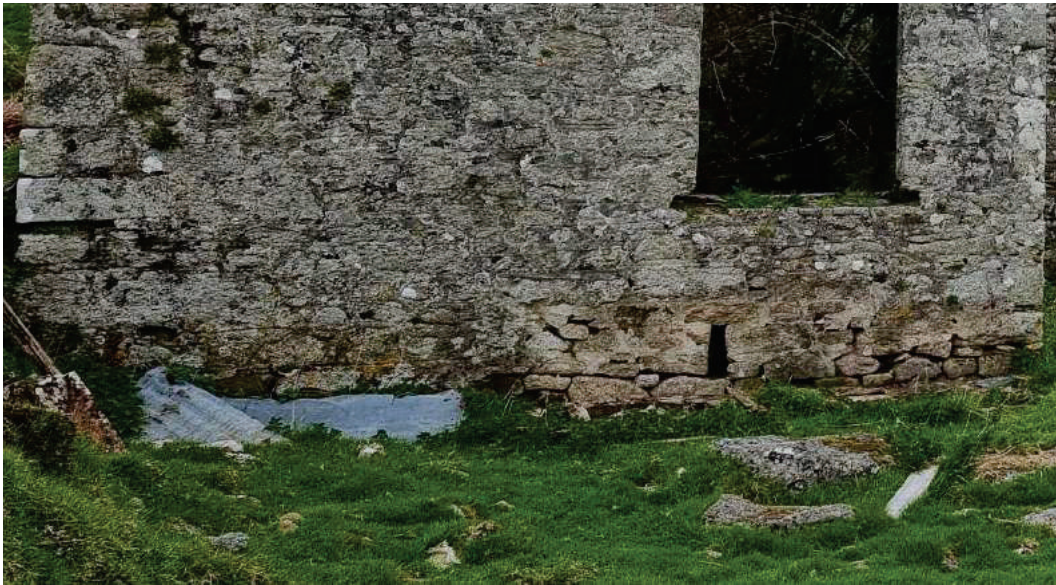
Photograph 7.0 – Voids to base of wall at front elevation

2.6 The base of the walls should be inspected throughout to ensure that the walls are not undermined or exposed. The external ground level should not be below the base of the wall. Locally to the front elevation, voiding and low ground levels are present which will likely require infilling and the external ground level locally raised.

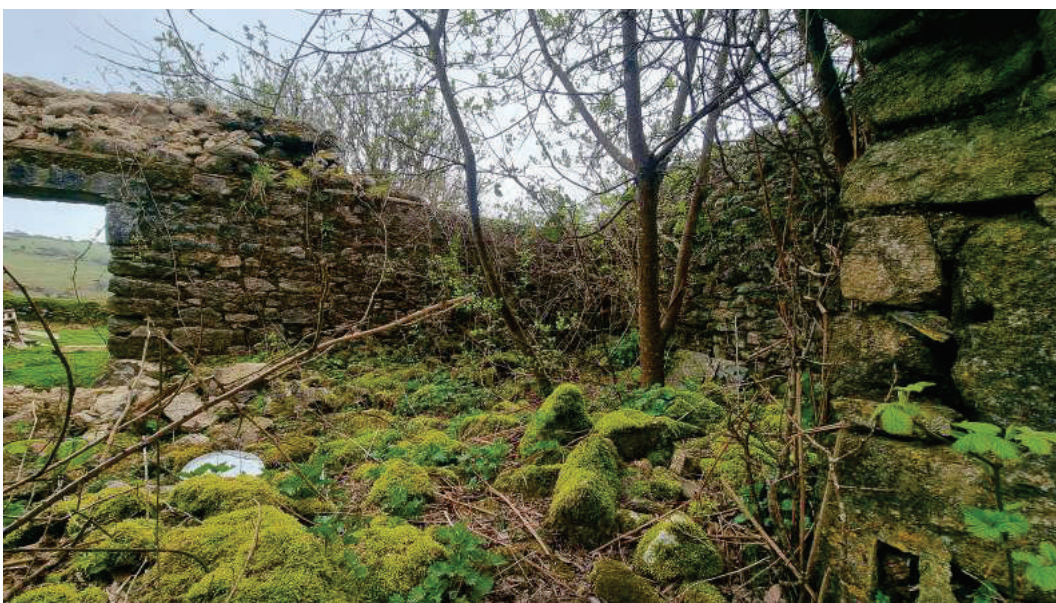
Photograph 8.0 – Tree and foliage visible internally

2.7 Throughout the building is a large build up of foliage internally and externally. This includes the growth of small trees inside the building. The foliage and trees are almost certainly undermining the building and require complete and careful removal. It is considered likely that where roots undermine the external walls, remedial local underpinning may be required to maintain the stability of the wall's base.

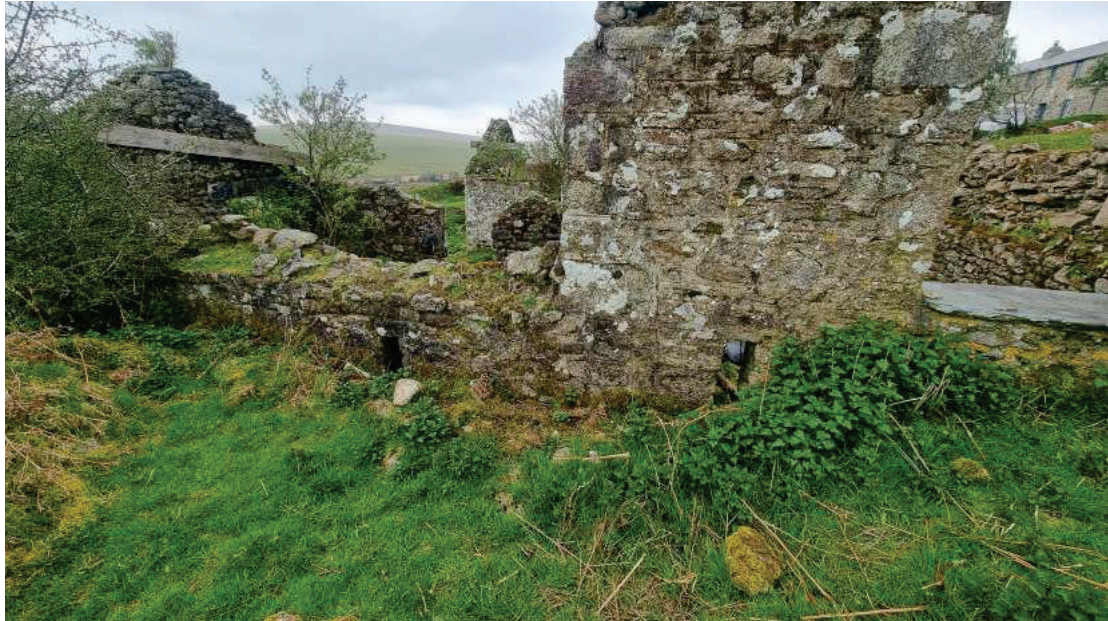
Photograph 9.0 - Build up of ground to external face with original levels unclear

2.8 The level of the external ground throughout the site varies. The rear flank wall and northern walls in particular retain ground. However it is unclear if these levels are original or a result of fill material and ruin that has been grown over. In any case considerations for drainage and tanking of any wall that retains ground should be given. It may be prudent to consider removing all retained ground against the building and adopting new separate external retaining walls.

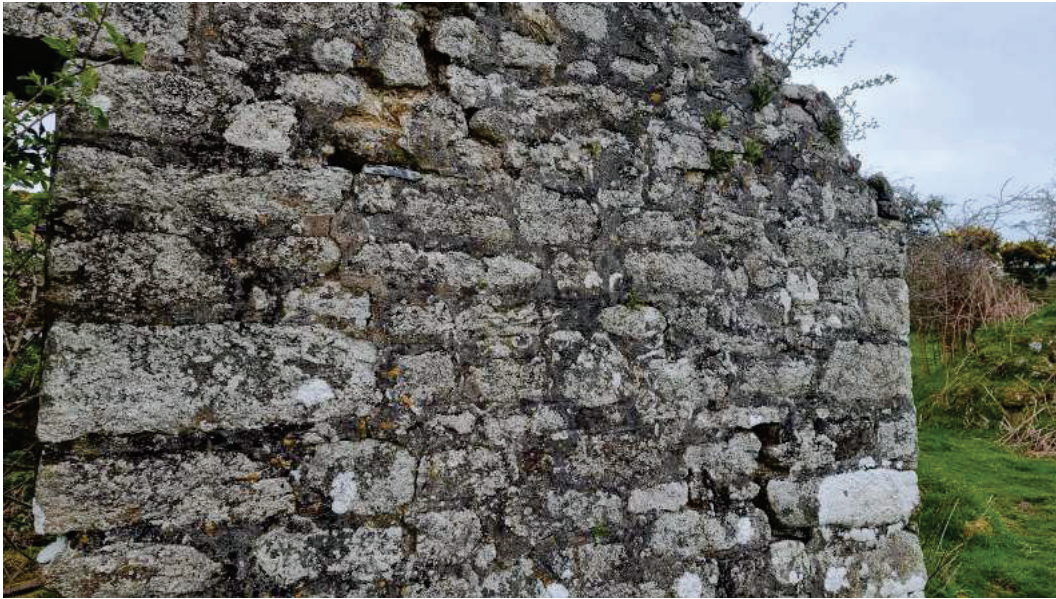
Photograph 10.0 - Vertical cracking to front elevation gable wall

2.9 Some areas of localised cracking are noted primarily to the front facing gable walls. These are likely to require stitching up their height with stainless steel helical bar by 'Helifix' or similar lain into the mortar up its height at a maximum of 450mm vertical centres.

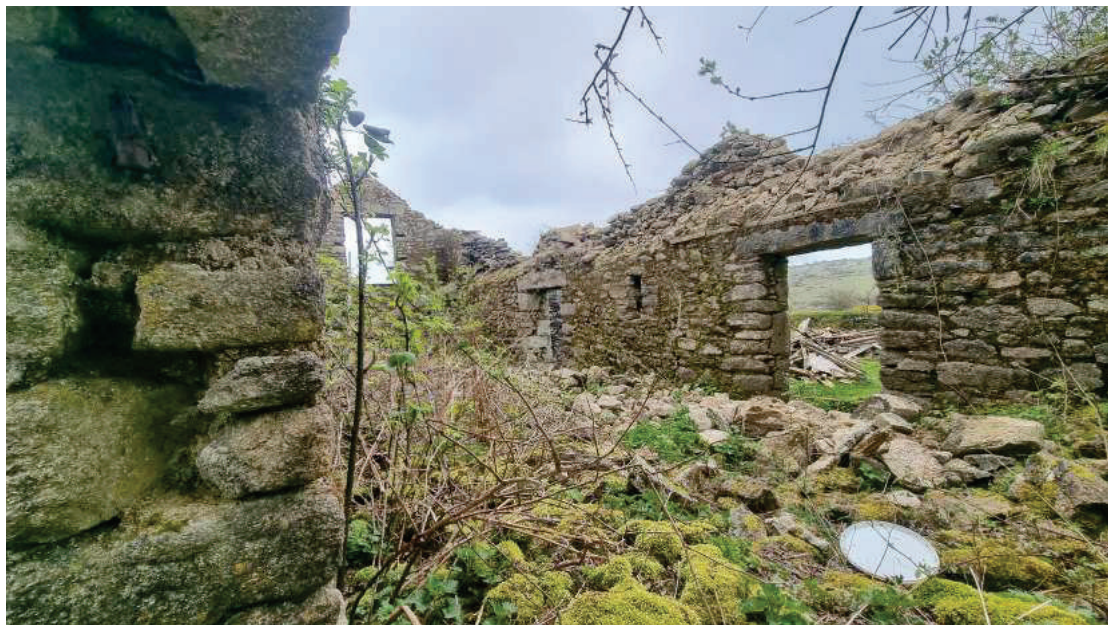
Photograph 11.0 - Internal floor concealed from rubble and foliage build up

3.1 The ground floor throughout appears to be a bare earthen floor although rubble and foliage may be concealing a formal floor beneath. It is suggested any existing ground floor make-up will require breaking up and re-laying level. It is likely any new floor may consist of a simple insulated ground bearing floor slab. Depending on proposed levels, consideration for underpinning may be required.

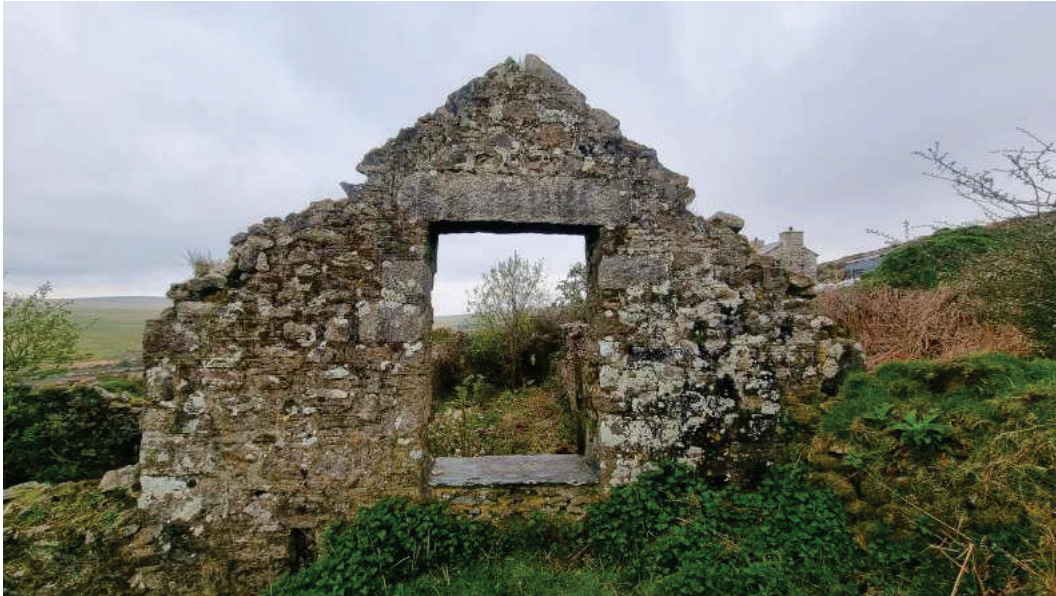
Photograph 12.0 – Possible first floor opening to northern gable wall

3.2 It is unknown if a first floor was present to the building in its history based on the remains, however once entrance is raised and may have been at a former first floor level. If proposed, a new suitably designed timber first floor deck would be required.

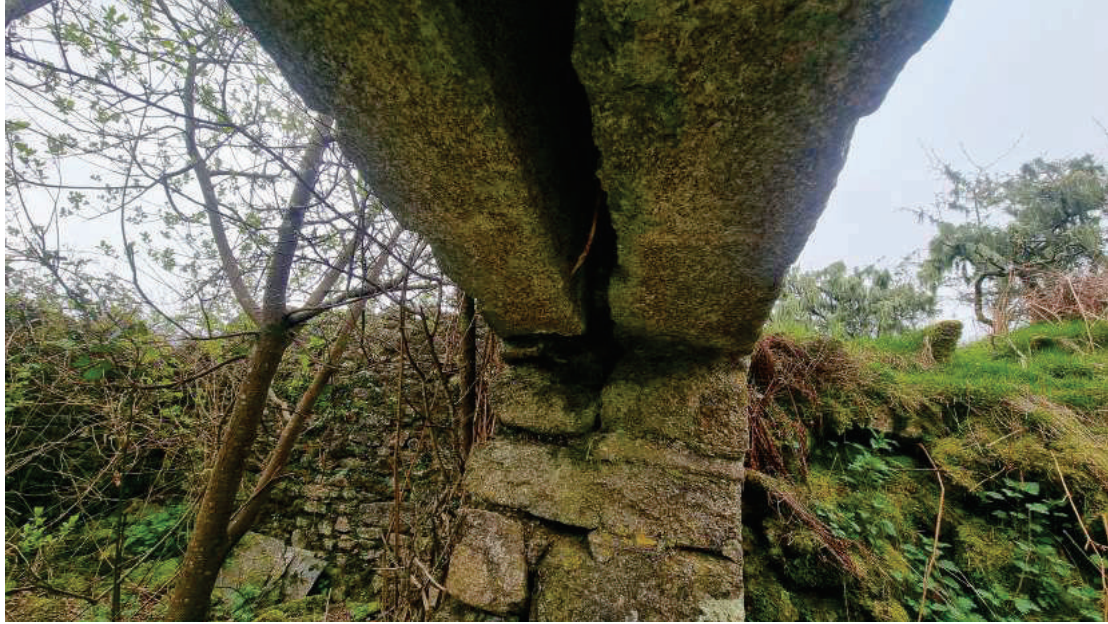
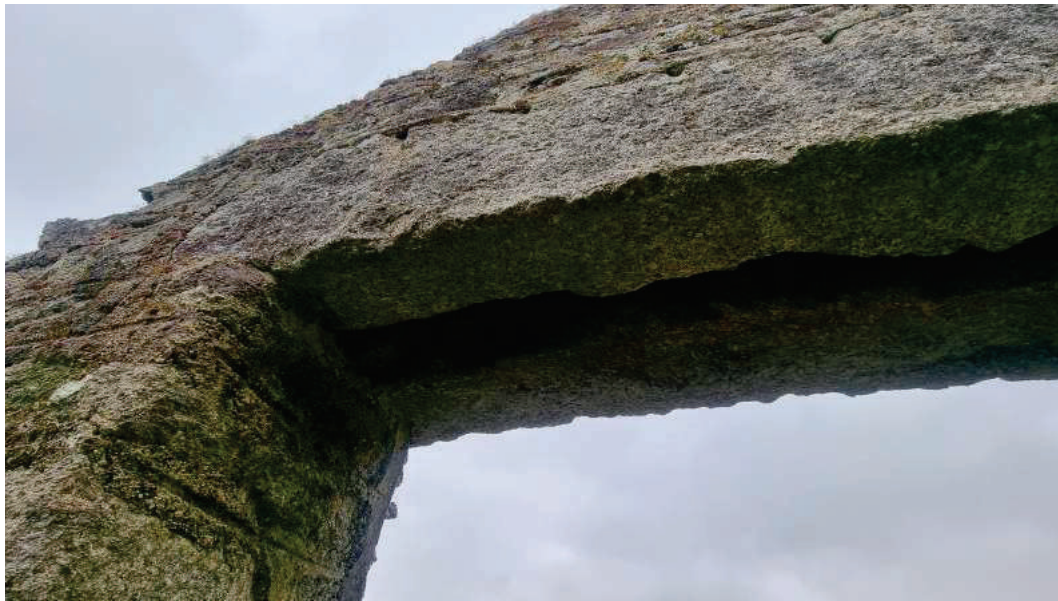
Photograph 13.0 – Granite lintels visible from underside [ground floor opening]

Photograph 14.0 – Granite lintels visible from underside [gable opening]

4.1 Where inspected, all remaining lintels are granite and appear to remain serviceable under their current use. Each lintel will need to be examined on a case-by-case basis upon conversion of the building, subjecting the anticipated new loading criteria to each as required. Whilst it is anticipated the majority of the existing lintels will be suitable to remain a number of replacements or repairs may be required if they are to support heavy loading or concentrated loads such as beam or truss bearings.
