Tree Report
Thornhill Baptist Church, Southampton, SO18 5TR.

1.1 Inspection date: 16th October 2023 by Mr. Kim Gifford, undertaken in the area of test and at the time of inspection. Fine weather conditions.

**1.6 T16: Sweet Chestnut,
Picus Test points level@ approximately 30cms from ground level.
Test Point 1 North:**

**1.9 T14: Sweet Chestnut,
Picus Test points level@ approximately 30cms from ground level.
Test Point 1 North:**

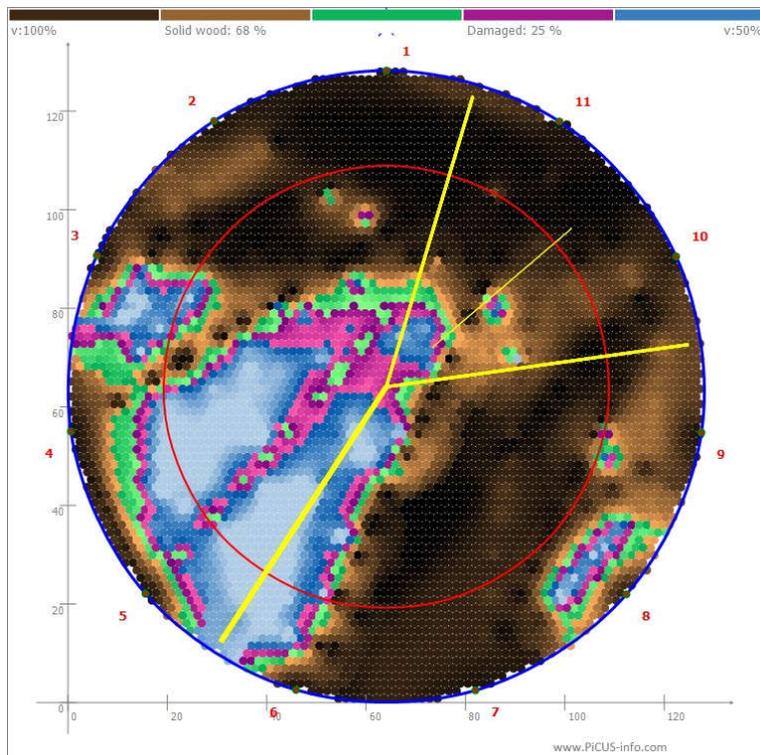
Figure 1- Tomographic image

The measuring point readings give evidence of medium velocities overall in the reference representation showing altered timber. The tomographic images shown above has a large percentage amount of altered timber. With reference to the 'color chart' in figure 3, the slowest velocities of sound is represented by the red and orange colors of data representation blue/violet being the slowest altered/decayed timber green being fast altered timber brown being fast sonic speeds solid timber

The resulting Picus tests are on acceptable limits in relation to the altered timber. This ratio could be a 'trunk ratio TR' (reference Class Mattheck has been calculated to be a guideline in terms of stability and rigidity of cylindrical structure. Although a debated theory in arboriculture generally the TR of 30% is an average.

The resulting data shows this specimen has a percentage of decay at the base evident in the trunk buttresses at ground level.

It is appropriate to recommend that the crown should be reduced overall by 2m to 3m to reduce the stress off the decayed areas.

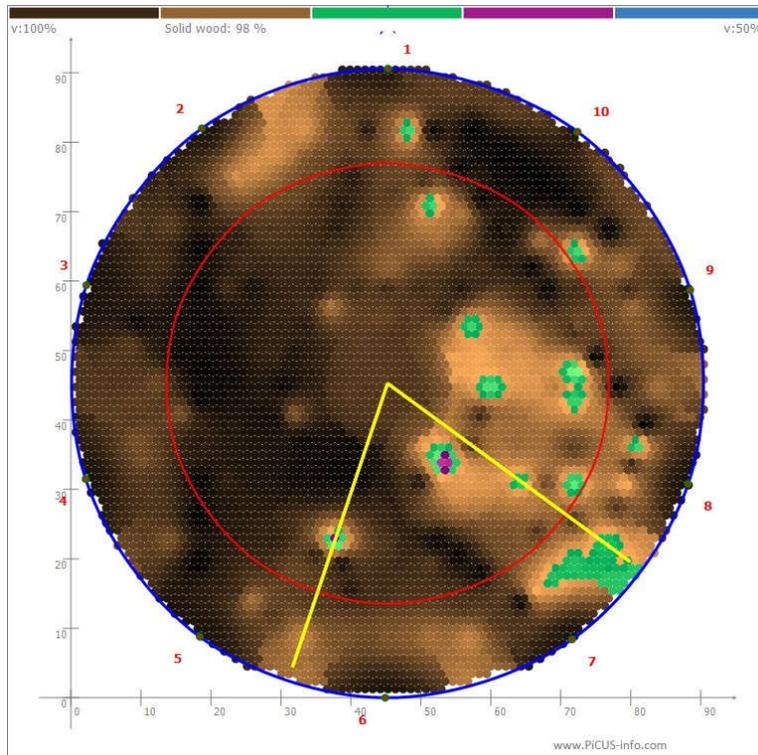
Figure 2- Tomographic image

The measuring point readings give evidence of high velocities overall in the reference representation showing sound timber. The tomographic images shown above has a large percentage amount of altered timber. With reference to the 'color chart' in figure 3, the slowest velocities of sound is represented by the red and orange data representation blue/violet being the slowest altered/delayed timber green being fast altered timber brown being fast sonic speeds solid timber

The resulting Picus tests are on acceptable limits in relation to the altered timber. This ratio could be a 'trunk ratio TR' (reference Class Mattheck has been calculated to be a guideline in terms of stability and rigidity of cylindrical structure. Although a debated theory in arboriculture generally the TR of 30% is an average.

The resulting data shows this specimen is sound at ground level.

It is appropriate to recommend that the upper crown should be reduced overall by 2m to 3m as the crown is dying back overall.
