Purpose of Issue
PL and LBC APPLICATION

Project **Log Store Roof, Chimneys, Retaining Wall and Field Shelter at Villa Farmhouse, Main Road, Aust, Bristol**

Title **As Existing**

Drawing No. **SHS3335.80-**

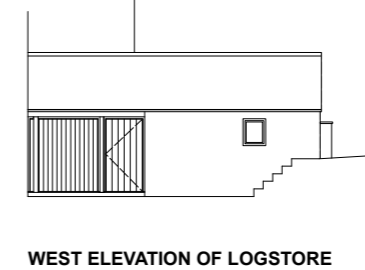
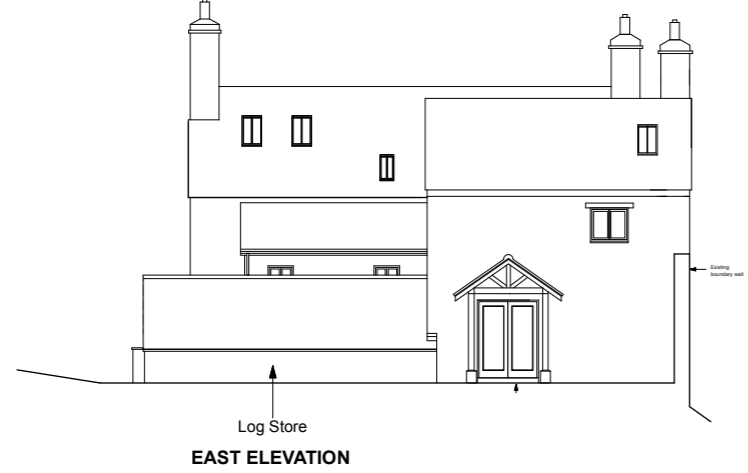
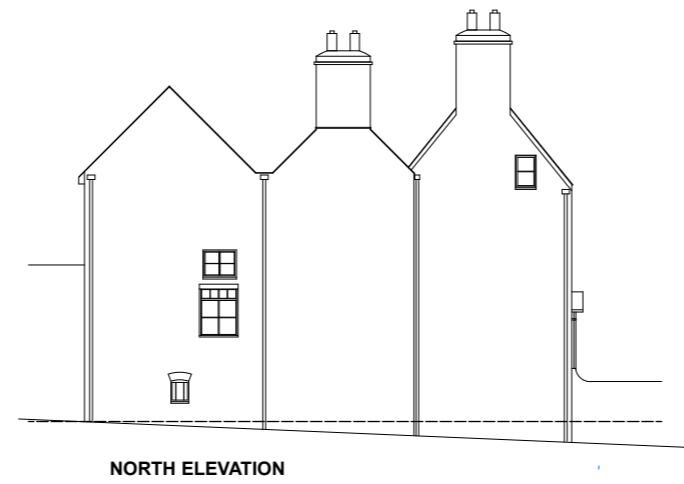
PHOTOS OF LOGSTORE ROOF

The log store roof structure was a mix of old and new timber. There was extensive rot in the old timber. See Photos right. The structure of the log store has heritage significance as part of the traditional form of construction, but the amount of rot meant that repair was un-viable. Replacement on a like-for-like basis follows good conservation principals
