Archer Ecology Ltd
Office 1
Engine House
Marshalls Yard
Gainsborough
Lincolnshire
DN21 2NA

20th December 2023

**Preliminary Roost Assessment:
2 Primrose Avenue, Newark-on Trent, Nottinghamshire**

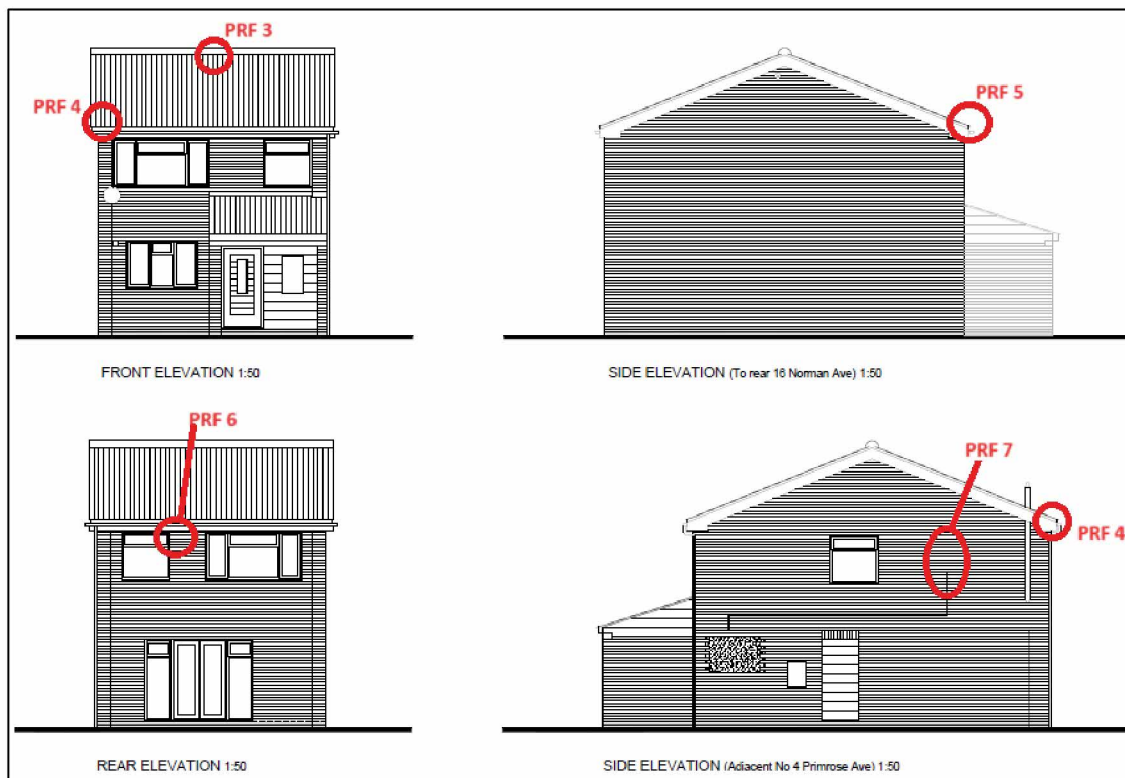
Figure 2 – Locations of external potential roost features and access/egress points

No evidence of bats was identified within the loft space. However, several PRFs and access/egress points were noted both internally and externally, as bulleted below. Where possible, these are shown in Figure 2, detailed below, and further photographs of them are given with Appendix I.

- PRF 1 – Loft space, with opportunities for bats to access/egress the loft void due to holes and tears within the roofing membrane;
- PRF 2 - Opportunities for bats to roost at the gable end between the breezeblock wall and roofing membrane;

- PRF 3 – Missing mortar between ridge tiles, which may allow access for bats beneath the tiles and into the area between the tiles and roofing membrane;

- PRF 4 – Lifted roofing tiles, allowing access for bats beneath the tiles into the area between the tiles and roofing membrane;
- PRF 5 – Missing mortar at the eaves on the gable end of the southern aspect of the roof which may allow access for bats into the area between the roofing membrane and tiles;

- PRF 6 – Hole in wall on western aspect where pipe has been removed, which may allow access for bats into the cavity wall;
- PRF 7 – Missing bricks and holes on northern aspect of the building where pipes have been removed, allowing access for bats into the cavity wall. It is anticipated that this area has been recently exposed as part of the current renovation works.

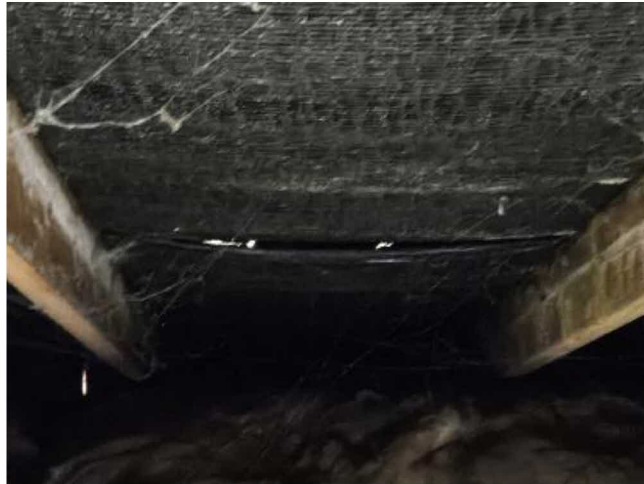
Photograph 5- Potential roost feature 1, gaps between sheets of roofing membrane

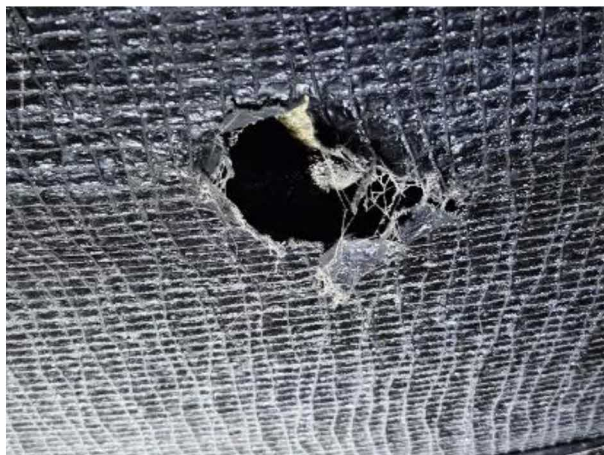
Photograph 6- Potential roost feature 1, hole in roofing membrane

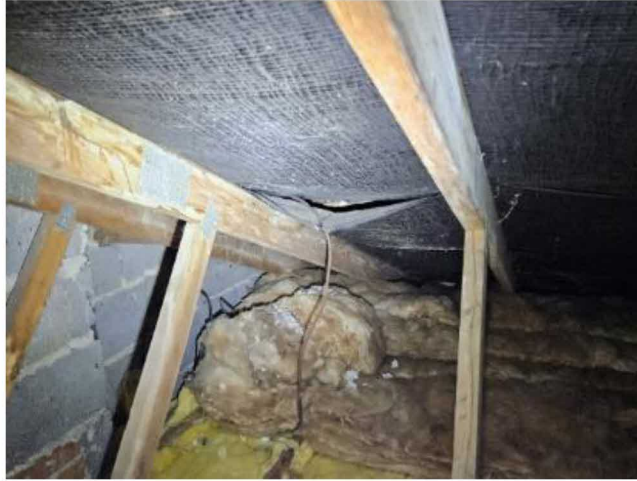
Photograph 7- Potential roost feature 1, gaps between sheets of roofing membrane

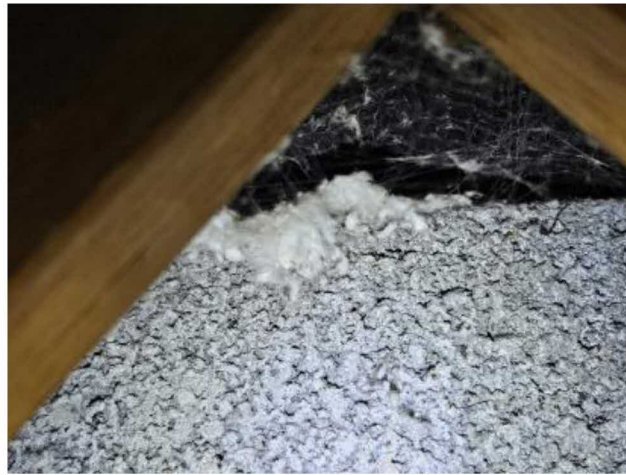
Photograph 8- Potential roost feature 2, space between top of breeze block gable end and ridge

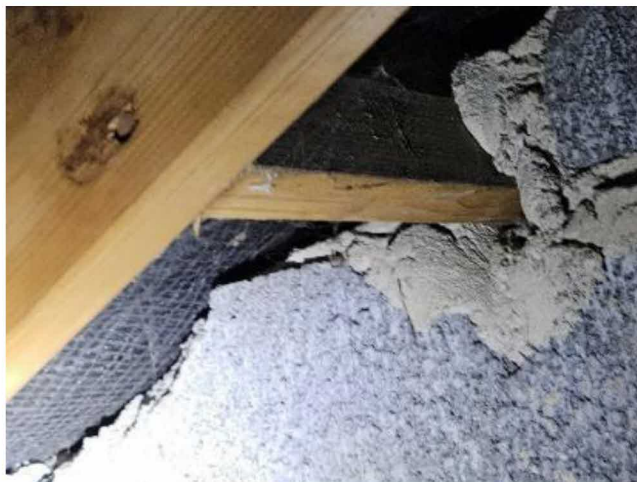
Photograph 9- Potential roost feature 2, space between top of breeze block gable end and ridge

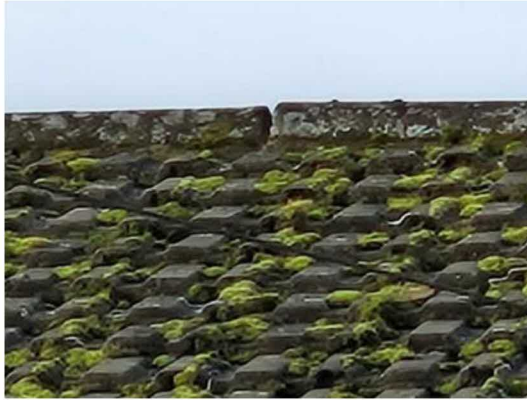
Photograph 10- Potential roost feature 3, missing mortar between ridge tiles

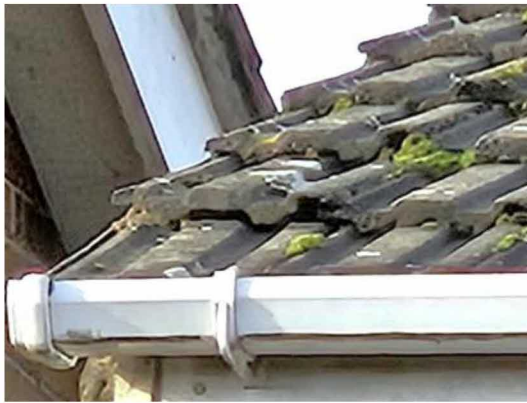
Photograph 11- Potential roost feature 4, lifted roof tiles

It should be noted that if bats are found to be utilising PRF 4 or PRF 7 then works will not be able to proceed until further surveys of the building are conducted and a licence from Natural England may be required.

Due to the presence of a non-bitumen coated roofing membrane within the main roof void, it is not considered appropriate to reinstate the lifted tiles at PRF 4, as any bats utilising this feature could become entangled within the membrane which could result in their injury or death. Therefore, the roof tiles should be reinstalled to ensure that they are tight fitting, and there are no gaps that could allow access for bats into the roof of the main loft void. As an additional enhancement measure, it is recommended that an integrated bat box such as the 'Vivara Pro Build-in Woodstone Bat Tube' is installed within the wall of the northern aspect of the new extension. The bat box should be positioned at a height of at least 4m as close to the eaves of the building as possible, and away from any artificial light sources.

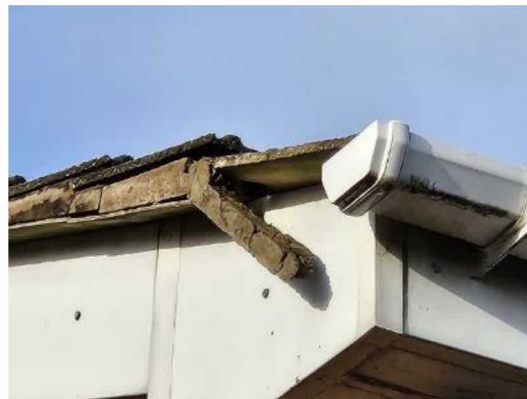
Photograph 12- Potential roost feature 5, missing mortar on southern aspect

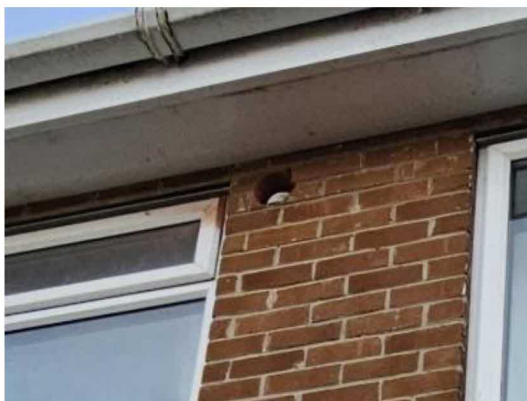
Photograph 13- Potential roost feature 6, hole in brick work on western aspect

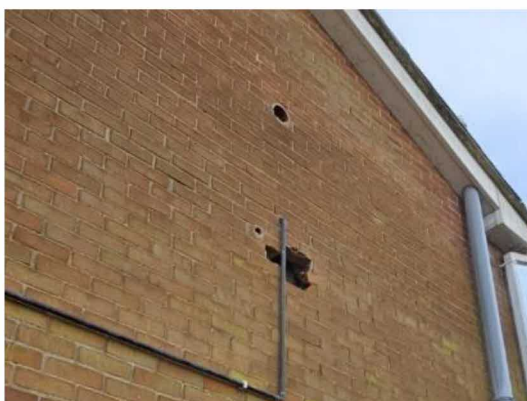
The proposed works involve the construction of a two-storey extension on the western aspect of the building. This will involve stripping two rows of tiles off the western aspect of the existing roof so that they marry into the new roof of the proposed extension. The site does offer potential roosting opportunities for bats although the majority of these are associated with the southern and south-eastern aspects of the roof which will not be directly affected by the proposals. PRF 4 (western aspect) and PRF 7, however, are located on the northern aspect of the property and will be impacted by the proposals.

Photograph 14- Potential roost feature 7, missing bricks and holes on northern aspect

Therefore, in accordance with the Bat Conservation Trust's *Good Practice Guidelines, 4th edition* (Collins, 2023), the building should be subject to a single nocturnal bat survey. The survey should be undertaken between May and August (inclusive), in suitable conditions for bats to be active (above 10°C, dry with low levels of wind).

Bats are transient animals and often change roost sites depending on weather conditions and other factors, therefore even if no bats are recorded during the nocturnal survey there is a chance that bats could colonise the feature and subsequently be harmed during works. If no bats are noted to emerge from the building, then tightly fitting boarding that is flush to the brickwork, with no gaps, should be installed over PRF 7 to prevent this from occurring. In addition, works to strip the two rows of existing roof tiles should be conducted under the supervision of a suitably licensed ecologist.

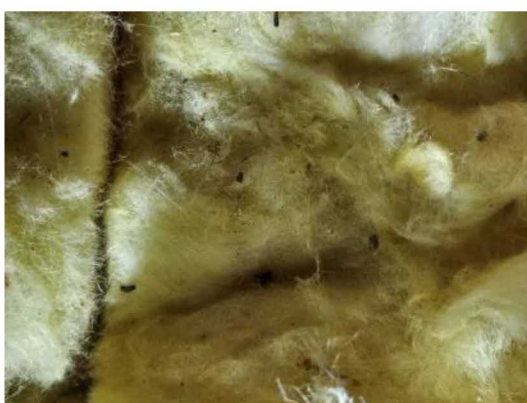
Photograph 15- Mouse droppings in loft

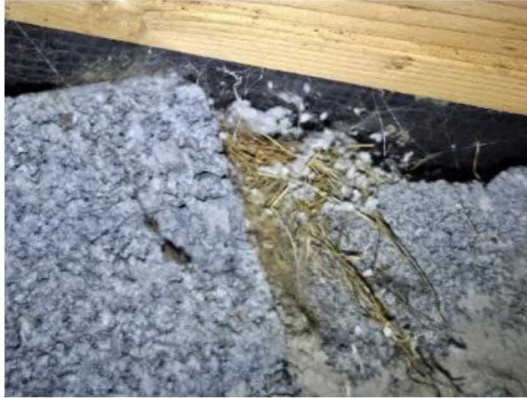
An accumulation of approximately six mouse droppings were observed atop the fibreglass insulation adjacent to the loft hatch. A disused bird's nest, likely built by a house sparrow *Passer domesticus*, was identified above the boiler, between the breezeblocks at the southern gable end and the roofing membrane. House sparrow are listed as red on the Bird of Conservation Concern 5¹. The property continues to offer potential nesting habitat for small-sized passerines within wall cavities and the loft void and underneath the tiles.

Photograph 16- Sparrow nest in loft

Should the works commence during the main nesting bird season (March to August, inclusive) a pre-works nesting bird check of the loft should be undertaken immediately (within 24 hours) prior to the proposed extension works by a suitably experienced ecologist. In the event that an active bird nest is identified then the works should immediately cease and no works must take place until it is confirmed by the ecologist that all young have fledged, and the nest is no longer active.
