Tree Condition Report Pertaining to One Beech Tree

**No. 4 Newlands Avenue, Radlett, Herts
WD7 6EL**

CLIENT:	Mr Barry Welck
CLIENT REF:	BW/NARH
AAAL REF:	SAL/KMA/11766
AAAL CONSULTANT:	Shane A Lanigan
REPORT DATE:	21st October 2023

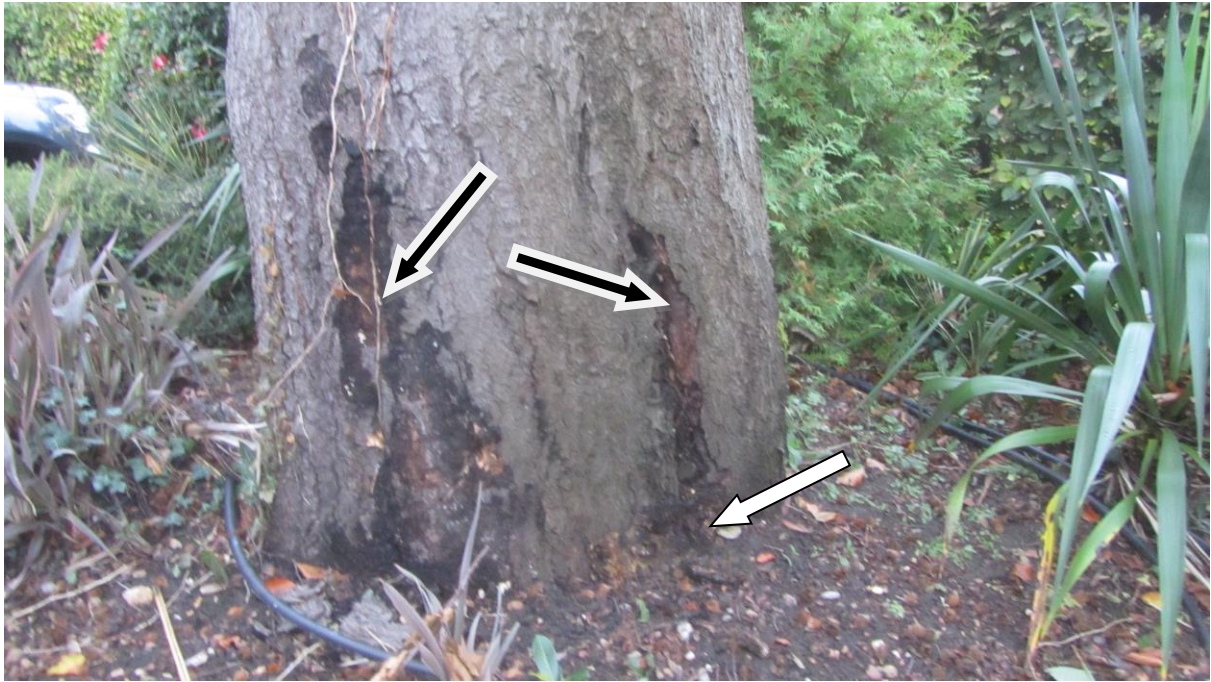
3.2.2 Brittle cinder fungus is an ascomycete fungus (see Photographs 3, 4, 6 & 9, Appendix 1 at the back of this report) that causes a simultaneous white rot in which both lignin and cellulose are digested together (fungi break down wood using external enzymatic [proteins] digestion). It is more active in the outer sapwood – as opposed to Artist's bracket fungi which causes a heart rot – and is consequently more dangerous (the great majority of a tree trunk's strength is concentrated at the outer circumference). Heart rotted trees can stand for many years, sometimes decades, following colonisation. Those affected by sapwood rotting fungi fail much more quickly.

3.3 **Structural condition:** This tree is massively structurally compromised due to the long-standing actions of the two fungi. Having extensively tested the trunk by probing and sounding from ground level – 2 m or so above ground I determined that this tree is contemporarily hazardous. It should be felled as soon as possible, certainly with one month.

PHOTOGRAPH NO. 3 – Base of T1 northeast side showing site of former Ganoderma fungal bracket (white arrow) and brittle cinder fungus on bark/sapwood (black arrows)

6.1 T1 – **Common beech** – fell to ground level within one month.

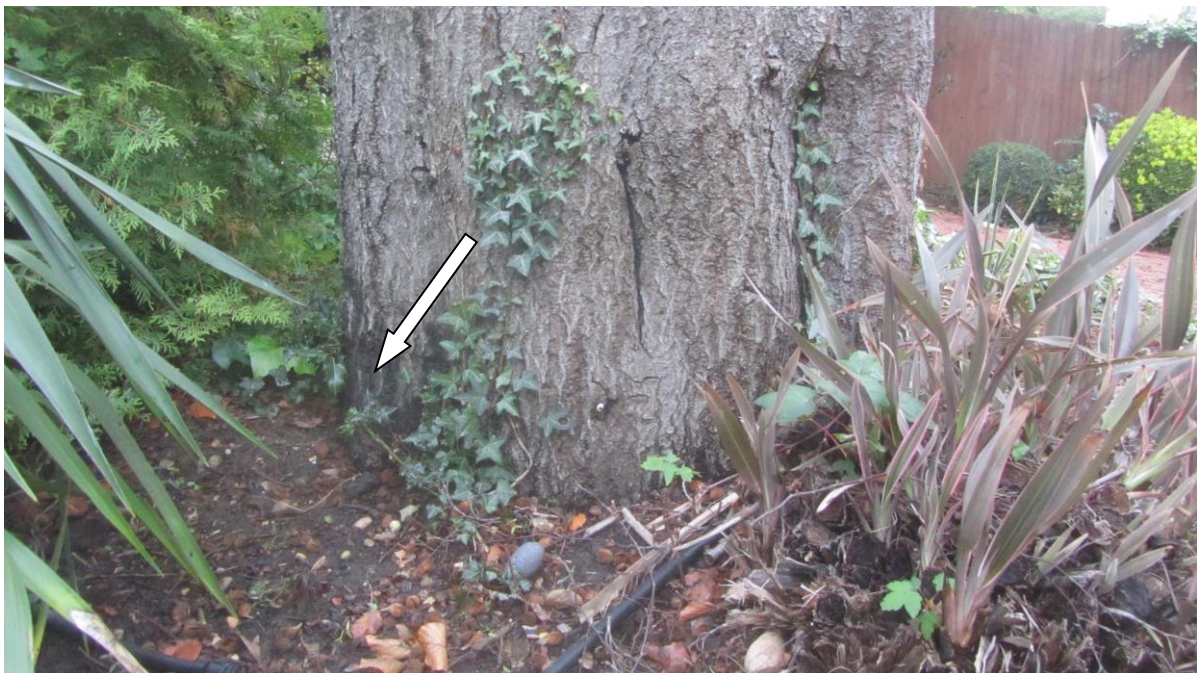
PHOTOGRAPH NO. 4 – T1 – Brittle cinder fungus on east side (arrowed)

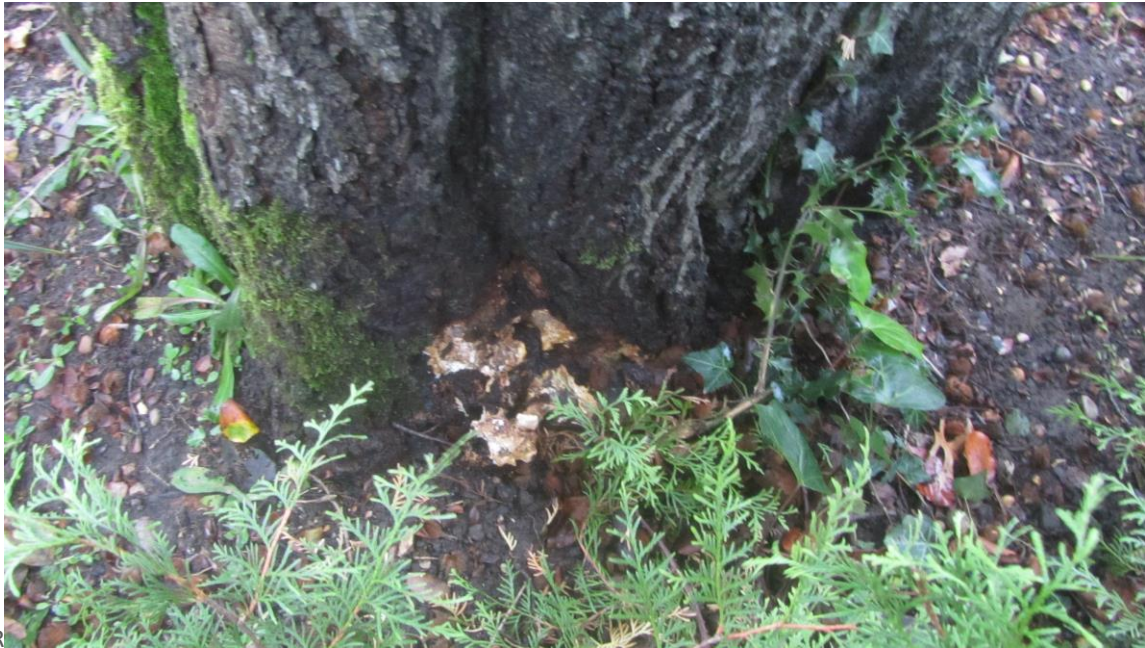
3.2 **Physiological condition:** I saw that the tree is in poor physiological condition. It has several areas of significant branch dieback (see Photographs 6, 7 & 8, Appendix 1 at the back of this report). Artist's bracket fungus has long been present within the tree (see Photograph 5, Appendix 1 at the back of this report). Although I did not see the brackets myself - due to them being kicked off as part of a supposed 'cure' by charlatan 'tree surgeons' – Mr Welck identified them from images I showed him. A 'bottle butt' form of the lower trunk (see Photograph 9, Appendix 1 at the back of this report) helps to confirm this diagnosis.

3.2.1 Artist's bracket is a white rot fungus that preferentially degrades the lignin content of wood thereby compromising its stiffness and resistance to compressive force. Cellulose and hemi-cellulose are degraded later.

PHOTOGRAPH NO. 5 – T1 – Remains of old Ganoderma fungal bracket on south side

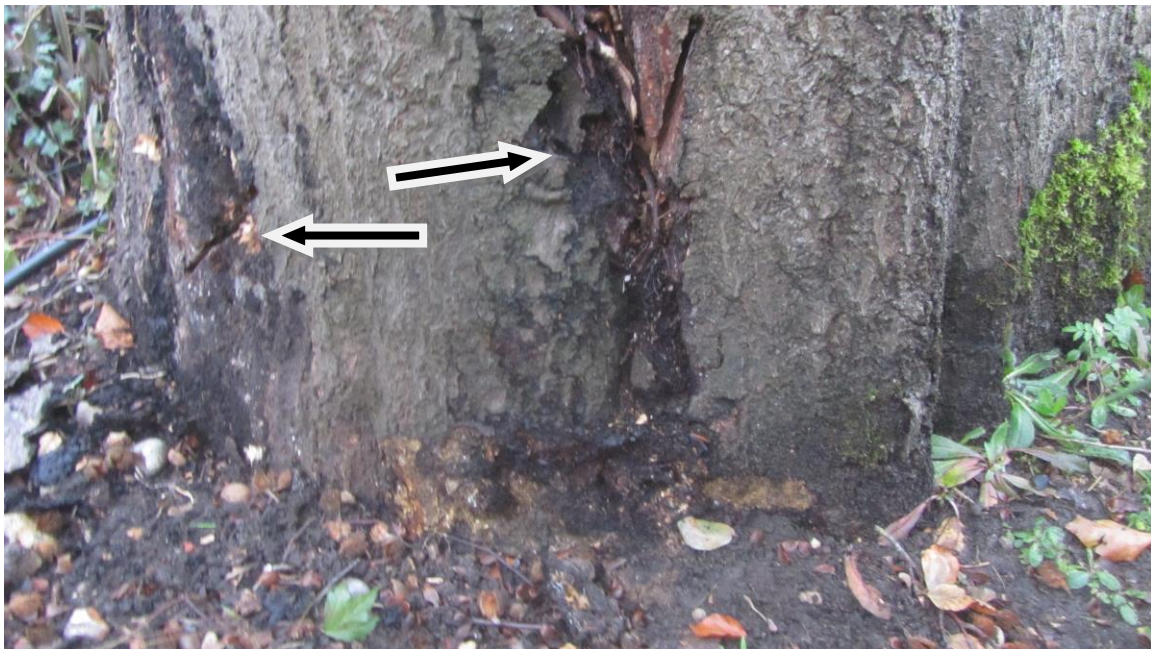
PHOTOGRAPH NO. 6 – T1 – Brittle cinder fungus on north side (arrowed)

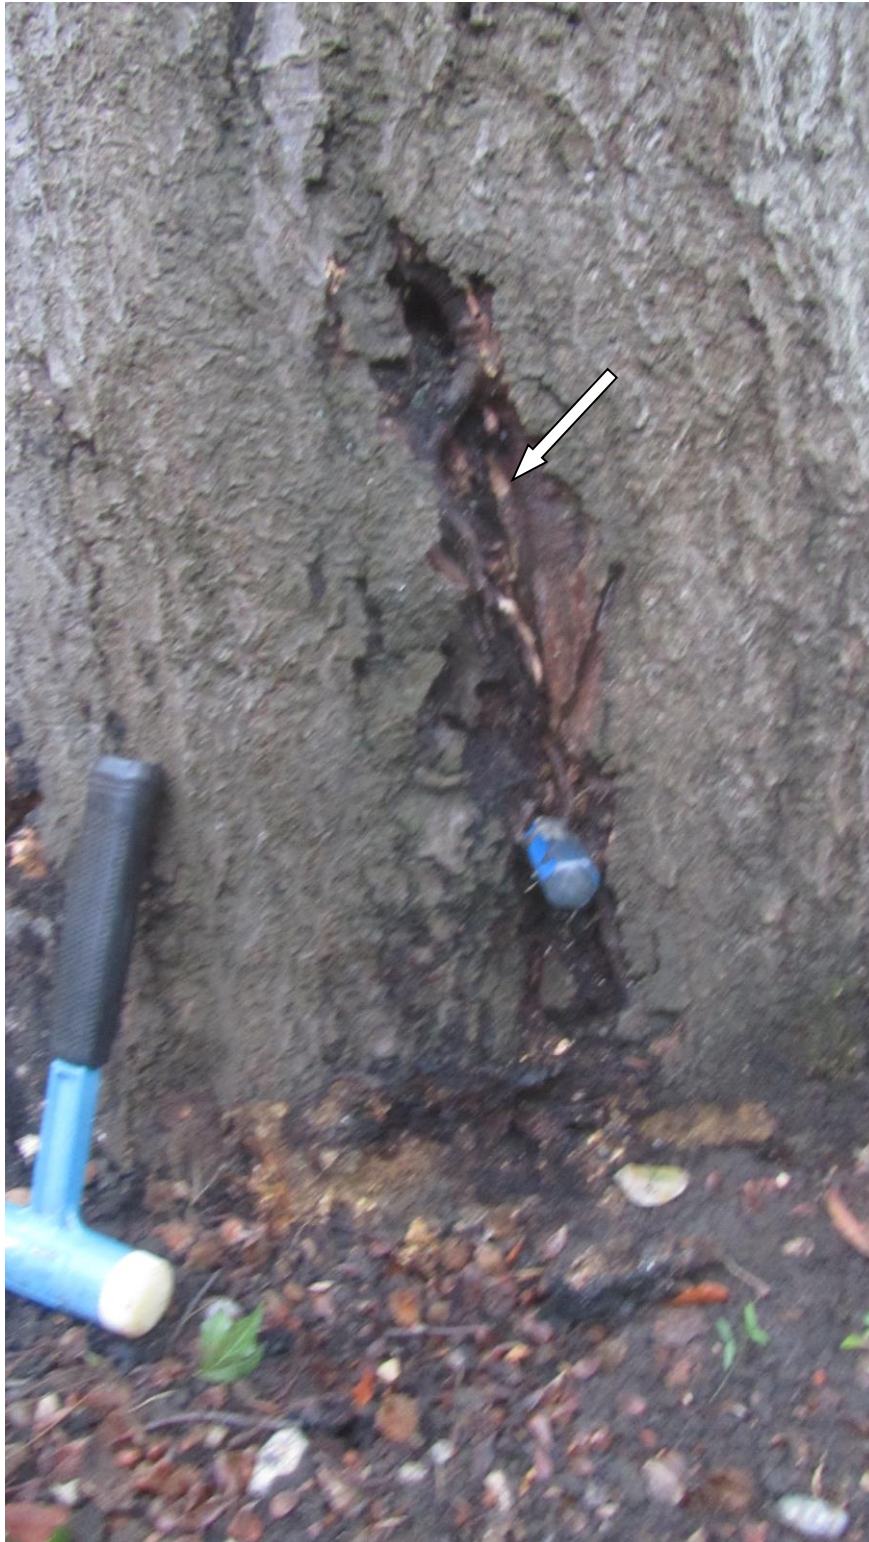
PHOTOGRAPH NO. 7 – T1 – Screwdriver pushed into decayed wood on northwest side with adventitious roots (arrowed)

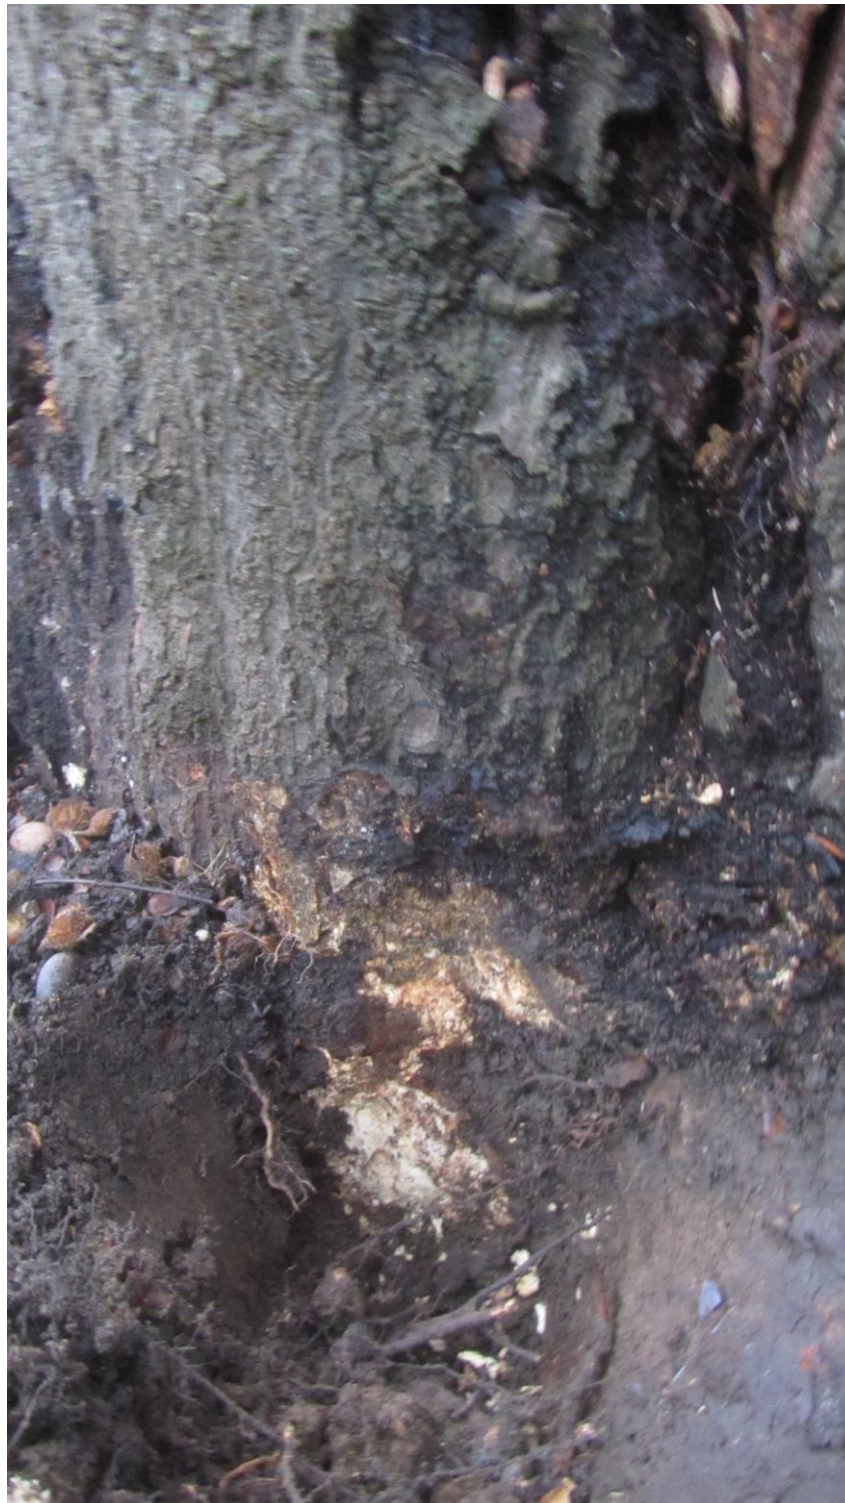
3.2.3 By destroying most of the tree's bark and sapwood the fungus has eliminated much of the vascular system, thereby depriving the branches, twigs and leaves of the mineral elements in solution (water) that they need to survive.

PHOTOGRAPH NO. 8 – Decayed bark and sapwood on the western side

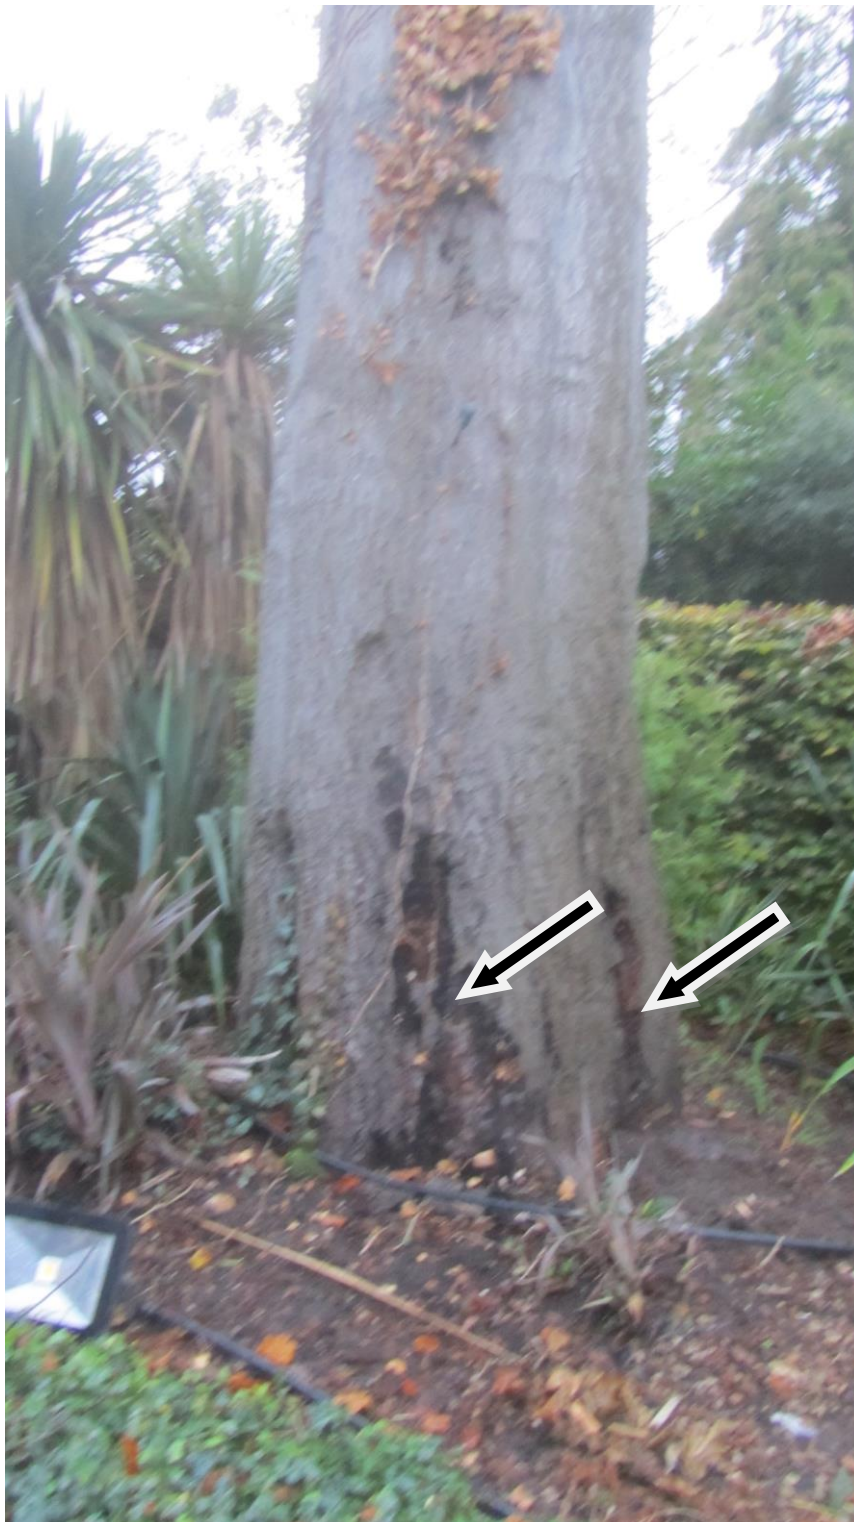
PHOTOGRAPH NO. 9 – ‘Bottle Butt’ form of the trunk of T1 – consistent with colonisation by a white rot fungi - with brittle cinder fungus at the base (arrowed)
