ARBORICULTURAL REPORT FOR THE PURPOSES OF A HOUSE PURCHASE

Adam Austin
Greenacres
The Common
Surlingham
Norwich
NR14 7AP

AAHRGREE

7th February 2023

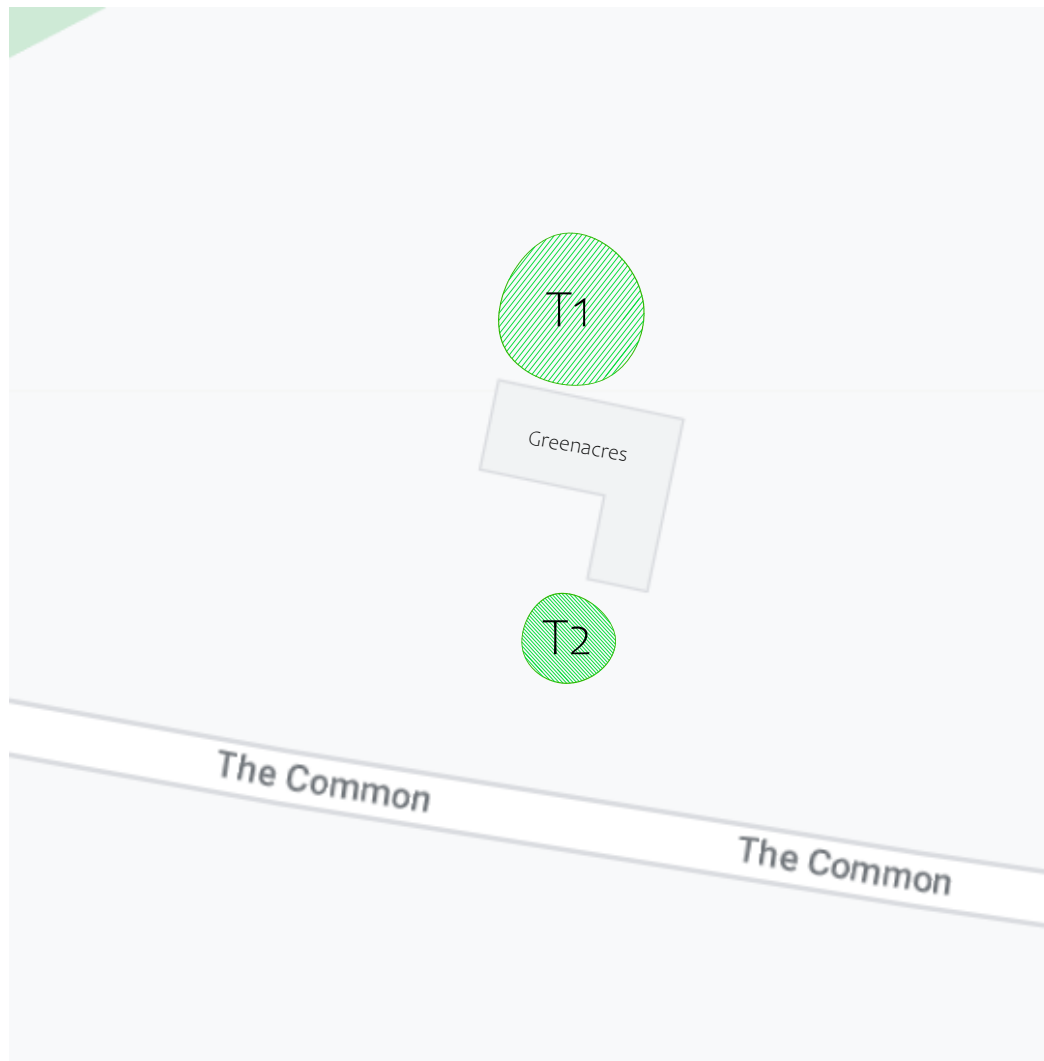
Plan showing location of surveyed trees and vegetation at Greenacres, The Common, Surlingham, Norwich, NR14 7AP
