GEOSLOPE STABILITY REPORT

SITE: FORMER G7 CONFERENCE FACILITY AT CARBIS BAY HOTEL, CARBIS BAY, CORNWALL

Our Ref: TJG/SSA/G003.Carbis Bay Hotel.Rev0

12th August 2023

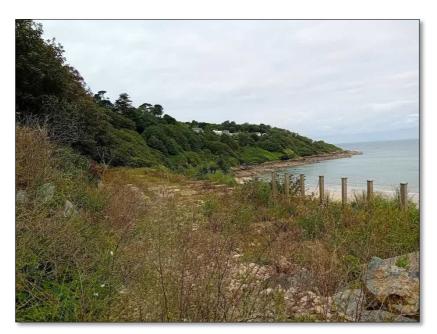
Figure 04: The former G7 Conference Facility – from the southeast corner looking west.

At the time of the inspection the site was partially obscured by shallow vegetation including grasses and weeds, however over the greater part of the site, the ground level was observed to have been made up of imported hardcore subbase. The exception to this was the concrete foundations along the northern boundary, and a small area of tarmac located at the eastern end of the site, adjacent to the southwest coastal path. The ground surface was extensively intact, although tracks marks were visible from the plant and equipment used for the removal of the previous structures. There was no sign of cracking or settlement that may be indicative of ground movement or slope failure.

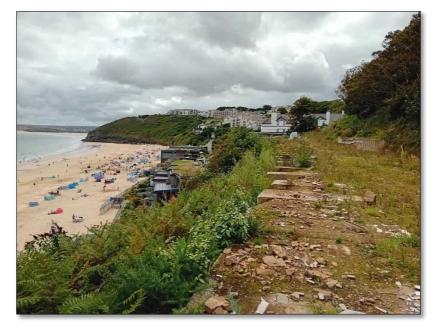
The concrete foundations are set at regular intervals along the northern boundary of the site. At the time of the inspection, the concrete foundations were partially buried by the hardcore material, however they appeared to be between approximately 2.5 and 3.0 metres in length, 0.7 metres in width and 0.9 metres in height. The concrete slabs appear to have been constructed of high-density concrete, cast in-situ onsite.

The slabs feature mounting bolts on the top, though it is not known if they contain steelwork or any other form of reinforcement, there are no obvious lifting points. The slabs are placed at regular intervals with 1.0 - 2.0 metres spacings, at the time of the inspection the slabs were observed to be in a good state of structural repair, with no observation of structural damage (cracking) and no visible surface weathering or degradation, the slabs were also partially buried in-situ.

Figure 05: The concrete foundation slabs on the northern boundary of the site – facing east.

In this case, the northern boundary of the site is extensively supported and reinforced by the presence of the concrete foundations, which provide both physical protection to the vulnerable slope crest and tensile support both to the ground surface and the slope crest.

Concrete foundations should remain in-situ. The concrete foundations serve to protect the vulnerable crest of the slope from erosion and degradation, and also serve to support the ground surface.

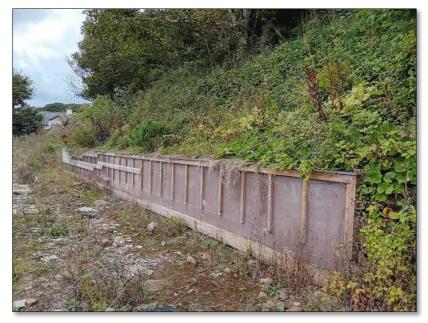
The concrete retaining wall is located towards the centre of the southern (landward) boundary of the site. The retaining wall is approximately 20 metres in length, 1.8 metres in height and > 0.4 metres in width and has been constructed to retain the foot of the prevailing slope on the southern boundary following limited excavation works. The retaining wall appears to have been constructed of mass pour concrete and cast in-situ onsite, with a wooded façade then fitted to the exterior, no drainage infrastructure or weepholes were observed within the wall.

Figure 06: The concrete retaining wall - facing northwest.

At the time of the inspection the concrete retaining wall was observed to be in a good state of structural repair, with no signs of structural damage (cracking or displacement) that may be indicative of structural failure or ground movement.

The existing retaining structures on the southern site boundary (the concrete retaining wall and granite boulders) should remain in-situ. The removal of these structures without the consideration of appropriate long-term retention and support of this slope face, will lead to increased risk of landslip and collapse of material from the slope face on the southern boundary of the site.

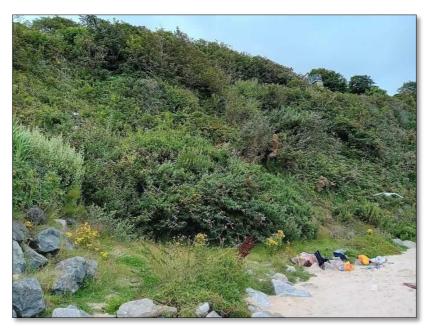
The sea cliffs to the rear of Carbis Bay Beach, and immediately below the northern boundary of the site were observed to be approximately 20 metres in height and at a variable slope face gradient of between 60 and 80 degrees (from horizontal). The slope face was extensively obscured by vegetation though the slope face was comprised of metasedimentary lithology (mudstones – weak to medium strong), with a prevalent bedding structure dipping to the north-northeast and northeast at a variable angle of dip of between 40 and 50 degrees (from horizontal).

Figure 07: The sea cliffs to the rear of Carbis Bay Beach – facing south.

The base of the sea cliffs are within the rearshore area and obscured by sand. There were no obvious erosional features within the slope face, such as erosional platforms or sea caves, although there was a steepening of the rock face at the base of the sea cliffs that may have been caused by erosion as a result of wave or tidal energy (wave cut notch).

The sea cliffs were extensively obscured by vegetation at the time of the inspection including bushes, shrubs and rare small, immature trees.

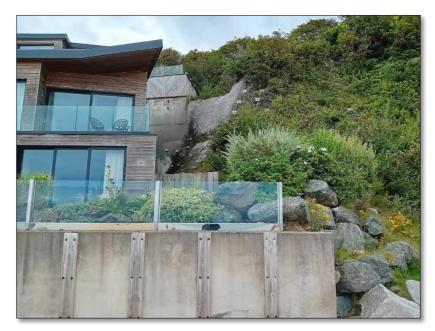
Rock anchors and draped steel mesh: Installed to the height of the slope face directly to the north and beneath the site, the works comprise rock anchors installed at regular 3 to 5 metres spacings into the slope face, with steel plates 300 mm diameter and 20 mm thickness. These anchors are installed in conjunction with a plastic-coated steel mesh and secured with steel cables across the slope face. At the time of the inspection, the installed anchors and slope face mesh were observed to be in a good state of repair, with no observation of damage or degradation. The installed mesh is extensively obscured by vegetation on the slope face, the upper anchor detail was not visible at the time of the inspection, but appears to be present below the crest of the slope (the northern boundary of the site).

Armourstone and sprayed concrete: The armourstone and *sprayed concrete* have been installed as part of the construction of the hotel chalet accommodation on the beach front. The chalet style accommodation incorporates a concrete sea wall on the seaward side, and the armourstone has been installed at the western end of the sea wall, and below the centre part of the site. The armourstone comprises stacked granite boulders, < 1.0 metres in diameter, that are designed to dissipate the impact energy of waves and tides.

The *sprayed concrete* is installed to the rear of the chalet accommodation and close to the boundary of the site in the northeast corner. The sprayed concrete has been installed directly to the slope face in conjunction with the rock anchors, and it is assumed the sprayed concrete may also incorporate steel mesh reinforcement.

At the time of the inspection, all rock slope stabilisation measures and reinforcement were observed to be in a good state of repair (where observable), with the steel mesh and anchors appearing to be appropriately tensioned to the slope face, and the sprayed concrete apparently intact with no observation of cracking or degradation (based on limited visual observation).

Figure 08: Rock slope stabilisation and reinforcement measures, rock anchors, draped ste and sprayed concrete.
