# GEOTECHNICAL

## for Subsidence Management Services

**58a Commercial End, Swaffham Bulbeck, Cambridge, CB25 0NE**

Client: Subsidence Management Services  
Client Contact: Peter Hughes  
Client Ref: IFS-AVI-SUB-22-0101842  
Policy Holder: [REDACTED]  
Report Date: 30 September 2022  
Our Ref: C65587G29670

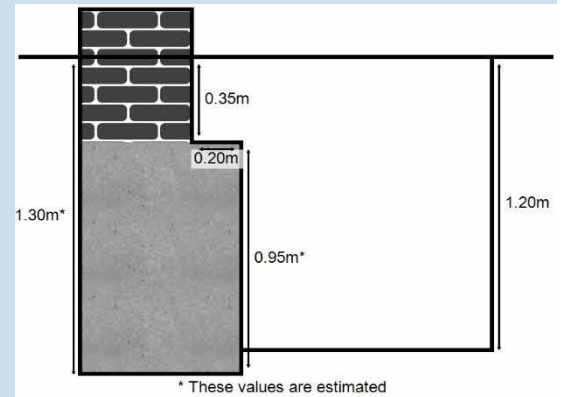
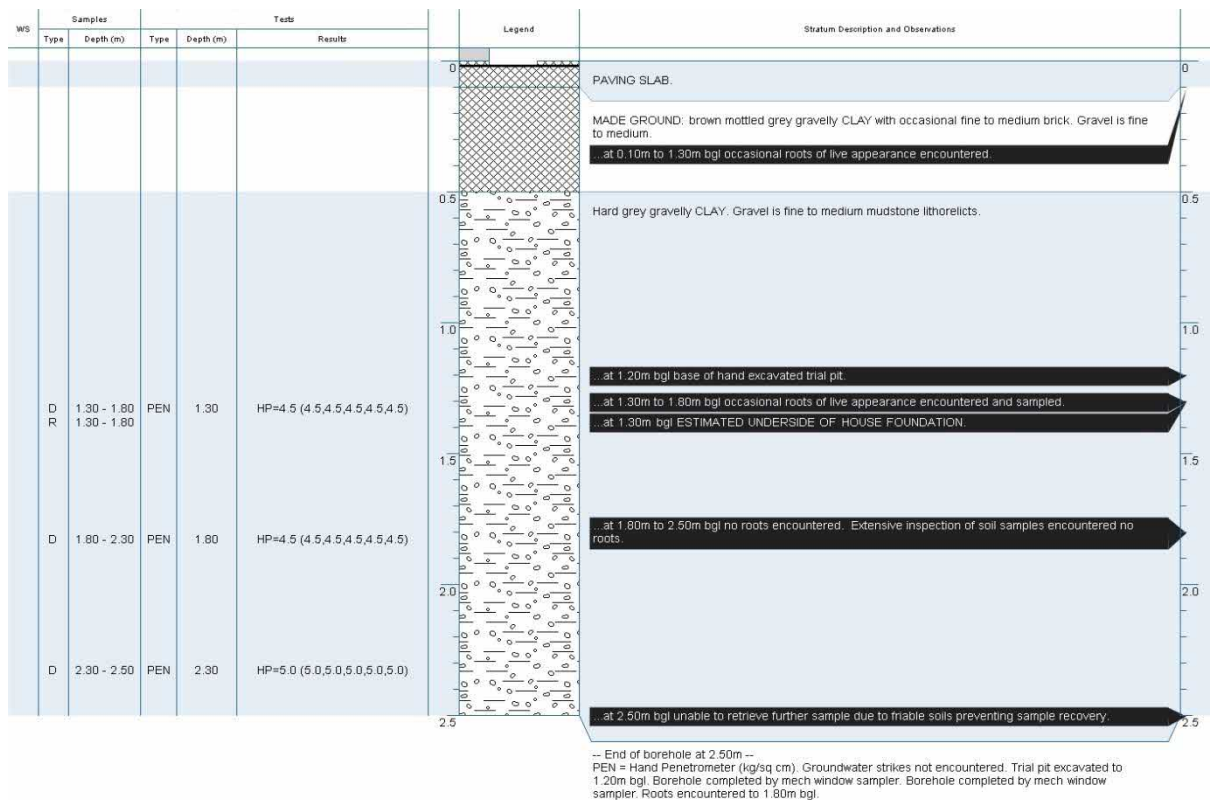
## TP/BH1 Foundation Detail and Borehole Log

House foundation comprised of brick wall to 350mm bgl, bearing on concrete to an estimated depth of 1300mm bgl, with a total projection of 200mm from the elevation. Underside of foundation (USF) was estimated by pushing a probe, approximately 200mm back from the face of the foundation, at an angle with no apparent contact with the face of the foundation beyond the estimated depth.

At 1.30m bgl ESTIMATED UNDERSIDE OF HOUSE FOUNDATION in TP/BH1.

At 1.20m bgl base of hand excavated trial pit in TP/BH1.

At 2.50m bgl unable to retrieve further sample due to friable soils preventing sample recovery in TP/BH1.

At 0.10m to 1.30m bgl occasional roots of live appearance encountered in TP/BH1.

At 1.30m to 1.80m bgl occasional roots of live appearance encountered and sampled in TP/BH1.

At 1.80m to 2.50m bgl no roots encountered. Extensive inspection of soil samples encountered no roots in TP/BH1.

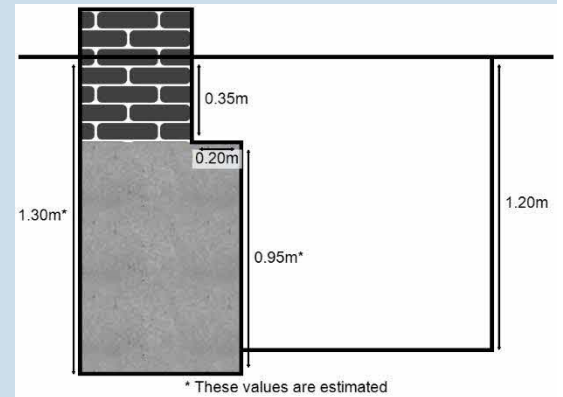
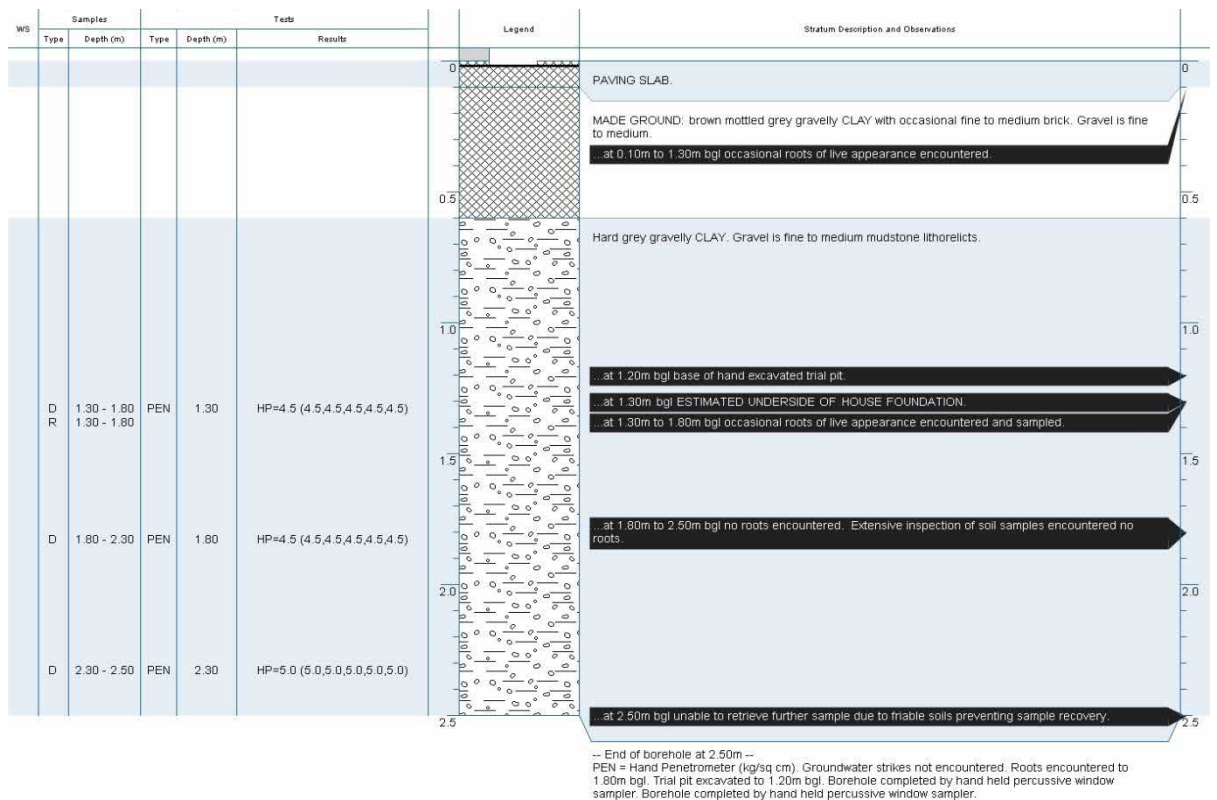
## TP/BH2 Foundation Detail and Borehole Log

House foundation comprised of brick wall to 350mm bgl, bearing on concrete to an estimated depth of 1300mm bgl, with a total projection of 200mm from the elevation. Underside of foundation (USF) was estimated by pushing a probe, approximately 200mm back from the face of the foundation, at an angle with no apparent contact with the face of the foundation beyond the estimated depth.

At 1.30m bgl ESTIMATED UNDERSIDE OF HOUSE FOUNDATION in TP/BH2.

At 1.20m bgl base of hand excavated trial pit in TP/BH2.

At 2.50m bgl unable to retrieve further sample due to friable soils preventing sample recovery in TP/BH2.

At 0.10m to 1.30m bgl occasional roots of live appearance encountered in TP/BH2.

At 1.30m to 1.80m bgl occasional roots of live appearance encountered and sampled in TP/BH2.

At 1.80m to 2.50m bgl no roots encountered. Extensive inspection of soil samples encountered no roots in TP/BH2.

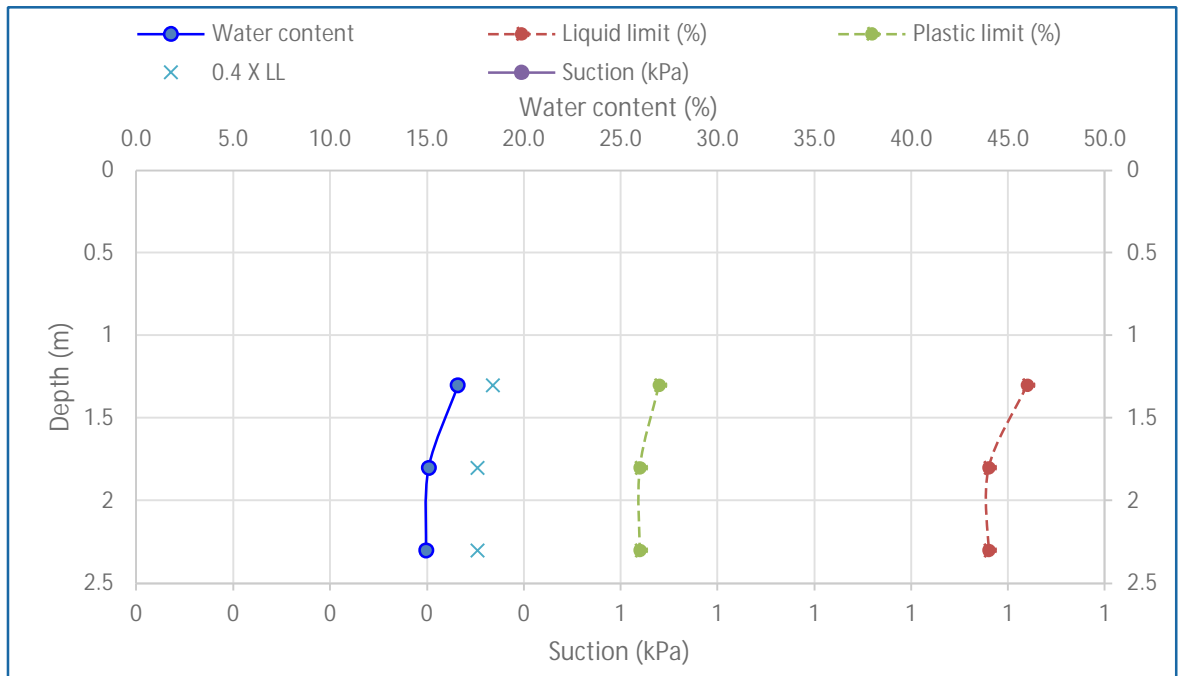
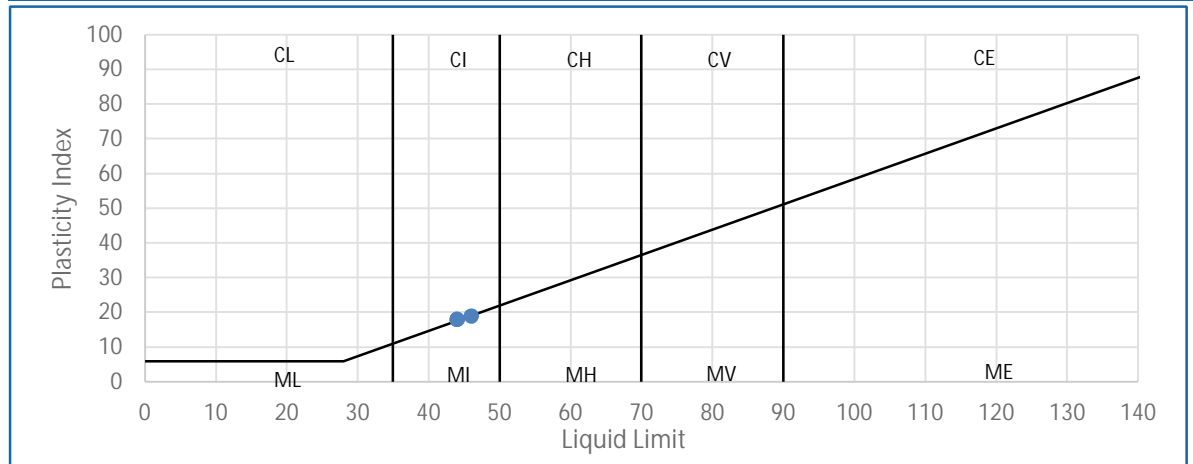
### Samples from BH1

Lab Ref	Depth (m)	WC (%)	LL (%)	PL (%)	PI (%)	.425 mm(%)	mod. PI (%)	Av. Suc. (kPa)	Description
1	1.3	16.6	46	27	19	88	17		Friable light grey slightly gravelly SILT . Gravel is fine, medium and coarse.
2	1.8	15.1	44	26	18	58	10		Friable light grey very gravelly SILT . Gravel is fine, medium and coarse.
3	2.3	15.0	44	26	18	58	10		Friable light grey very gravelly SILT . Gravel is fine, medium and coarse.

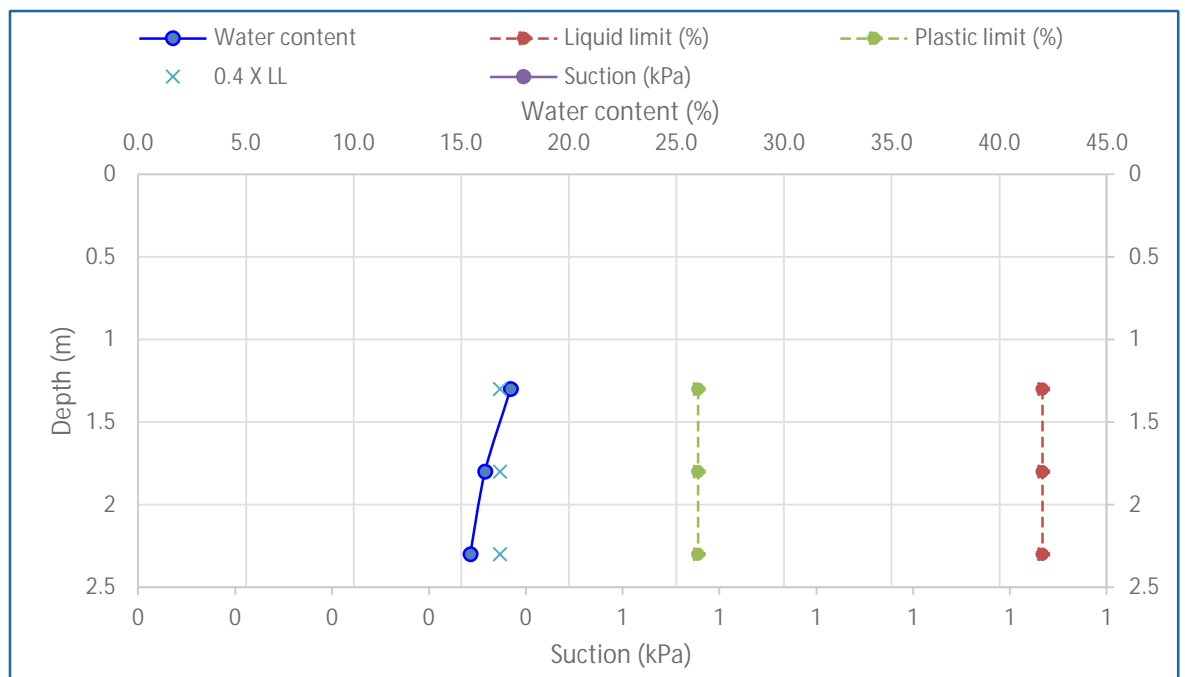
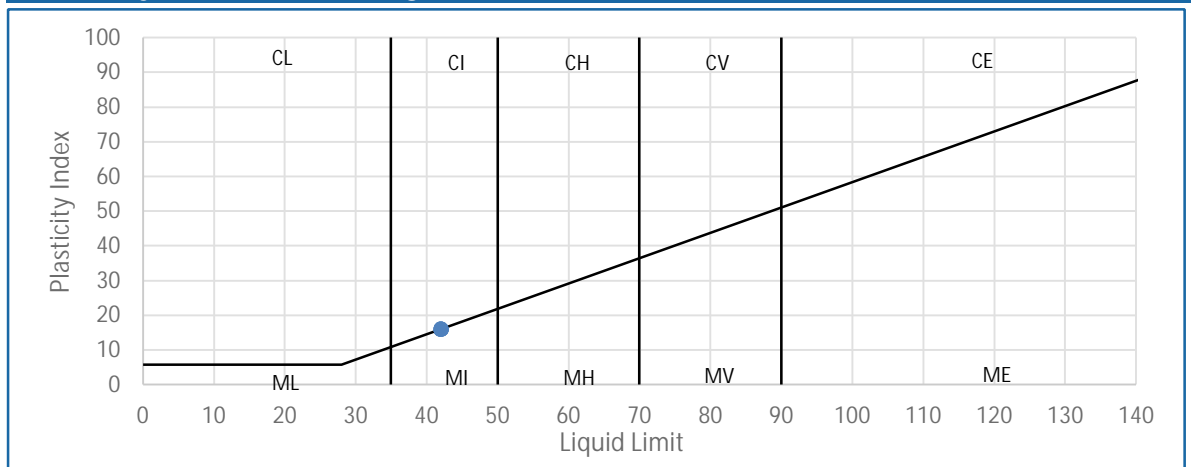
### Samples from BH2

Lab Ref	Depth (m)	WC (%)	LL (%)	PL (%)	PI (%)	.425 mm(%)	mod. PI (%)	Av. Suc. (kPa)	Description
4	1.3	17.3	42	26	16	98	16		Friable light grey slightly gravelly SILT . Gravel is fine, medium and coarse.
5	1.8	16.1	42	26	16	98	16		Friable light grey slightly gravelly SILT . Gravel is fine, medium and coarse.
6	2.3	15.4	42	26	16	58	9		Friable light grey very gravelly SILT . Gravel is fine, medium and coarse.
