# Arboricultural Consultancy for Aviva

Insured	Mr & Mrs Edward & Carol Taylor	Address	58a Commercial End , Swaffham Bulbeck, CB25 0NE		
Client	Subsidence Management Services	Contact	Peter Hughes	Claim No.	IFS-AVI-SUB-22-0101842
ES Ref	SA-252273	Consultant	Kirk Thompson	Contact No.	0330 380 1036
Report Date	20/02/2023

## 5. Technical Synopsis

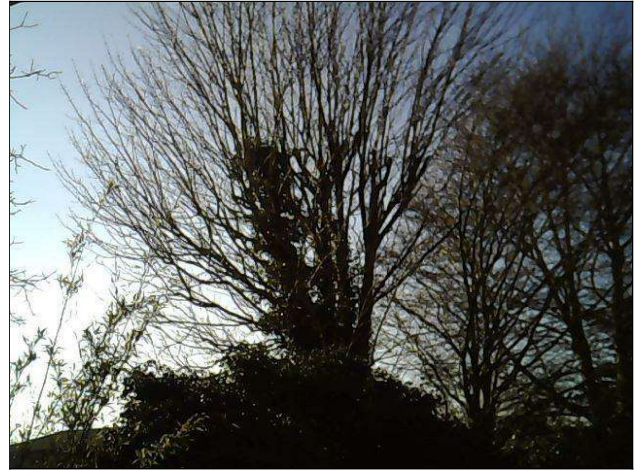
View looking towards T1, T2 & T3

With due regards to species profile, size and proximity, T2 (Sycamore) and T3 (Hornbeam) are considered the dominant features proximate to the focal area(s) of movement and accordingly, where vegetation is confirmed as being causal, we have identified them as the primary cause of the current subsidence damage.

The size and proximity of the above vegetation is consistent with the advised location(s) of damage and it is our opinion, on balance of probability, that roots from the above vegetation will be in proximity to the footings of the insured property.

Consequently, we have advocated the complete removal of T2 and T3 as it will offer the most certain arboricultural solution likely to restore long-term stability.

Tree No.	Species	Age Cat	Approx. Height (m)	Distance to Building (m) *	Ownership	Action	Requirement
T2	Sycamore	1	13	12.3	A - Third Party	Remove	Remove close to ground level and treat stump to inhibit regrowth.
T3	Hornbeam	1	10.5	11	A - Third Party	Remove	Remove close to ground level; do not treat stump due to translocation risk. Where such a risk exists, we advise that any emergent regrowth is removed annually.

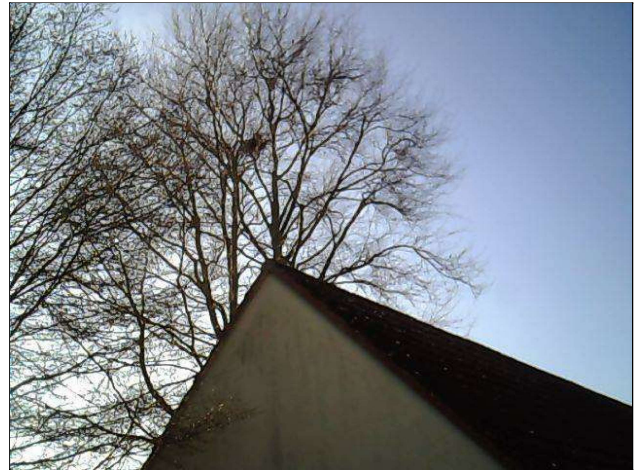
T4 - Beech

Please note that the footing of the insured property fall within the anticipated rooting distance of additional vegetation which we believe presents a foreseeable risk of future damage and accordingly we have made recommendations in respect of this.

SG1	Rose	1	1.2	0.2	C - Insured	Action to avoid future risk	Maintain at broadly current dimensions by way of regular pruning.
T1	Walnut	1	12.5	17.5	A - Third Party	Action to avoid future risk	Maintain at broadly current dimensions by way of regular pruning.
T4	Beech	1	17	16	A - Third Party	Action to avoid future risk	Crown reduce overall canopy by 30% (minimum) to achieve a crown volume reduction in line with BRE IP7/06. Maintain at reduced dimensions by re-pruning back to points of previous reduction on a 3 year (max) cycle.
