**Project:** 23\_VTA\_11\_37  
**Site:** Tinwell House, Main Street, Tinwell, Stamford, Rutland, PE9 3UD  
**Client:** Rockleigh Ltd

Document Title:	Tree Safety Survey
Document Author:	Peter Haine FDS Sc Arb, M ArborA
Project Manager:	Peter Haine
Project Title:	Tinwell House, Main Street, Tinwell, Stamford, Rutland, PE9 3UD

The tree survey for Tinwell House contains the details of a single mature Beech tree located near the southern boundary of the plot.

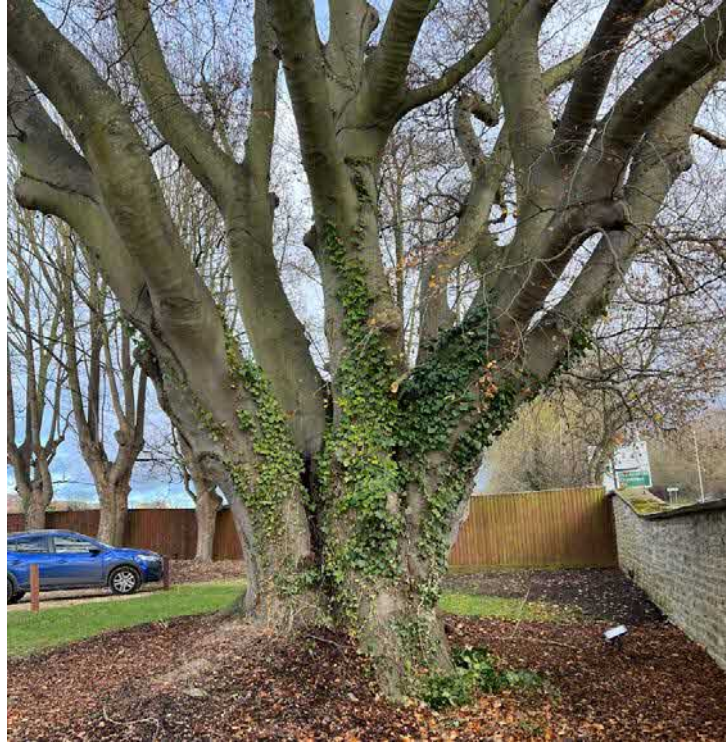
*Photographic plate showing the lower section of the stem (ROAVR, 2023)*

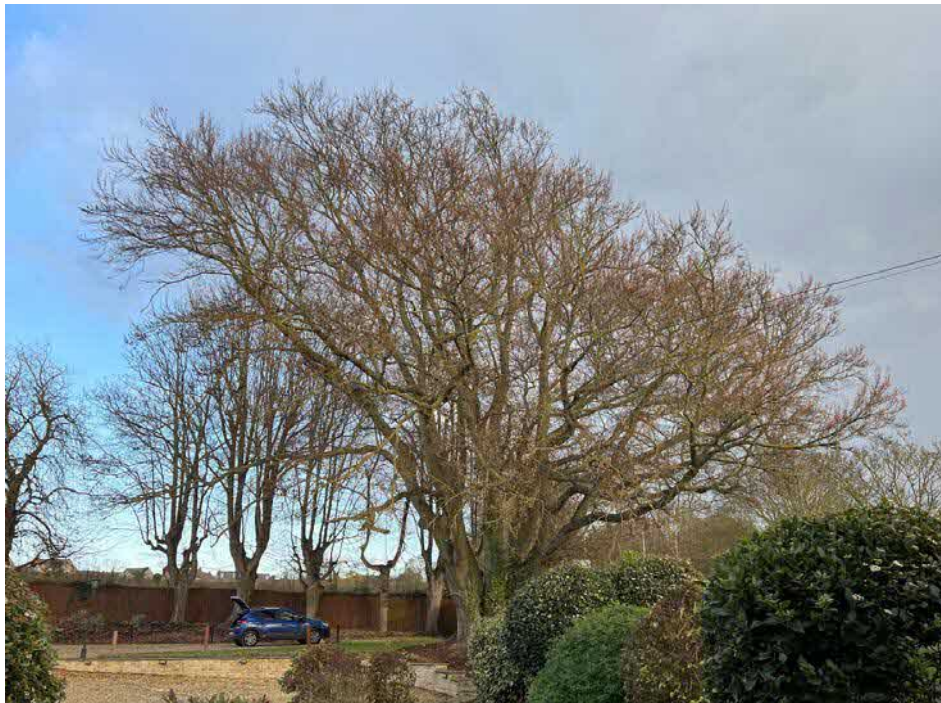
*Photographic plate showing the extent of the canopy. (ROAVR, 2023)*

- 4.4 The pruning work should consist of:
- Crown reduction to the canopy spread all round by a maximum of 2 metres, to leave a natural flowing outline. No height reduction is recommended.

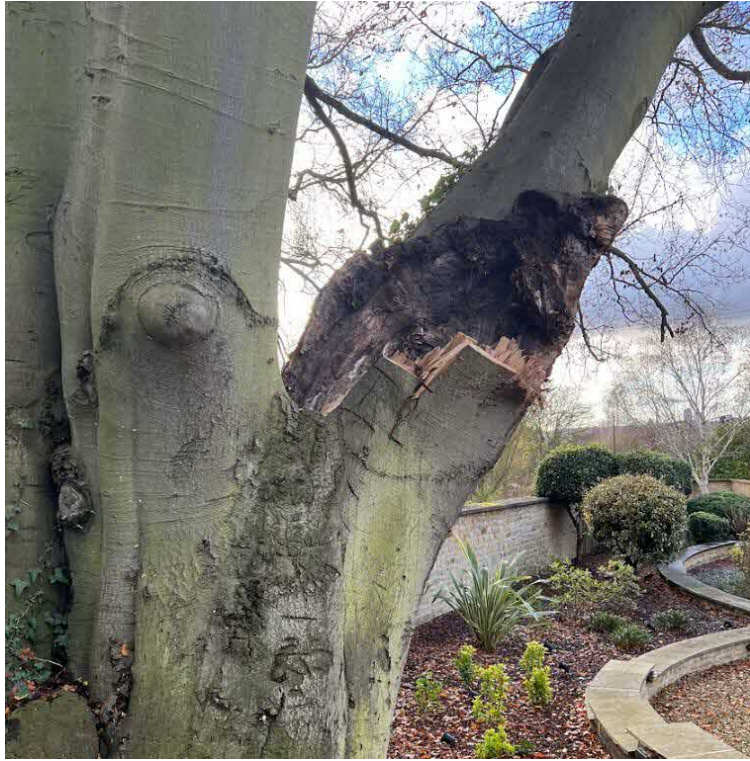
The tree has recently lost a major limb due to a bark included union failure.

*Photographic plate showing the damage from the recently lost limb. (ROAVR, 2023)*

- 3.4 The recent limb failure leaves a wound on the adjacent stem, with a very clear bark inclusion and adventitious roots visible in the open wound. This type of fork is prone to failure as the fibres of the tree stem are separated by the included bark, creating a weak point. When sufficient force is exerted on this fork by high winds or heavy snow loading the included union will fail, causing the loss of the limb or stem, but the remaining parts of the tree survive.

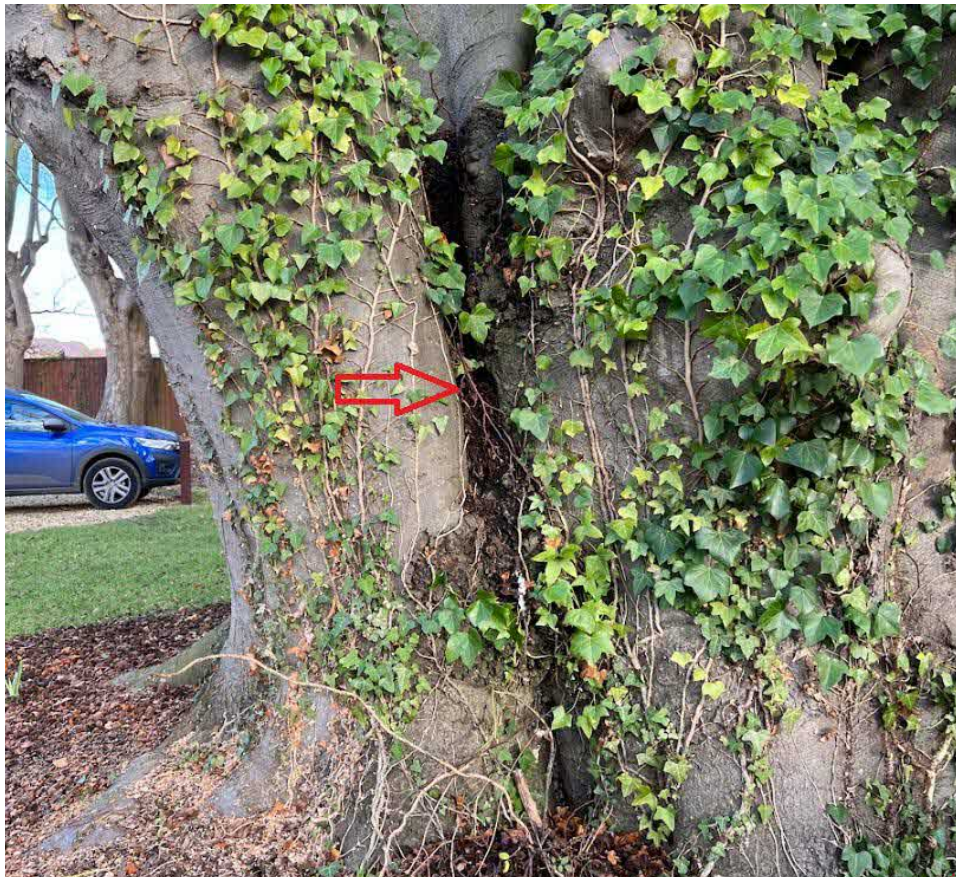
*Photographic plate showing dark vertical bark included union (red arrow indicating position). (ROAVR, 2023)*

- 3.5 Several other included unions are identified around the stem, these are shown in the photographic plates above.
- 3.6 Wide, cup shaped unions, or those with extensive natural grafting above, are generally a strong structure and at no greater risk of failure than any other limb or stem.

- 3.9 Unions to the south and south west of the stem do appear to have a degree of bark inclusion, with a narrower form, and are therefore at a high risk of failure.

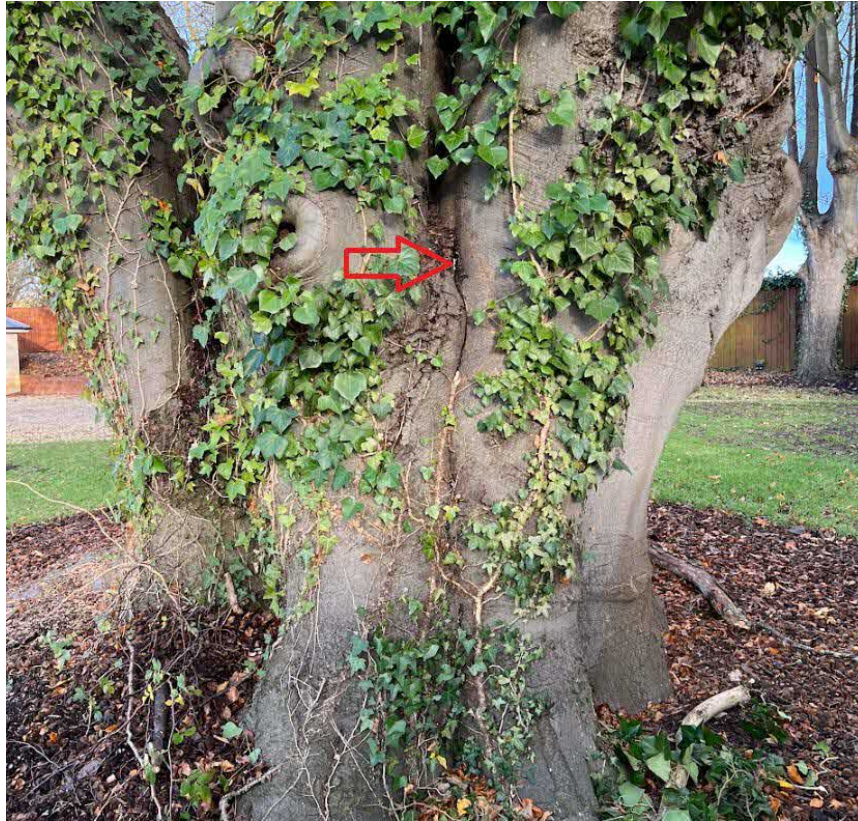
*Photographic plate showing vertical bark included union (red arrow indicating position).  
(ROAVR, 2023)*

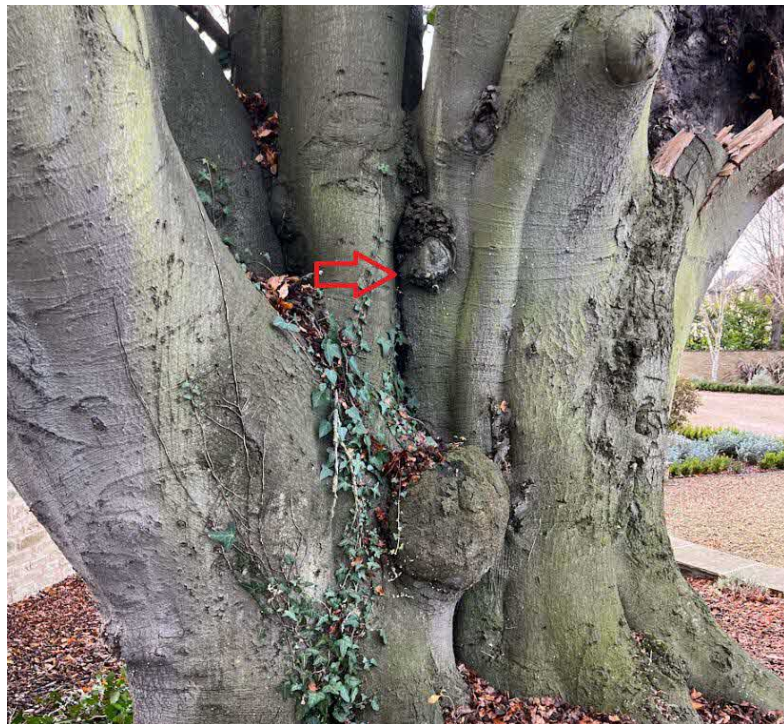
*Photographic plate showing dark vertical bark included union (red arrow indicating position).  
(ROAVR, 2023)*

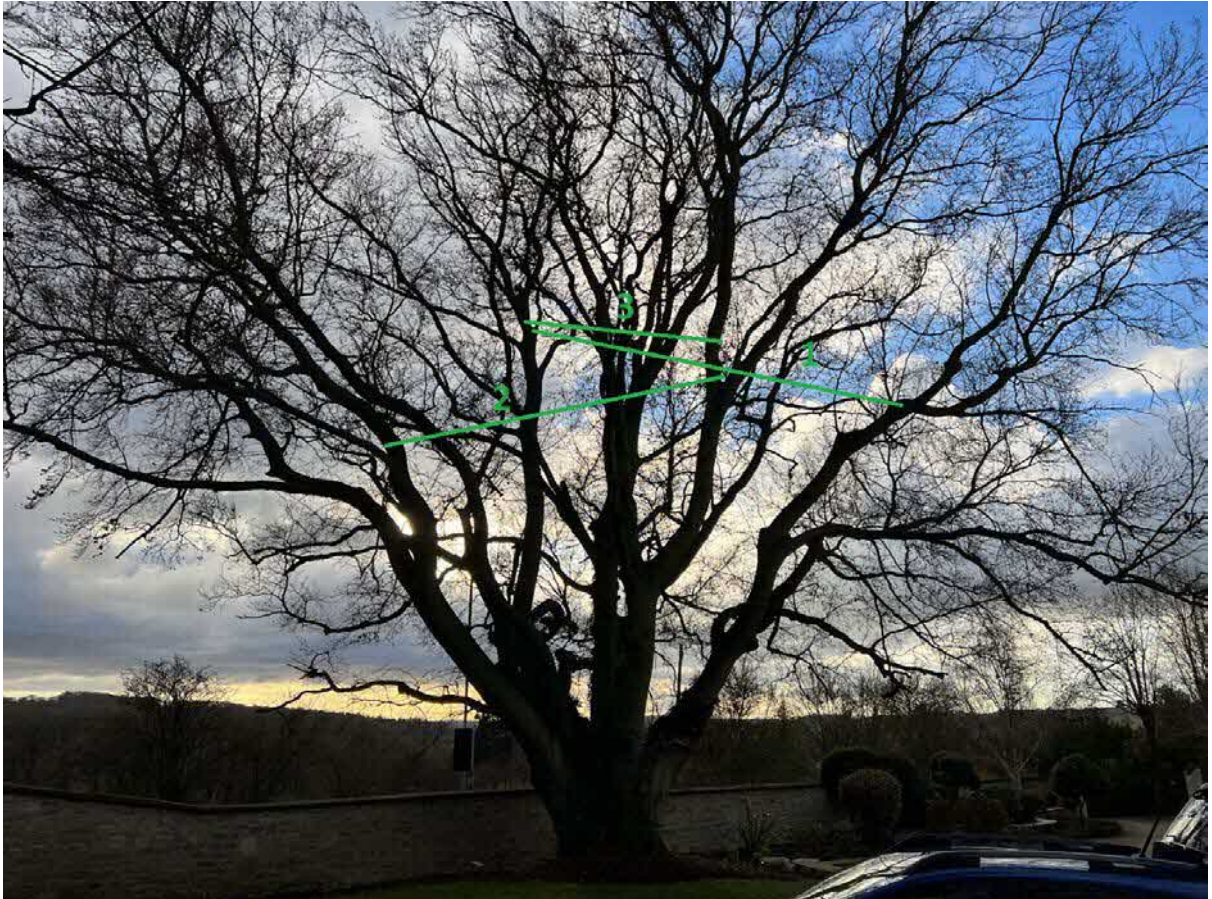
*Photographic plate proposed locations of dynamic cable braces (ROAVR, 2023)*

- Removal of stubs to the lower part of the canopy over the parking area.
- 4.5 Bracing:
- It is recommended that three dynamic cable braces are installed as shown in the photographic plate above. Cobra 4T, installed to the manufacturer’s specifications, or similar proprietary system should be used.

- 4.7 Dynamic braces should be inspected every three years, in line with the normal trees safety survey lifecycle.
