REPORT
- on -
BARN AT BURNT HOUSE FARM
LITTLE CORNARD, SADBURY
SUFFOLK, CO10 0NU
- for -
THE ROYAL AGRICULTURAL
BENEVOLENT INSTITUTION (RABI)

HARCOURT-POWELL LTD
9 GAINSBOROUGH STREET
SADBURY
SUFFOLK CO10 2EU
NHP/JM/CBS0026

In accordance with the attached Terms & Conditions of Engagement dated 5th November 2018 and signed by Jeremy Zeid, Authorised Agent, The Royal Agricultural Benevolent Institution (RABI), c/o Whirledge & Nott, The Estate Office, White Hall, Margaret Roding, Chelmsford, Essex, CM6 1QL to inspect the above premises and prepare a Building Condition Survey to report on feasibility of residential conversion into a single dwelling without significant re-building.

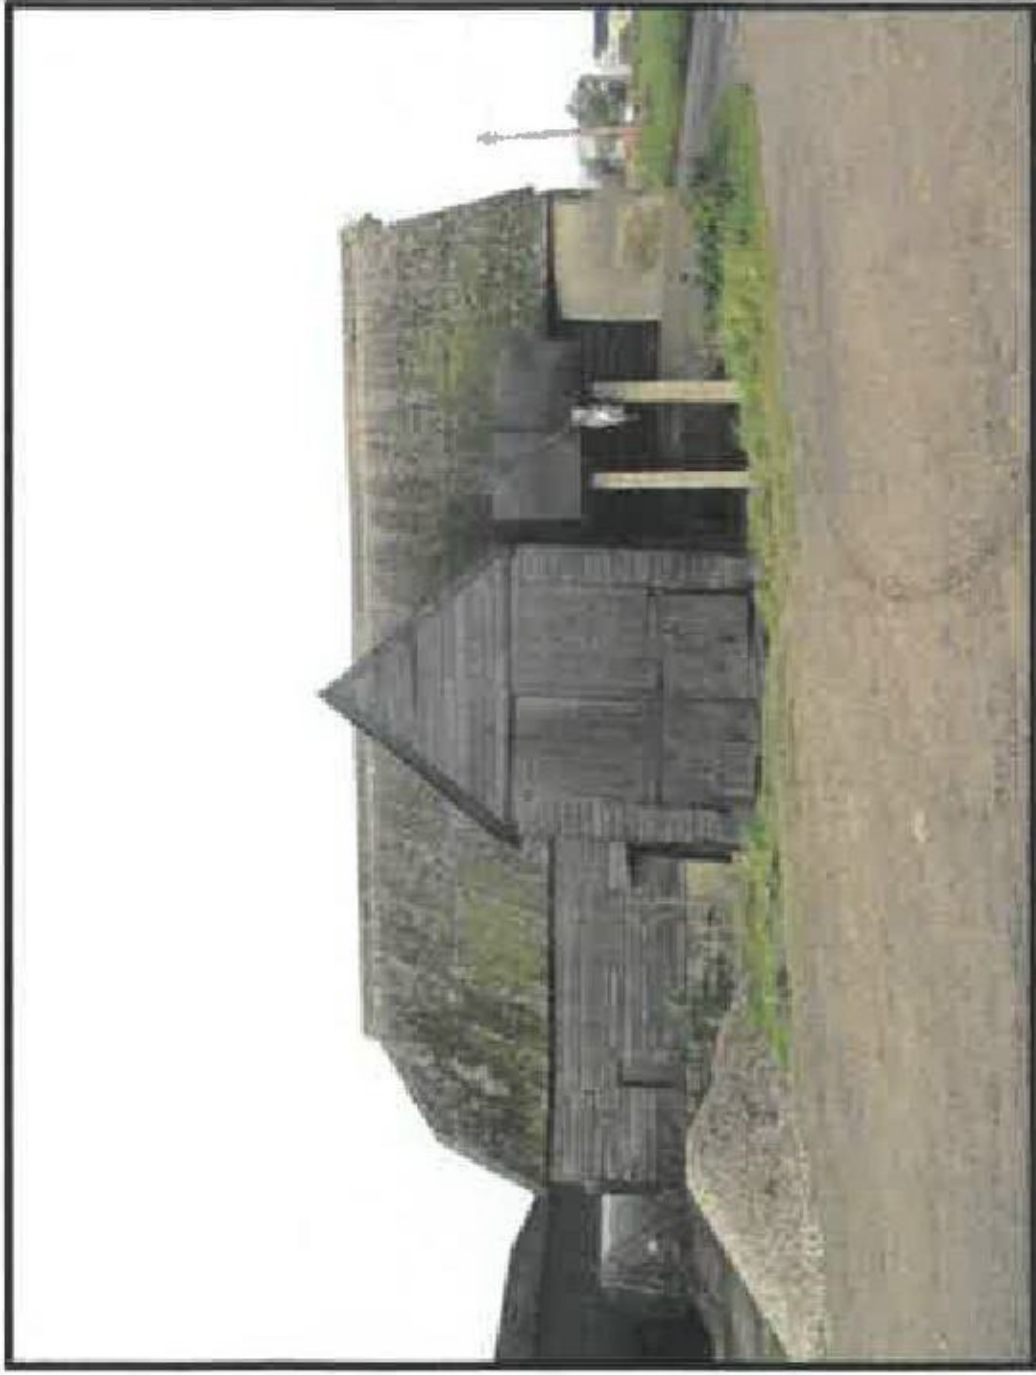
Front Elevation/South-East Side - Photo 1

The main Barn is covered with a corrugated iron sheet roof which has been laid over softwood horizontal bearers over the original roof rafters. The sheet roofing has been relatively successful in preventing any significant surface water ingress into the roof framework. The roof covering will need to be replaced as part of any conversion to residential use and could revert back to possibly the original tiled roof finish without too much adaption (**see Photos 1, 16 & 21**).

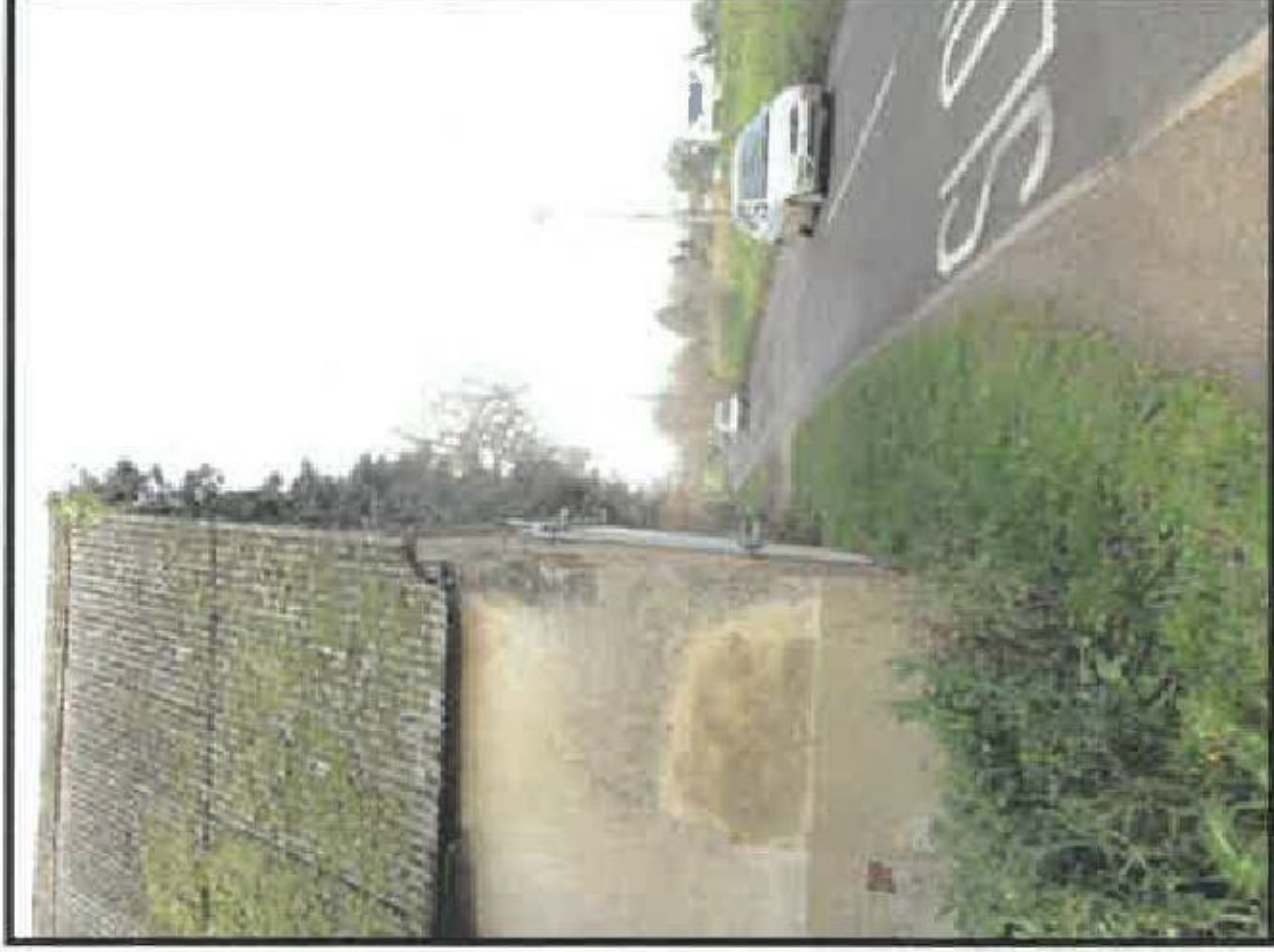
Front Elevation/South-East Side - Photo 2

As part of any renovation works and conversion to residential use some substantial repairs will be required to the brickwork to remove delaminated and cement based mortars which cause damage to the brickwork (see Photos 2 & 4). In addition, some partial re-building and re-forming of the wall will be required to restrain the wall and allow the removal of the present temporary shoring structure. The walls may also require local underpinning to provide an adequate foundation to support the weight of the gable wall and restrain the roof structure. Some raking out will be required to the outer face of the gable wall where there are stepped mortar cracks to the left-hand side and localised repairs will also be required and similarly to the right-hand side below the 'S' iron tie (*see Photos 34-36*). A full inspection of the right-hand side (north-west side) was not possible due to the dense Ivy growth and plant vegetation.

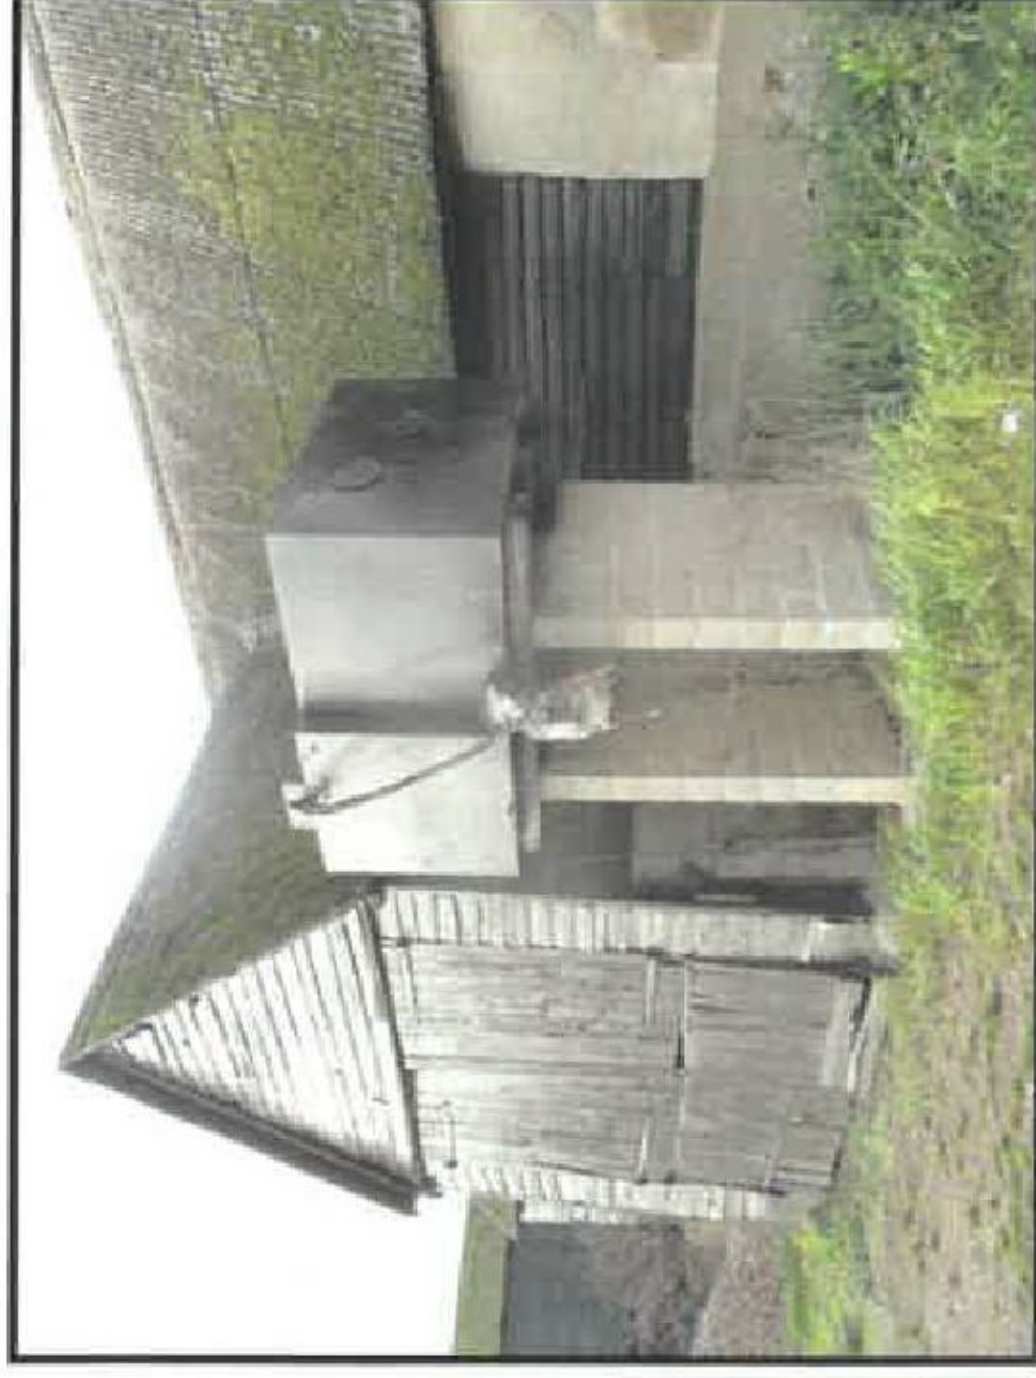
Front Elevation/South-East Side - Photo 3

The solid brickwork to both sides has been cement rendered externally up to the sole plate and the render is sparse/cracked and loose (*see Photos 3 & 8*). As part of any renovation works the render will need to be removed and the brickwork reinstated. The remainder of the wall has been finished with part 19th and part 20th Century tar/black painted feather edged horizontal weatherboards which are mostly sound, although some repairs and replacements will be required.

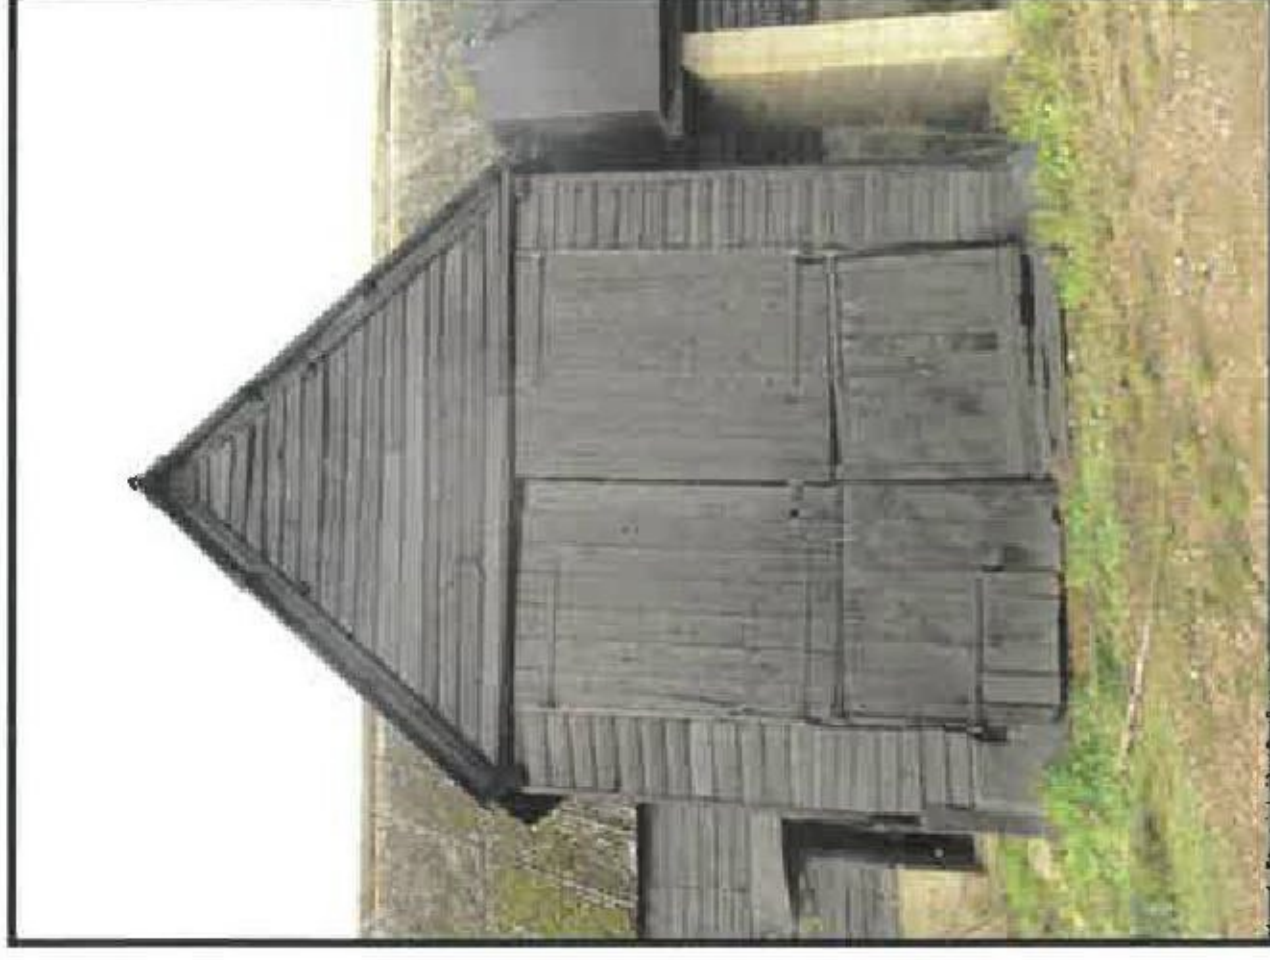
Front Elevation/South-East Side - Photo 9

There is a double pair of doors to the entrance to the mid-strey which have been split and these will also require some repairs (**see Photos 9 & 53**).

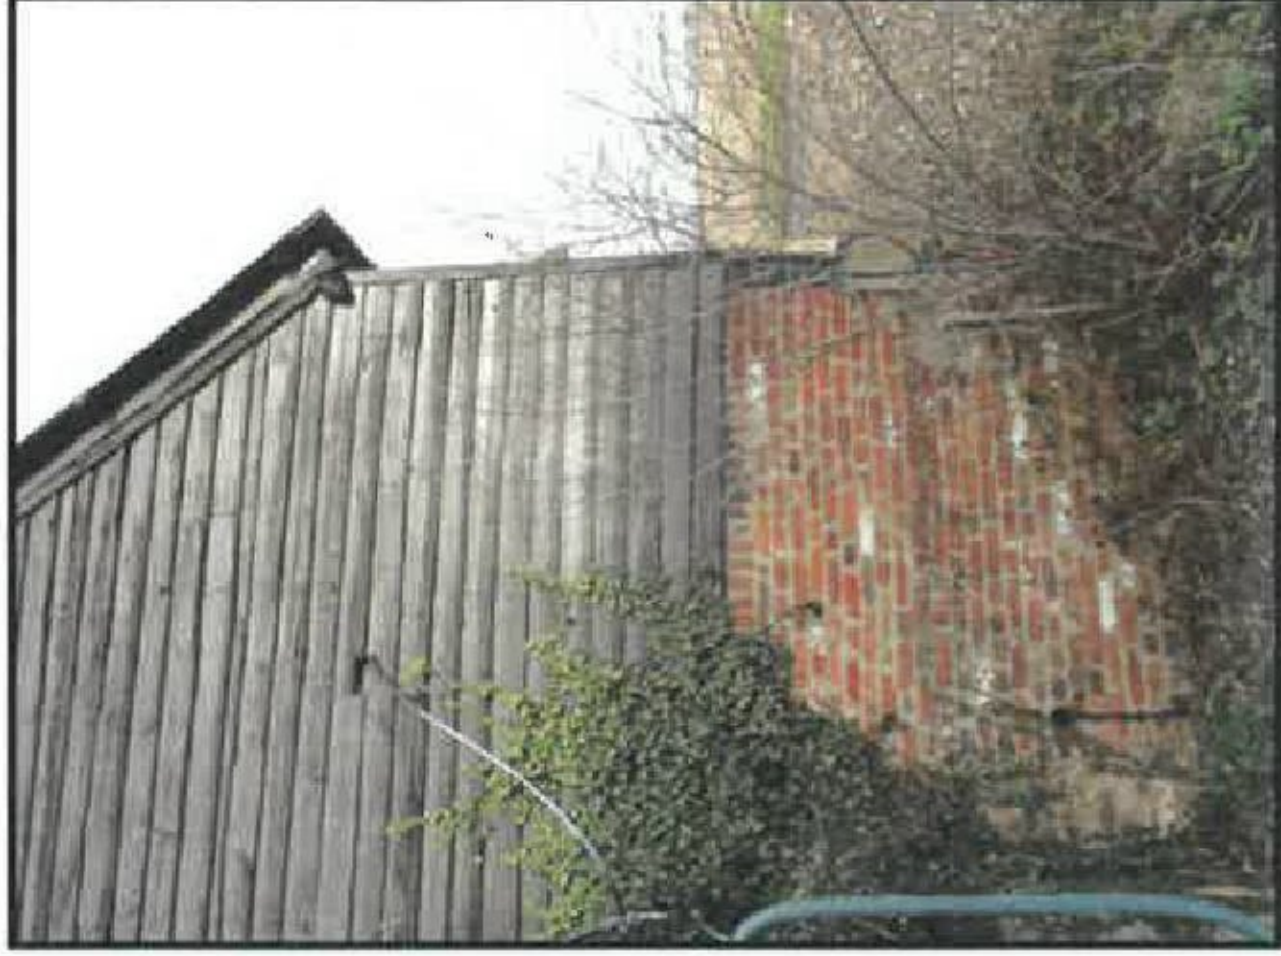
South-West Side Elevation - Photo 14

The south-west gable wall has been formed from about 425mm/325mm solid red brickwork which has been mostly repointed in cement based mortars (*see Photos 14, 16-19*). The wall has been partly concealed by Ivy growth and the large rendered buttress and could not be fully inspected. However, there was evidence of a number of spalled bricks which will need to be repaired and replaced as part of any renovation works. The remainder of the upper wall has been formed from matching timber framework with 20th Century black painted feather edged horizontal weatherboards. A number of the weatherboards have split and curled and will require replacement. Internally the brickwork has been painted as for the south-east side and the timber framework above is of similar condition.

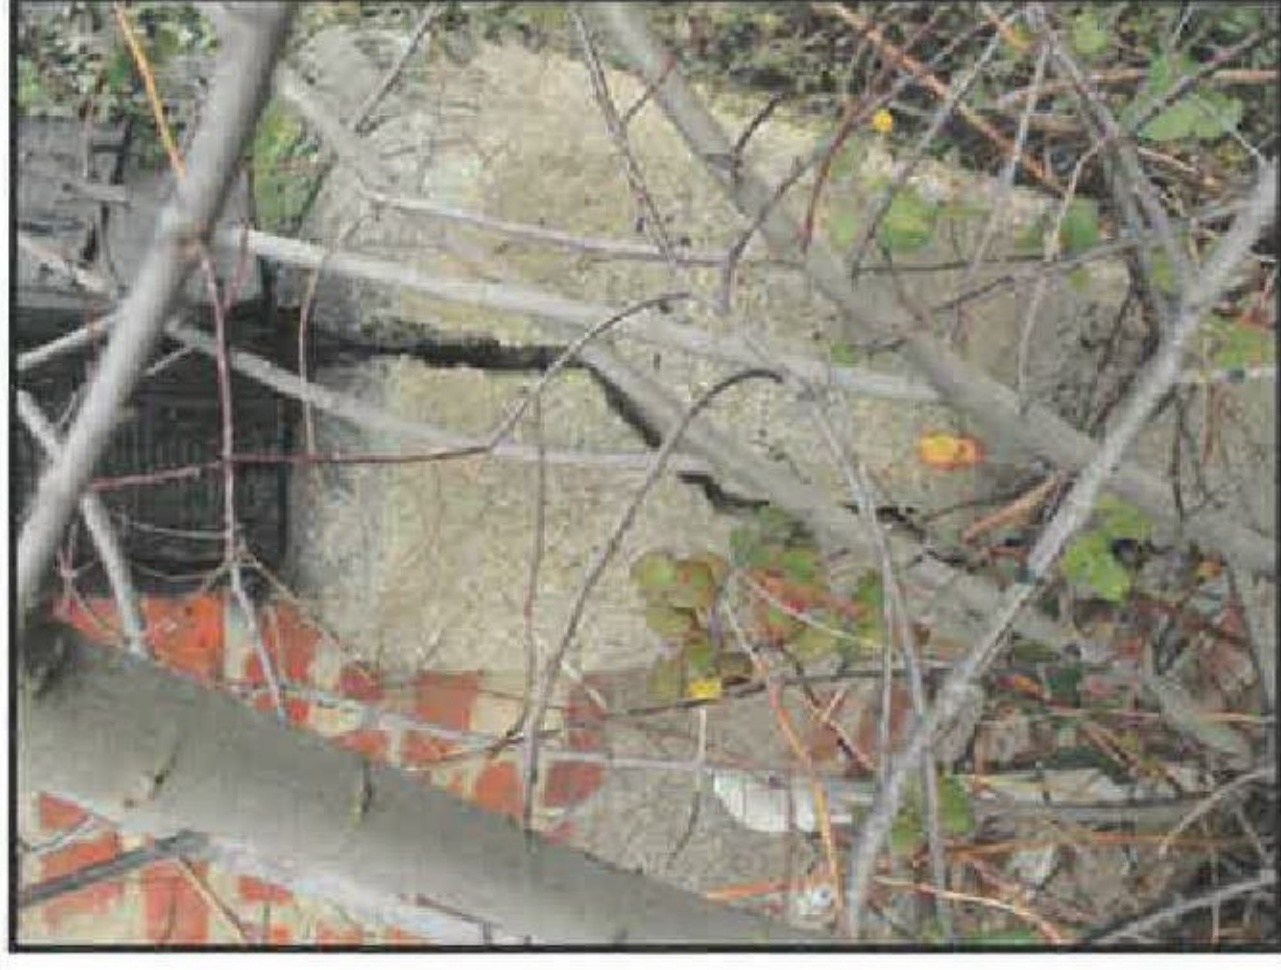
South-West Side Elevation - Photo 15

To the south-east corner the plinth wall has been covered with a thick cement/shuttered concrete over the brick plinth and this has been affected by movement cracking (**see Photo 15**) which has allowed further surface water ingress into the brick plinth wall. Substantial repairs will be required to this part of the plinth wall including the removal of the shuttered concrete and reinstatement of the original brick plinth walls. Internally the brick plinth walls have been painted over and the lower part of the framework concealed by fibreboard from the Kitchen, Store and W.C. compartment. The fibreboard will need to be removed as part of any conversion works and the framework above is of similar condition and construction to the remainder of the Barn.

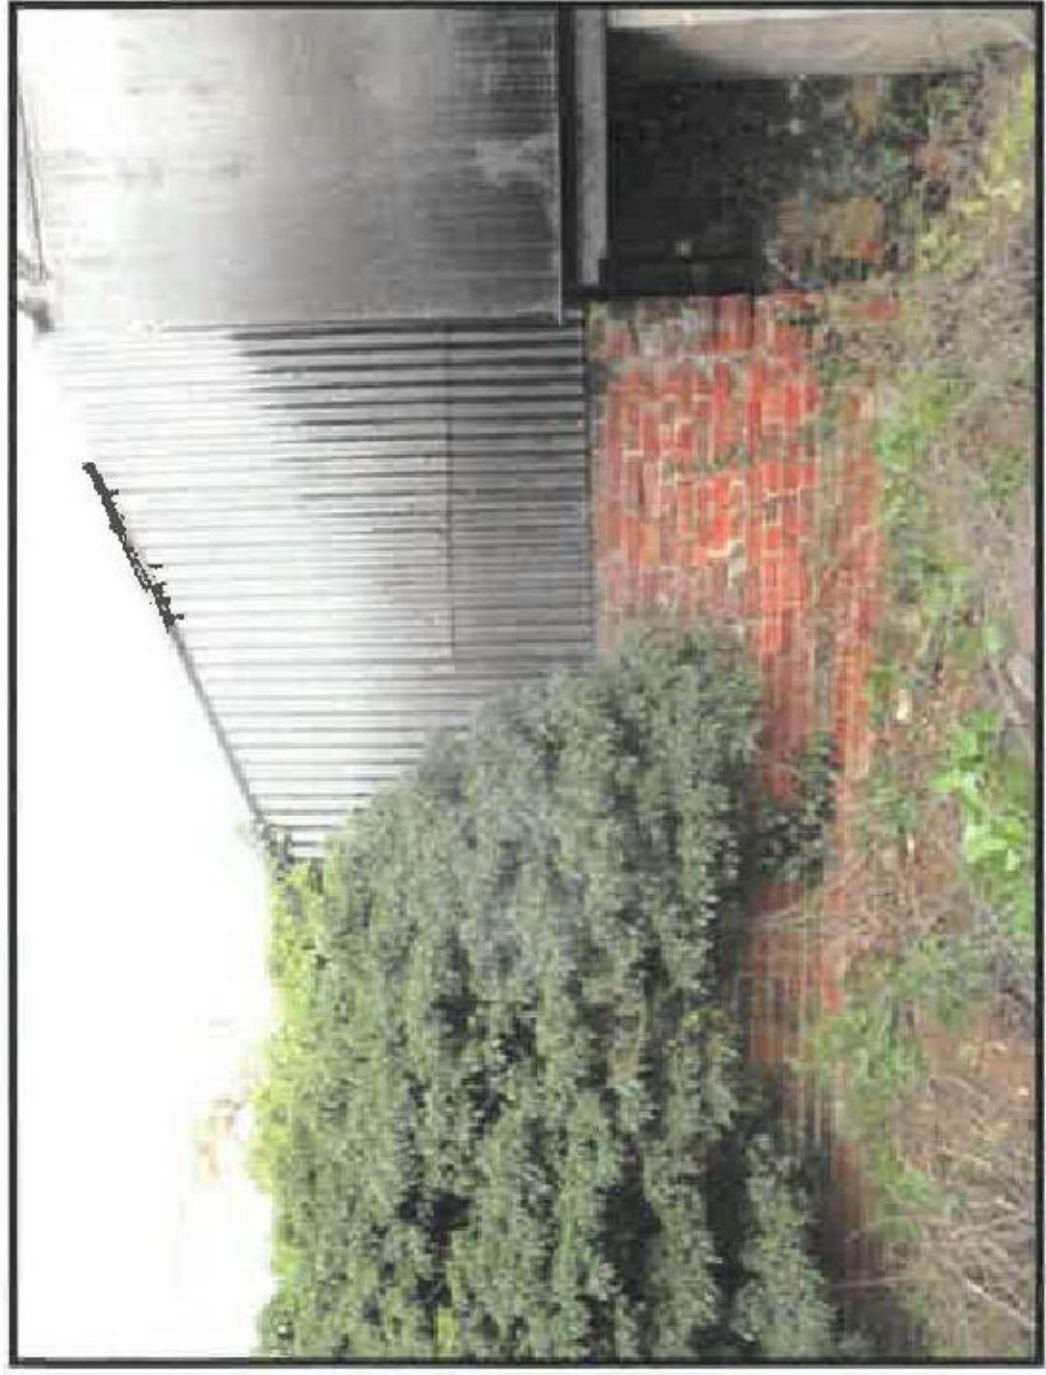
South-West Side Elevation - Photo 19

Due to the overgrowth within the bay area a full inspection was severely limited. The south-west side wall has been formed from a solid red brick wall comprising about 325mm brick plinth walls to a depth of about 600mm with the upper wall formed from 225mm solid brickwork. The brick wall has been laid in mostly original lime based mortars and these now need repair and repointing. The remainder of the upper wall has been formed from timber framework and finished with painted corrugated iron sheeting. ***The corrugated iron sheeting will need to be removed and re-clad with horizontal weatherboarding as part of any renovation and conversion works (see Photo 19).***

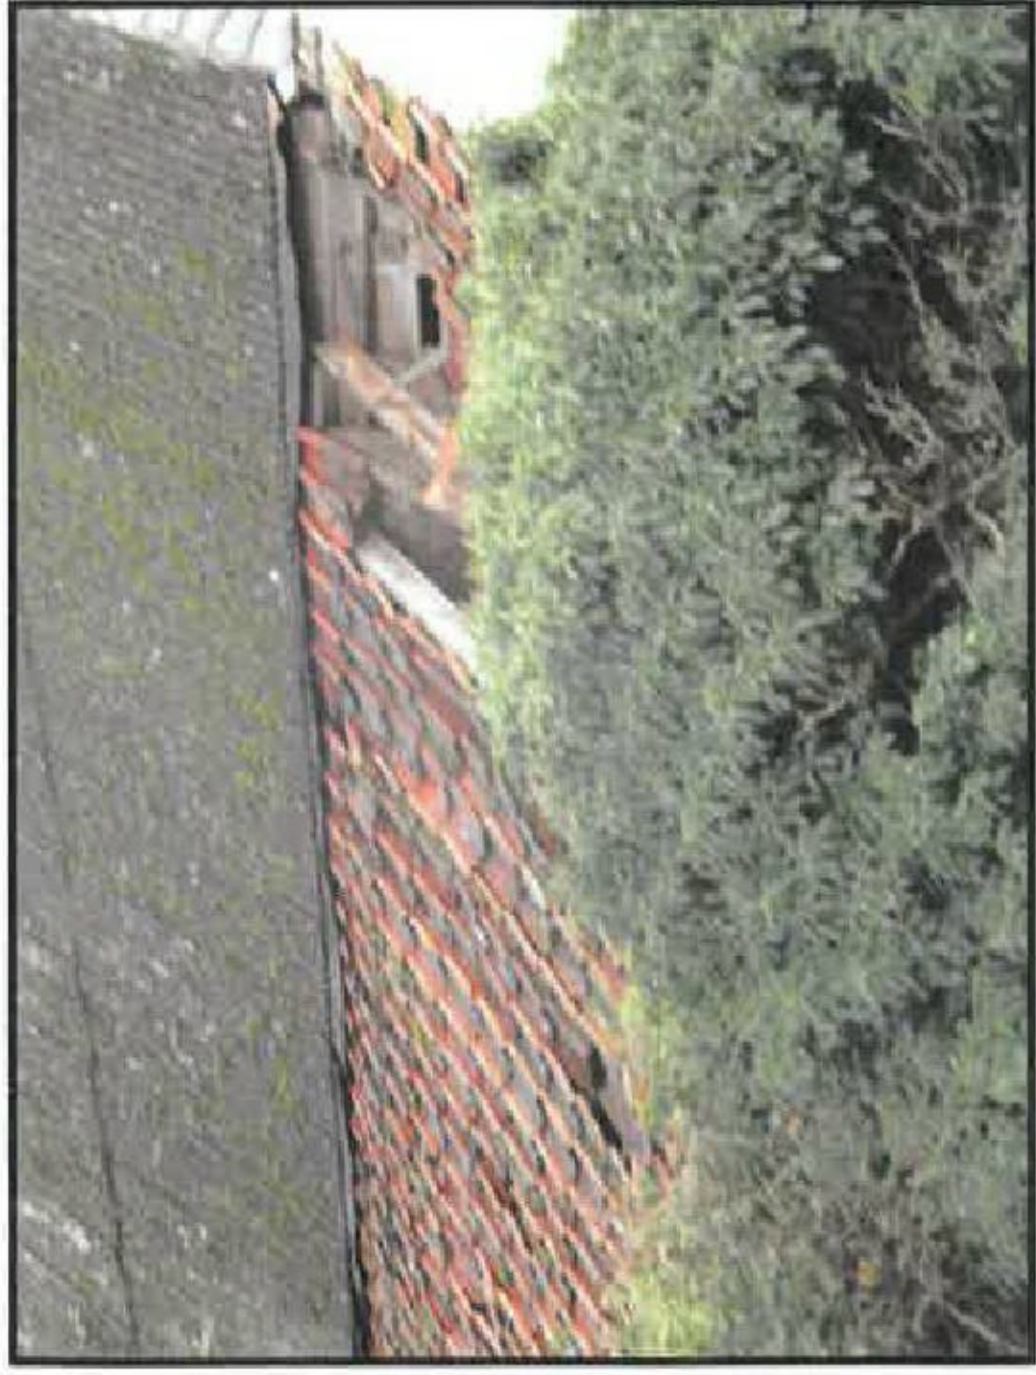
North-West Side Elevation - Photo 22

The lean-to roof over the open fronted building to the north-west side has partially collapsed and some of the clay pantiles remain (**see Photos 22 & 26**). Following repairs to the roof framework the roof could be re-covered with the salvaged sound clay pantiles made up with matching reclaimed pantiles.

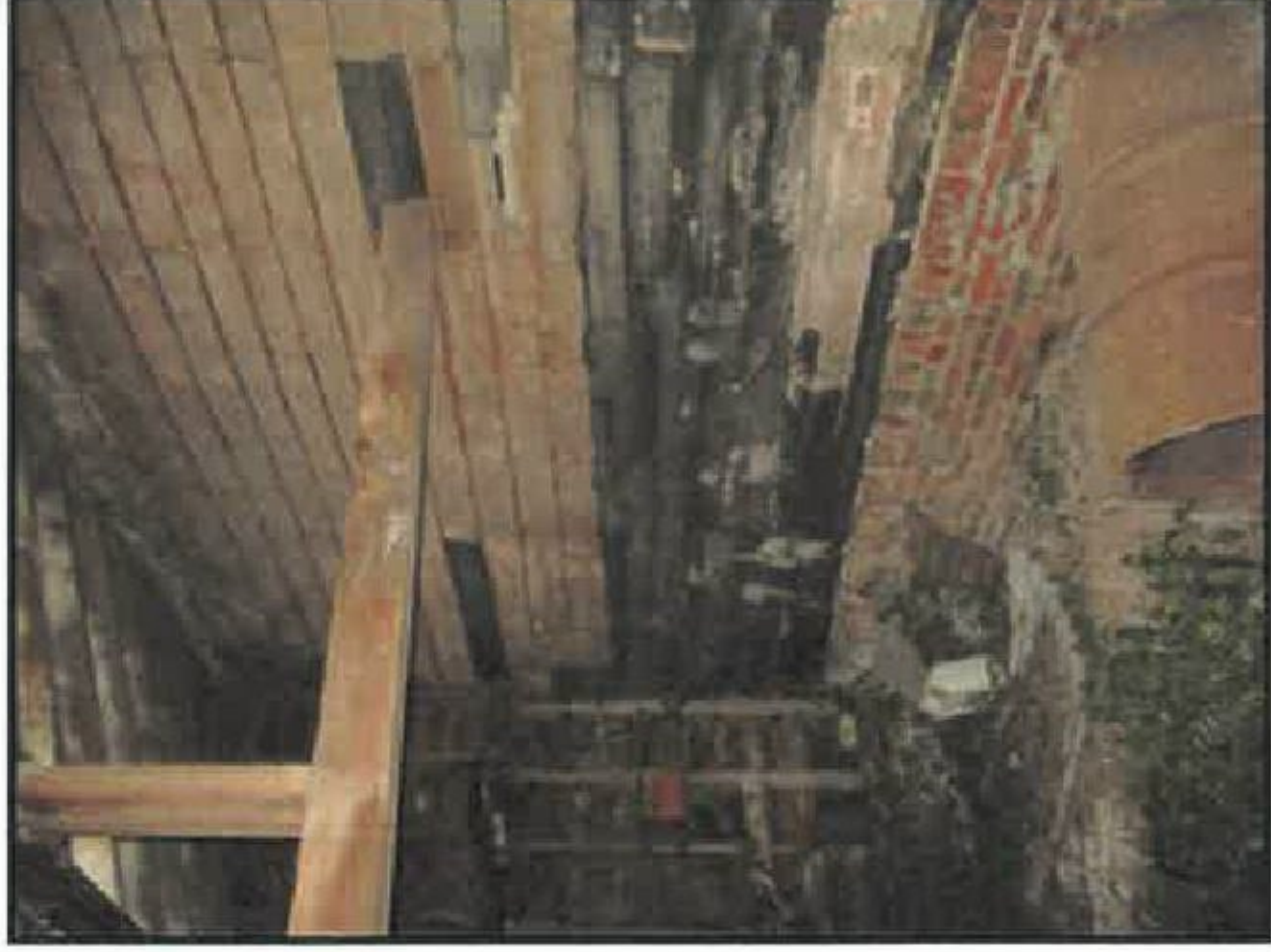
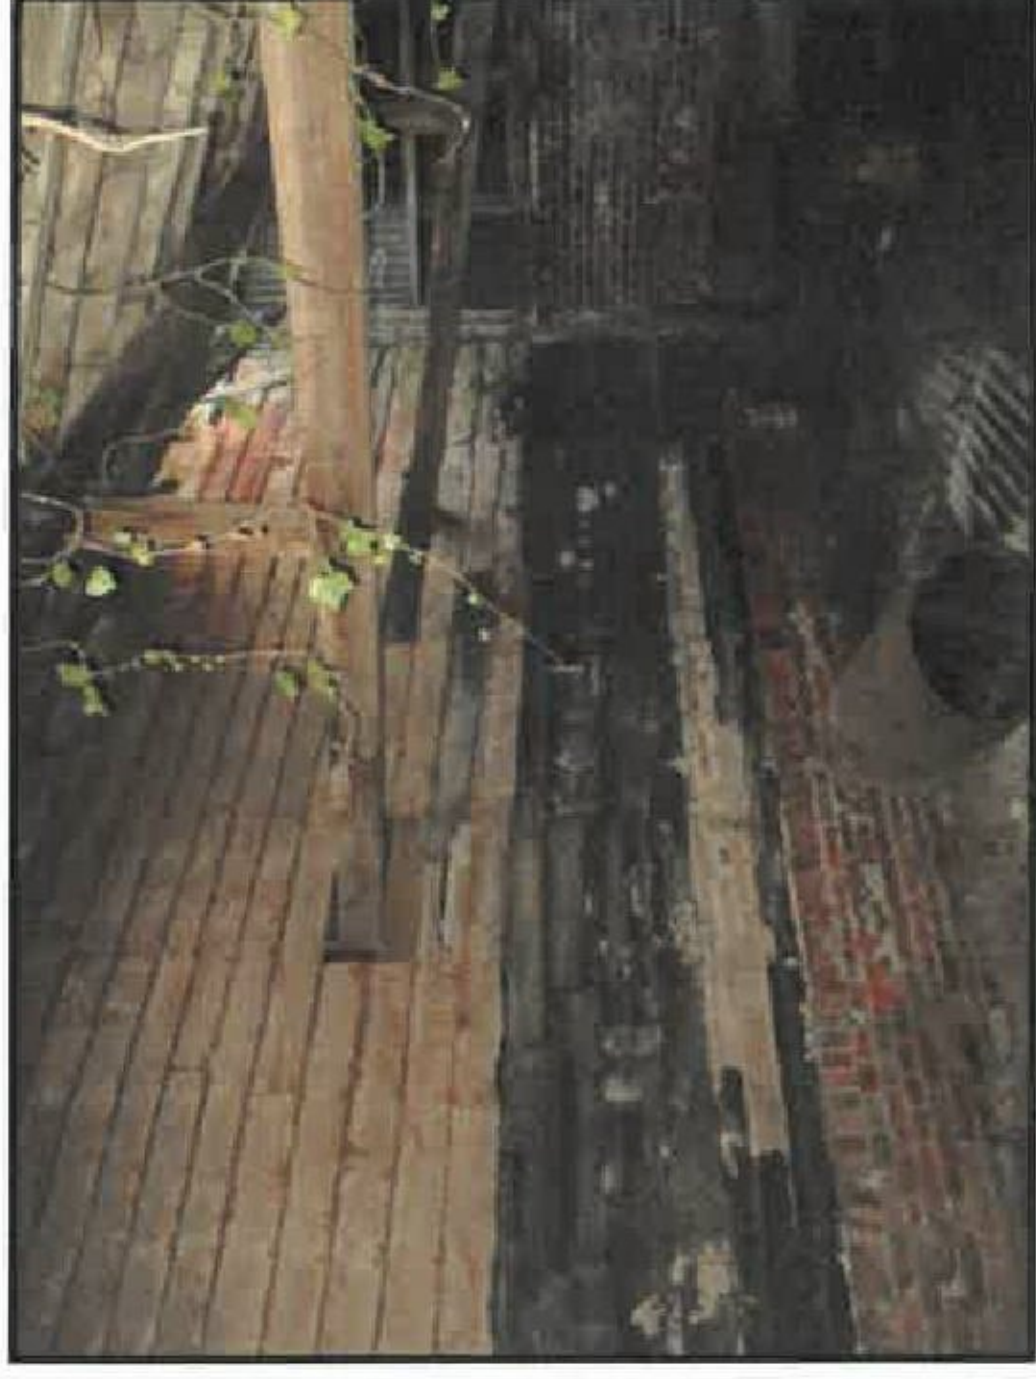
The roof frame has partially collapsed with the tiles falling off and there has been surface water ingress into the roof frame and this will clearly need more substantial repair and refurbishment before re-forming the roof slope (*see Photos 23,24,26,28 & 30*).

To the north-west side the bay is enclosed mainly by the lean-to structure (**see Photos 23-25**). There is a red brick plinth which is generally sound, although some localised repointing and repairs are required. The upper wall has been clad with horizontal feather edged weatherboard which has been left untreated and some repairs will be required. Internally the sole plates have been concealed and red brickwork has been concealed by cement render infill's and these will need to be removed and an allowance for repairs (**see Photo 59**). The framework above is of similar condition as the remainder of the framework and is generally serviceable and will need to be treated for infestations.

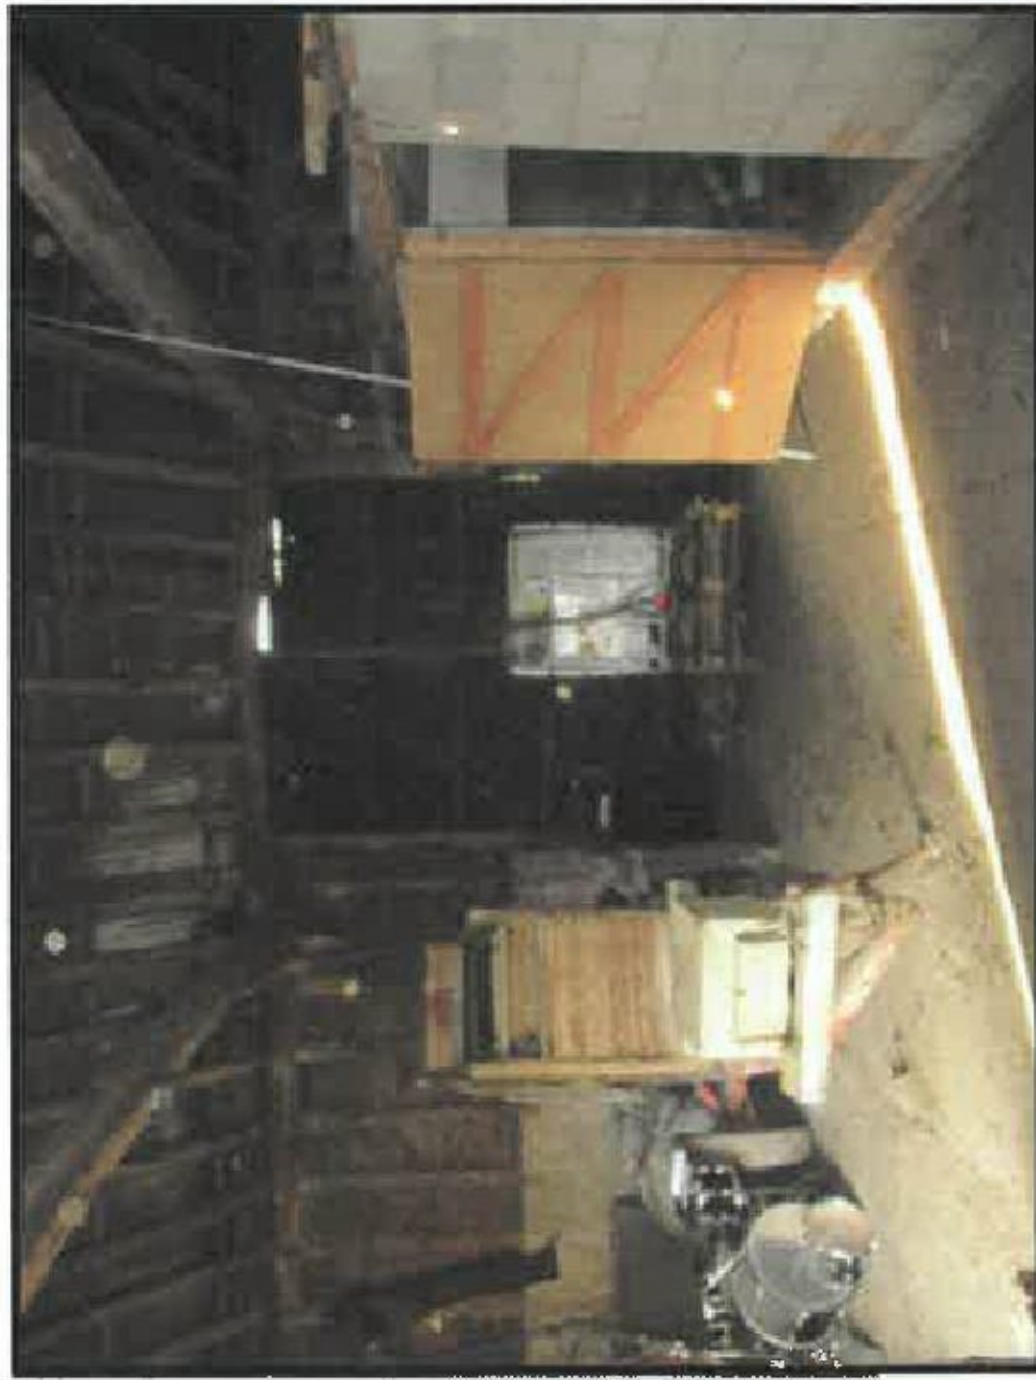
Bay 3 - Photo 49

There is a double pair of doors to the north-west side which are vertical boarded ledged and braced and these are in need of repair but could be salvaged and repaired as part of any conversion works (*see Photo 49*).
