# WINDOW CONDITION SURVEY

WOODVILLE  
MOUNT ERICHT ROAD  
BLAIRGOWRIE

REPORT: WINDOW CONDITION SURVEY  
CLIENT: POOLE  
PROPERTY: WOODVILLE MOUNT ERICHT

JOB NO: 10326  
DATE: NOV 2022

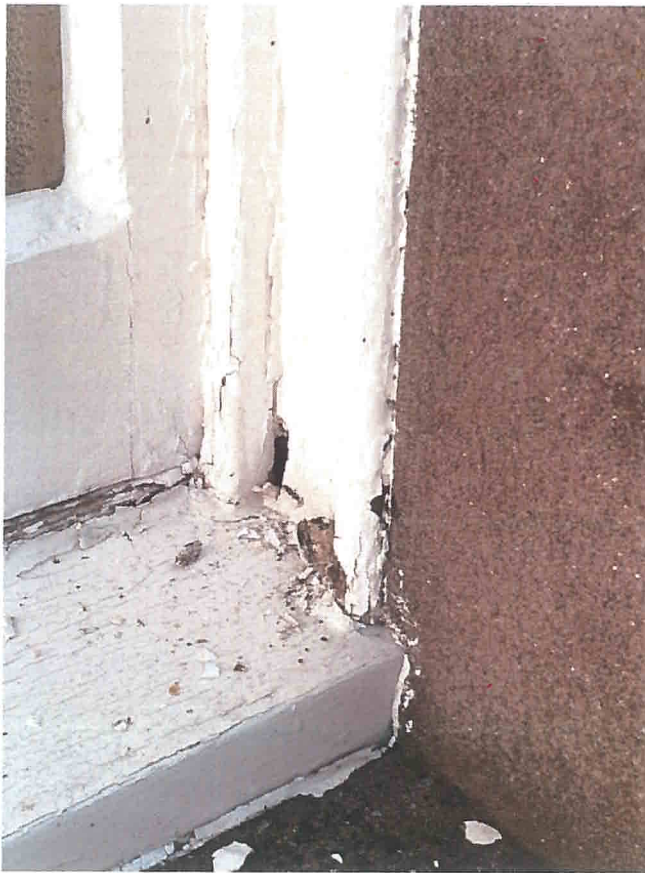
### (i) Timber Decay at Strategic Points

Although the paint system is performing well in most other areas of the window frames, there are strategic, vulnerable points in any sash & case window frame. The most vulnerable of these is the sill, pulley stile, outside facing juncture. At this point, the windows have suffered water ingress into this point, and through continuous cycles of soaking, drying, and excessive solar gain have compromised this critical juncture of the frame. Also, windows of this period do not tend to have a capillary groove on the underside of the sill. The half-sill repairs are also fitted hard to the sandstone sill and the timber interfaces sealed only with white silicone sealant. This encourages water capillarity between the two surfaces, rotting the timber and exacerbating the cycle of decay where the repairs have been made. Any replacement/repair of the sills should incorporate such a groove and an adequate sand-mastic bed, pointed beyond the point of the capillary groove to aid effective weathering.

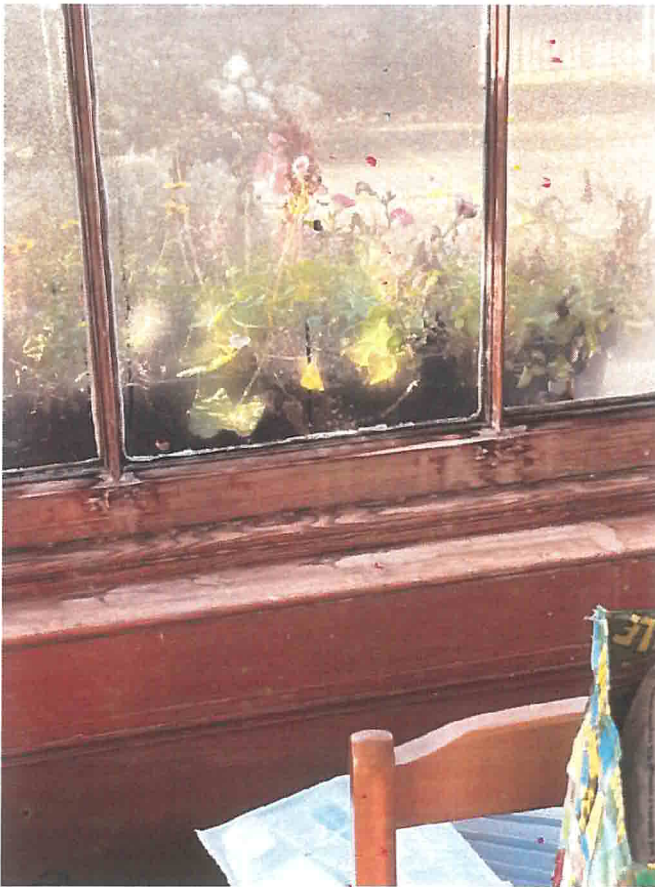
**(ii) Excessive Internal Condensation**

This photograph best demonstrates the impact on the windows by the creation of internal condensation. The extent of the issue suggested there was/is an active water source creating so much condensation. The property owner had informed me that a leak was discovered in the flat roof of the rear extension. Once repaired the house can begin the process of drying out, eliminating further excessive condensation.

The damage done to the windows, however, is not superficial. The horizontal members where this moisture has collected has deteriorated both the timber and the glazing rebate – the moisture working its way between the timber and glass leading to unforeseen timber decay. These areas are so badly affected by this residual moisture collection over an extended period of time, in any attempted 'refurbishment' would have to include the reproduction of many affected sashes.

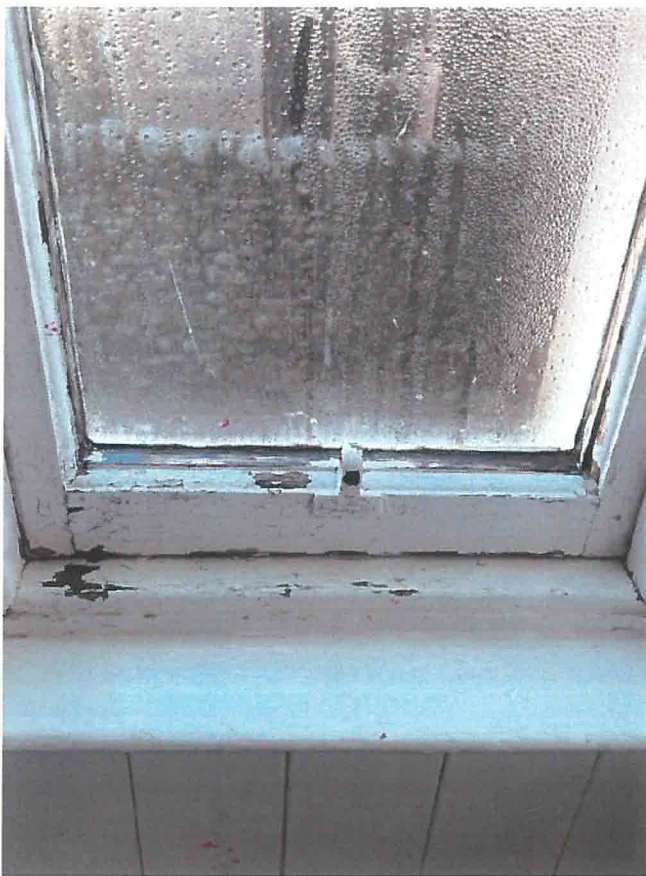
### (iii) Paint System Breakdown & Excessive Condensation

The overpainting of the windows has rendered most top sashes inoperable. The paint on mostly the horizontal surfaces has cracked and flaking. Once the paint surface has been breached, water will rot the sill timber as illustrated above. In this case, however, the paint has also begun to flake and break down internally. Again, the damage caused by the excessive condensation can be seen to the horizontal sill/sash members.

Successive cycles of soaking and drying, especially to windows of exposed elevations, have been mostly affected. The timber deterioration then affects the pulley stiles making repair very costly and most likely cost prohibitive.

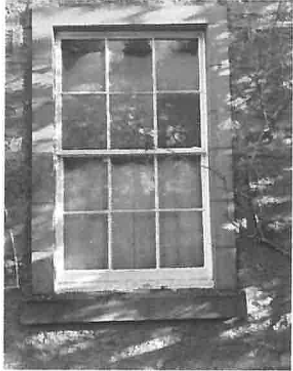
SILL/PULLEY STILE/OUTSIDE FACING JUNCTURE COMPROMISED AT BOTH JAMBS - THIS DECAY HAS INCREASED UP THE PULLEY STILE  
 PREVIOUS SILL/PULLEY STILE REPAIR HAS DETERIORATED FURTHER. THE REPLACEMENT SILL IS FITTED HARD TO THE SANDSTONE SILL  
 REPAIR INTERFACE HAS BEEN SEALED USING SILICONE AND NOT THE USUAL PULLEY STILE INFIL METHOD. THIS HAS FURTHER EXPOSED THE  
 SILL/PULLEY STILE/OUTSIDE FACING JUNCTURE AND THE ENDGRAIN OF BOTH SILL AND PULLEY STILE.  
 WINDOW HAS BEEN OVERPAINTED. PREVIOUS COATS HAVE NOT BEEN ADEQUATELY REMOVED TO ENSURE FULL OPERATION OF THE WINDOW  
 PAINT BREAKDOWN ALONG THE SILL EXPOSING BARE TIMBERS  
 TOP SASH MEETING RAIL HAS DROPPED INDICATING JOINT FAILURE  
 BOTTOM SASH STILES ENDGRAIN EXHIBITING TIMBER DECAY TRACKING UP THE TIMBER SECTION

EXCESSIVE CONDENSATION PRESENTING AND CONDENSATION DAMAGE TO GLAZING REBATE AND ALL HORIZONTAL SURFACES  
 BOTTOM SASH OPENS WITH FORCE  
 TOP SASH PAINTED SHUT  
 MEETING RAIL DETAIL IS SPLAYED - THIS IS A SECURITY ISSUE AS A SLIM IMPLEMENT CAN BE FORCED BETWEEN THE SASHES TO DISENGAGE THE FASTENERS

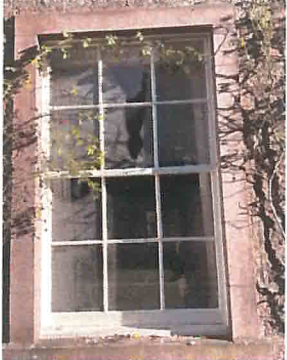
SILL/PULLEY STILE/OUTSIDE FACING JUNCTURE COMPROMISED AT BOTH JAMBS - THIS DECAY HAS INCREASED UP THE PULLEY STILE  
 PREVIOUS SILL/PULLEY STILE REPAIR HAS DETERIORATED FURTHER. THE REPLACEMENT SILL IS FITTED HARD TO THE SANDSTONE SILL  
 REPAIR INTERFACE HAS BEEN SEALED USING SILICONE AND NOT THE USUAL PULLEY STILE INFIL METHOD. THIS HAS FURTHER EXPOSED THE  
 SILL/PULLEY STILE/OUTSIDE FACING JUNCTURE AND THE ENDGRAIN OF BOTH SILL AND PULLEY STILE.

TOP SASH MEETING RAIL HAS DROPPED INDICATING JOINT FAILURE

BOTTOM SASH STILES ENDGRAIN EXHIBITING TIMBER DECAY TRACKING UP THE TIMBER SECTION

EXCESSIVE CONDENSATION PRESENTING AND CONDENSATION DAMAGE TO GLAZING REBATE AND ALL HORIZONTAL SURFACES

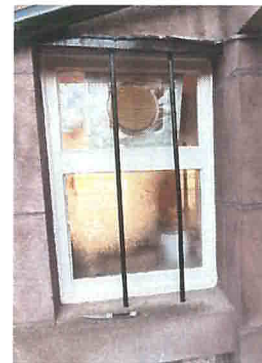
REINFORCED CONCRETE LINTEL STEEL REINFORCEMENT BARS HAVE OXIDISED, FRACTURING THE CEMENTITIOUS BANDING  
 LOWER PORTION OF WINDOW FRAME - TIMBER DECAY NOTED AROUND SILL  
 WINDOW FRAME TRANSOME MORTICE & TENON JOINTS HAVE BEEN COMPROMISED  
 EXCESSIVE SASH/FRAME CLEARANCES

WINDOW FRAME/SILL INTERFACE HAS A TIMBER FILLET FIXED TO DISGUISE EXCESSIVE FRAME MOVEMENT  
 DAMP PATCHES/WATER STAINING TO CEILING DUE FISSURE IN RC TO LINTEL/POOR STONE POINTING  
 AIR EXTRACTION UNIT INOPERABLE

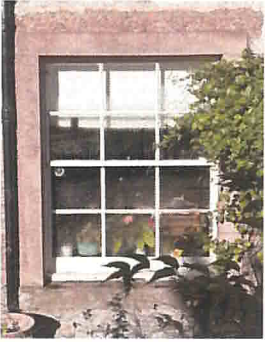
SILL/PULLEY STILE/OUTSIDE FACING JUNCTURE COMPROMISED AT BOTH JAMBS - THIS DECAY HAS INCREASED UP THE PULLEY STILE  
 SILL/PULLEY STILE/OUTSIDE FACING JUNCTURE AND THE ENDGRAIN OF BOTH SILL AND PULLEY STILE.  
 SILL HAS BEEN PREVIOUSLY REPAIRED. THIS HAS BEEN EXECUTED POORLY - THE REPLACEMENT SILL FITTED WITHOUT NECESSARY WICKING DETAIL.  
 WINDOW HAS BEEN OVERPAINTED. PREVIOUS COATS HAVE NOT BEEN ADEQUATELY REMOVED TO ENSURE FULL OPERATION OF THE WINDOW  
 PAINT BREAKDOWN ALONG THE SILL EXPOSING BARE TIMBERS. THESE TIMBERS ARE SATURATED.  
 BOTTOM SASH STILES ENDGRAIN EXHIBITING TIMBER DECAY TRACKING UP THE TIMBER SECTION

EXCESSIVE CONDENSATION PRESENTING AND CONDENSATION DAMAGE TO GLAZING REBATE AND ALL HORIZONTAL SURFACES  
 BOTTOM SASH OPENS WITH FORCE  
 TOP SASH PAINTED SHUT

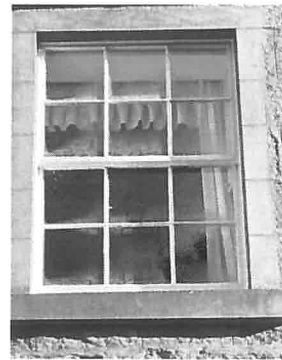
SILL/PULLEY STILE/OUTSIDE FACING JUNCTURE COMPROMISED AT BOTH JAMBS - THIS DECAY HAS INCREASED UP THE PULLEY STILE  
 PREVIOUS SILL/PULLEY STILE REPAIR HAS DETERIORATED FURTHER. THE REPLACEMENT SILL IS FITTED HARD TO THE SANDSTONE SILL  
 REPAIR INTERFACE HAS BEEN SEALED USING SILICONE AND NOT THE USUAL PULLEY STILE INFIL METHOD. THIS HAS FURTHER EXPOSED THE  
 SILL/PULLEY STILE/OUTSIDE FACING JUNCTURE AND THE ENDGRAIN OF BOTH SILL AND PULLEY STILE.  
 WINDOW HAS BEEN OVERPAINTED. PREVIOUS COATS HAVE NOT BEEN ADEQUATELY REMOVED TO ENSURE FULL OPERATION OF THE WINDOW  
 PAINT BREAKDOWN ALONG THE SILL EXPOSING BARE TIMBERS  
 TOP SASH MEETING RAIL HAS DROPPED INDICATING JOINT FAILURE  
 BOTTOM SASH STILES ENDGRAIN EXHIBITING TIMBER DECAY TRACKING UP THE TIMBER SECTION

EXCESSIVE CONDENSATION PRESENTING AND CONDENSATION DAMAGE TO GLAZING REBATE AND ALL HORIZONTAL SURFACES  
 BOTTOM SASH OPENS WITH FORCE  
 TOP SASH PAINTED SHUT

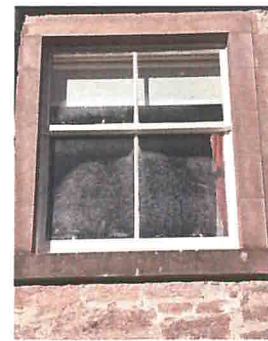
SILL/PULLEY STILE/OUTSIDE FACING JUNCTURE COMPROMISED AT BOTH JAMBS - THIS DECAY HAS INCREASED UP THE PULLEY STILE  
 SILL/PULLEY STILE/OUTSIDE FACING JUNCTURE AND THE ENDGRAIN OF BOTH SILL AND PULLEY STILE.  
 WINDOW HAS BEEN OVERPAINTED. PREVIOUS COATS HAVE NOT BEEN ADEQUATELY REMOVED TO ENSURE FULL OPERATION OF THE WINDOW  
 PAINT BREAKDOWN ALONG THE SILL EXPOSING BARE TIMBERS. THESE TIMBERS ARE SATURATED.  
 BOTTOM SASH STILES ENDGRAIN EXHIBITING TIMBER DECAY TRACKING UP THE TIMBER SECTION

EXCESSIVE CONDENSATION PRESENTING AND CONDENSATION DAMAGE TO GLAZING REBATE AND ALL HORIZONTAL SURFACES  
 BOTTOM SASH OPENS WITH FORCE  
 TOP SASH PAINTED SHUT
