TREE SAFETY SURVEY ESMS, Stewart's Melville College, Queensferry Road

TREE SAFETY SURVEY

Erskine Stewart's Melville Schools
in regard of
Stewart's Melville College
Queensferry Rd

October 2023

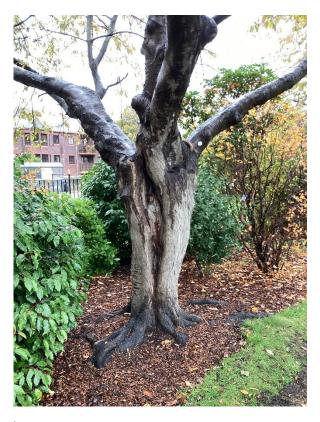
Tag	Species	Height (m)	DBH Range (cm)	Crown Spread (N)	Crown Spread (E)	Crown Spread (S)	Crown Spread (W)	Life Stage	Vigour	Targets	Condition	Survey Notes	Recommendations	Timescale	Life expectancy (years)	Inspect Period
2202	Wild Cherry (Prunus avium)	11	L (50- 75cm)	8	7	7	6	Over Mature	Normal	Target # - footpath. Target # - playground. Target # - road.	Poor	Multi stem tree adjacent to site boundary and sports pitch; open wounds with active decay, poor reaction wood and exposed and degraded heartwood in min stem to west; hollow sound in majority of scaffold limbs	Remove	High (3 months)	N/A	Not Recorded
2203	Wild Cherry (Prunus avium)	10	L (50- 75cm)	8	7	7	6	Over Mature	Low	Target # - footpath. Target # - playground. Target # - road.	Poor	Multi stem tree adjacent to site boundary and sports pitch; open wounds with active decay, poor reaction wood and exposed and degraded heartwood in limbs to northeast and southwest; hollowness detected in several scaffold	Remove	High (3 months)	N/A	Not Recorded

CHERRY (2202) EXHIBITING OPEN CAVITY AND SEVERE HOLLOWING OF TRUNK

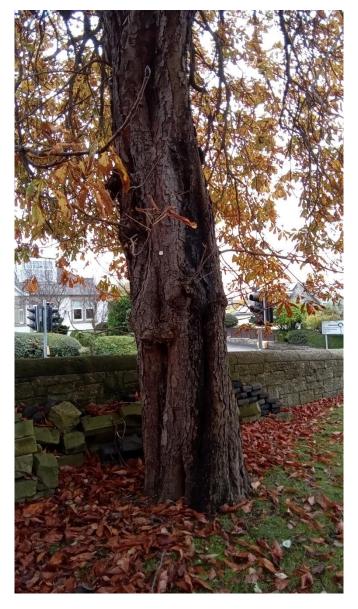
Tag	Species	Height (m)	DBH Range (cm)	Crown Spread (N)	Crown Spread (E)	Crown Spread (S)	Crown Spread (W)	Life Stage	Vigour	Targets	Condition	Survey Notes	Recommendations	Timescale	Life expectancy (years)	Inspect Period
2220	Horse Chestnut (Aesculus hippocastanum)	17	VL (75- 100cm)	6	7	8	9	Over Mature	Normal	Target # - building Target # - footpath. Target # - road. Target # - street lights.	Fair	Large tree growing on site boundary; planted above retaining wall, weighted toward; likely change in ground level at base, obscuring basal flare; possible hollowness of stem to northeast; dark exudate on trunk to east at site of rib; subject to significant crown lifting with numerous wounds of varying size and degree of occlusion; not all unions fully observable from ground level	PICUS sonic tomograph of stem at ground level; aerial inspection of major unions and pruning wounds; crown reduction by up to 1/3rd	Moderate (6 Months)	2+	2 Years

CHESTNUT (2220) EXHIBITING BURIED BASAL FLARE ABOVE RETAINING WALL WITH POSSIBLE STEM HOLLOWING

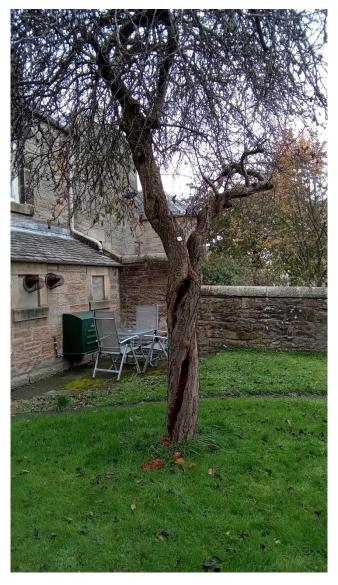
2221	Crab Apple (Malus sylvestris)	5	M (25- 50cm)	3	3	3	4	Mature	Normal	Target # - building Target # - public area	Poor	Severely hollowed stem with open cavity and advanced cubical rot	Remove	Moderate (6 Months)	N/A	Not Recorded
2222	Common Lime x4 (Tilia x vulgaris)	20	M (25- 50cm)	4	5	6	5	Mature	Normal	Target # - building Target # - footpath. Target # - road.	Fair	Row of multi stem trees growing on site boundary; all historically topped at 3m and allowed to grow on, presence of some disrupted tissue around historic pruning points	Aerial inspection of major unions	Moderate (6 Months)	5+	2 Years

CRAB APPLE (2221) EXHIBITING SEVERE STEM HOLLOWING

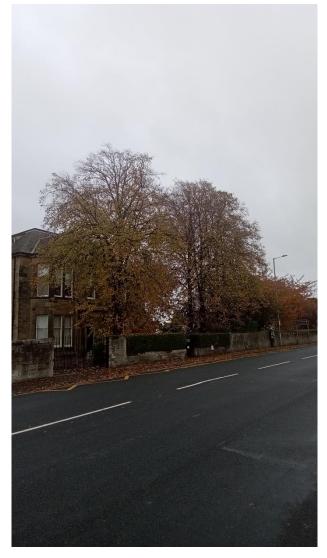
4 x LIME (2222) EXHIBITING HISTORIC TOPPING WOUNDS NOT FULLY VISIBLE FROM GROUND LEVEL

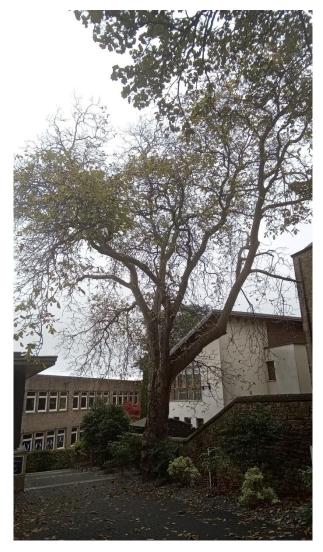
A walnut between buildings and subject to relatively recent ground disturbance due to construction work, and a large chestnut on the boundary to the west require further investigation of stem integrity by means of sonic tomography, in addition to aerial inspection of wounding and branch unions.

Tag	Species	Height (m)	DBH Range (cm)	Crown Spread (N)	Crown Spread (E)	Crown Spread (S)	Crown Spread (W)	Life Stage	Vigour	Targets	Condition	Survey Notes	Recommendations	Timescale	Life expectancy (years)	Inspect Period
2224	Black Walnut (Juglans nigra)	22	VL (75- 100cm)	8	7	10	9	Over Mature	Low	Target # - building Target # - footpath. Target # - road. Target # - street lights.	Fair	Large tree growing on site boundary; likely change in ground level at base, obscuring basal flare; relatively recent construction and monoblock paving around root zone; possible hollowness of stem; major union at 4m; long limb originating at 4m to south exerting significant leverage on main stem; subject to significant crown lifting and reduction away from buildings with numerous wounds of varying size and degrees of occlusion; not all unions fully observable from ground level	PICUS sonic tomograph of stem at ground level; aerial inspection of major unions and pruning wounds; brace large limb to south	Moderate (6 Months)	2+	2 Years

WALNUT (2224) IN CLOSE PROXIMITY TO SURROUNDING BUILDINGS WITH RECENT BUILDING WORK IN ROOT ZONE AND POSSIBLE HOLLOWING OF MAIN STEM
