CONDITION REVIEW

Oxleas NHS Foundation Trust

Shamrock

May 2023
Revision A

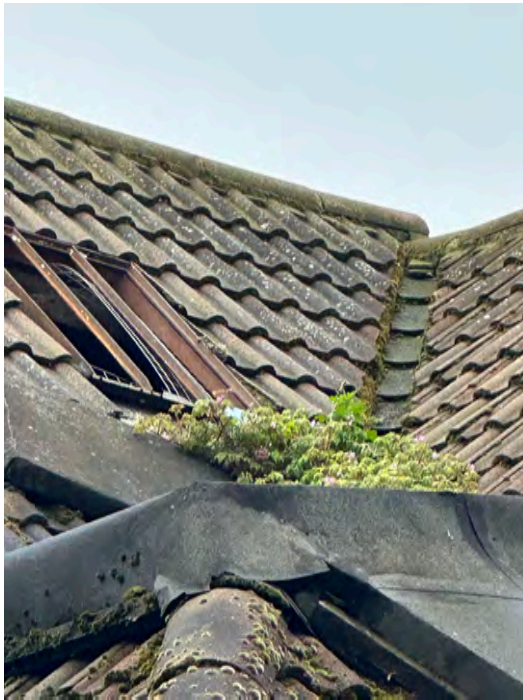
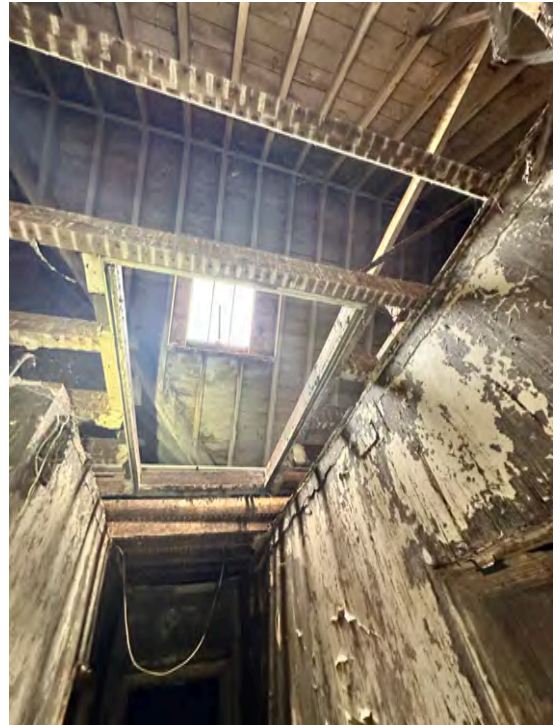
- 2.1.1.2 On the rear pitch of the main roof a roof light has failed leaving the fabric open to the elements.

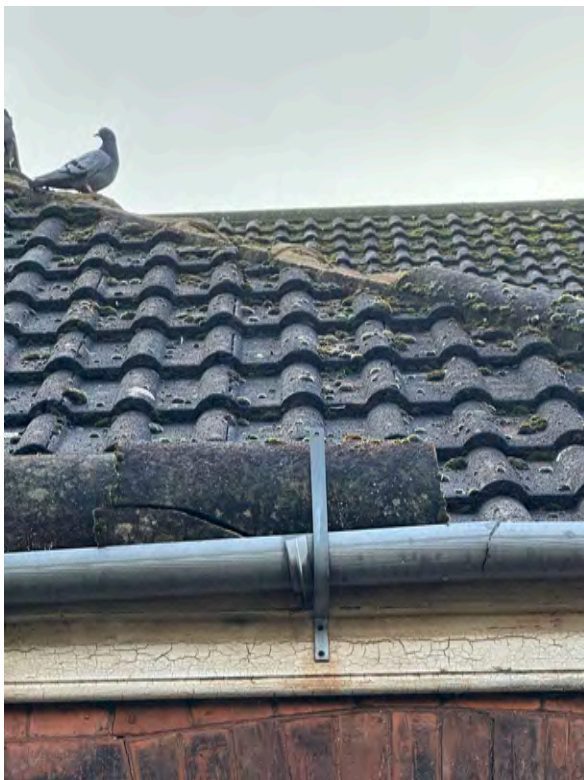
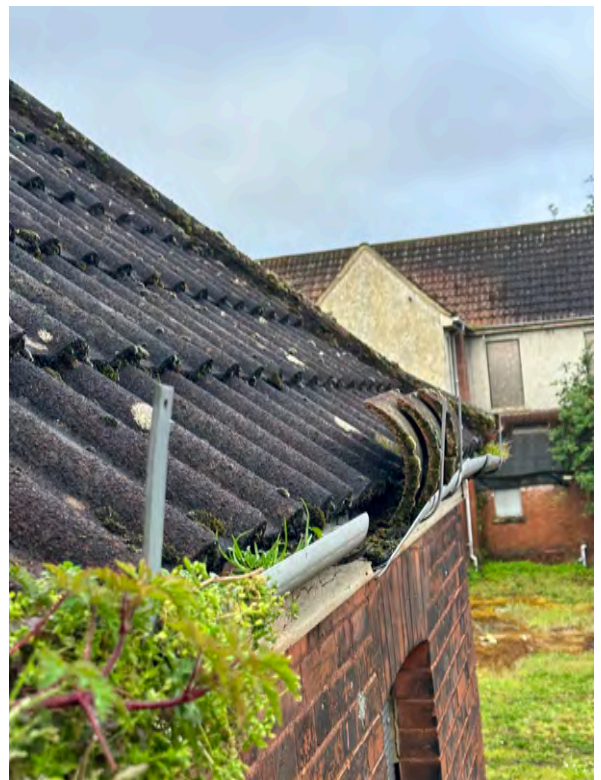
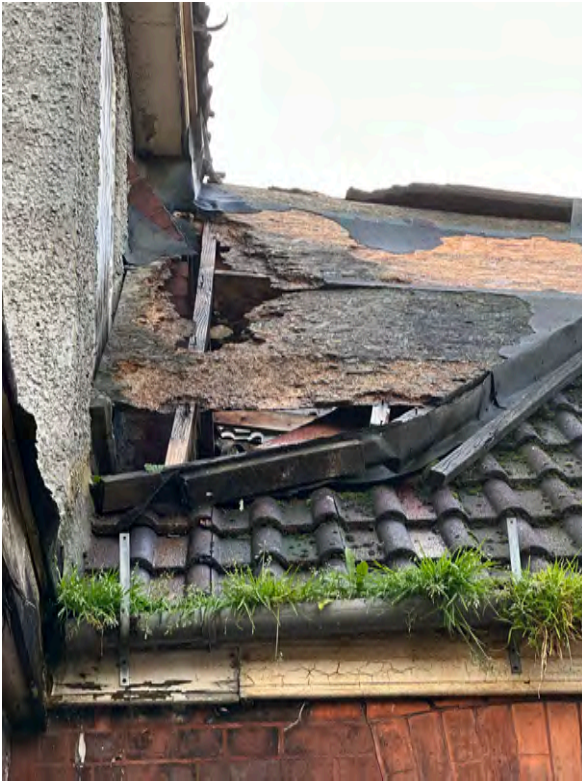
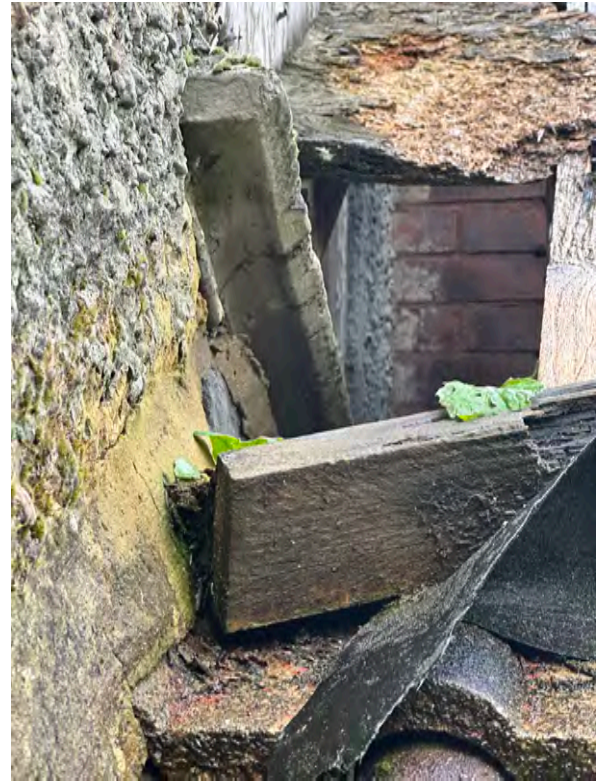
2.1.1.3 The pitched roofs are tile covered with double roman concrete interlocking tiles, most likely Redland 50s. The tiles have a build up of moss and lichen and a number of ridge tiles have either become dislodged or are missing. A section of the hipped roof over the single storey section at the rear has collapsed, the roof structure has been exposed to the elements for many months. The structure is now dangerous and immediate works are required to make the building safe and to ensure the roof does not collapse, causing considerable damage.

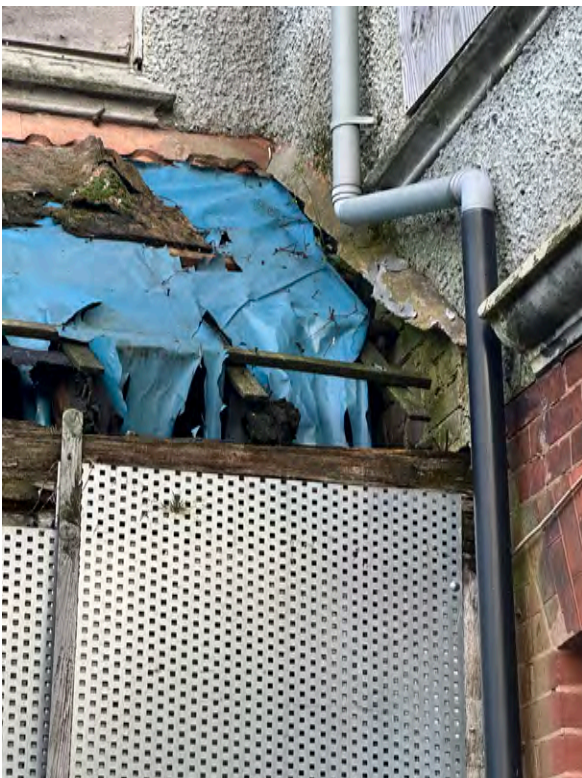
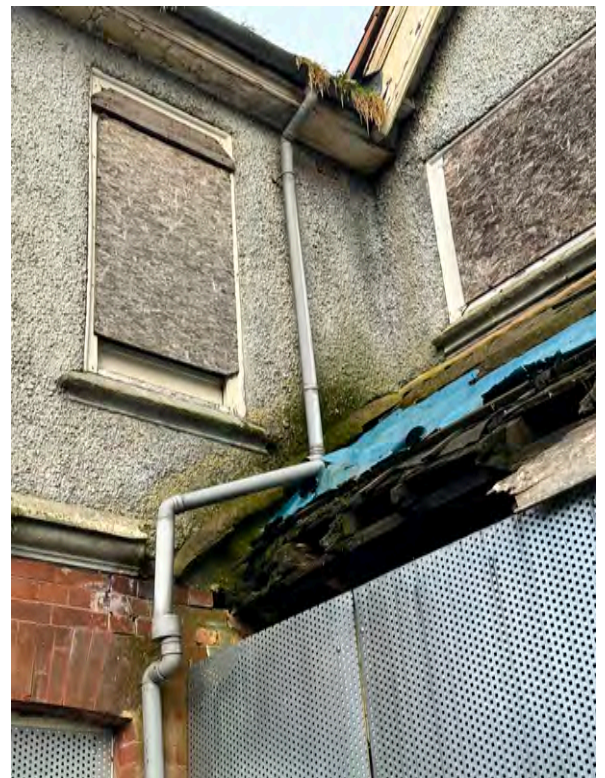
2.1.1.4 The small mono pitch roofs are also in poor condition, tiles have been removed and sheet material used to weather the pitch, this is not a robust permanent solution and, as is to be expected has failed.

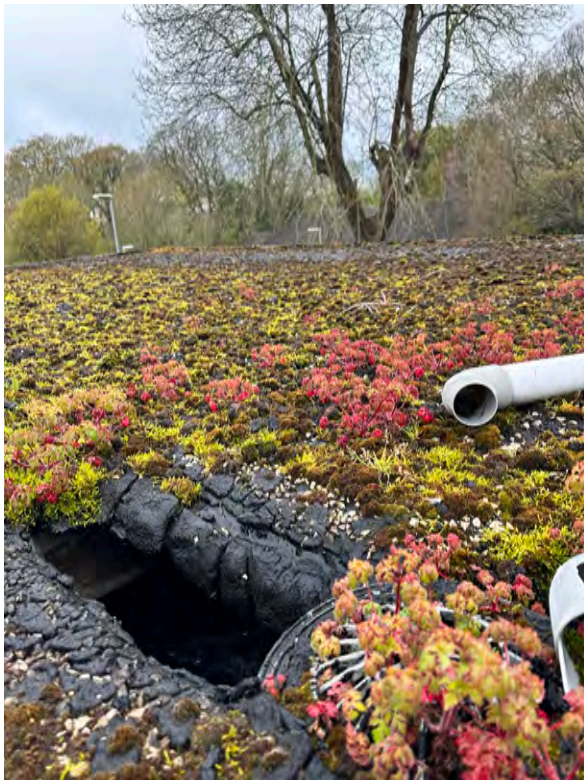
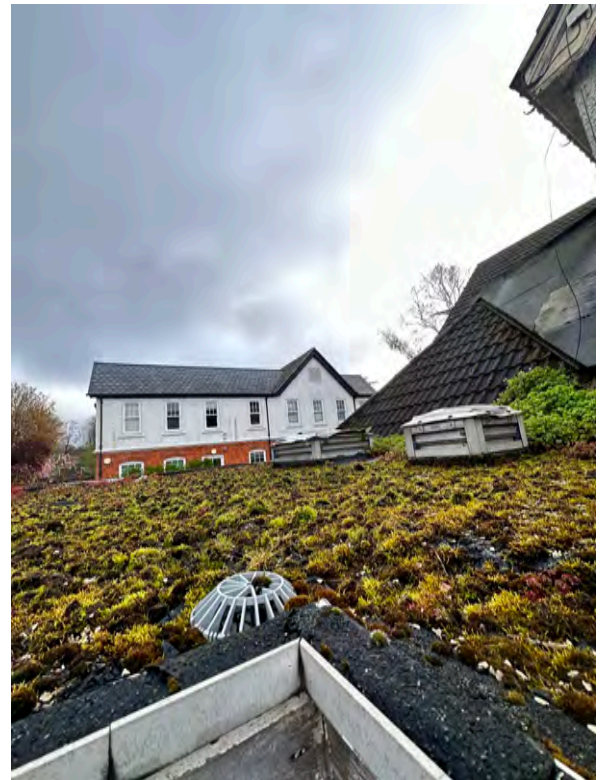
2.1.1.5 The flat roofs are felt covered, all are in poor condition.

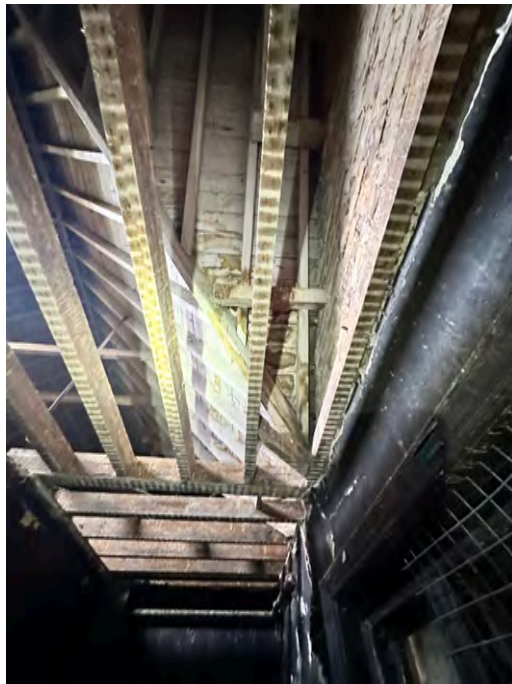
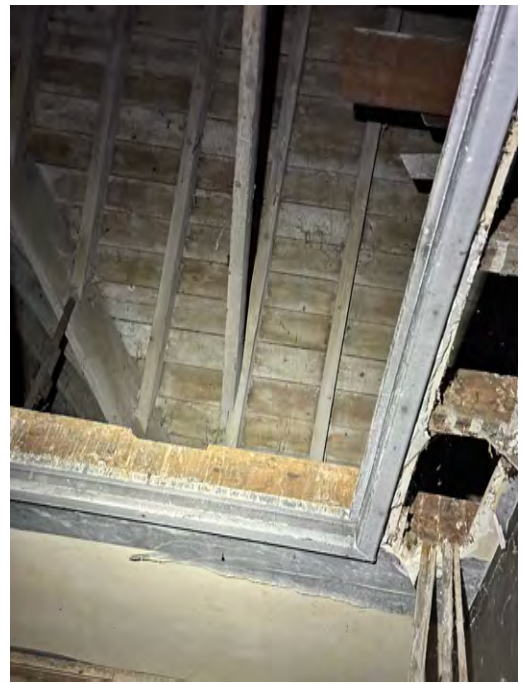
- 2.1.1.6 Over and above the immediate works to make safe the structure we recommend the roof structure be inspected prior to undertaking any replacement works to ensure the structure is capable to withstanding the proposed loads. Due to the age of the building the original roof coverings were most likely slate or clay plain tiles. Both of which are lighter than the replacement concrete interlocking tiles now fitted.
- 2.1.1.7 For safety reasons we were not able to inspect the roof space. However, in places where the first floor ceilings had collapsed we could see the rafters and sarking boards, water staining was noted thus indicating the poor condition of the roof.

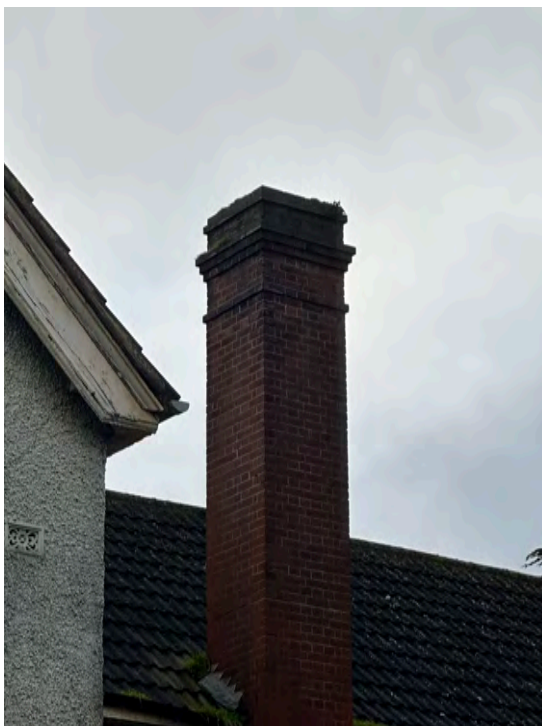
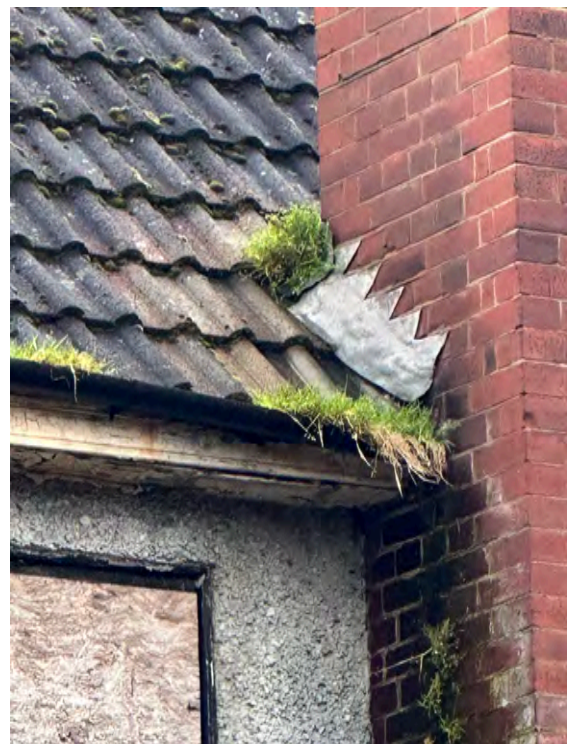
- 2.1.2.1 The main building was originally served by three brick built chimneys, all bar one have been reduced in height and capped off just below the gable end barge boards. The upper parts of the flues should be ventilated to help disperse moist air. We could not see any high level ventilation. The chimney at the rear remains intact although the pots have been removed. Plant growth was noted at the upper sections and around the roof junction.

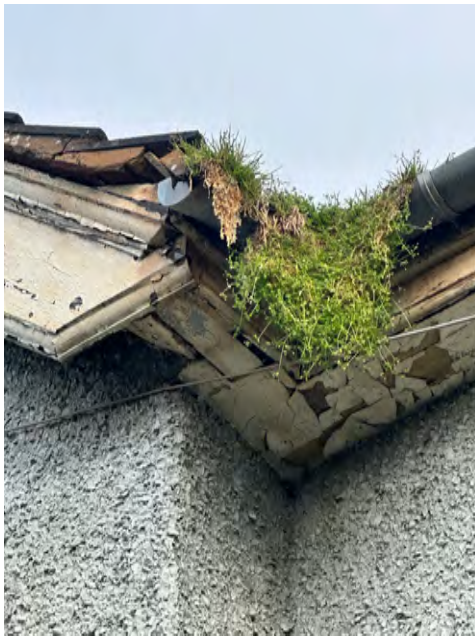
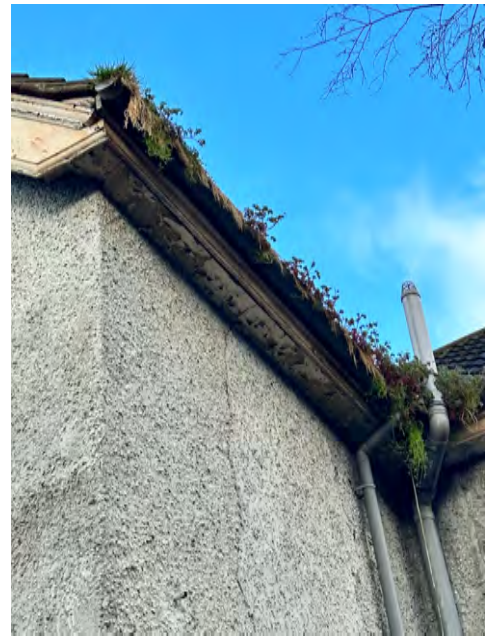
- 2.1.4.1 All fascia's and soffits are in poor condition. Some have collapsed thus leaving the fabric exposed which has resulted in further decay and deterioration.

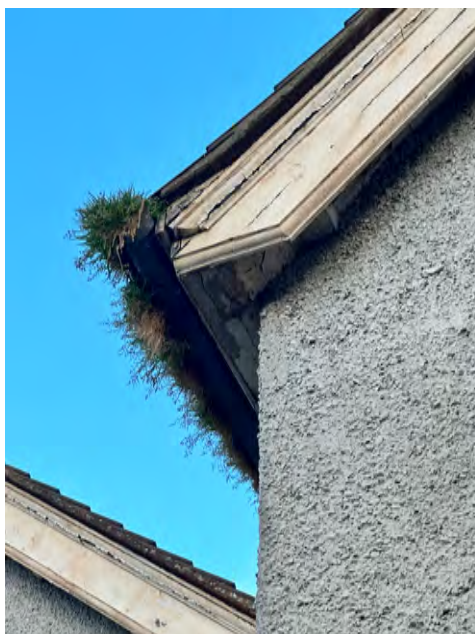
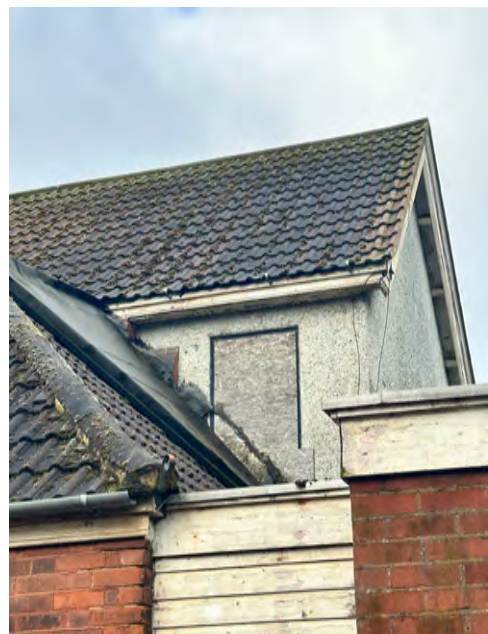
- 2.1.4.1 The gutters and down pipes are in poor condition, sections have failed and plants have become established, as such the discharge of rainwater is not being controlled and is therefore saturating the building fabric.

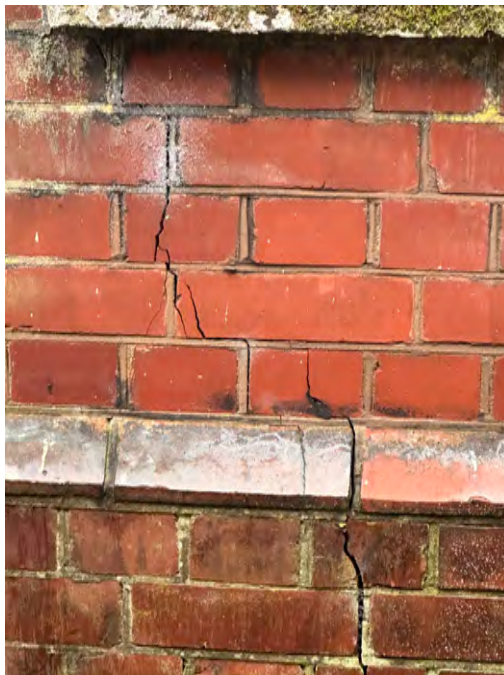
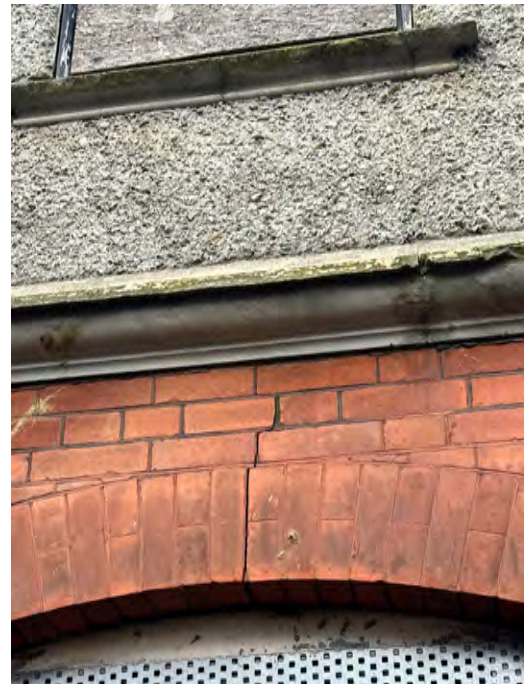
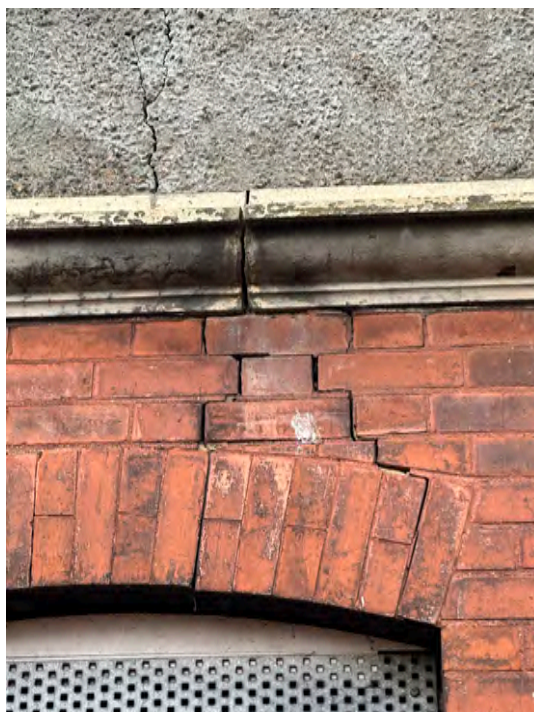
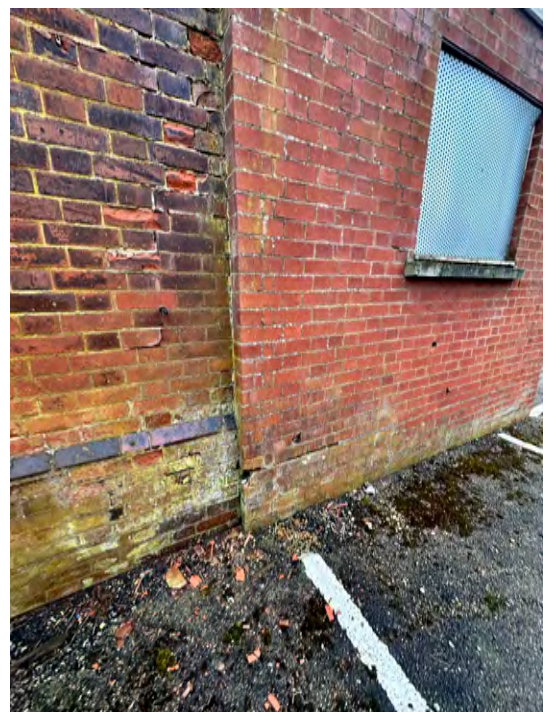
2.1.5.2 There are a number of brick repairs required due to impact damage and pipework penetrations etc. We also noted a number of cracks around the building to the extent that stone window cills and window heads have snapped as the cracks extend up the building.

2.1.5.5 Overall the brickwork is in a serviceable condition but will require substantial replacements, repairs and repointing to bring it back to its original condition. We recommend that full cleaning be undertaken prior to undertaking any masonry repairs to remove any dirt and loose debris to gain a better view of the overall condition particularly at the rear where sections of brickwork are stained. Any self seeded plants should be removed and the masonry made good to prevent deterioration of the masonry. The building and cracks should be considered by a structural engineer prior to any works taking place.

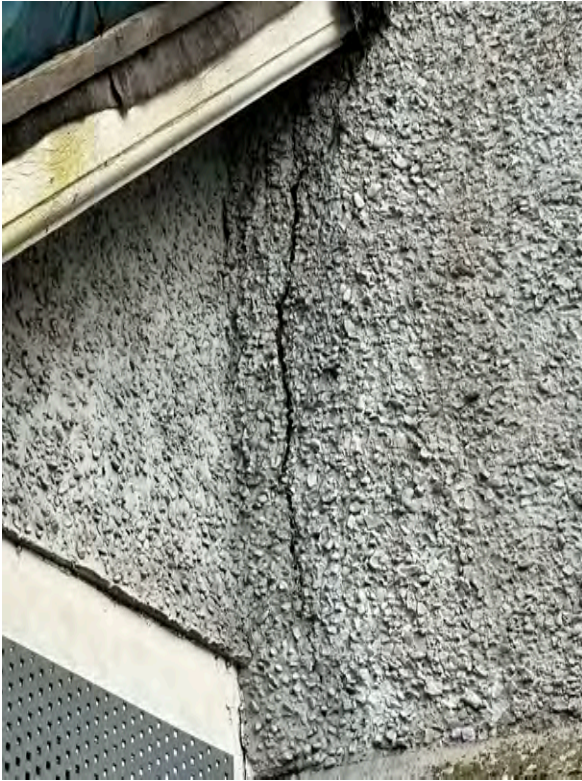
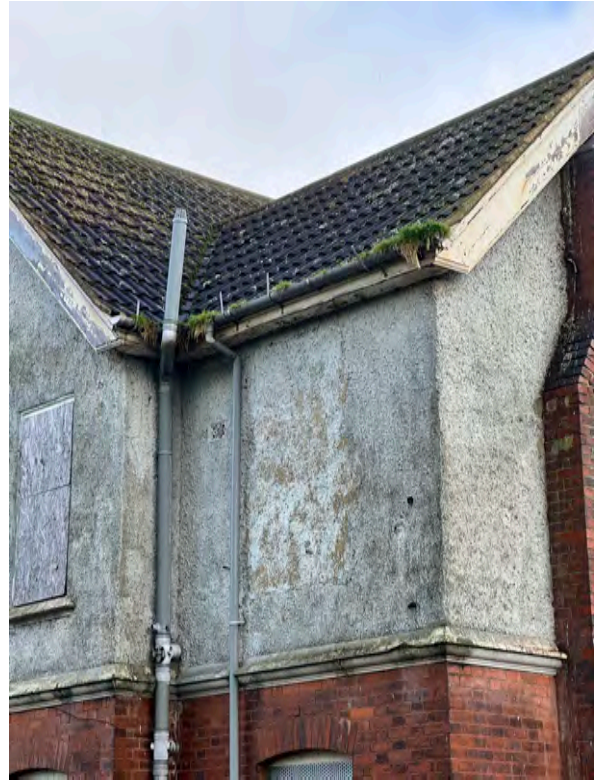
2.1.5.3 The render is in poor condition. We would expect the render to be hacked off and replaced as part of project to repair and refurbish the building.

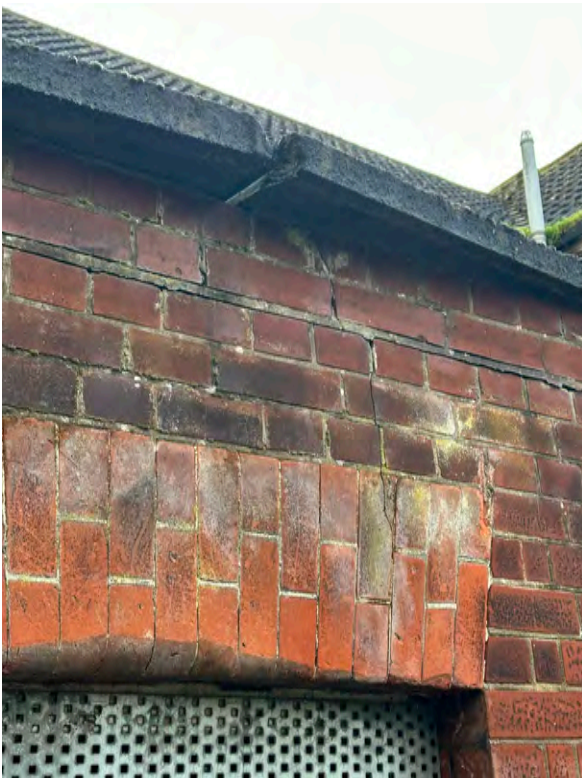
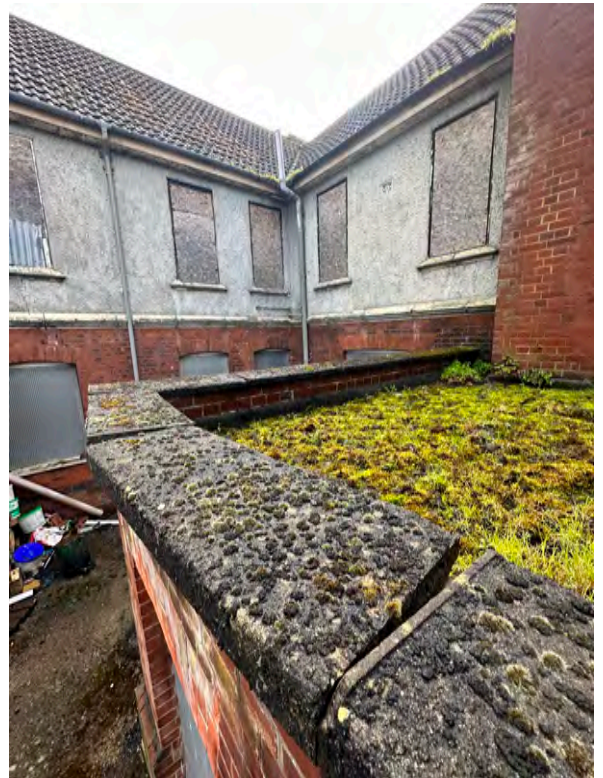
2.1.5.4 At the rear, the boiler room extension is finished with a parapet wall capped with concrete coping stones. The copings have become dislodged and the joints are open.

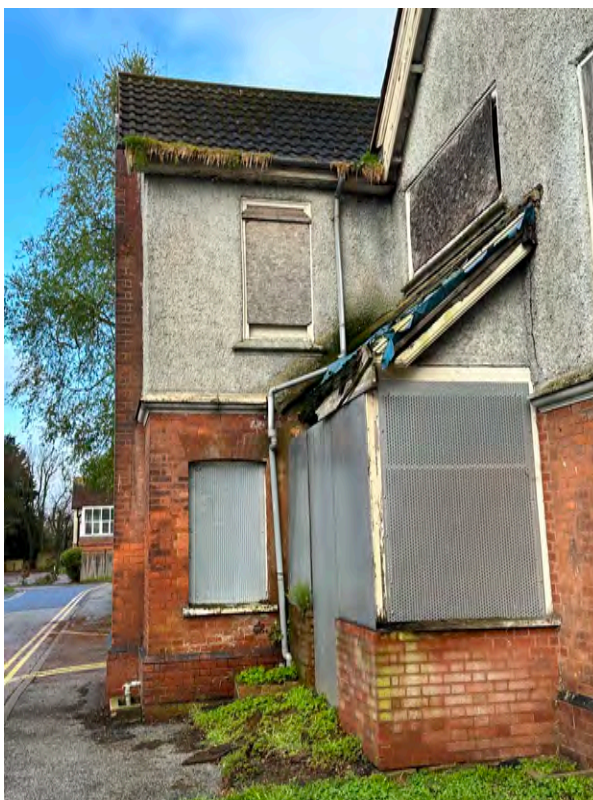
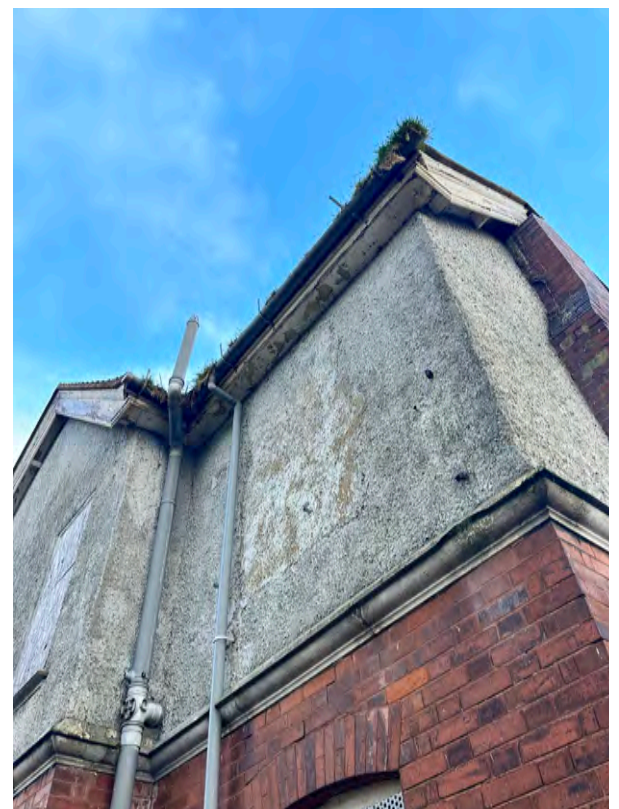
2.1.7.1 The external decorations are in a poor condition and we recommend a full redecoration package be undertaken.

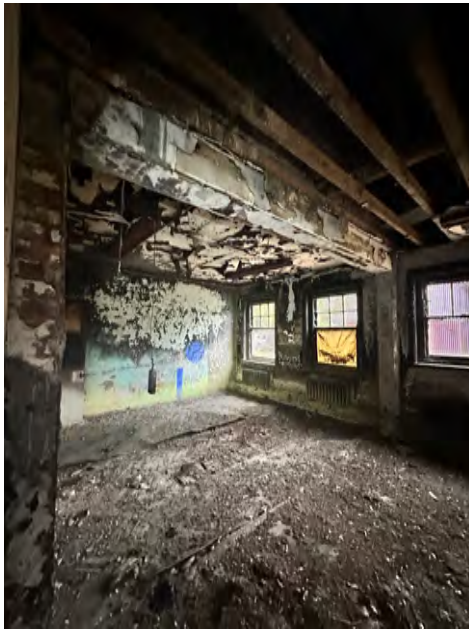
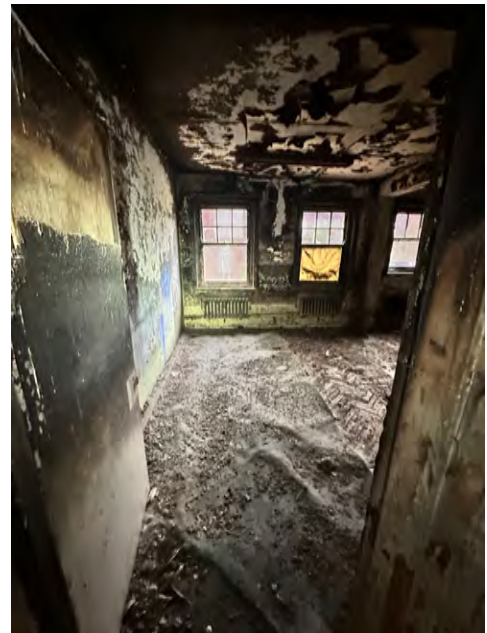
2.2.1.1 The internal parts have suffered fire and smoke damage.

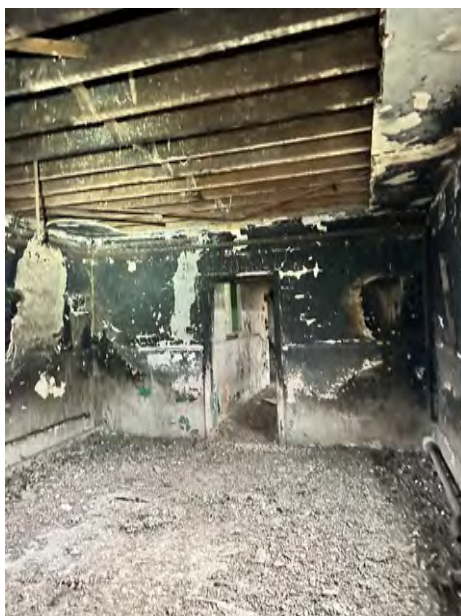
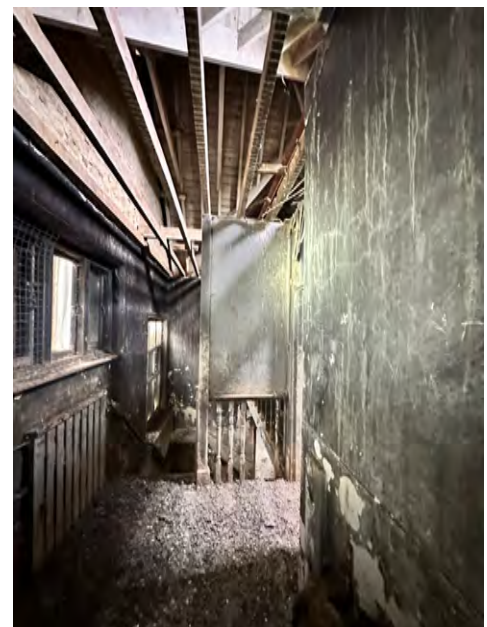
2.2.3.1 All ceilings are in poor condition and some have collapsed.

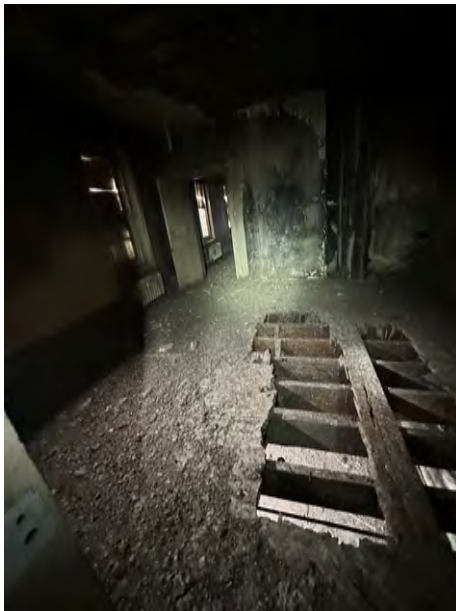
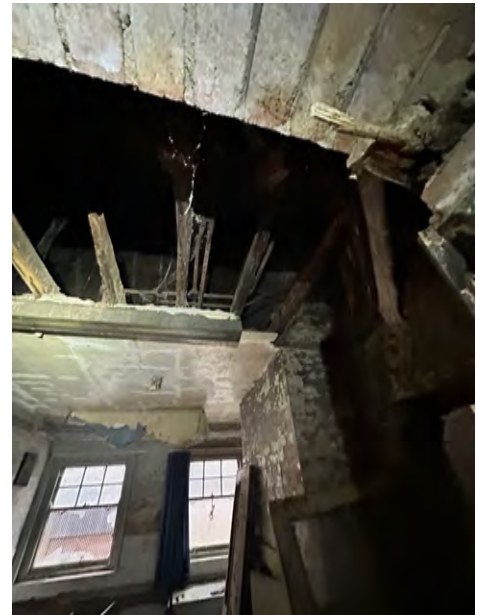
2.2.5.1 Concrete floors are provided throughout the ground floor. The first floor is a suspended timber floor and have deteriorated due to water ingress, floorboards have fallen through and holes have appeared. Sections of the first floor joists will need to be replaced. All floor coverings are beyond repair.

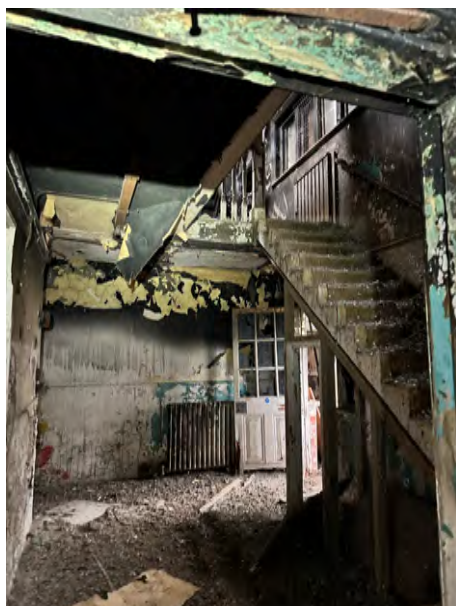
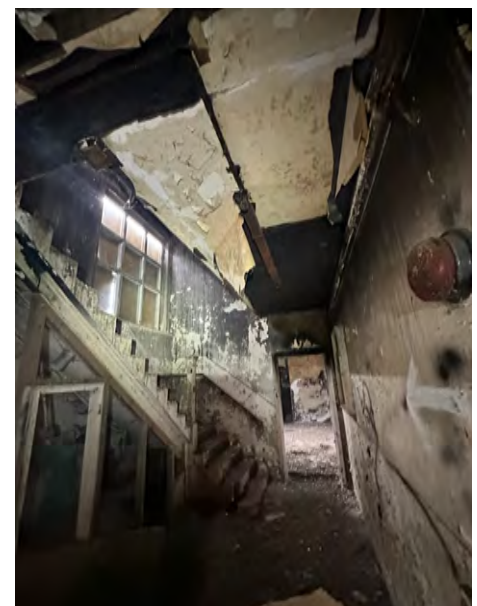
2.2.5.2 Access to the first floor is gained via one of two timber staircases located at either end of the building. The staircases extends up and wind around to the first floor. The handrails are missing and the staircases are in poor condition. We would expect them to be replaced as part of a project to repair and refurbish the building.

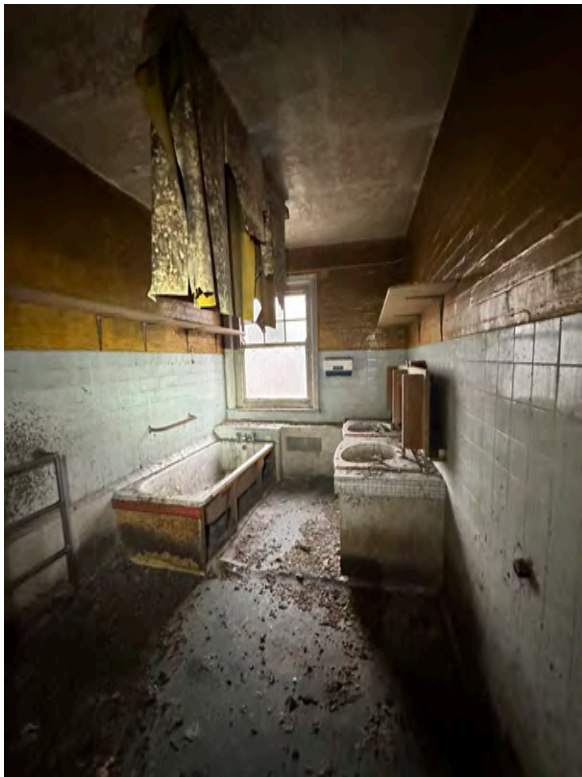
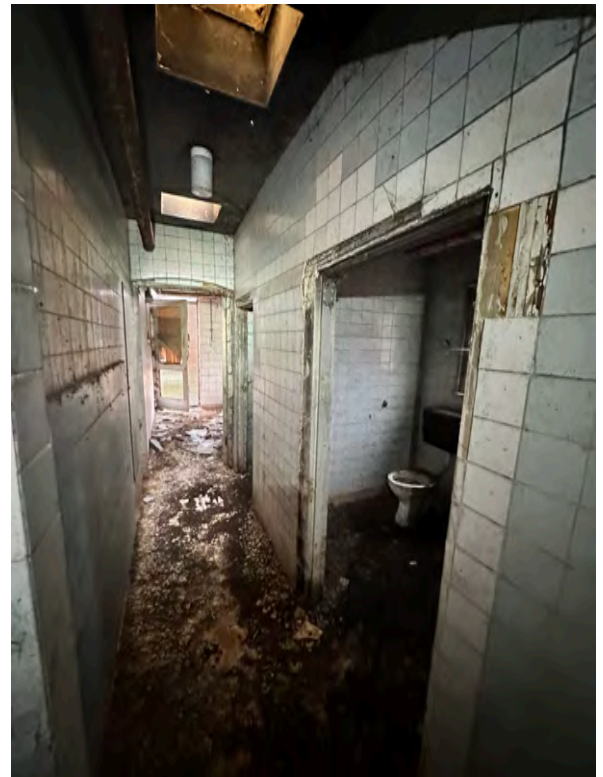
2.2.8.1 The remaining sanitary ware is in poor condition. We would expect new sanitary ware to be fitted as part of a project to repair and refurbish the building.

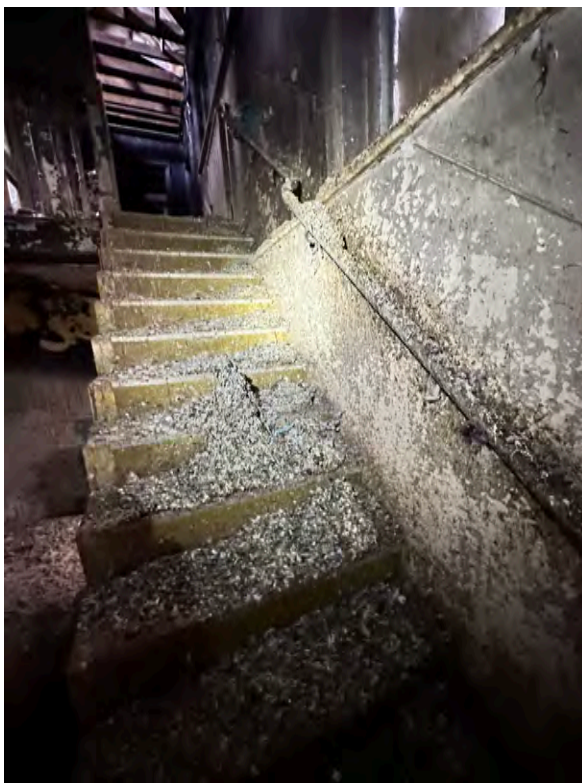
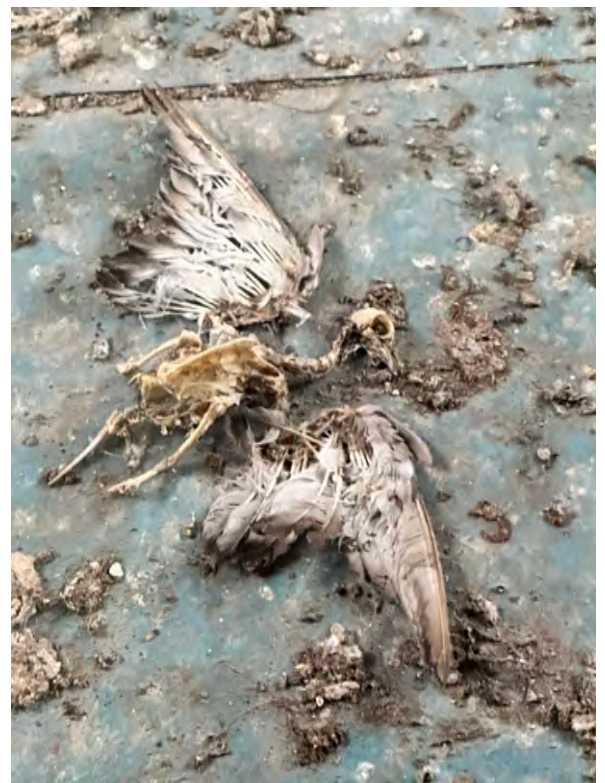
- 2.2.11.1 Pigeons have free access into this building via the failing fabric. As such a significant quantity of guano (droppings) has accumulated throughout the building.

- 2.2.11.2 Pigeon guano can be very dangerous. Ornithosis, Listeria, bird flu, E-coli and other nasty pathogens can be passed through droppings and by the birds themselves. When dry, the droppings can become airborne leading to respiratory complaints such as psittacosis, and the cryptococcus fungus.

- 2.2.11.3 The guano will need to be removed by an experienced operator and this will add a cost to the works. The Environment Agency state that large quantities of guano can be disposed of in a standard skip, providing that the company used is an 'Authorised Waste Carrier'. Virtually every company renting skips in the UK is an Authorised Waste Carrier. When the skip is taken away the contractor will fill in a 'Transfer Note', which asks for details of the quantity of waste being removed, the type of waste and the date. The information provided on this form will direct the driver to dispose of the waste at an authorised facility.

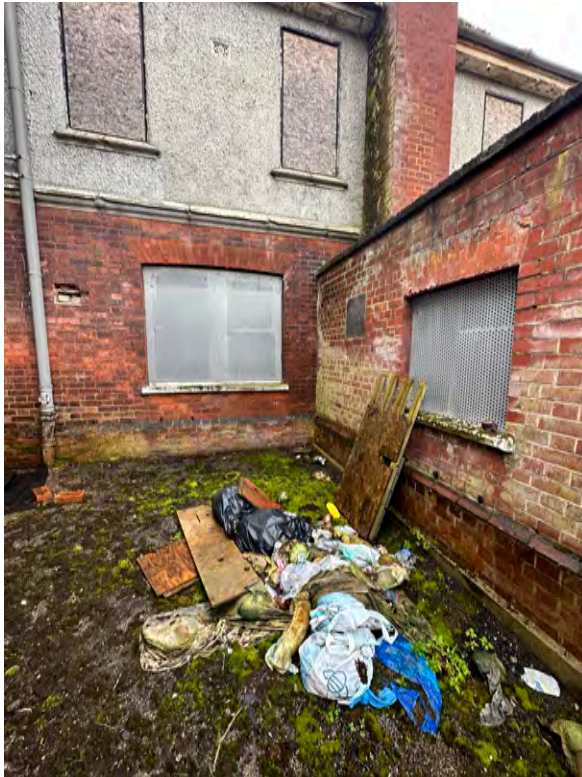
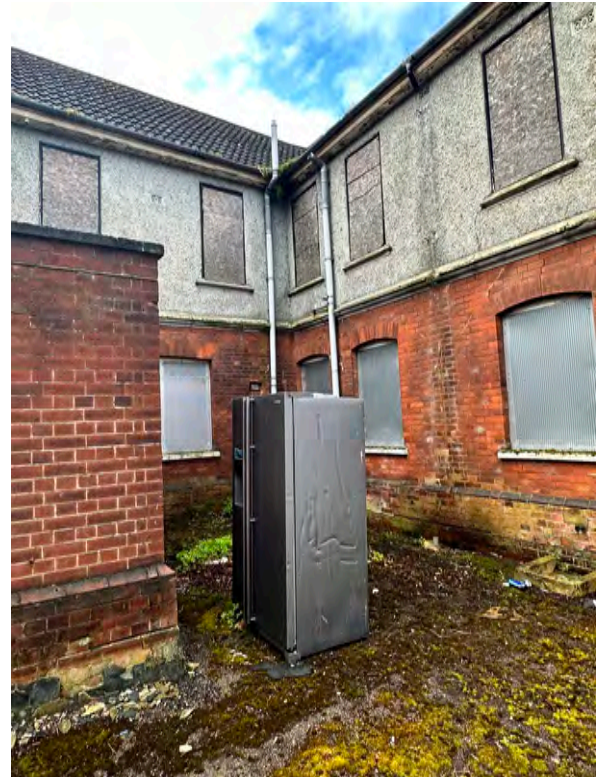
2.2.12.1 The external parts are open and in places quite overgrown. The space at the rear has been exploited by fly tippers.
