## CONDITION REVIEW

**Oxleas NHS Foundation Trust**

**Thistle**

May 2023  
Revision A

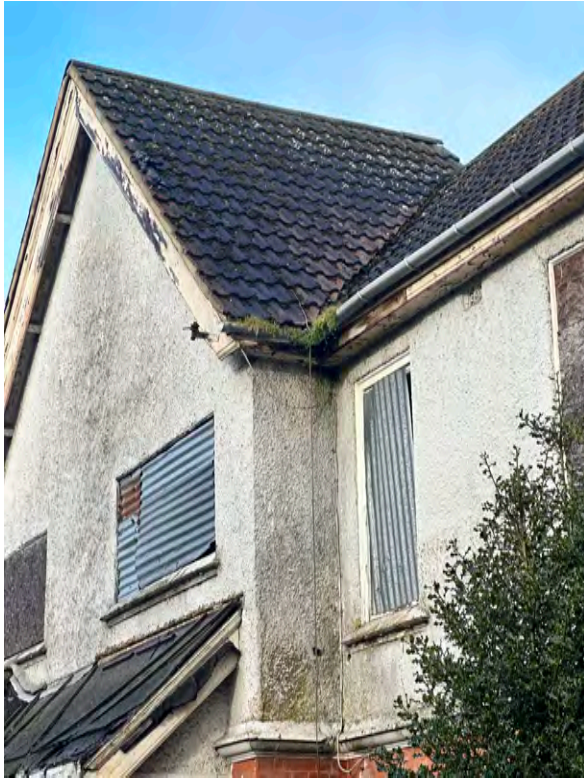
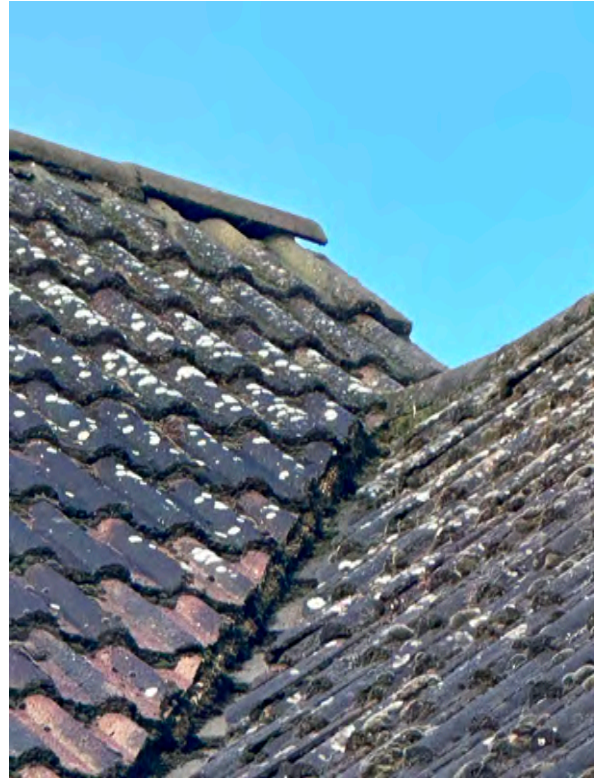
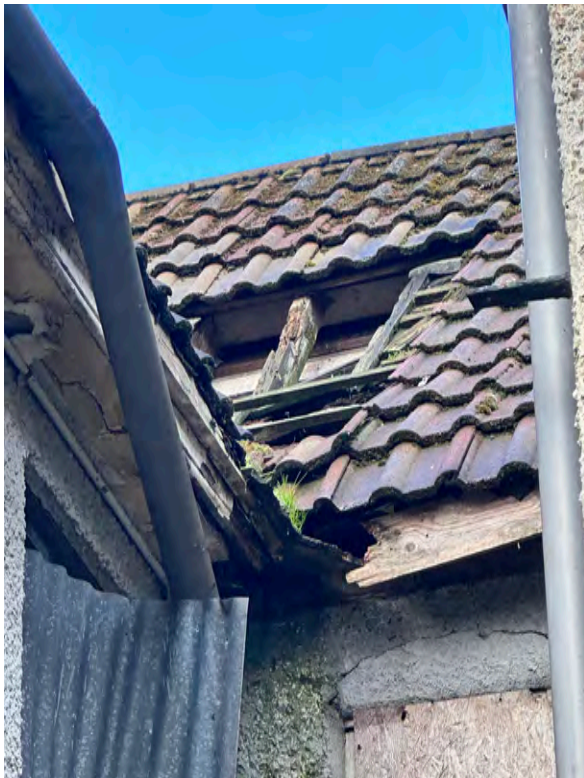
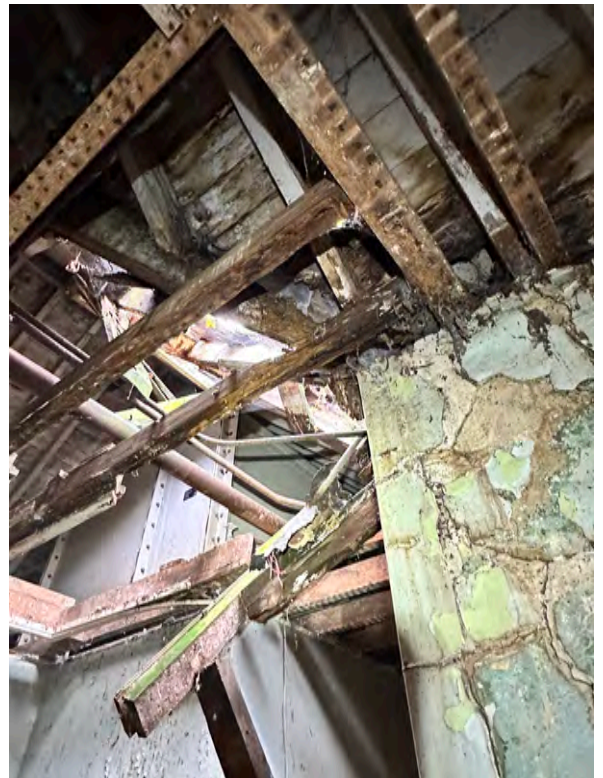
- 2.1.1.2 The pitched roofs are tile covered with double roman concrete interlocking tiles, most likely Redland 50s. The tiles have a build up of moss and lichen and a number of ridge tiles have either become dislodged or are missing. A section of the main roof at the rear has collapsed, the roof structure has been exposed to the elements for many months. The structure is now dangerous and immediate works are required to make the building safe and to ensure the roof does not collapse, causing considerable damage.

2.1.1.5 Over and above the immediate works to make safe the structure we recommend the roof structure be inspected prior to undertaking any replacement works to ensure the structure is capable to withstanding the proposed loads. Due to the age of the building the original roof coverings were most likely slate or clay plain tiles. Both of which are lighter than the replacement concrete interlocking tiles now fitted.

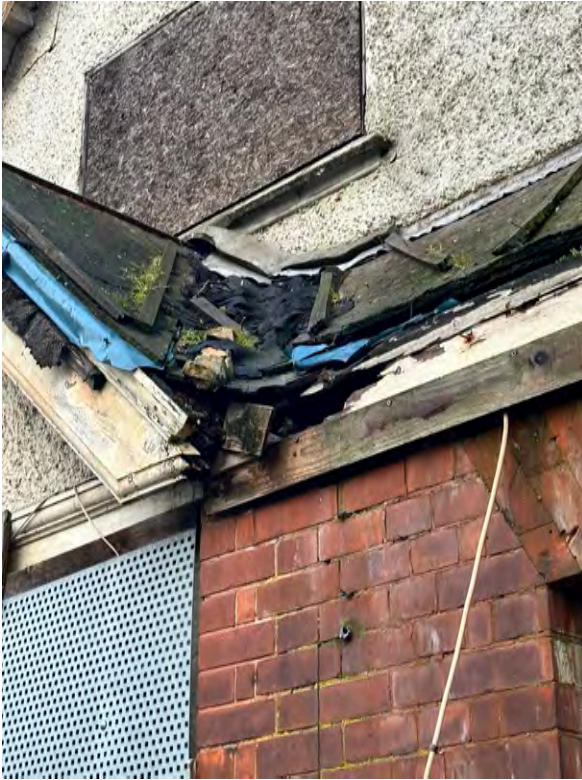
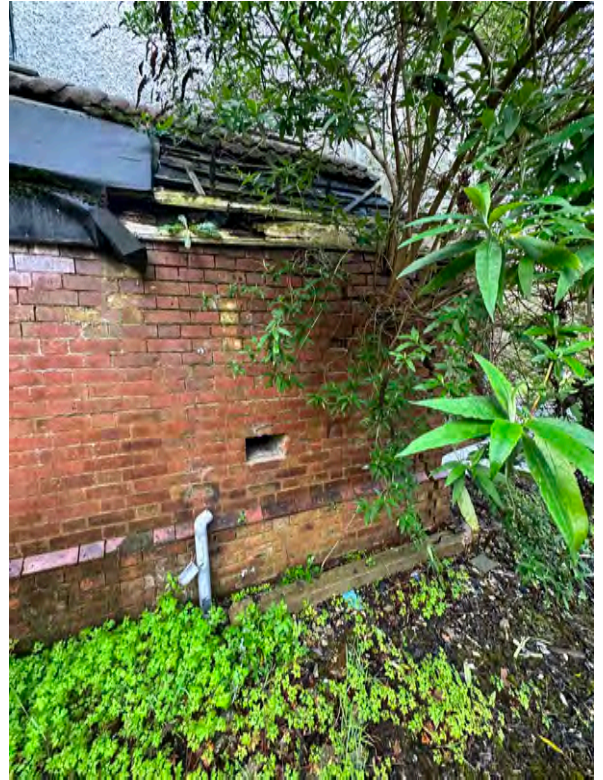
- 2.1.1.3 The small mono pitch roofs are also in poor condition, tiles have been removed and sheet material used to weather the pitch, this is not a robust permanent solution and, as is to be expected has failed.

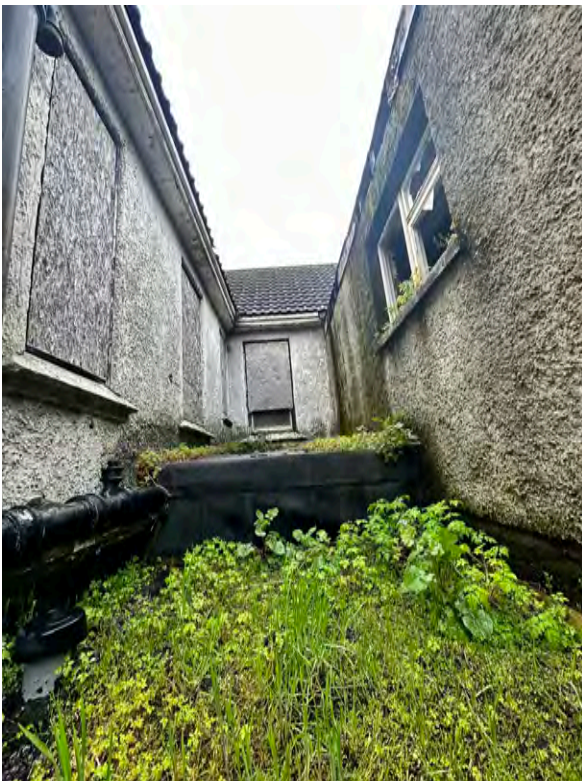
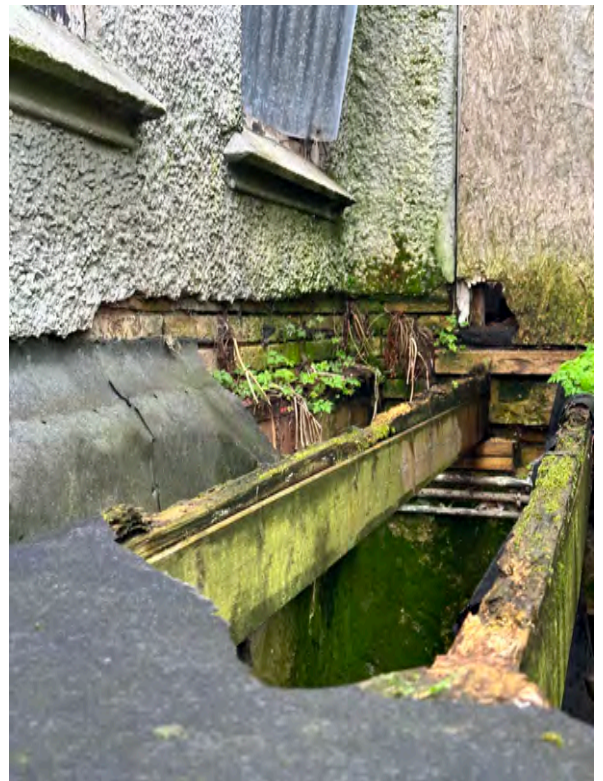
2.1.1.4 The flat roofs are felt covered, all are in poor condition.

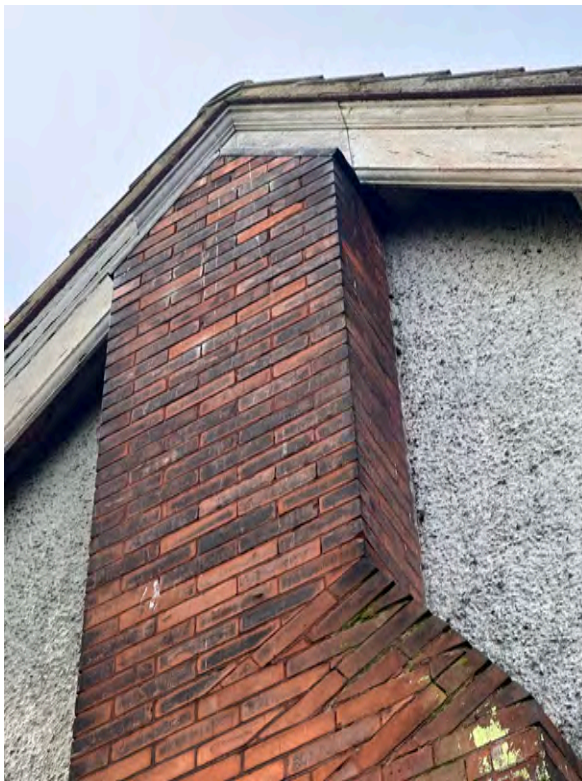
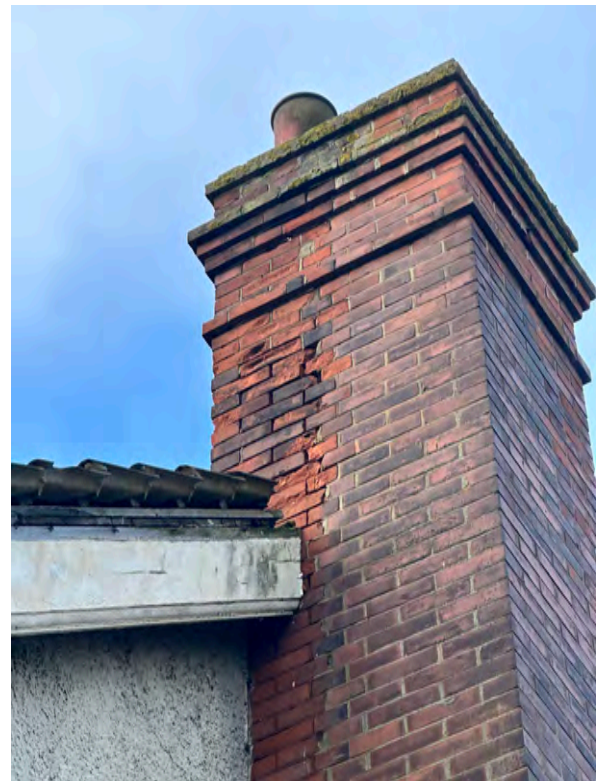
- 2.1.2.1 The main building was originally served by three brick built chimneys, all bar one have been reduced in height and capped off just below the gable end barge boards. The upper parts of the flues should be ventilated to help disperse moist air. We could not see any high level ventilation. The chimney at the rear remains intact with pots still in place. The brickwork is in poor condition and needs to be repointed.

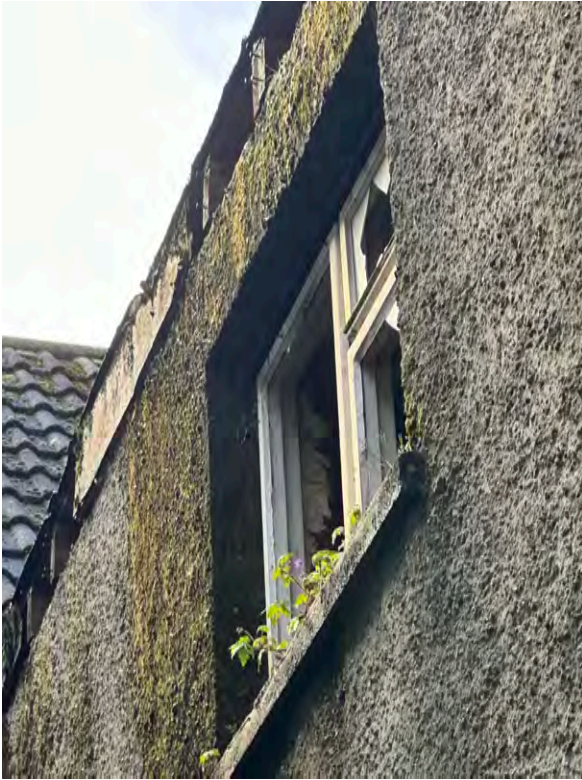
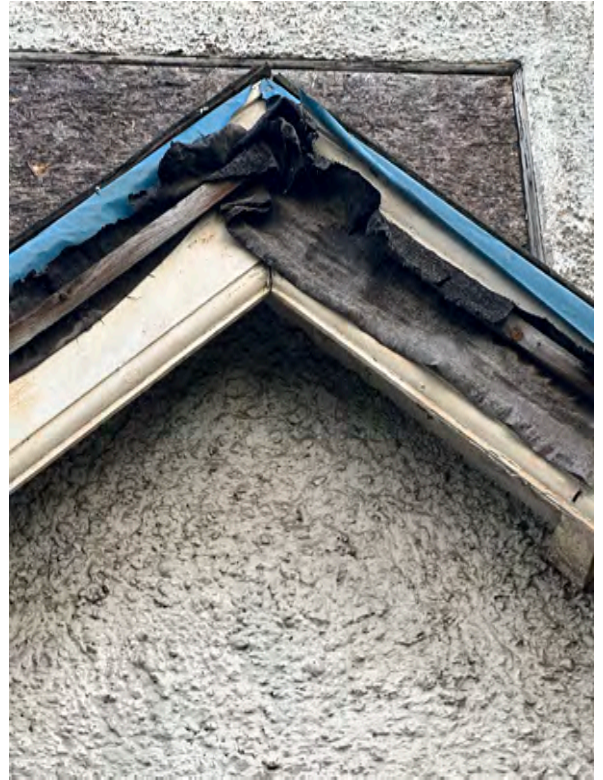
- 2.1.4.1 All fascia's and soffits are in poor condition. Some have collapsed thus leaving the fabric exposed which has resulted in further decay and deterioration.

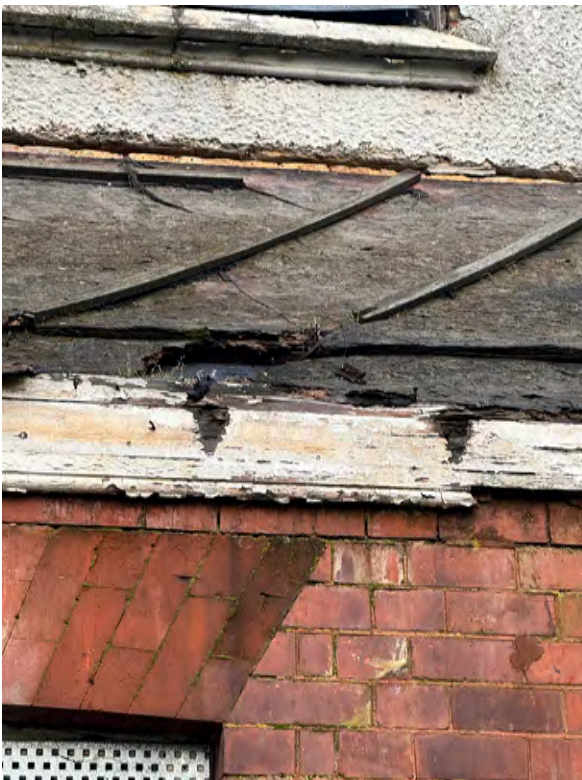
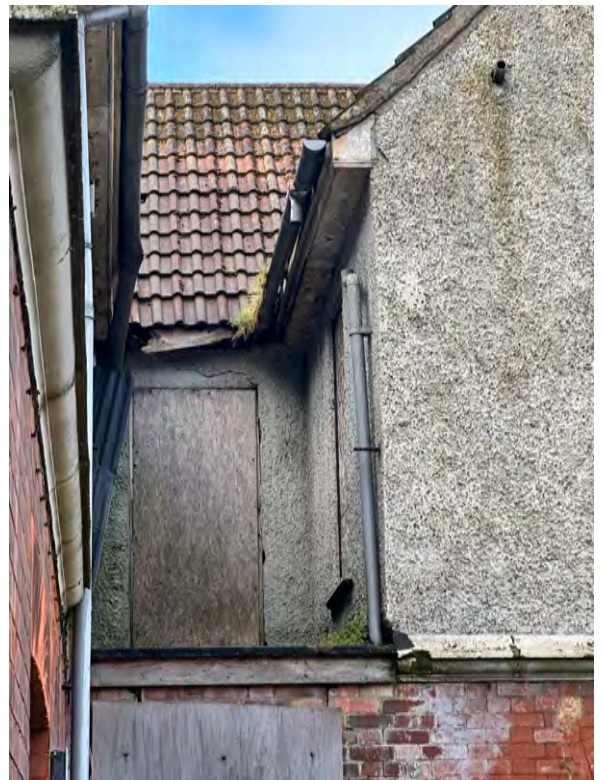
2.1.4.1 The gutters and down pipes are in poor condition, sections have failed and as such the discharge of rainwater is not being controlled and is therefore saturating the building fabric.

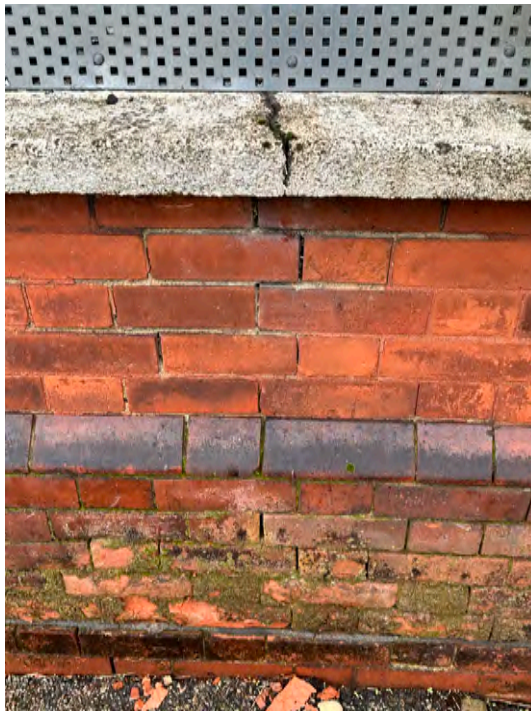
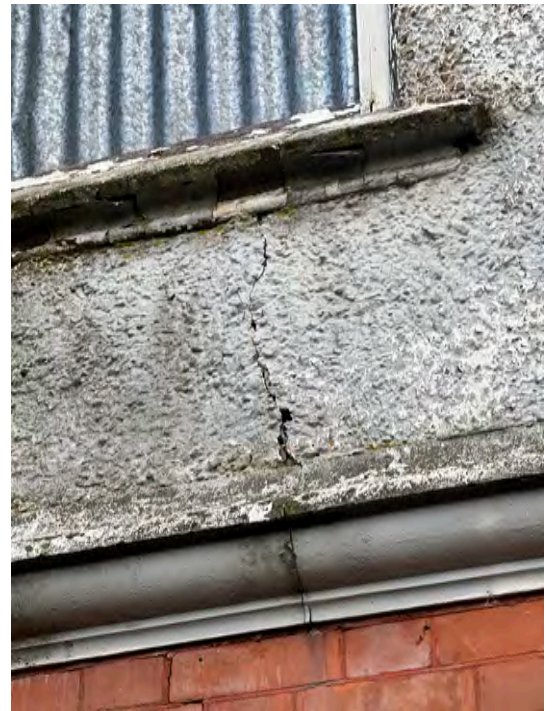
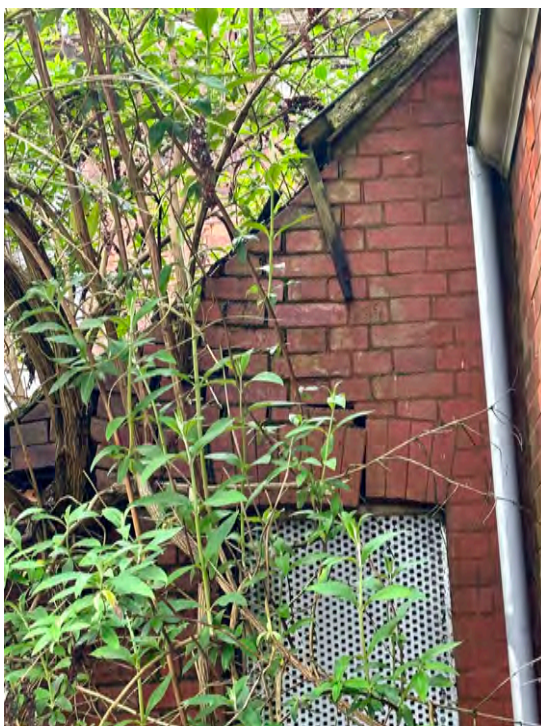
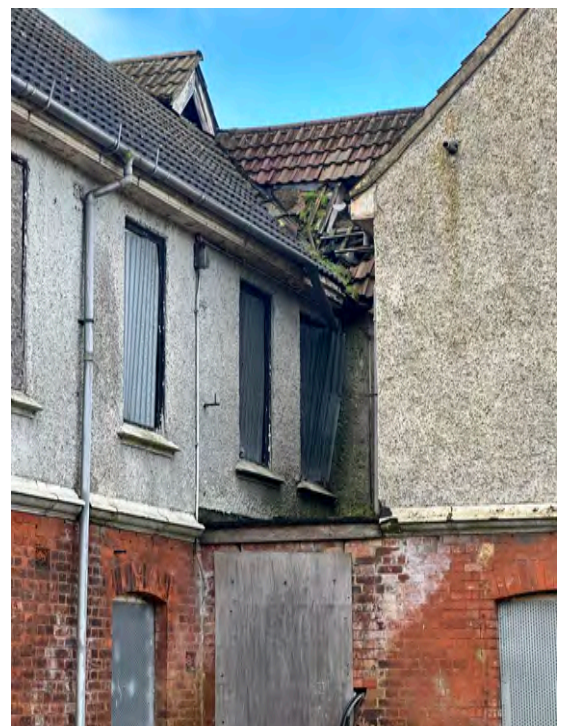
- 2.1.5.1 At ground floor level, the main building is constructed of smooth-faced red clay bricks laid in Flemish bond with coloured mortar pointing and a cant brick plinth at the base. At first floor level the walls are finished with painted pebble dash render. The window heads are a combination of both arched and flat lintels typical for this age of building.
- 2.1.5.2 There are a number of brick repairs required due to impact damage and pipework penetrations etc. We also noted a number of cracks around the building to the extent that stone window cills and window heads have snapped as the cracks extend up the building.

- 2.1.5.4 Overall the brickwork is in a serviceable condition but will require substantial replacements, repairs and repointing to bring it back to its original condition. We recommend that full cleaning be undertaken prior to undertaking any masonry repairs to remove any dirt and loose debris to gain a better view of the overall condition particularly at the rear where sections of brickwork are stained. Any self seeded plants should be removed and the masonry made good to prevent deterioration of the masonry. The building and cracks should be considered by a structural engineer prior to any works taking place.

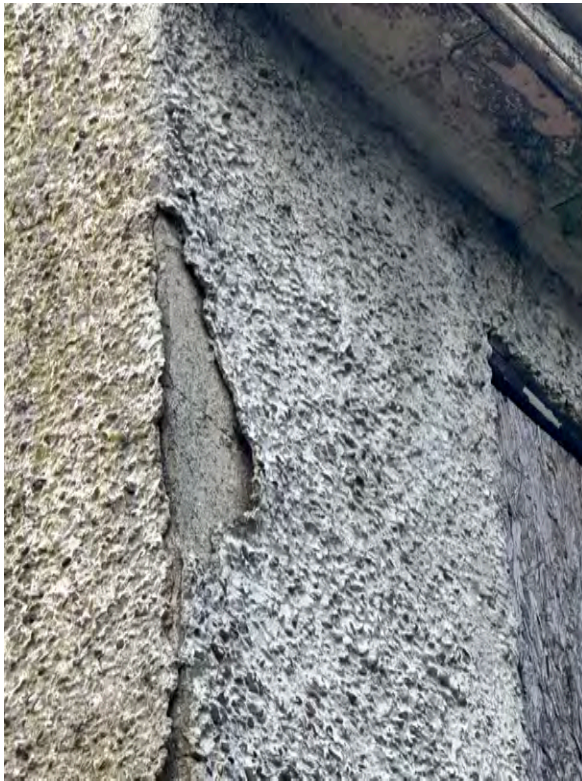
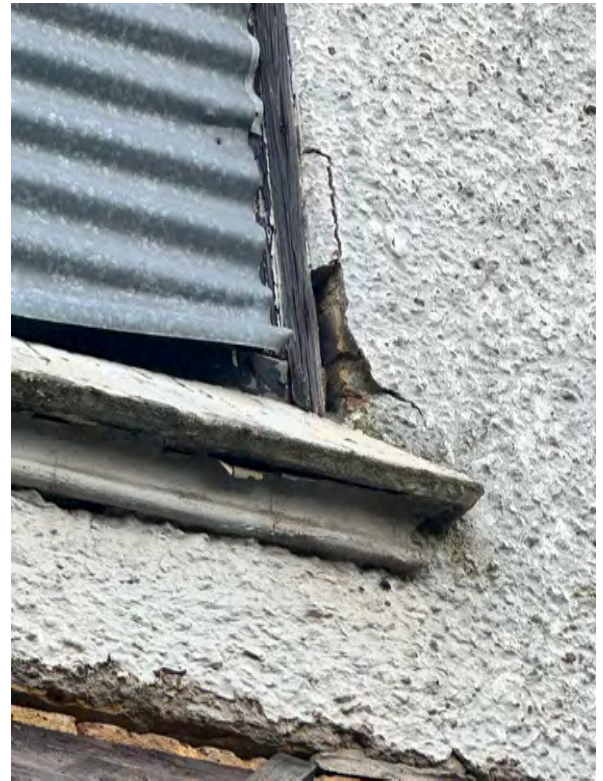
- 2.1.5.3 The render is in poor condition. We would expect the render to be hacked off and replaced as part of project to repair and refurbish the building.

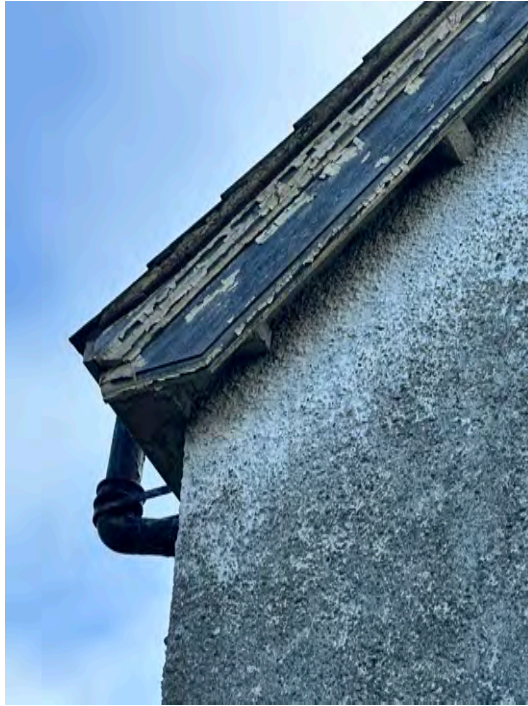
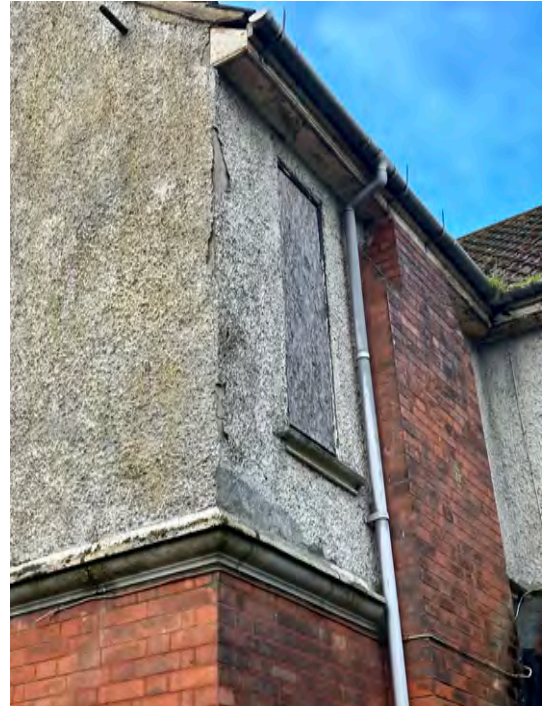
- 2.1.7.1 The external decorations are in a poor condition and we recommend a full redecoration package be undertaken.

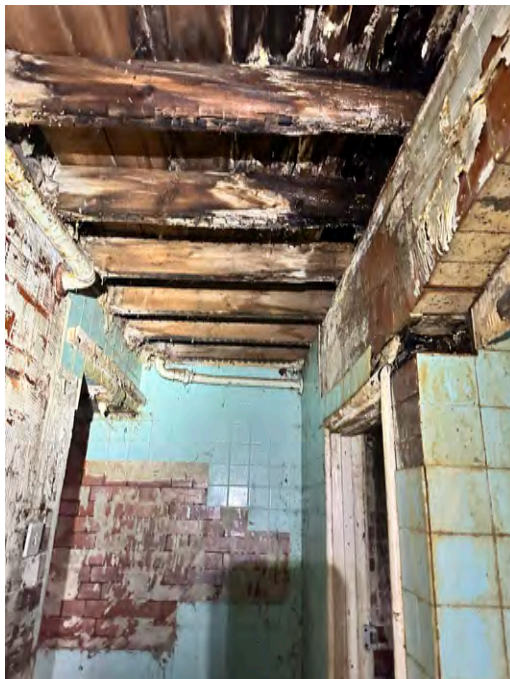
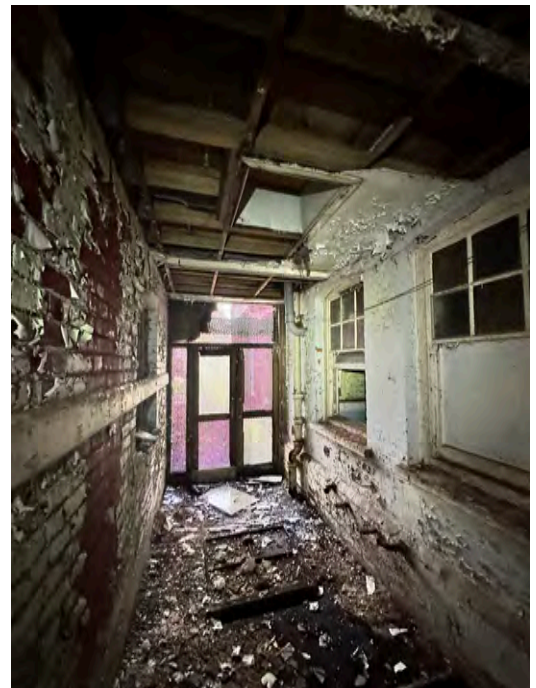
2.2.2.1 All ceilings are in poor condition and some have collapsed.

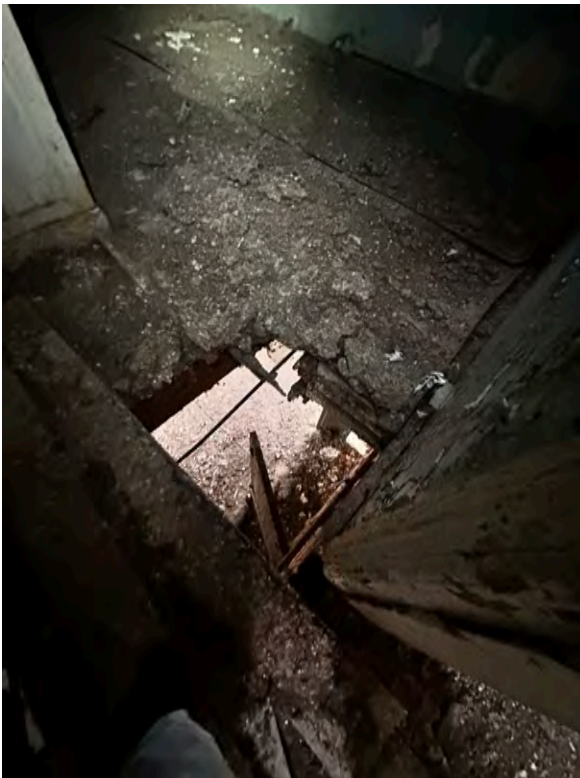
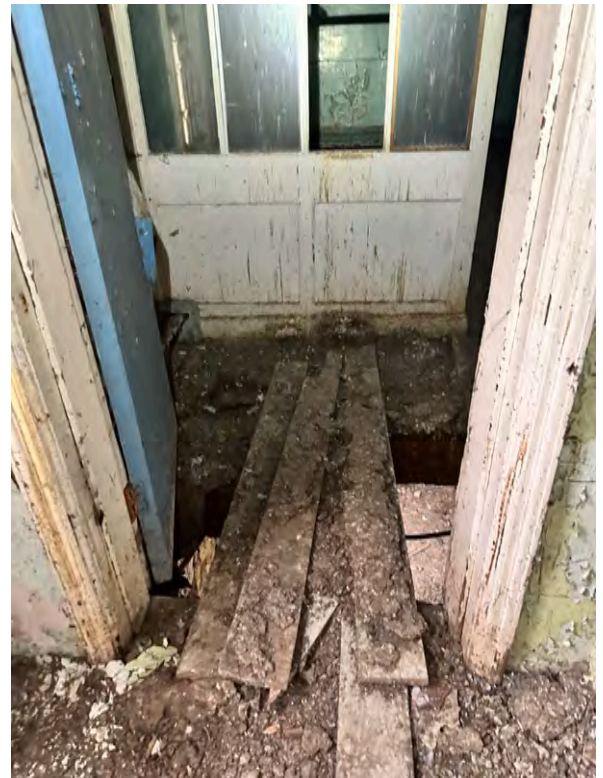
2.2.4.1 Concrete floors are provided throughout the ground floor. The first floor is a suspended timber floor and have deteriorated due to water ingress, floorboards have fallen through and holes have appeared. Sections of the first floor joists will need to be replaced. All floor coverings are beyond repair.

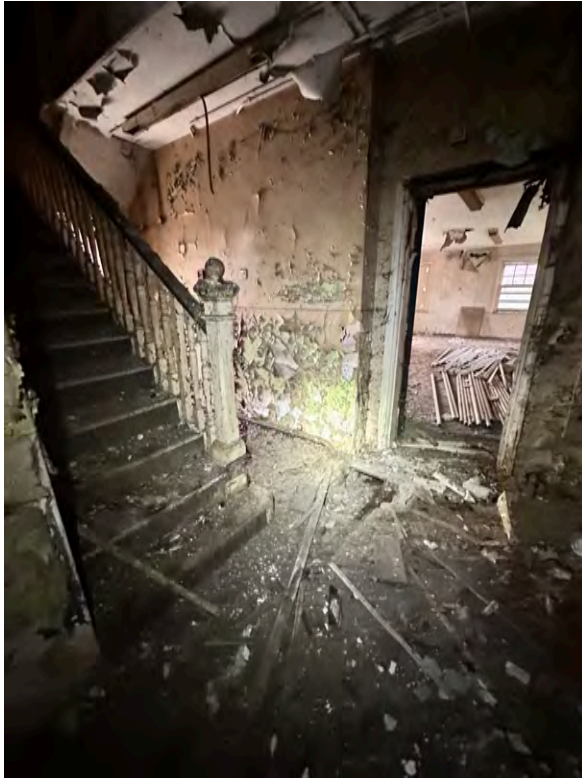
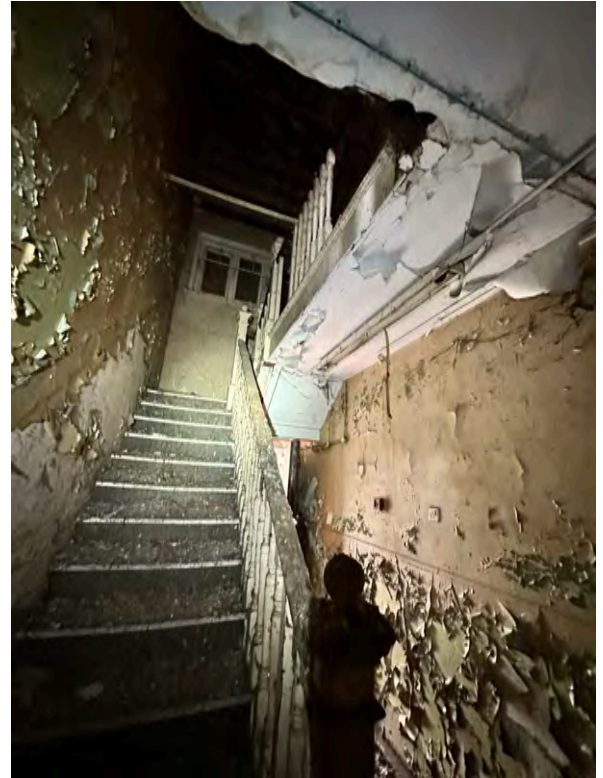
2.2.4.2 Access to the first floor is gained via a single timber staircase located centrally. The staircase extends up and winds around incorporating a midpoint landing. The staircase is in poor condition. We would expect it to be replaced as part of a project to repair and refurbish the building.

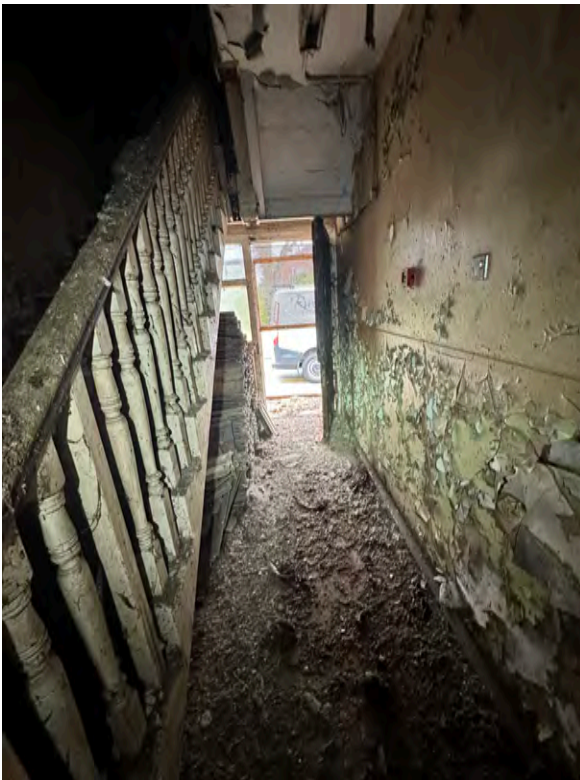
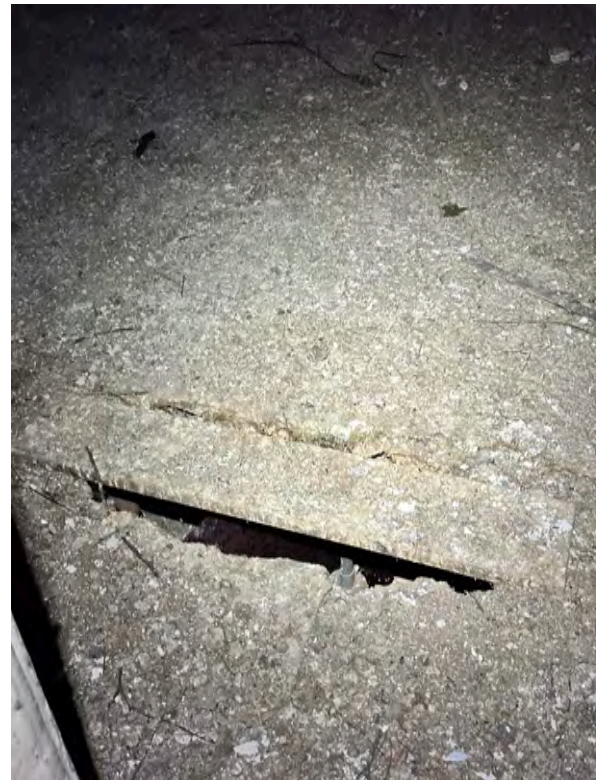
- 2.2.11.1 Pigeons have free access into this building via the failing fabric. As such a significant quantity of guano (droppings) has accumulated throughout the building.

- 2.2.11.2 Pigeon guano can be very dangerous. Ornithosis, Listeria, bird flu, E-coli and other nasty pathogens can be passed through droppings and by the birds themselves. When dry, the droppings can become airborne leading to respiratory complaints such as psittacosis, and the cryptococcus fungus.

- 2.2.11.3 The guano will need to be removed by an experienced operator and this will add a cost to the works. The Environment Agency state that large quantities of guano can be disposed of in a standard skip, providing that the company used is an 'Authorised Waste Carrier'. Virtually every company renting skips in the UK is an Authorised Waste Carrier. When the skip is taken away the contractor will fill in a 'Transfer Note', which asks for details of the quantity of waste being removed, the type of waste and the date. The information provided on this form will direct the driver to dispose of the waste at an authorised facility.

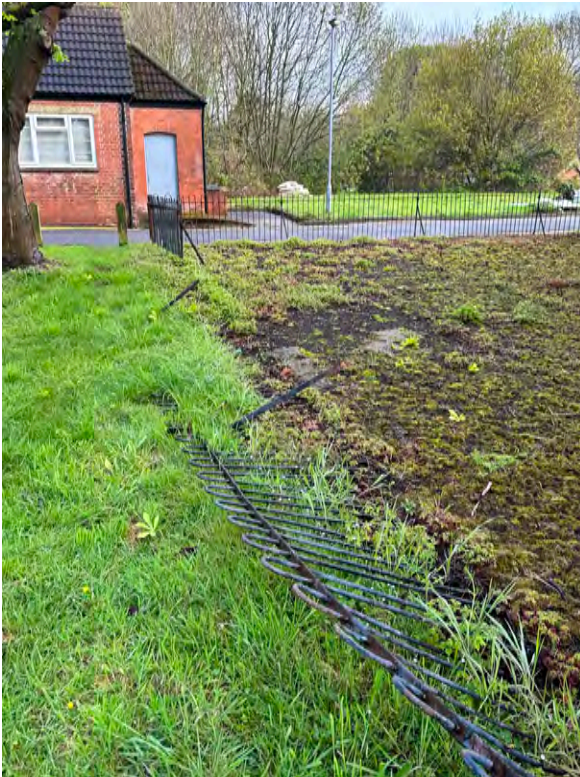
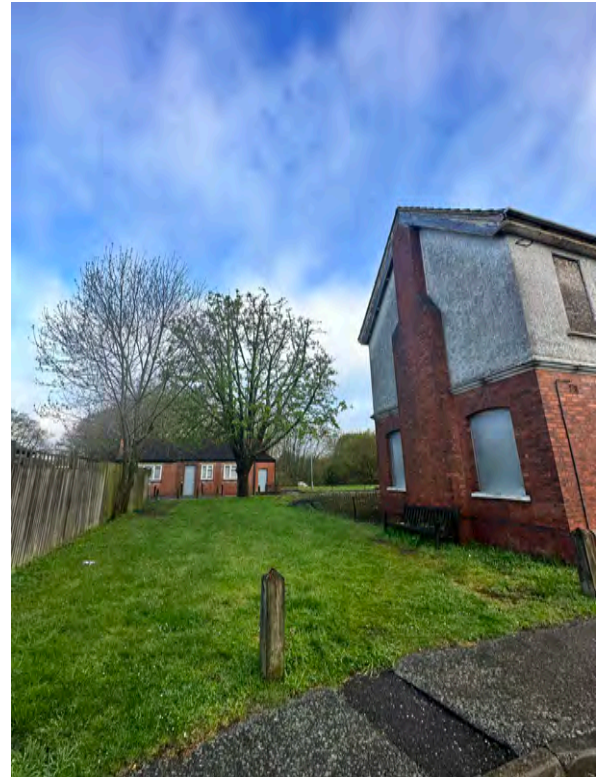
- 2.2.12.1 The external parts are open and in places quite overgrown. The hoop top fence running down the side of the building is in poor condition and has collapsed. There is a danger of sharp edges projecting above the ground and for someone to get injured. The fence should be removed.
