PLEASE REFER TO THE PROPOSED GROUND, FIRST AND SECOND FLOOR, PROPOSED ELEVATIONS, PROPOSED ROOF PLAN AND PHOTOGRAPH LOCATION PLAN AND SUPPORTING IMAGES PART 1

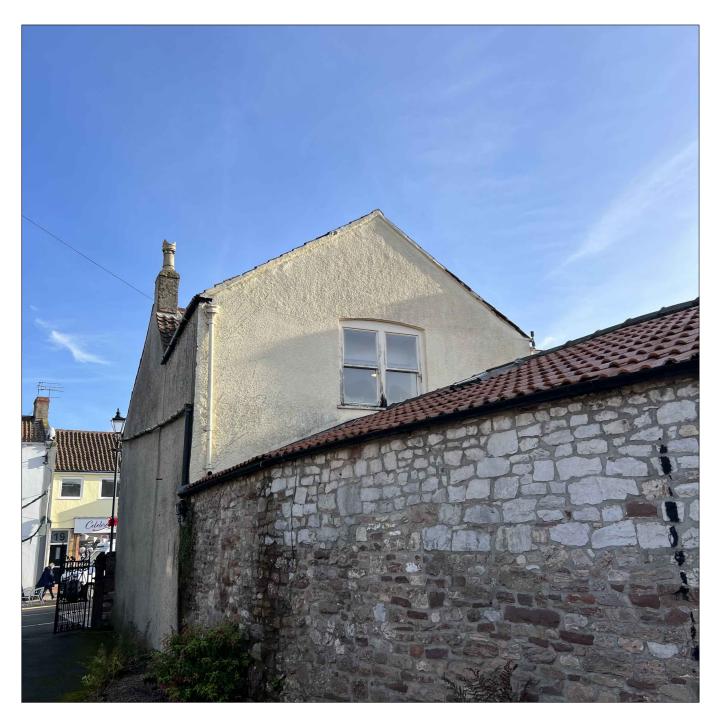
PHOTOGRAPH 8

PHOTOGRAPH 8: IMAGE OF THE LADIES TOILET WINDOW WITH ROTTEN MULLION

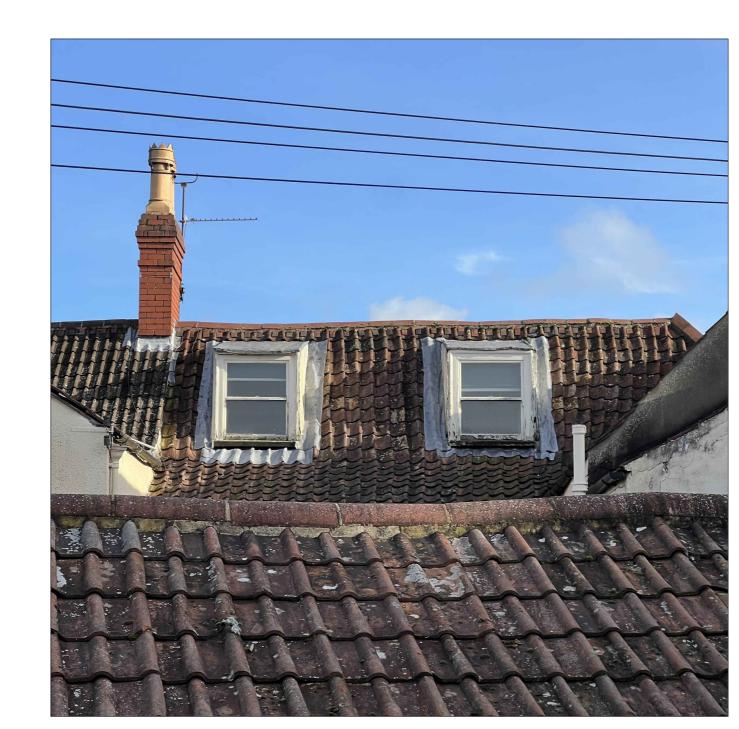
PHOTOGRAPH 9

PHOTOGRAPH 9: IMAGE OF WINDOW 8/9 AND THE ROTTEN FRAMES

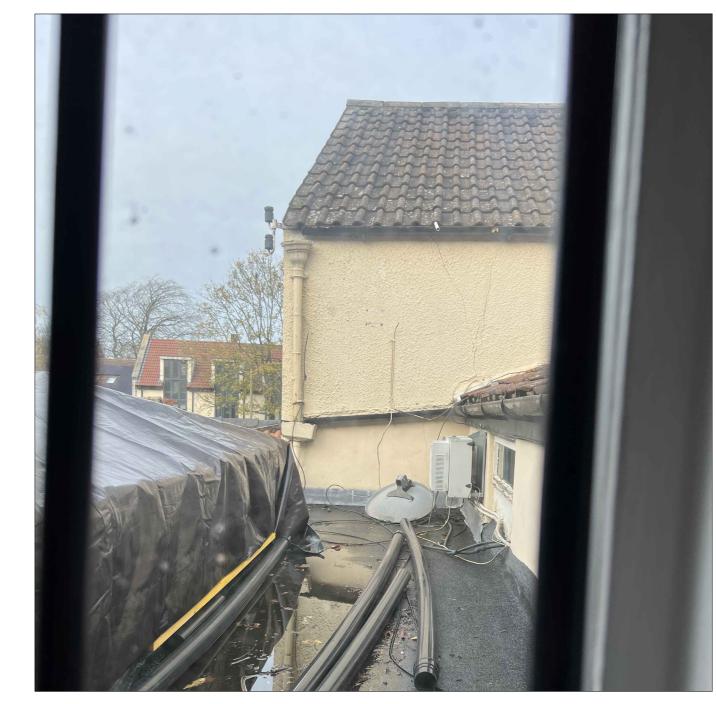
PHOTOGRAPH 10

PHOTOGRAPH 10: IMAGE OF THE MAIN SKYLIGHT COVERED UP DUE TO IT LEAKING AND THE DEBRIS ON THE FLAT ROOF

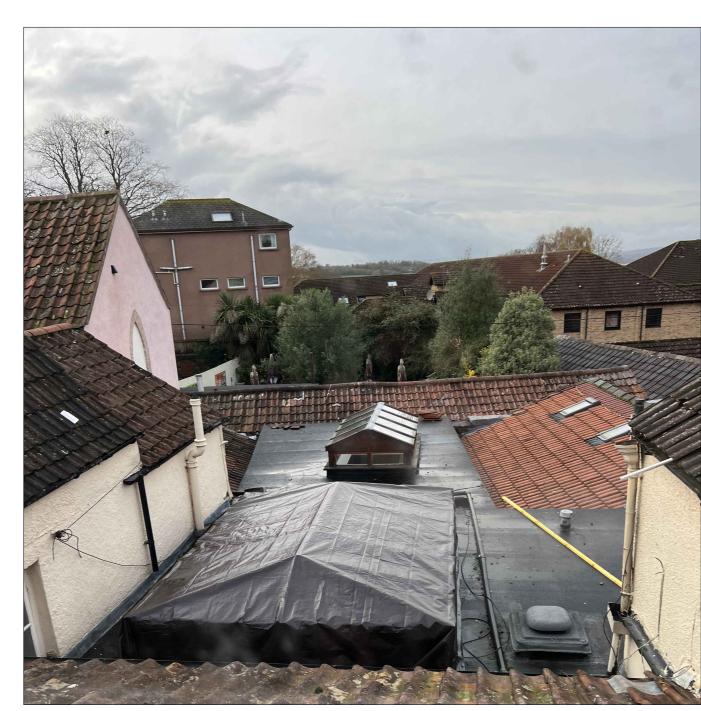
PHOTOGRAPH 11

PHOTOGRAPH 11: IMAGE FROM
THE DORMER WINDOW TO SHOW
EXTENT OF DEBRIS AND THE
COVERED UP SKYLIGHT

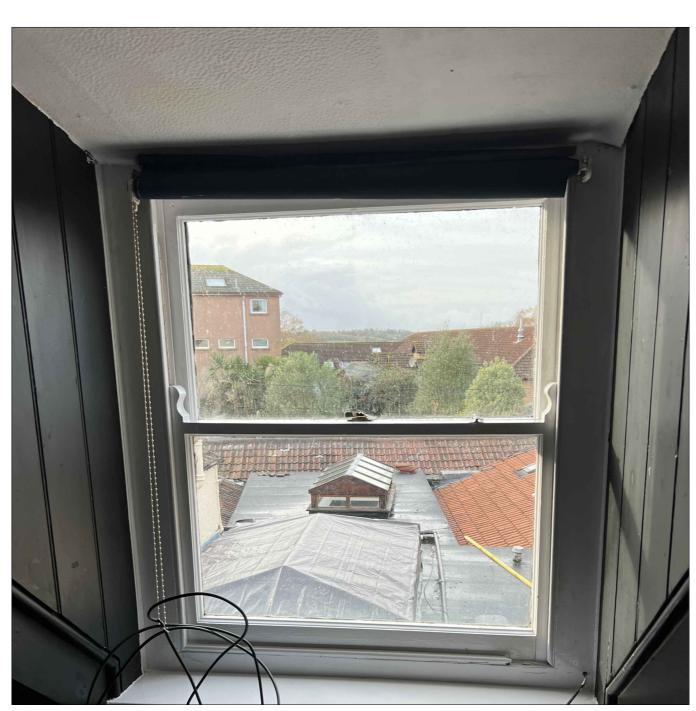
PHOTOGRAPH 12

PHOTOGRAPH 12: IMAGE OF THE CURRENT DORMER WINDOW FROM THE INSIDE THAT SHOWS THE EXTENT OF DEBRIS AND THE COVERED UP SKYLIGHT

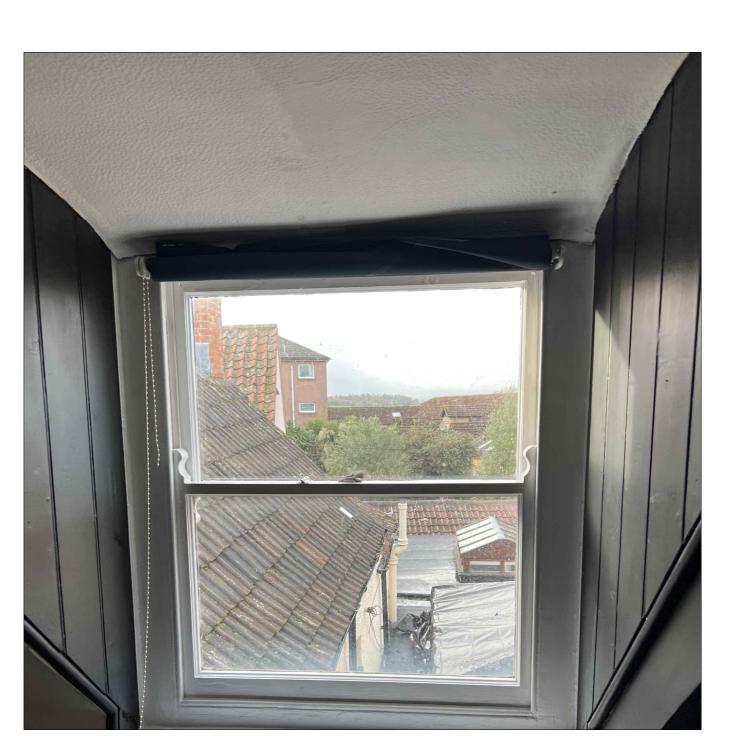
PHOTOGRAPH 13

PHOTOGRAPH 13: IMAGE OF THE OTHER CURRENT DORMER WINDOW FROM THE INSIDE
