◆ **DAVID SMITH ASSOCIATES LLP** ◆ Consulting Structural & Civil Engineers ◆
◆ London ◆ Northampton ◆ Cheltenham ◆ Birmingham ◆
www.dsagroup.co.uk

RE: 25 CHURCH STREET, STANWICK, NN9 6PS

Thank you for your request for us to carry out a visual structural inspection of the Barns to the rear of the above property. We confirm inspecting 2No. Barns, 1 the Plumbing Shop and also the Loft Barn. For clarity within this report, we will comment on those individually.

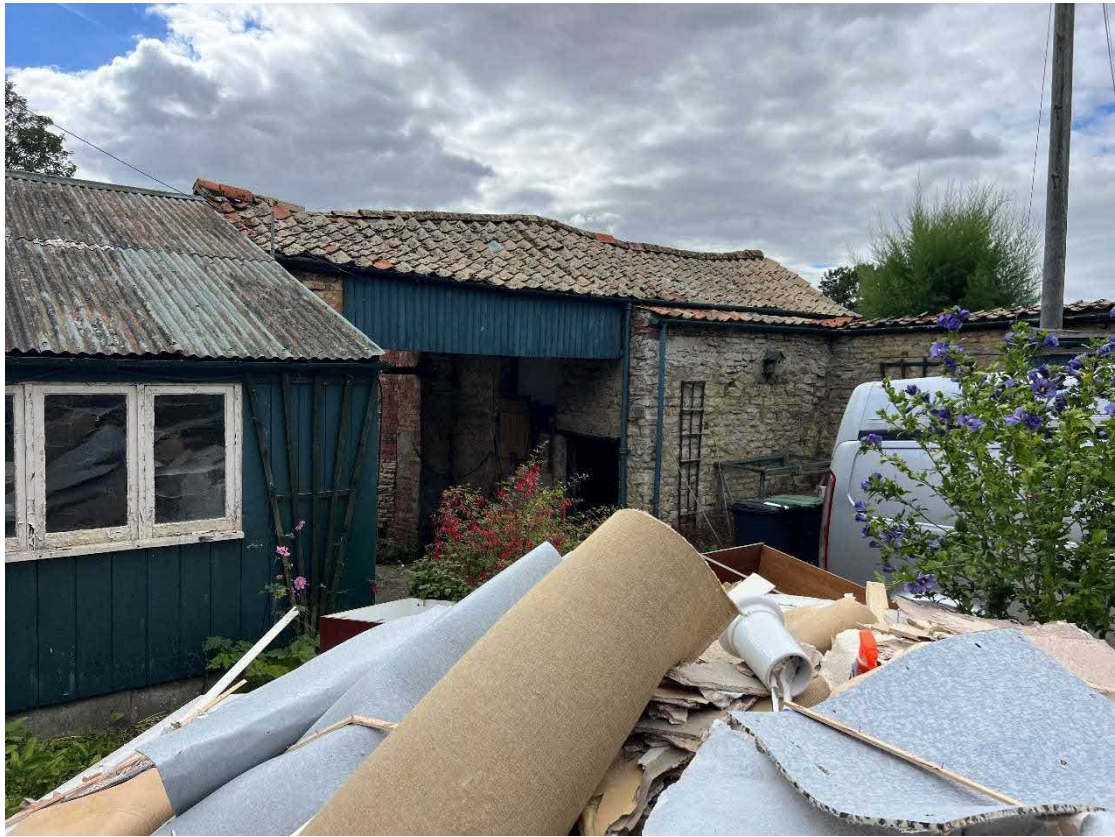
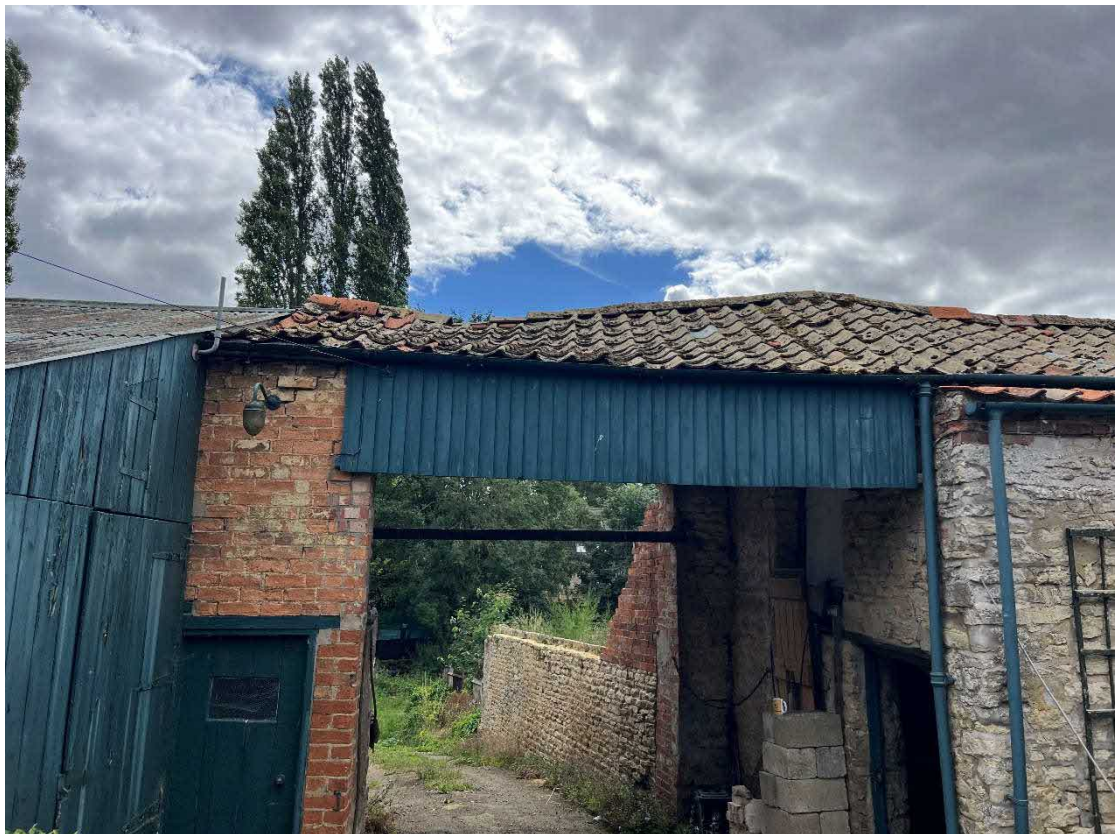
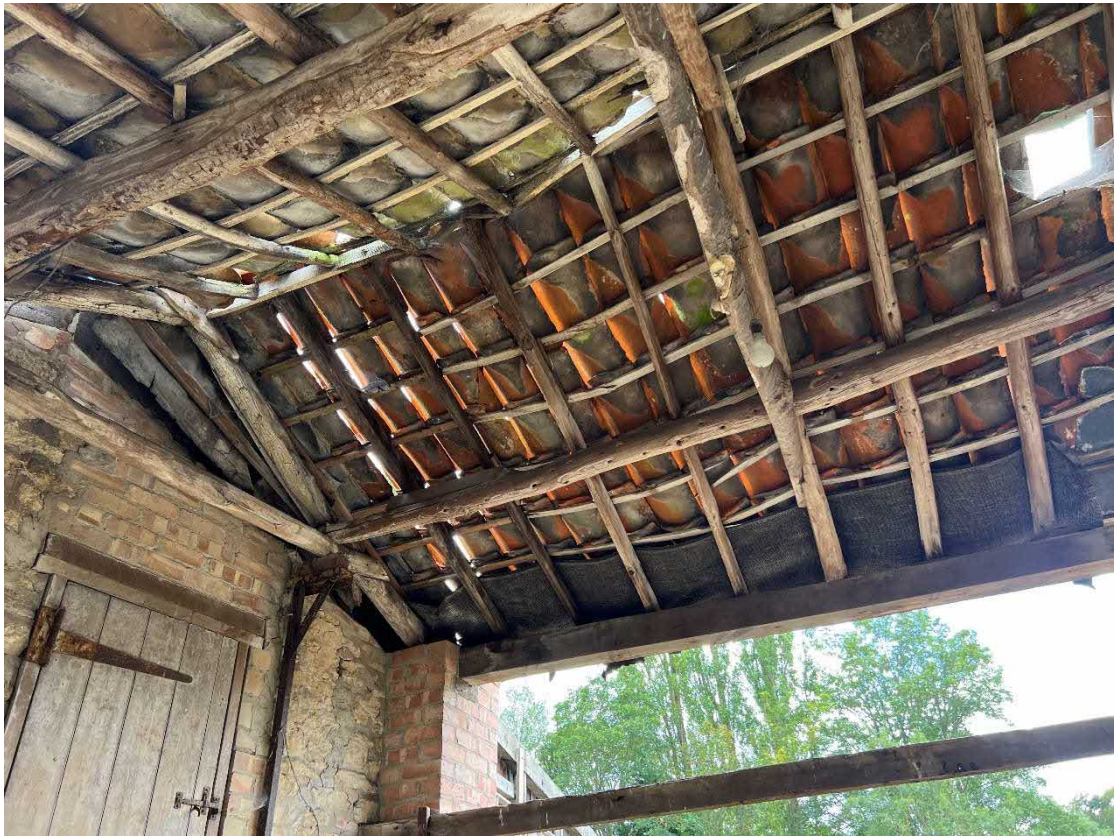
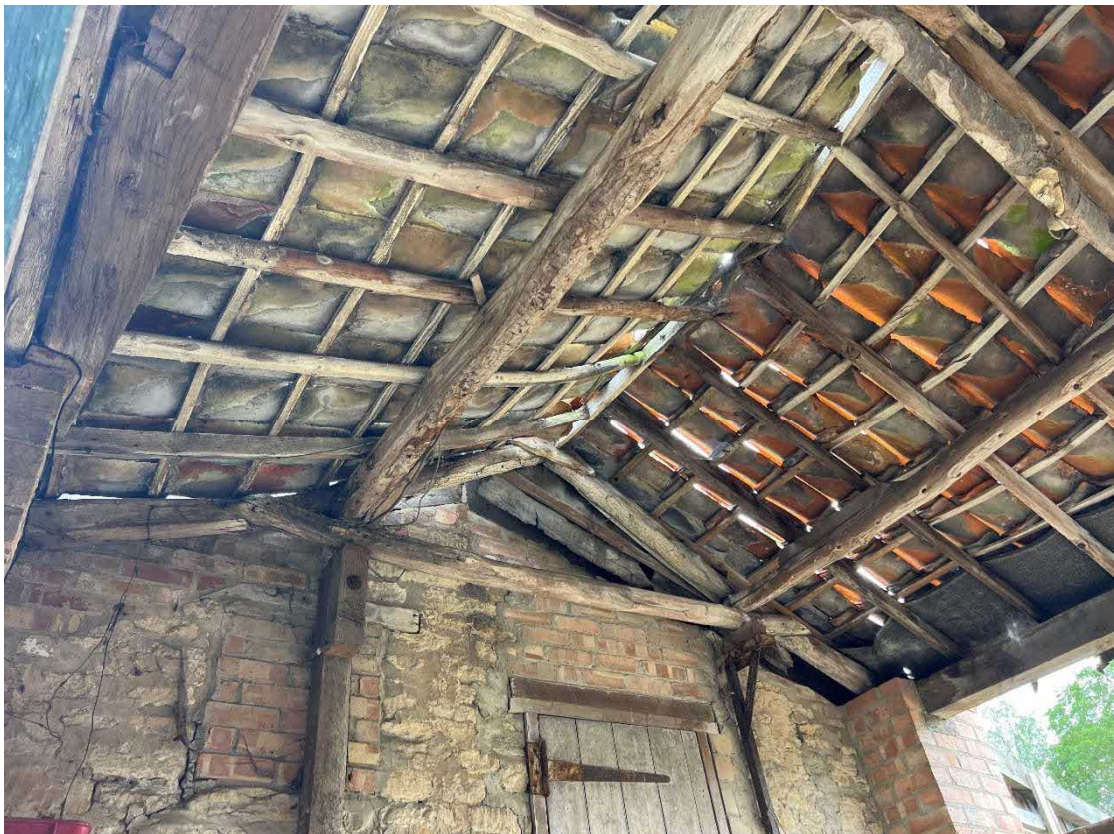
In principle, this is a double height stone-built brick Barn with a duo pitch concrete tile roof covering. We can confirm that the roof structure is in very poor condition and shows considerable deviation both over the Barn and the flyover. The ridge has deflected significantly due to the rotting of the ridge board and some of the rafters have deflected and snapped. The rafters are very small and are not fit for purpose. Therefore, we recommend that the roof is removed and replaced with modern sawn cut timbers, appropriate felt and batons. Please refer to Photographs 1 – 4 in Appendix A.

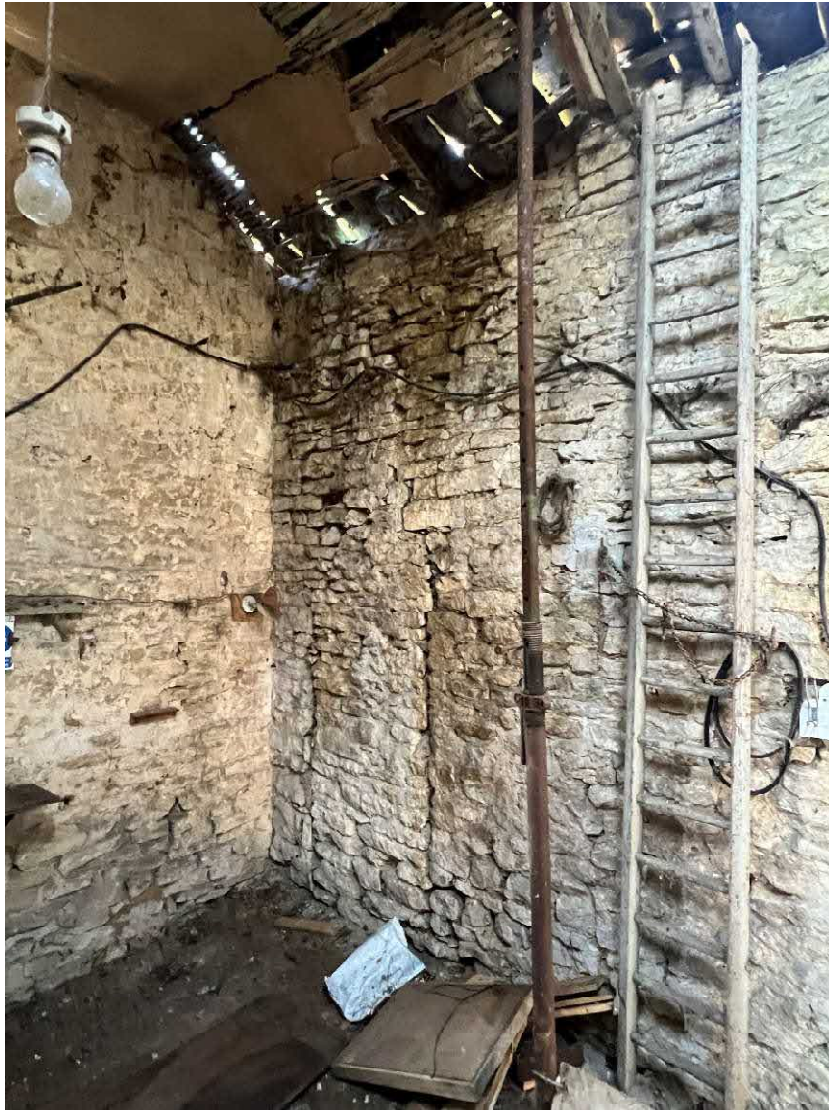
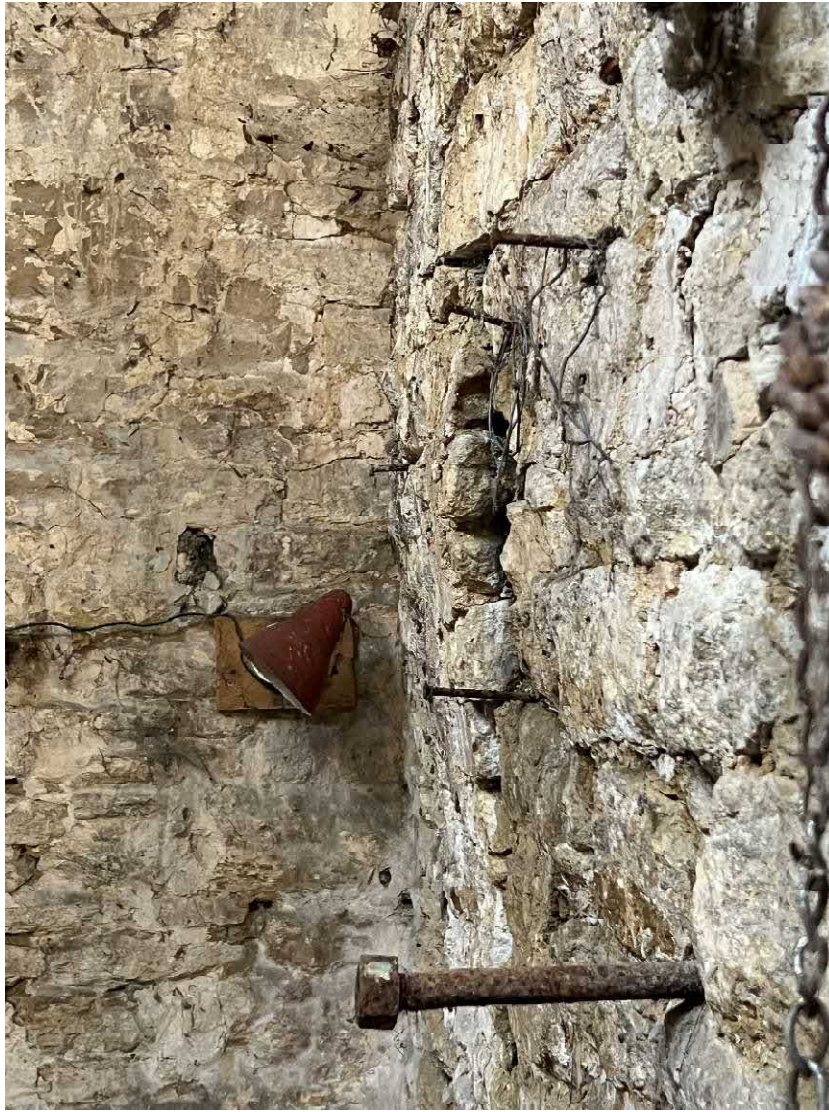
In addition to this, we inspected the stonework on the north elevation, which appears to have been a door infill or similar at some point in the past. This is part of the wall is in particularly poor condition and bulges out approximately 75mm. Please refer to Photographs 5 & 6 in Appendix A.

It is our opinion that this inner skin has the potential to collapse and, therefore, should be propped as soon as practicably possible and/or taken down. (Please note that any demolition works should be considered as to their knock-on effect to the remaining structure).

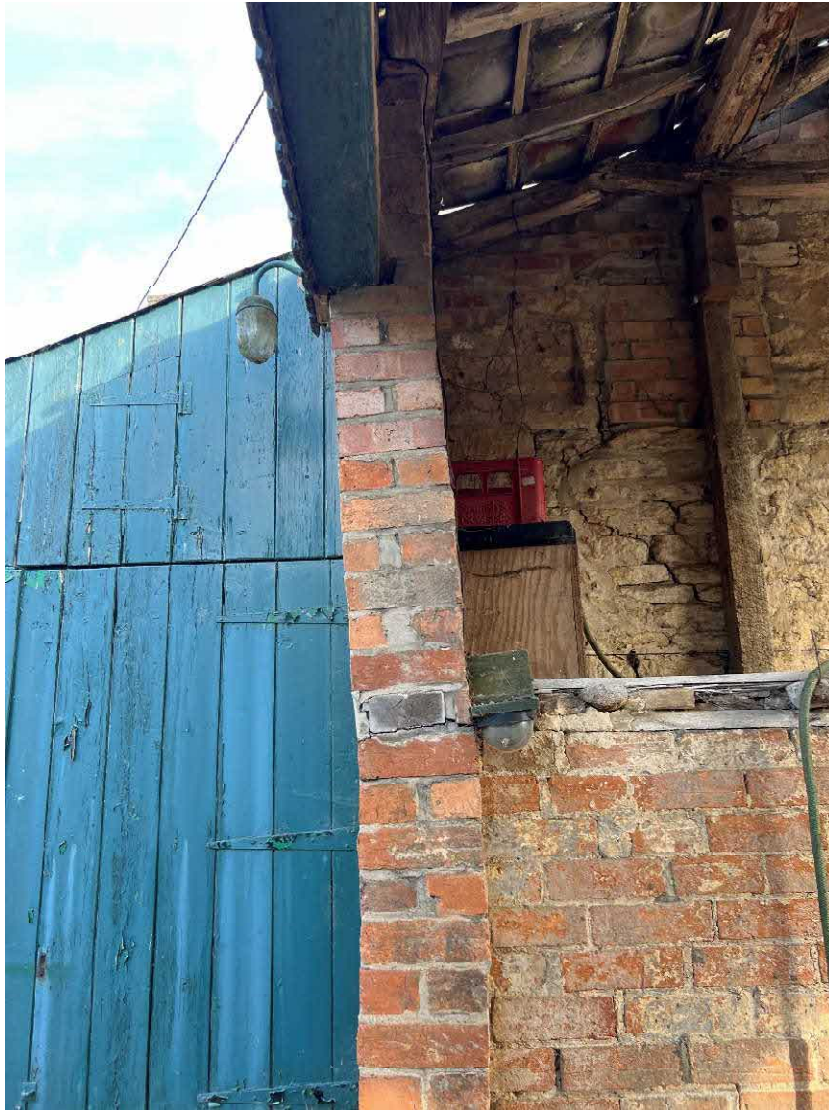
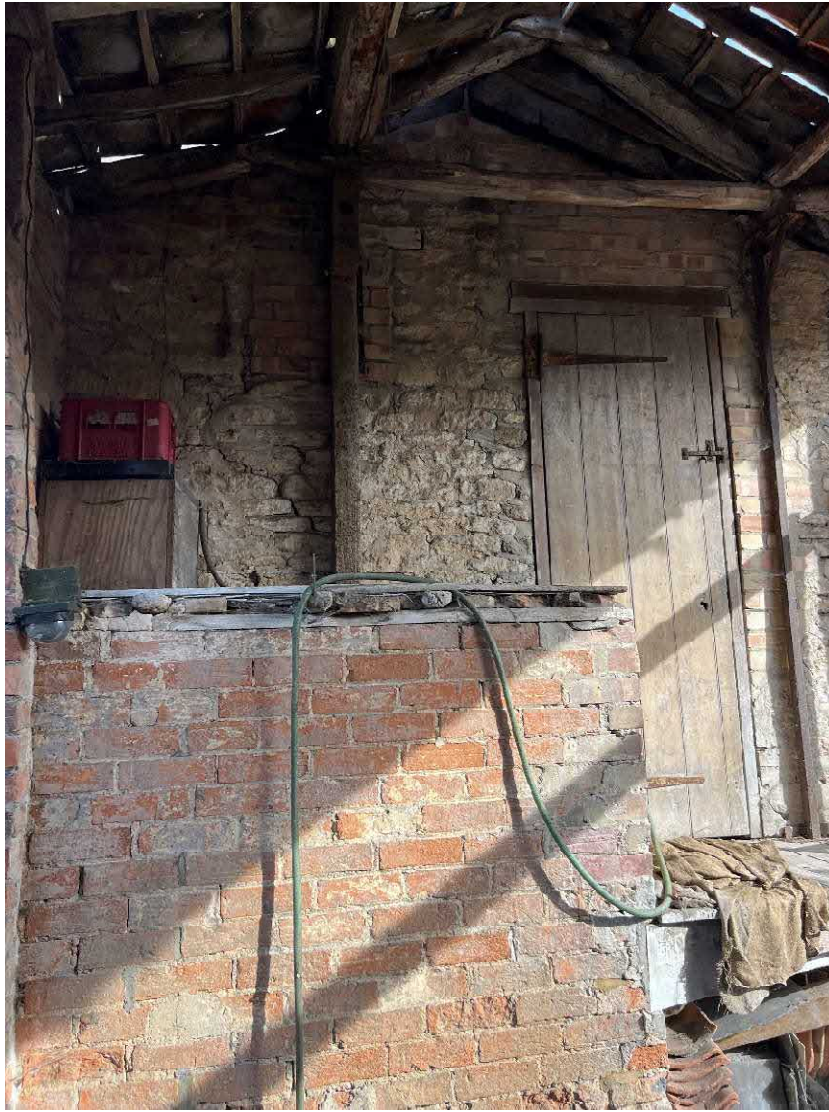
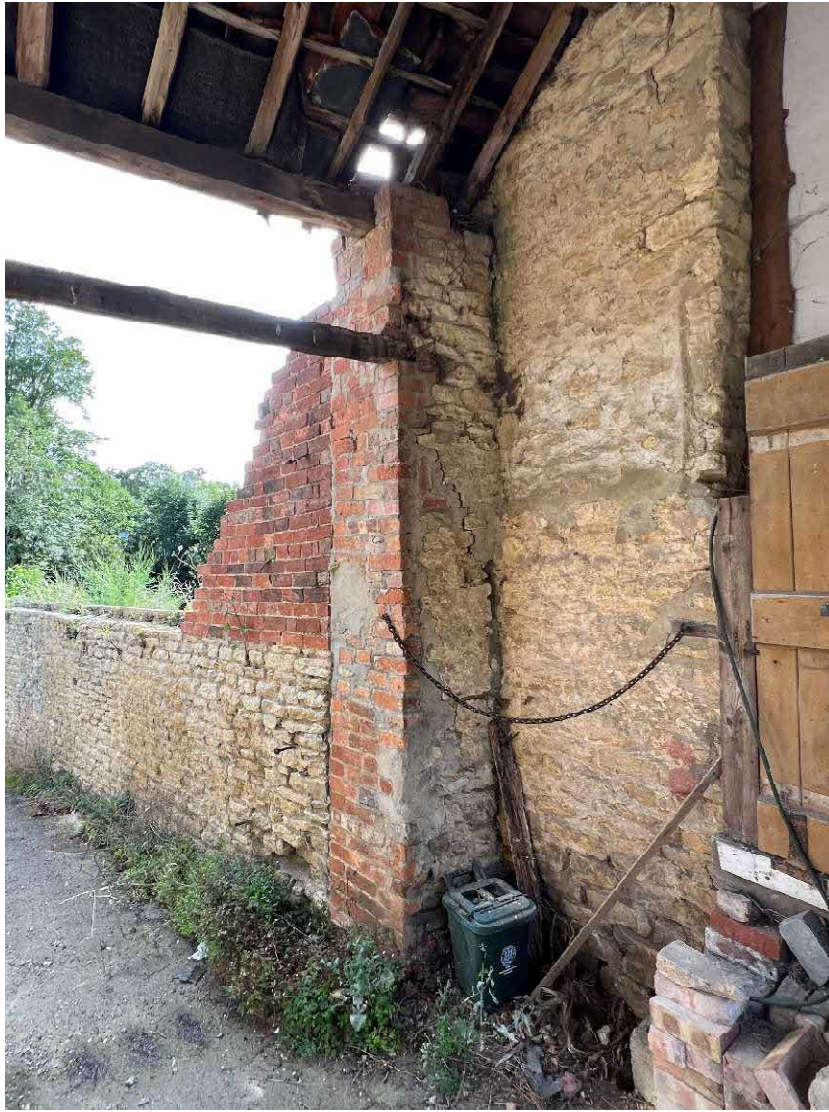
We did note various other areas of fairly significant cracking to both the stonework, and the buttressing brickwork and to the brickwork over the front opening which has kicked out and leans towards the front of the property. We recommend that you also consider either propping or taking this down and rebuilding to suitable standards. Please refer to Photographs 7 – 9 in Appendix A.

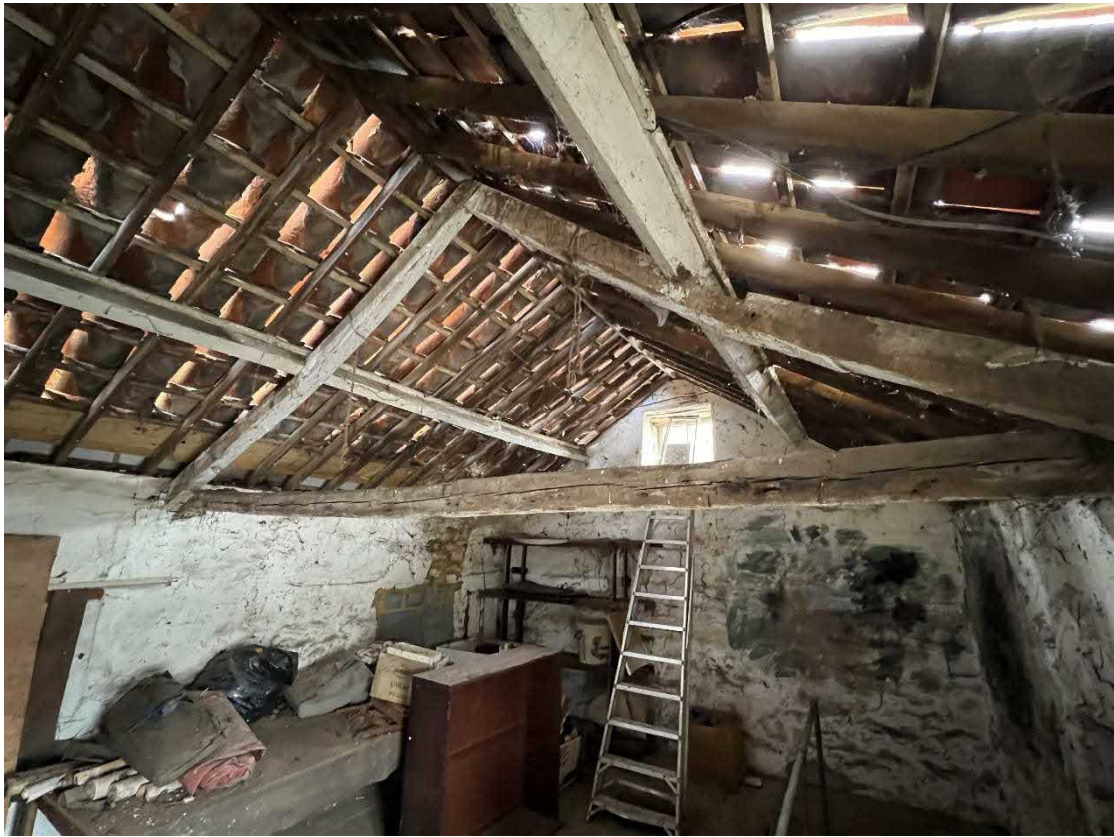
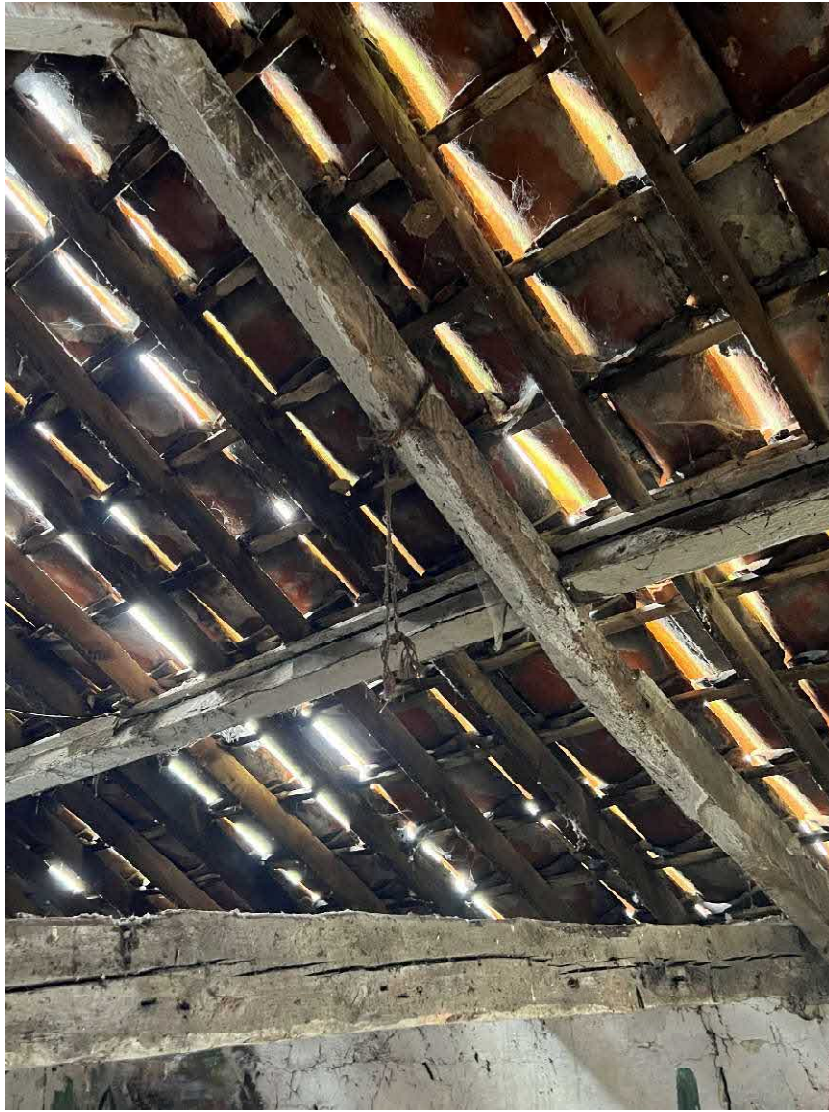
The roof structure within the Loft Barn is of similar construction and is also of poor condition with under-sized timber rafters. This roof structure is subject to horizontal roof thrust and we confirm that it is unlikely that we would be able to justify the roof to modern building regulations and, therefore, recommend that it is replaced to the suitable modern standards. Please refer to Photographs 10 & 11 in Appendix A.
