Heritage Assessment

Ludlow Hospital, Gravel Hill, Ludlow

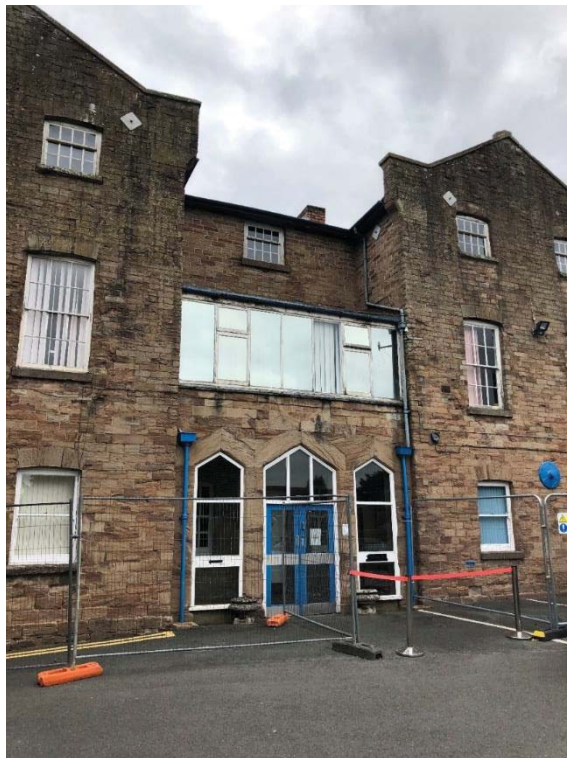
Figure 12: View of the later porch and glazed balcony and original and replacement fenestration

replacements. The porch to the front of the building and glazing of balcony over the entrance are 20th century alterations.

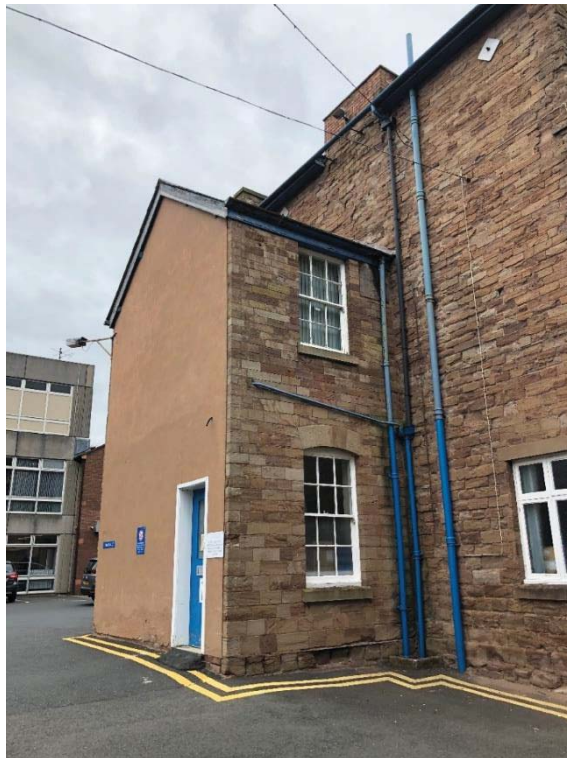
Figure 13: Western elevation of the entrance block, showing truncated western wing and brick chimney replacement

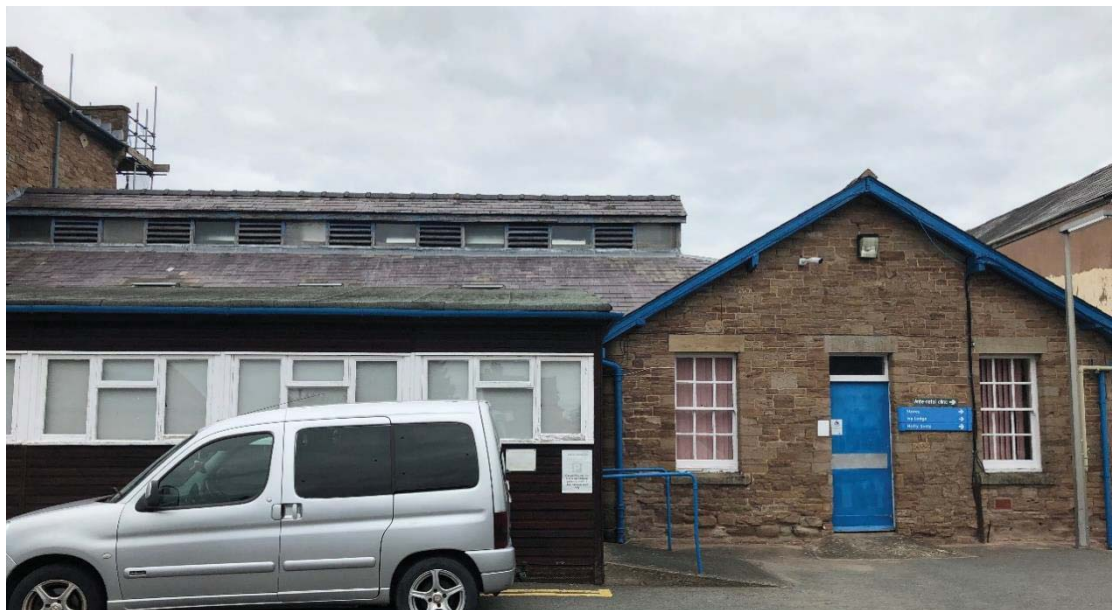
Figure 14: Vagrants infirmary (louvered clerestory roof visible), 1960s wooden shed at forefront, and range added prior to 1924 (right).

30. The vagrants infirmary (now Holly Suite) replaced the earlier bakehouse and male reception. The building was constructed at the same width as the entrance block (substantially wider than the original wing) and at one storey but with a high clerestory roof affording greater ventilation. The evidence on site suggests that the roof is a later replacement rather than a late 19th Century structure.

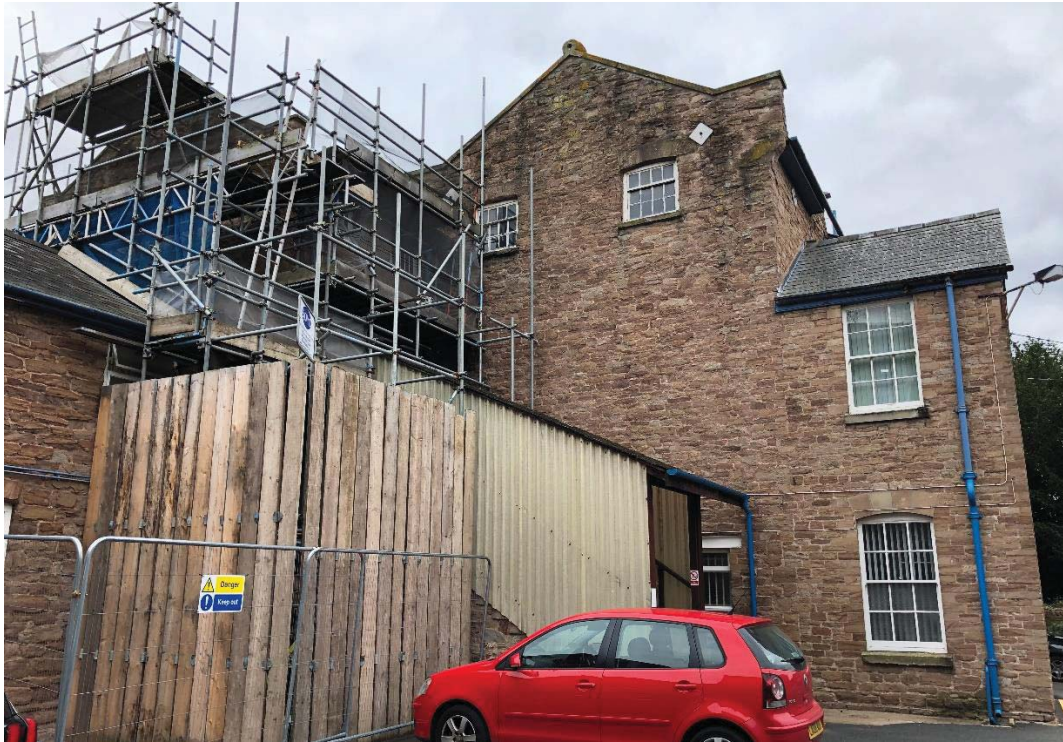
Figure 16: rear elevation of the entrance block showing original fenestration to upper floors, scaffolded and cordoned stairwell to access.

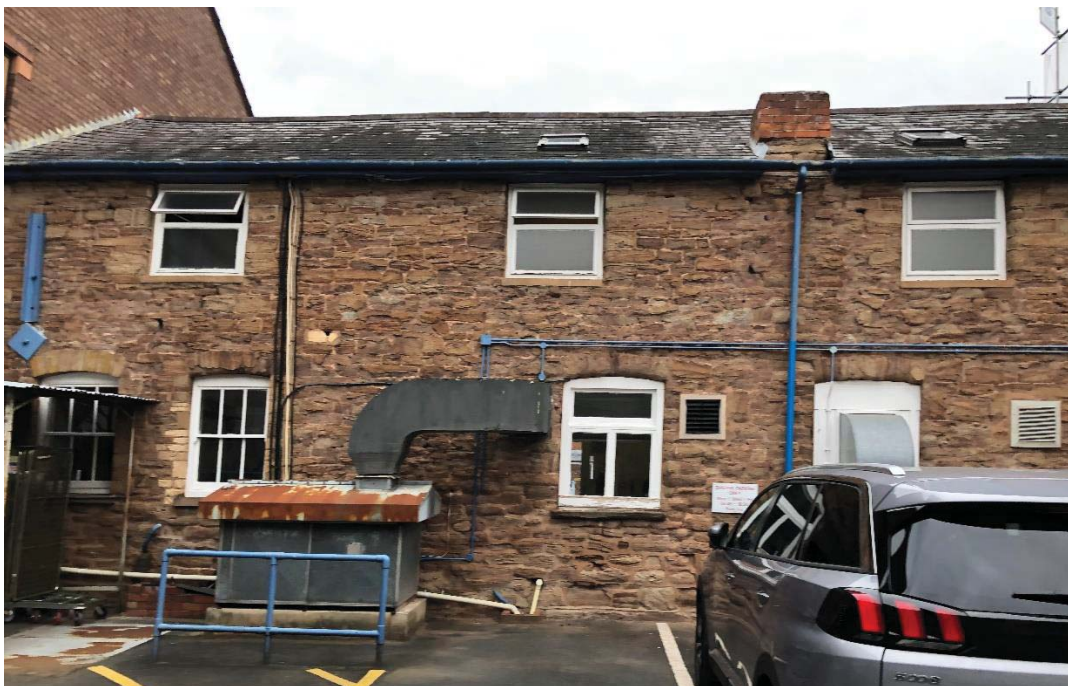
Figure 17: Rear range (radial 'spoke') western elevation adjoining the later 20th century hospital building to its north, and showing brick replacement chimney stack, replacement windows and inserted ventilation and ducting.

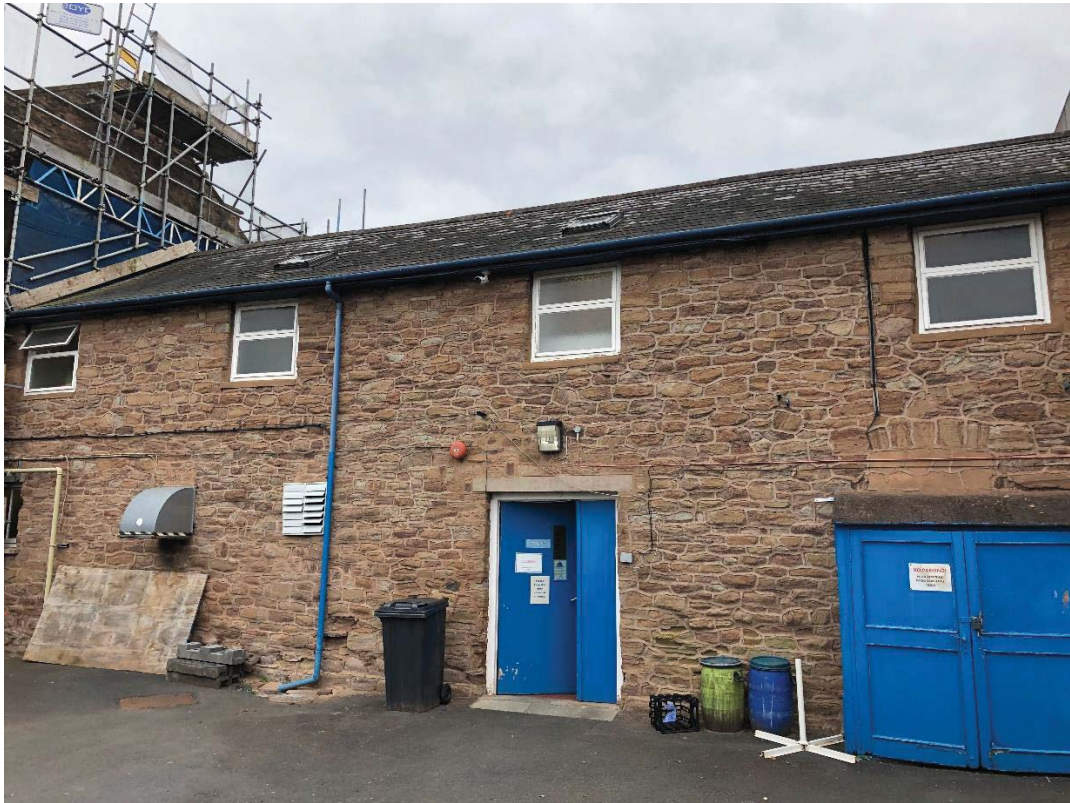
Figure 18: Rear range (radial 'spoke') eastern elevation adjoining the entrance block to the south, hospital building to its north, and showing replacement windows and doorway alteration.

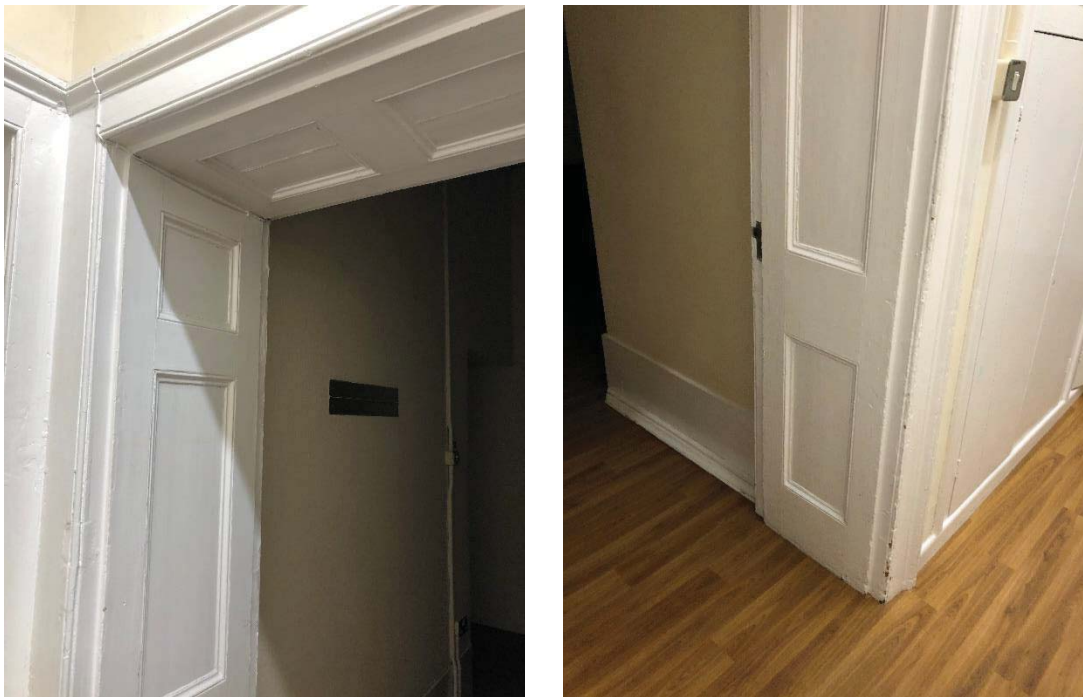
Figure 20: Panelled doorway reveal on ground floor of entrance block

22. With the exception of some panelled doorway reveals (mentioned in the list description) the ground floor possesses few indications of its original interiors (Figure 20). The panelled reveals are examples of historic joinery but are no longer an element of a complete interior treatment and are not of particular note in terms of 19th century joinery.

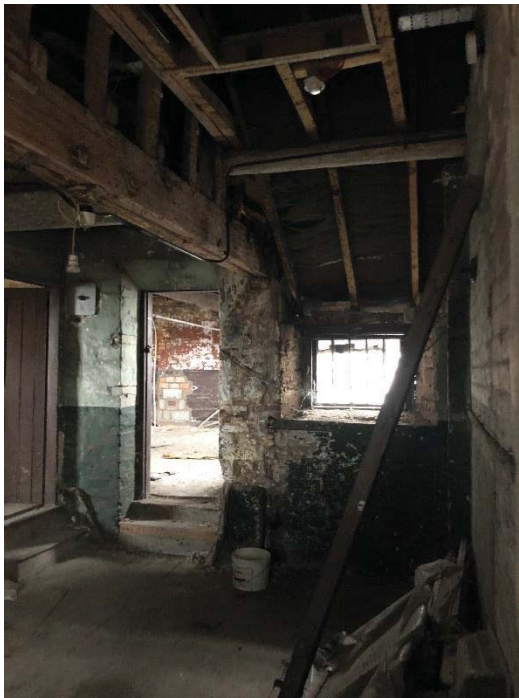
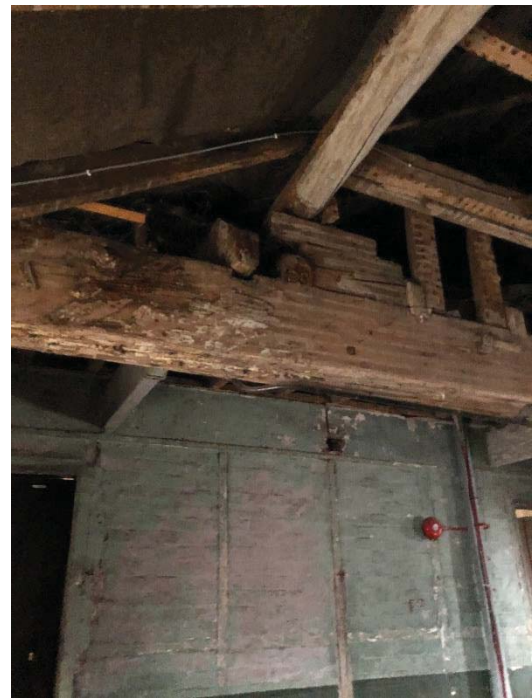
Figures 29 and 30: room at rear of the second floor, showing doorway to western room and condition of roof beams

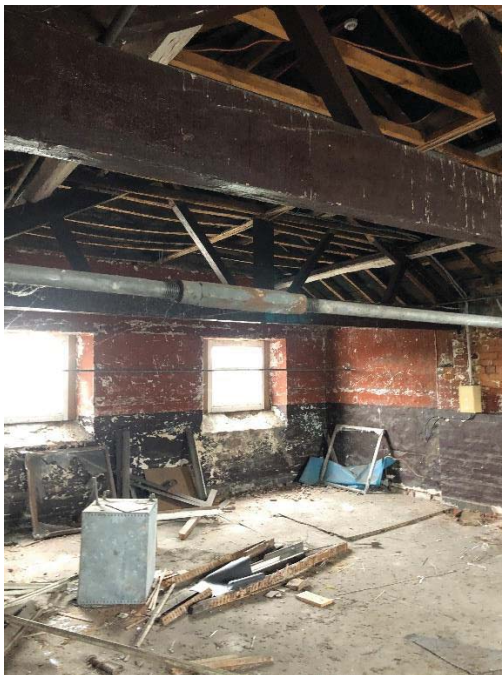
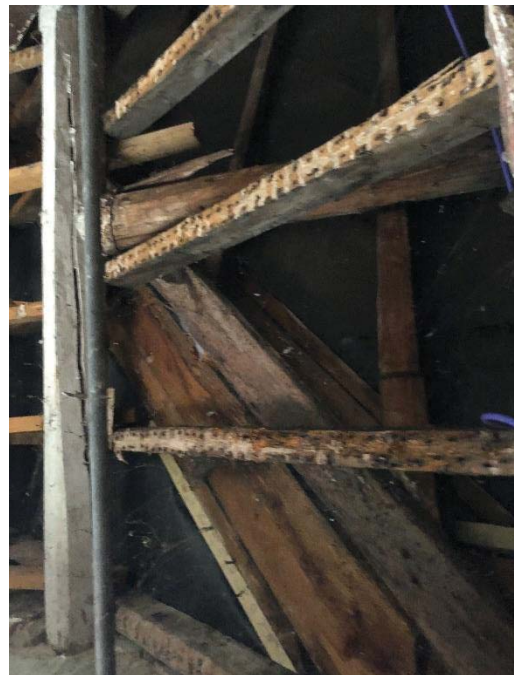
Figures 33-34: Western room on second floor, collapsed roof beams and replacements and window detail

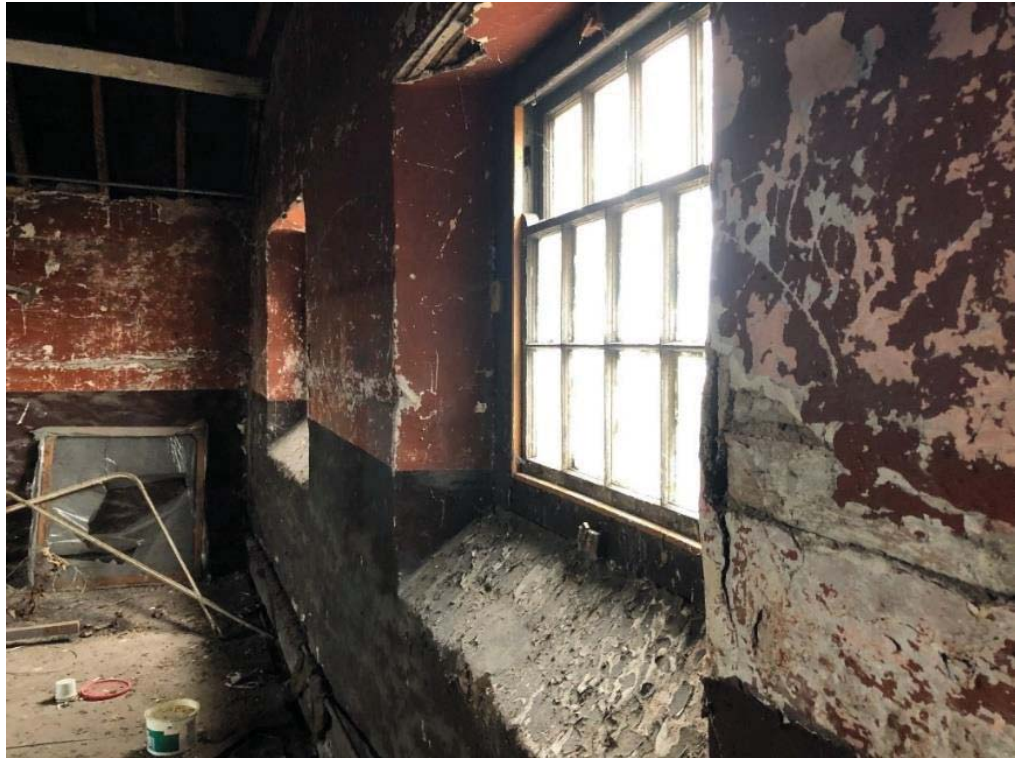
Figures 35 and 36: Western room on second floor window detail, and below, blocked stairwell from the central rear room of the second floor (leading to first floor, not accessible)

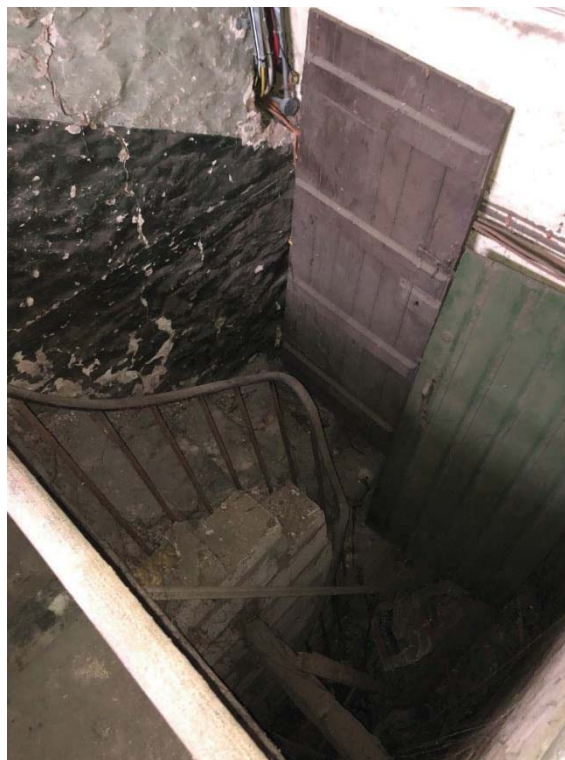
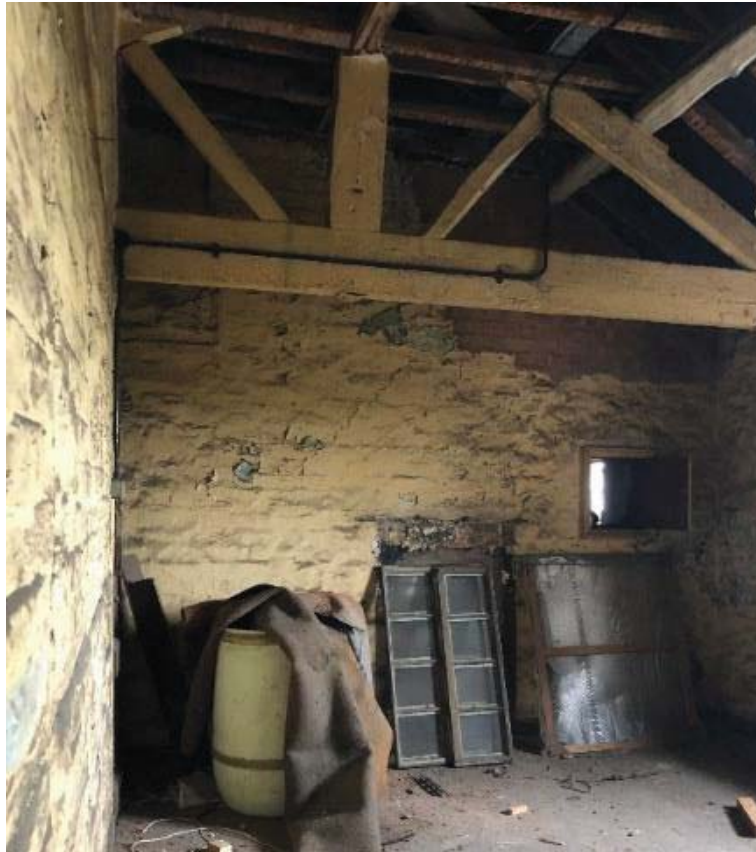
Figures 37 and 38: front central room of second floor (repaired roof structure)

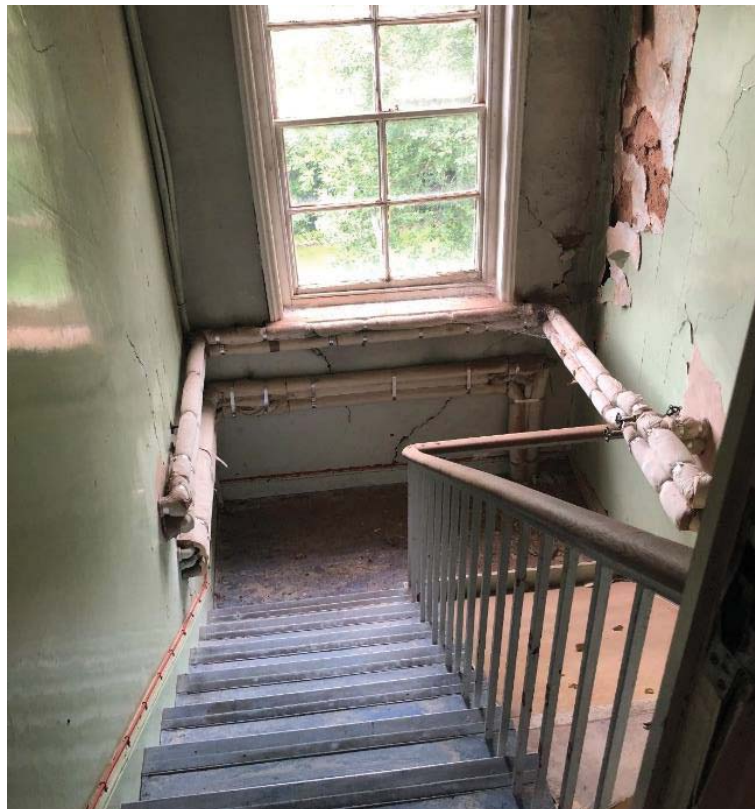
Figure 42: Blocked stairwell within the building
