19th September 2023

Our ref: JW/B810/0923

Re: Tree survey at Chase Farm, Enfield

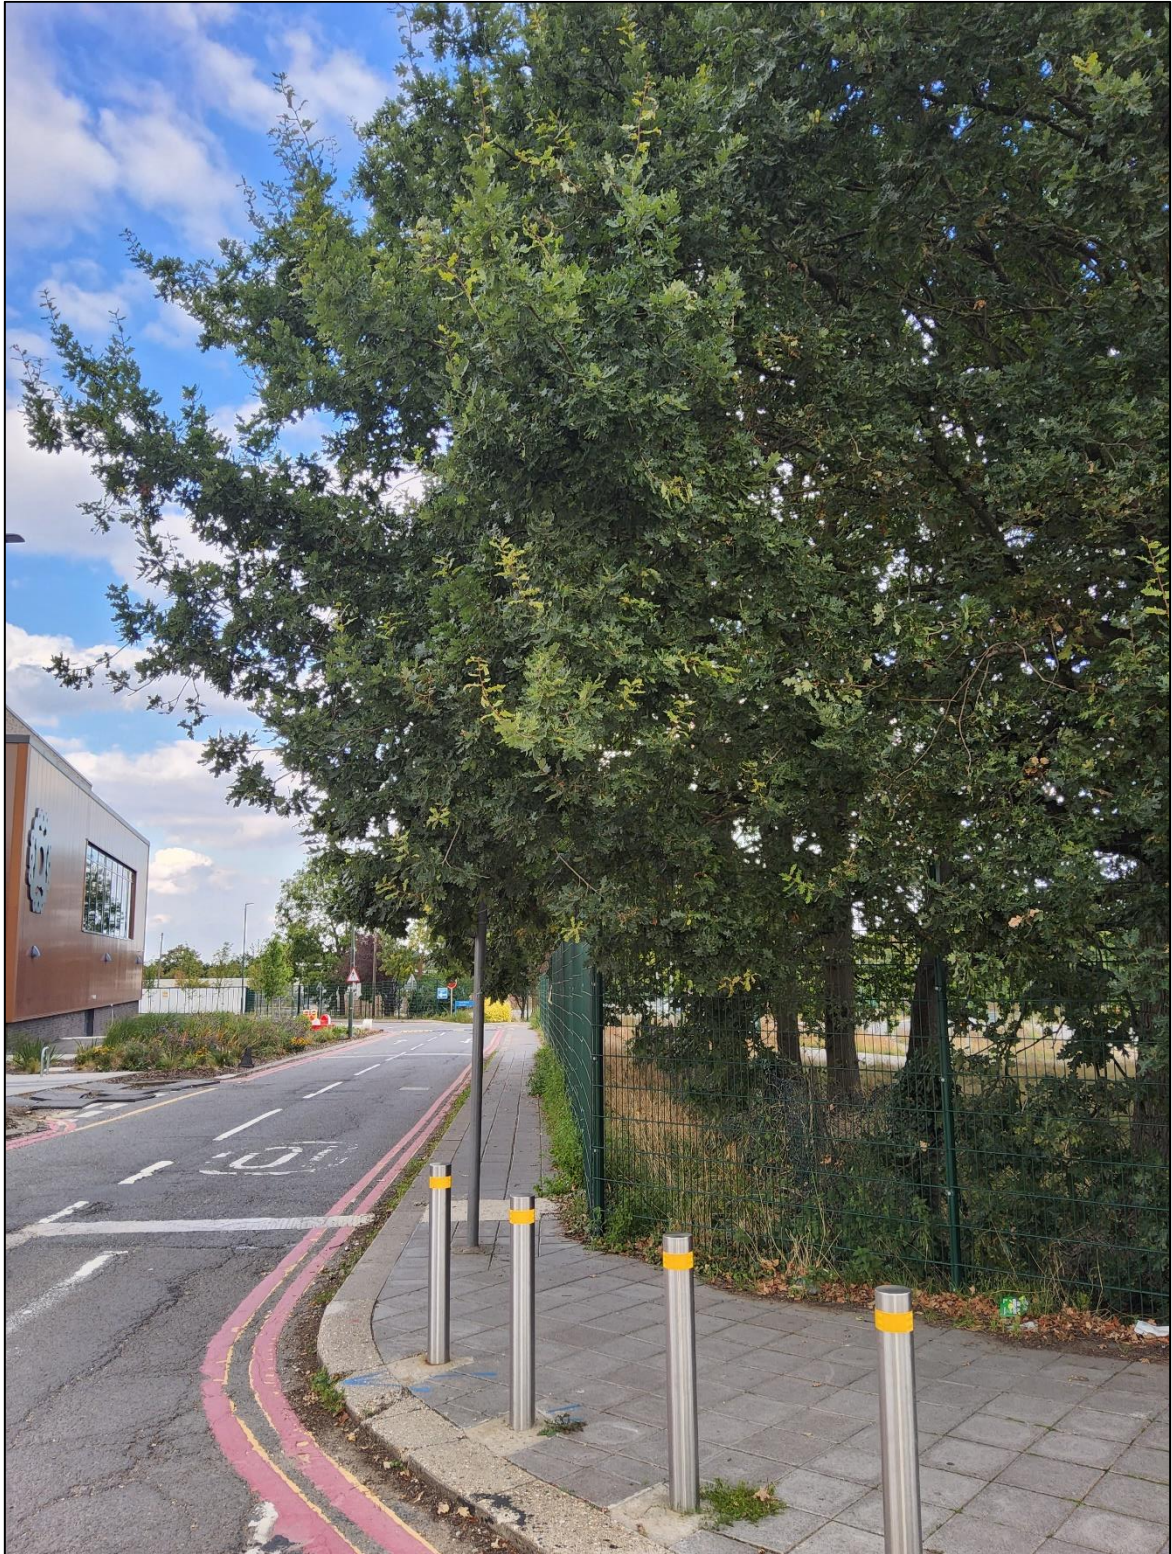
G306 is a cohesive group of five Oak trees located in the north west corner of the large, central plot. It overhangs the public footpath and road. We do not note any significant defects within the group. However,

there are low hanging branches over the northern and western aspects which are beginning to obstruct the public footpath and growing into the security fence. Therefore, when time and finances permit, we advise crown raising the group over the northern and western aspects to achieve 1.5m clearance from the security fence and 3m over the public footpath. This should be achieved with a maximum cut diameter of 50mm.

Photograph 1 – Low hanging crowns of Oak G306

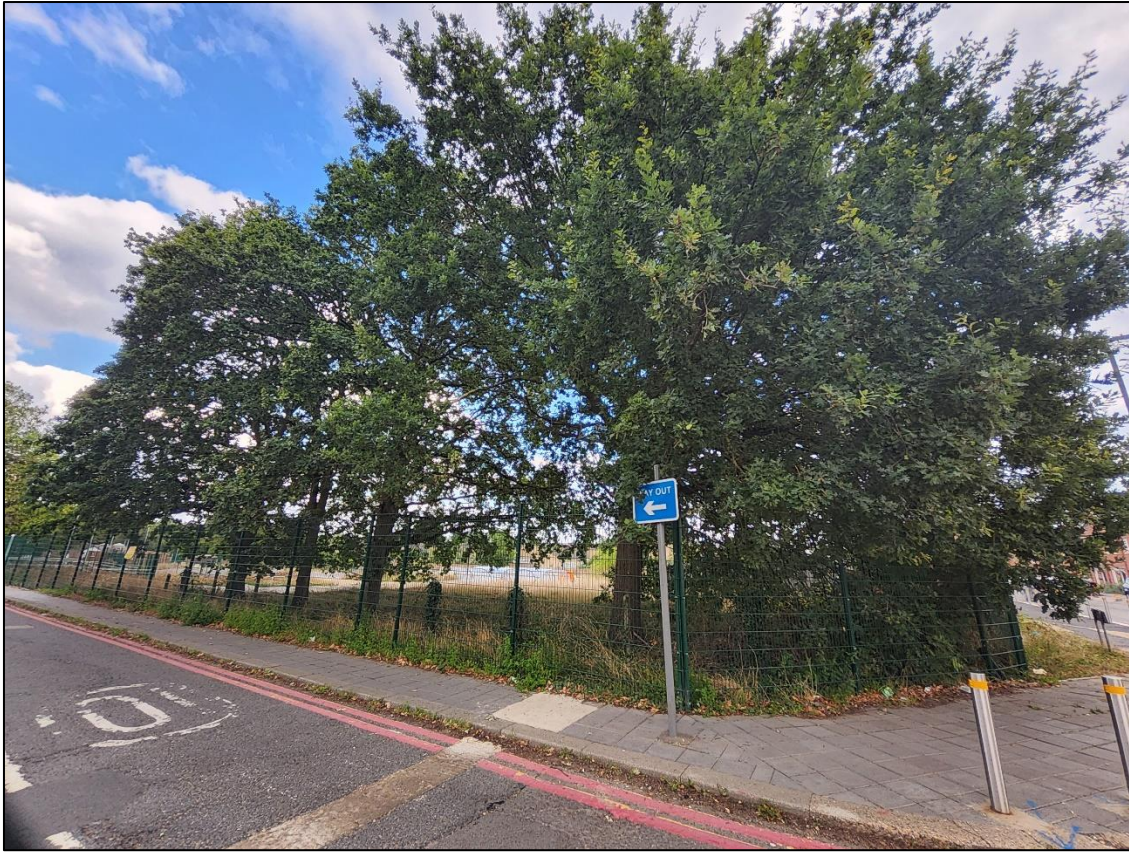
Photograph 2 - Oak G306 in context

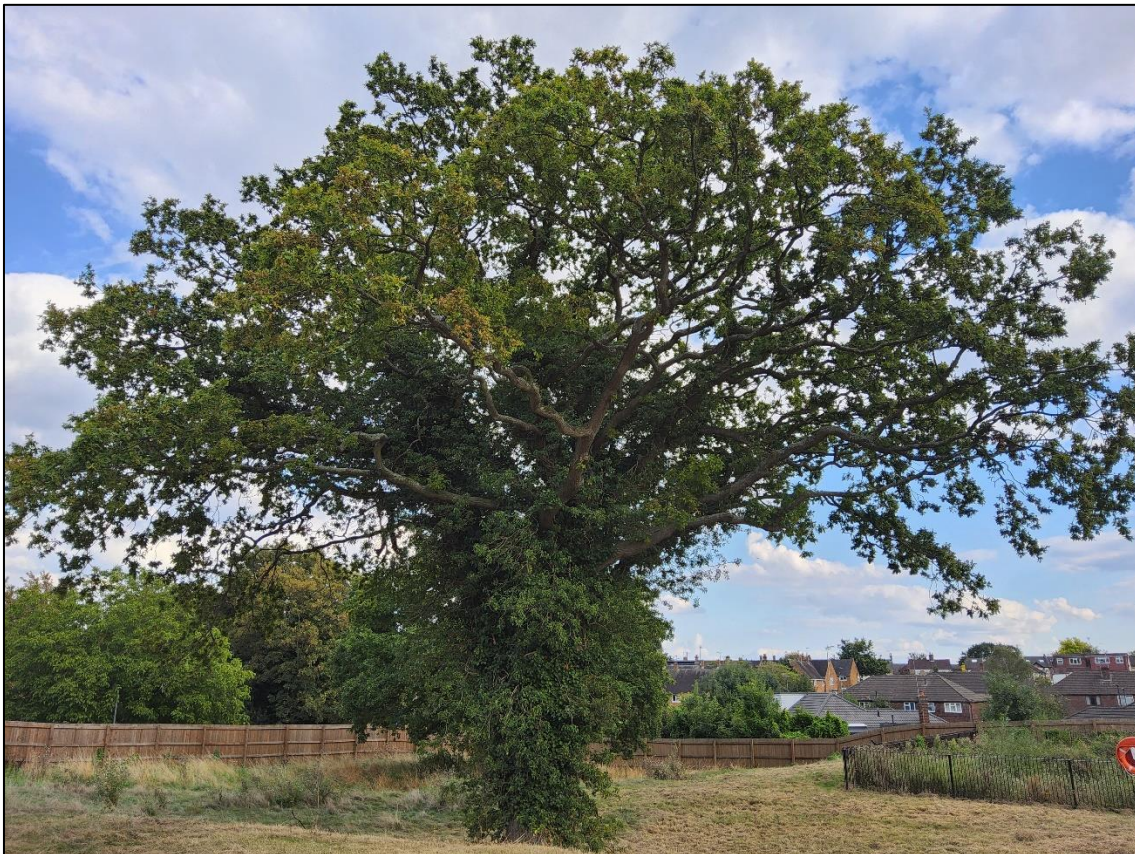
T307 is a good example of a mature standalone Oak tree located to the north east of the large, central plot. It overhangs the greenspace and stands within falling distance of the footpath and road. There is dense ivy growing on the main stem and primary branches. Ivy does not directly damage trees. It can, however, obscure defects within the trunk of the tree and increase the windage on the crown of the tree. Ivy can prevent an effective inspection of trees, particularly the lower trunk where decay can often have serious consequences. Therefore, prior to the next scheduled inspection, we advise removing the lowest 1.5m of ivy from the main stem.

Photograph 3 – Oak T307 in context, with dense ivy growth on main stem

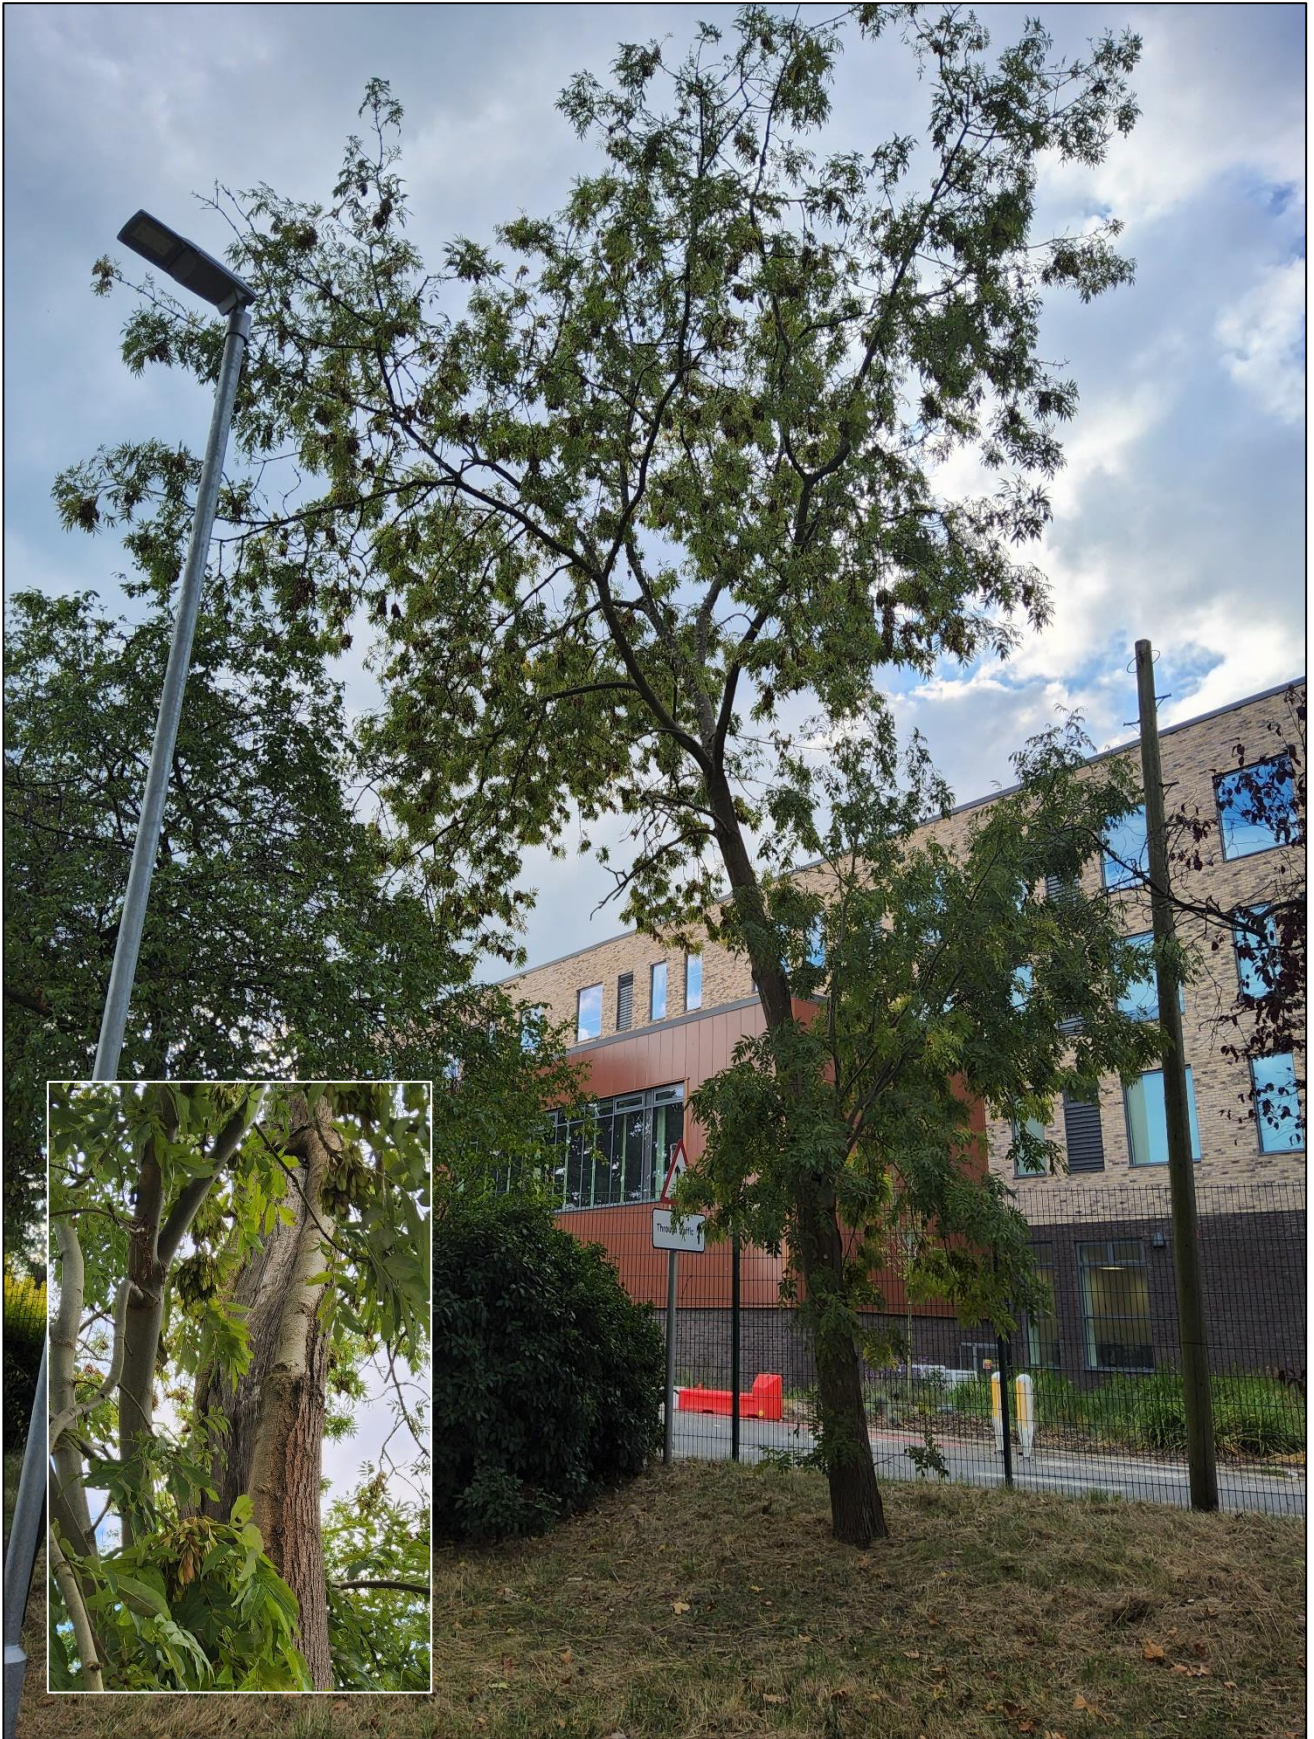
Ash T308 has a significant open cavity at approximately 3m above ground level. This appears to have been formed from historic storm damage. Some localised structural adaptations are exhibited that are likely adequate at this stage. Whilst the tree is in a good physiological condition, there is good reason to believe that adaptation will continue. However, should it become infected with ADD this may change. Therefore, we recommend reinspecting it during summer 2024.

Photograph 4 – Ash T308 in context with historic storm damage (inset)

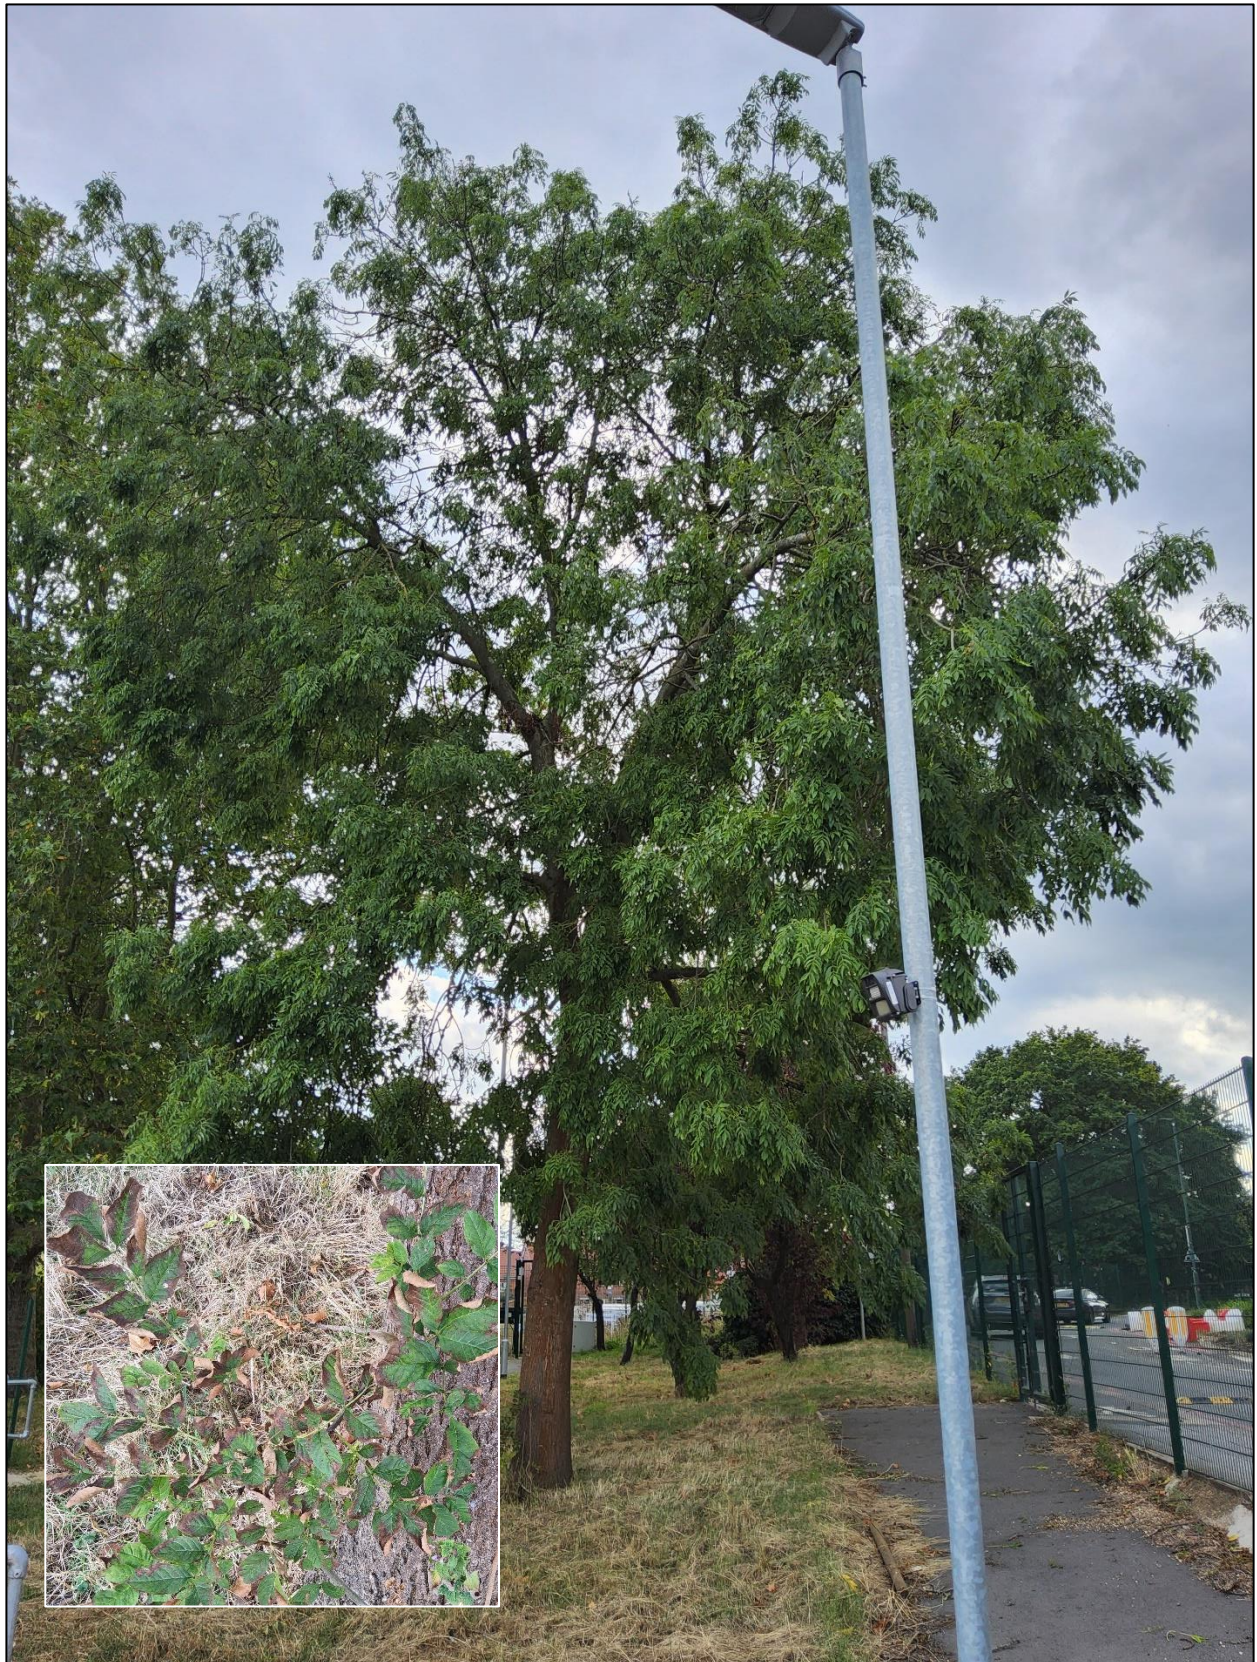
Ash T309 looks to have a very early infection from ADD. However, as the tree appears in good structural condition, there is no defect requiring action at this stage. Nonetheless, we recommend reinspecting it during summer 2024 to monitor the condition.

Photograph 4 – Ash T309 in context with ADD symptoms on basal growth (inset)
