ARBORICULTURAL REPORT

INITIAL TREE SURVEY

1 Hawksfold House, Hawksfold Lane, Fernhurst, GU27 3JW

D3043.V1.0-TS

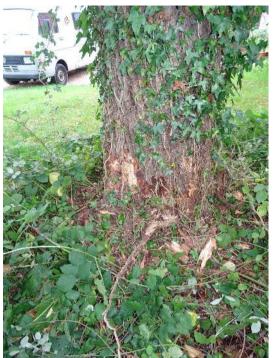
Figure 6 - T2: Decayed base

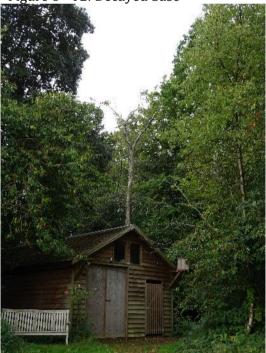
Figure 8 – T5: Dead Birch

Т	5	Silver Birch	1	1	13	2.5	2	4 4.5	N	7	390	М	L	4.7	68.8	Dead	Dead	U	NA	Dead standing tree	Remove	Health and Safety
Т	6	Portuguese Laurel	1	2	8	4	5	3.5 3	E		340, 170,	EM	L	4.6	65.0	Poor	Fair	C3	10-	Twin-stem from ground level. Ivy colonised stem. The Eastern stem appears to be in decline and suffering from crown die-back. Monitor in the future	Sever and remove 1.5m of Ivy from ground level to allow the crown more light to help regenerate. Prune The Eastern crown as required to remove the die- back	Good Arboricultural Management
Т	7	Holm Oak	1	1	14	6.5	4	6 6	N	3	650	М	М	7.8	191.1	Good	Fair	B2	20-	lvy colonised stem. Stem bifurcates at 4m	/	/
Т	8	Yew	1	1	11	3.5	4	6 6	Е	0	520	EM	М	6.2	122.3	Good	Fair	B2	20-	Epicormic growth on the main stem. Stem bifurcates at 2.5m	/	/

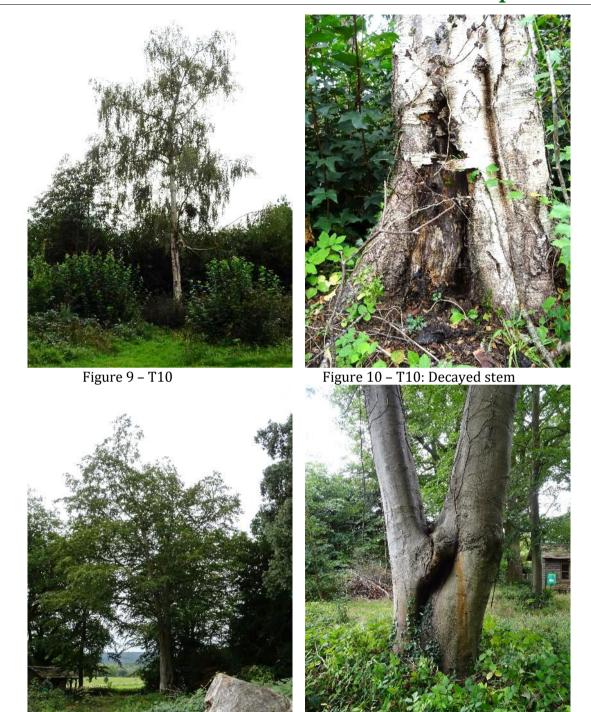
Figure 11- T9

Figure 12 - T9: Included union

Prefix G	Species	No. Trees	No. Stem	HT (m)		Spr (n	own ead n) S W	LB/Bear	LB/Ht(m)	DBH (mm)	Age	Landscape	RPR (m)	RPA (m ²)	Vitality	Structure	BS Cat	Life (yrs)	Notes and Observations	Preliminary Management Recommendations	Reason
Т 9	Beech	1	2	16	5	7	8 8	ВЕ	4	420, 600,	М	М	8.8	242.2	Good	Poor	C2	10+	The main stem bifurcates from near ground level up to 1.5m with a long, tight and included union. The eastern stem is considerably smaller in diameter but contributes to half of the overall crown	Install a non-invasive cable brace in the upper one-third of the crown to support weak union. Reduce crown height by 3m and sides by up 2m to shape and further reduce stress at the union	Good Arboricultural Management
T 10	Silver Birch	1	1	14	4	6	5 4	l N	4	550	М	Н	6.6	136.8	Fair	Poor	U	<10	Decayed buttress on the West side that is spreading up the stem. Sporadic crown dieback. Several lower dead branches. Limited future potential. Limited life expectancy	Remove	Health and Safety

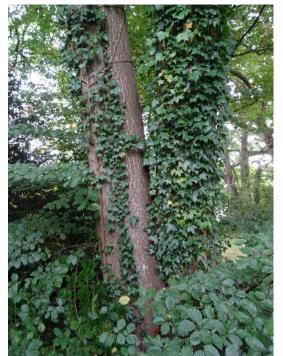
Figure 14 - T14: included union

G 11	Mixed	/	/	6	2	2	2 2	2 N	0	250	EM	L	3.0	28.3	Fair	Fair	C1	10+	Mixed area of Cherry Laurel, Holly, Hazel, Box, Oak, Beech and Willow. The majority are smaller trees with a DBH of 150mm or less	/	/
T 12	Beech	1	1	10	3	4.5	3.5 3.	5 N	2	380	EM	М	4.6	65.3	Good	Good	B2	20+	/	/	/
T 13	Yew	1	1	12	3.5	4.5	7 3	3 N	3	880	М	М	10.6	350.3	Good	Fair	A2	40+	Epicormic growth on the main stem. Becomes multi-stem from 2m. Leans towards and over the track to the South	/	/
T 14	Beech	1	2	16	8	8	8 2.	5 N	8	520, 450,	М	M	8.3	214.4	Good	Poor	C1	10+	The main stem bifurcates from 0.5m above ground level with a tight and slightly included union. Large basal stem. The North West stem grows up and supports an adjacent Oak limb. Asymmetrical crown with a bias towards the East, which is associated with the close proximity to adjacent Oak	Install non-invasive cable brace in the upper one third of the crown to support the weak union	Good Arboricultural Management

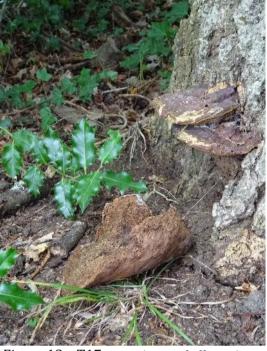
Figure 18 – T17: Ganoderma pfeifferi at base

Prefix	ID	Species	No. Trees	No. Stem	HT (m)		Spr (r	owr read m) S	d	LB/Bear	LB/Ht(m)	DBH (mm)	Age	Landscape	RPR (m)	RPA (m²)	Vitality	Structure	BS Cat	Life (yrs)	Notes and Observations	Preliminary Management Recommendations	Reason
Т	16	Oak	1	1	17	11	9	10	10	N	5	1570	М	Н	18.8	1115.1	Good	Good	A2	40+	Larger mature specimen. The crown breaks into multiple stems from 3-5m. Ivy colonised stem. The crown has undergone historic pruning works, with re-growth of approximately 6m in length. Small volume of dead wood throughout the crown	/	/
Т	17	Oak	1	1	19	5	4	11	. 12	S	5	1800	М	Н	21.6	1465.7	Good	Fair	B2	20+	Degraded Sporophores of Ganoderma pfeifferi on the Southern side, surrounding sounding doesn't indicate a significant area of decay. The crown breaks into multiple stems from 2-3m. Ivy colonised stem. Crown weighted towards the West. There is a significant volume of medium sized dead wood throughout and some major sized pieces of dead wood throughout the crown, some over track to the South	Carry out decaying detection on the stem and compile a report with recommendations. Remove dead wood over the track	Good Arboricultural Management
