STRUCTURAL ENGINEERS REPORT ON THE CONDITION OF 2 STOREY Grade II LISTED

POND FARMHOUSE
STEEPLE CLAYDON
BUCKS

CLAYDON ESTATES

11TH AUGUST 2023

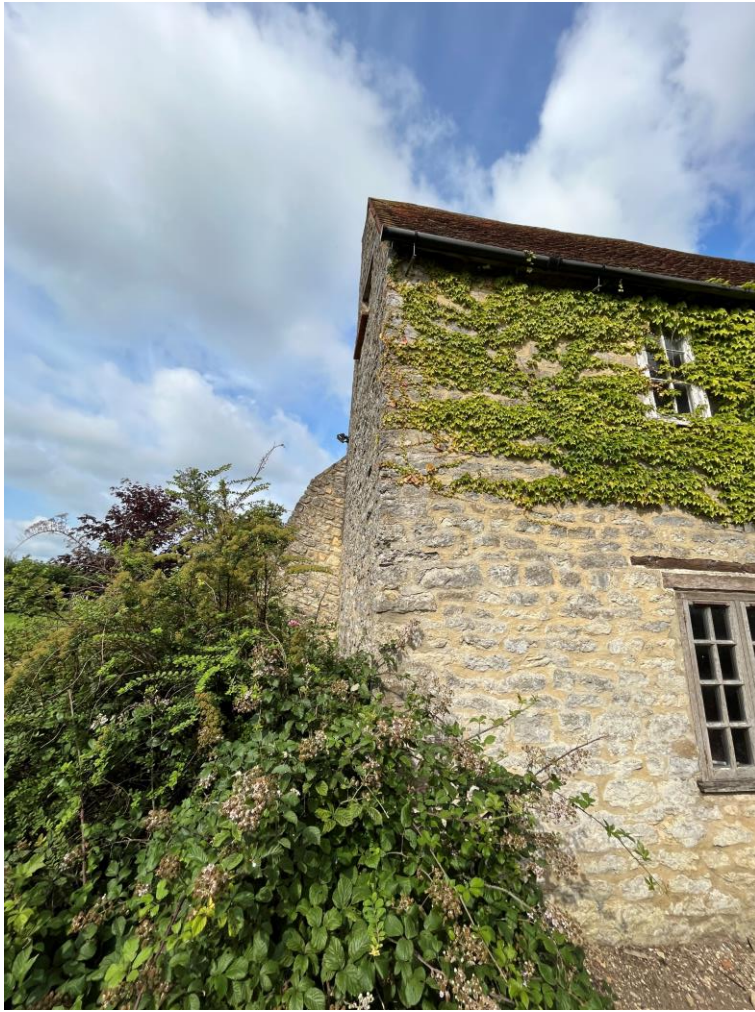
The southern Gable, where there is a large buttress, also shows signs of leaning out, this could be seen in the internal cracking, and external displacements. This has moved, leaving the verge tiles behind allowing water to ingress into the centre of the wall. The upper section of this wall would require repair, and we would recommend rebuilding it. From the 2nd floor windowsill to ridge level.

Southern Gable end, verge leaning outwards allowing water into the wall.

- 3) Southern Gable. Rebuilding works to upper part of gable in like for like way, ensuring both leaves tied together.
- 4) Some masonry repairs required where buttress joins Southern gable, to ensure stability and weatherproofing.

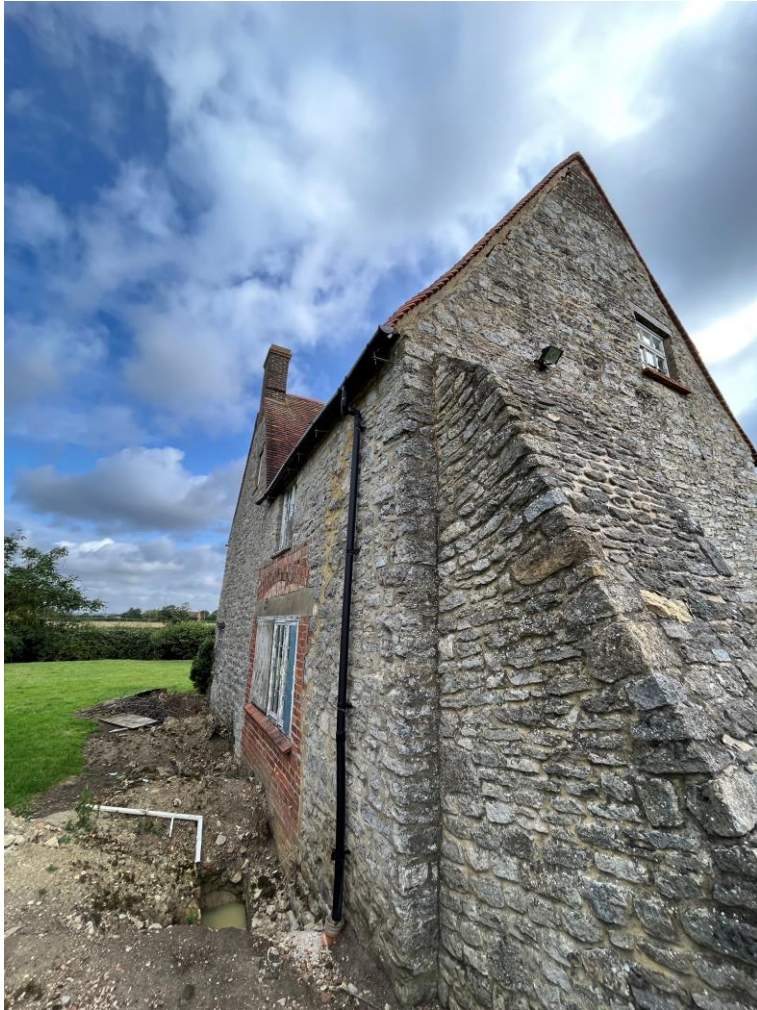
There is a large buttress to the western side of the elevation. There was a large crack between the buttress and the main elevation. This appears to be tapered and widest at the top. The buttress appears to be pulling away from the gable. There has been some excavation around the buttress to expose the foundations. It appears a land drain (Victorian clay pipe) runs beneath the buttress. This had been disturbed.

We suggest it is active, as the excavations adjacent to the buttress revealed that there was a Victorian land drain that runs beneath it. This has been disturbed also. We therefore would recommend that the drain is diverted away from the buttress. Given the softening from the water discharging from the drainage system, we would also suggest that this buttress is underpinned to a depth where a suitable bearing capacity can be found, to prevent risk of further movement. This would have to be completed in several pits or sections, a minimum of 3 perhaps 4 sections.

Huge Buttress tilting away from building. Excavations also laying with water.

- 7) Underpinning works to buttress should be undertaken to ensure buttress is founded on suitable bearing stratum.

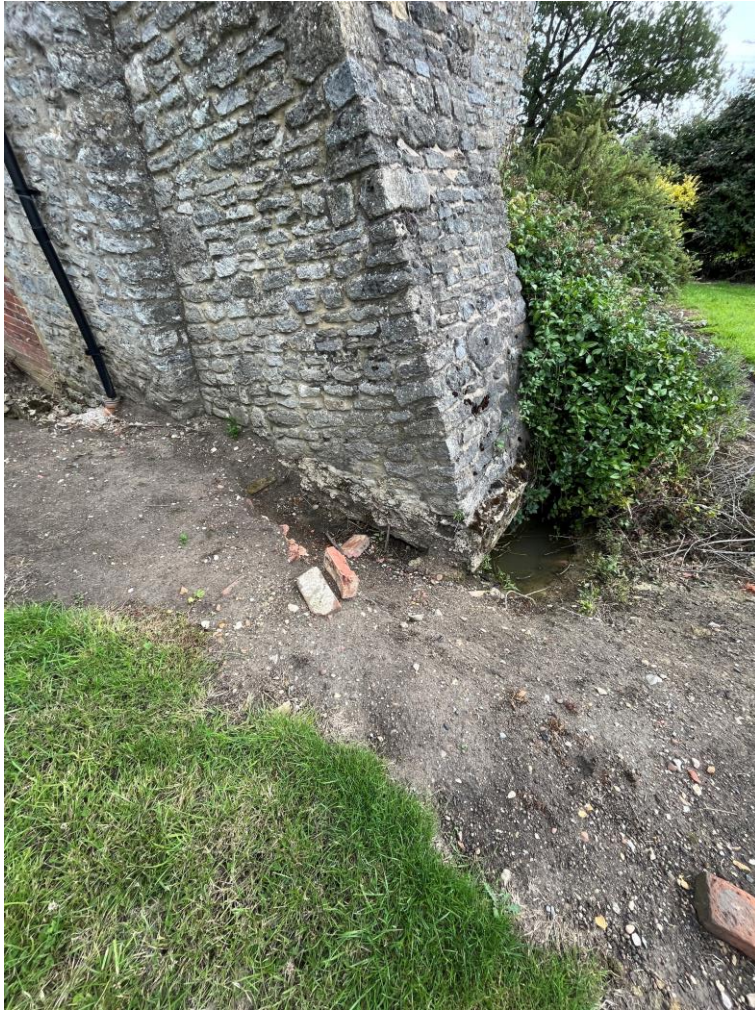
Water laying around undermined buttress.

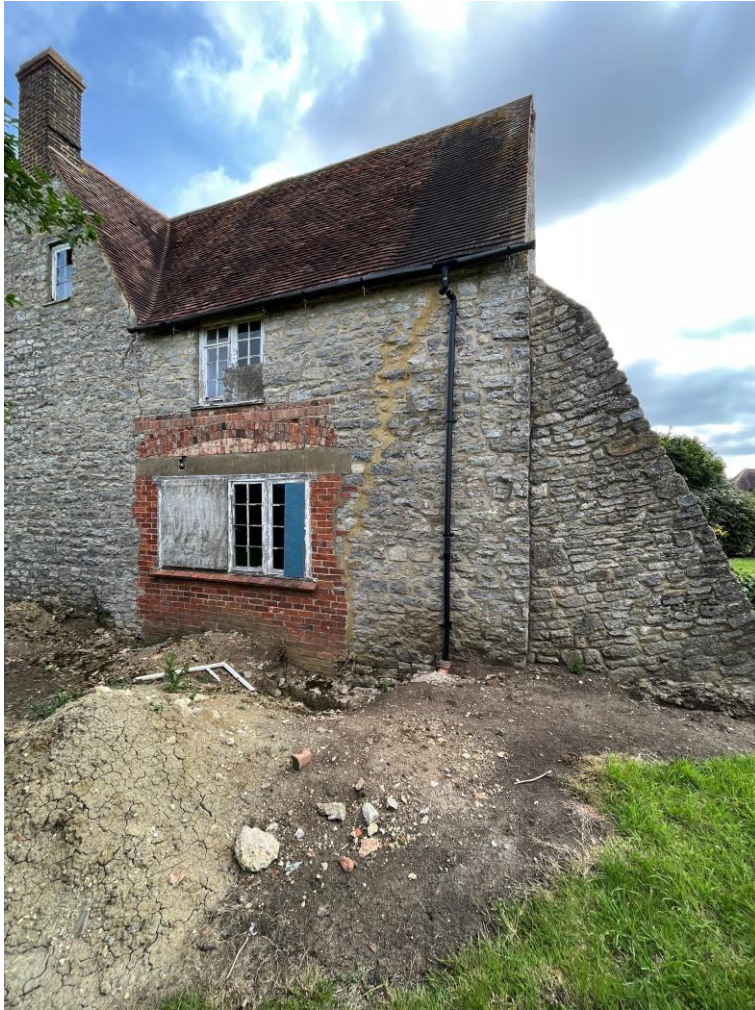
Either side of this brickwork panel there were vertical cracks extending from ground level to eaves.

Cracking to Western elevation either side of masonry panel. Disconnected downpipe, Modern machine-made tiles near verge end.

- 5) Crack stitching to cracks to Western elevation. Several require stitching.
- 6) Repointing generally, the build has been repointed with a cement-based mortar. Ideally this should be raked out and repointed with a soft lime mortar. However, this is a massive undertaking given the area. This is something to consider if budgets allow. However, where existing mortar joints are in poor condition these should be made weatherproof. A lime or NHL lime mortar should be used for new repointing works.

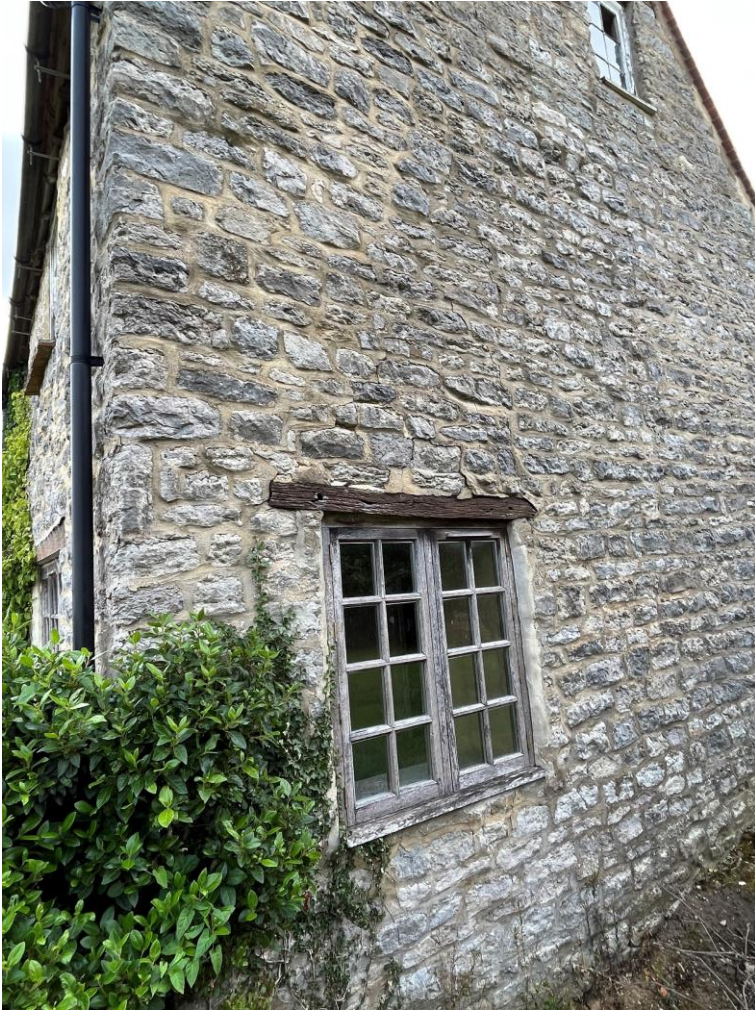
This elevation also had some bulging over the lounge window, and decay to the timber lintel. The decay of the timber lintel at its bearing (RH side, especially), has led to cracking and bulging of a triangle of masonry over. This will require replacement in a like for like way and rebuild masonry locally.

Lintel failure to lounge window.

- 1) Remove climbers, and self-set saplings, and manage shrubs/trees near to building.
- 2) Lintel repairs. Carry out lintel repairs and rebuild bowing masonry over lounge/snug window.

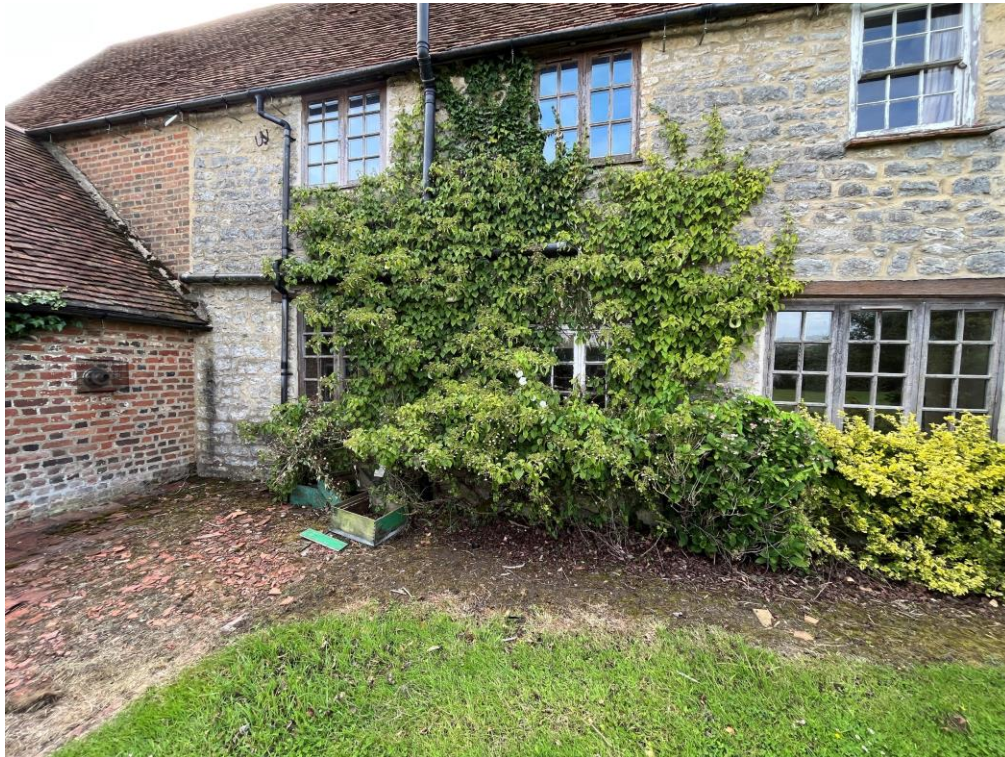
Large creeper/climber covering windows. Holding moisture against the building

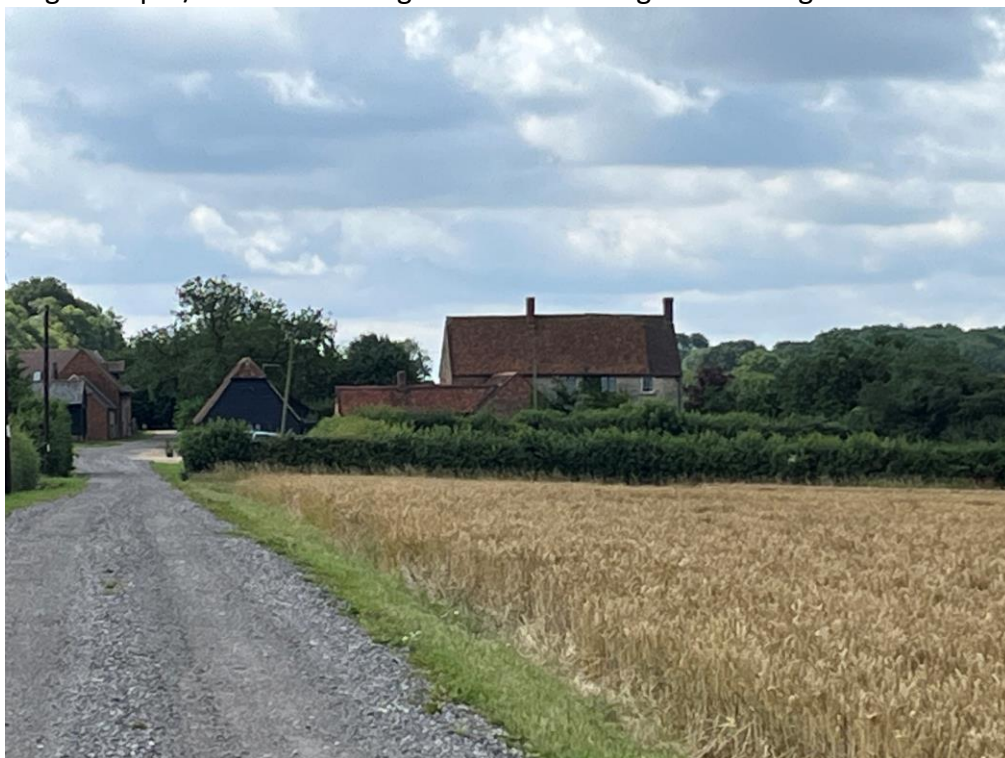
Visible tilt to ridgeline from afar. Note downward slope on RHS towards Western chimney/gable.

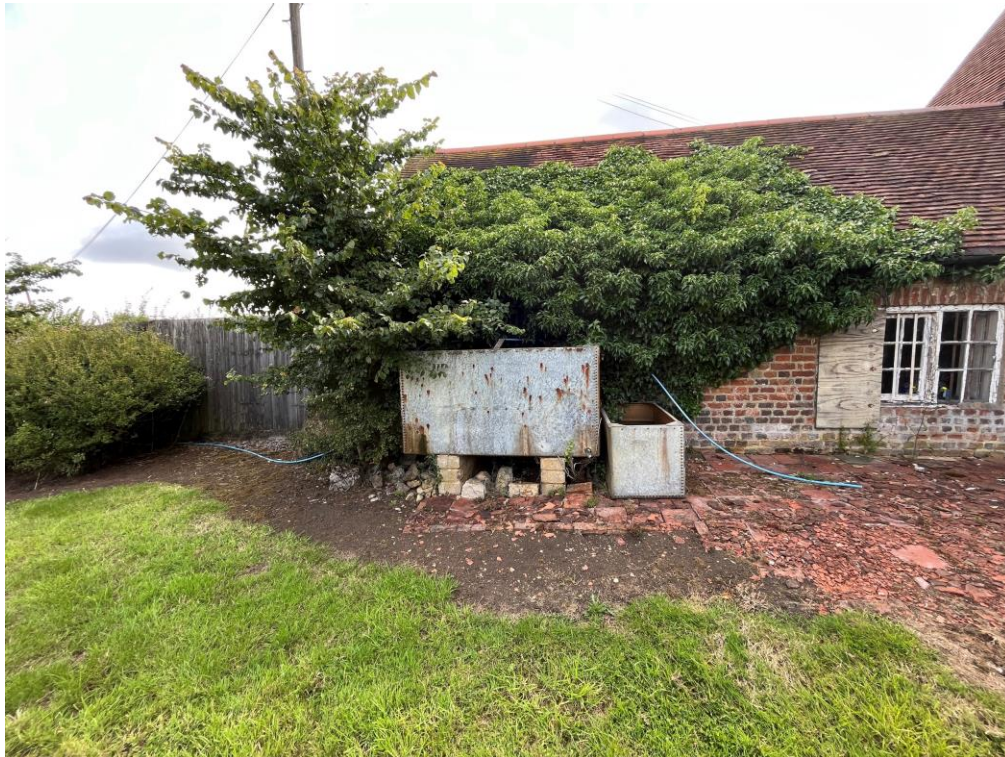
Climbers over roof, adjacent saplings, and tanks.

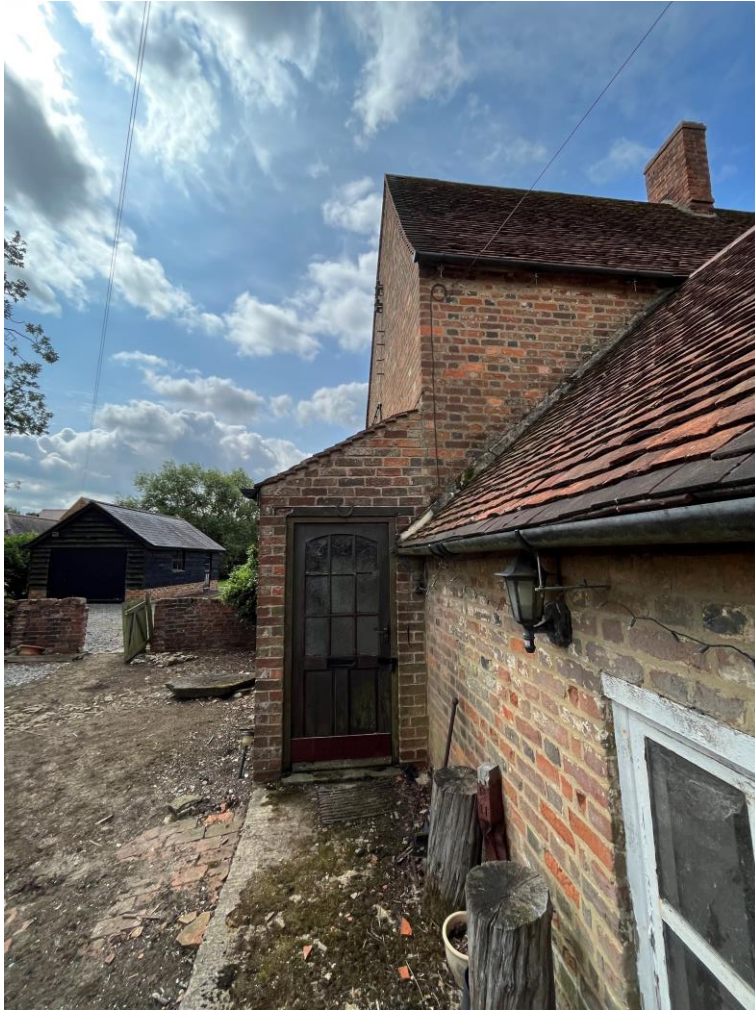
The mortar fillet to the roof where it abuts the two-storey main house is no displaced or missing, and no longer appears effective.

Missing lead flashing to porch, and poor condition of mortar fillet at abutment.

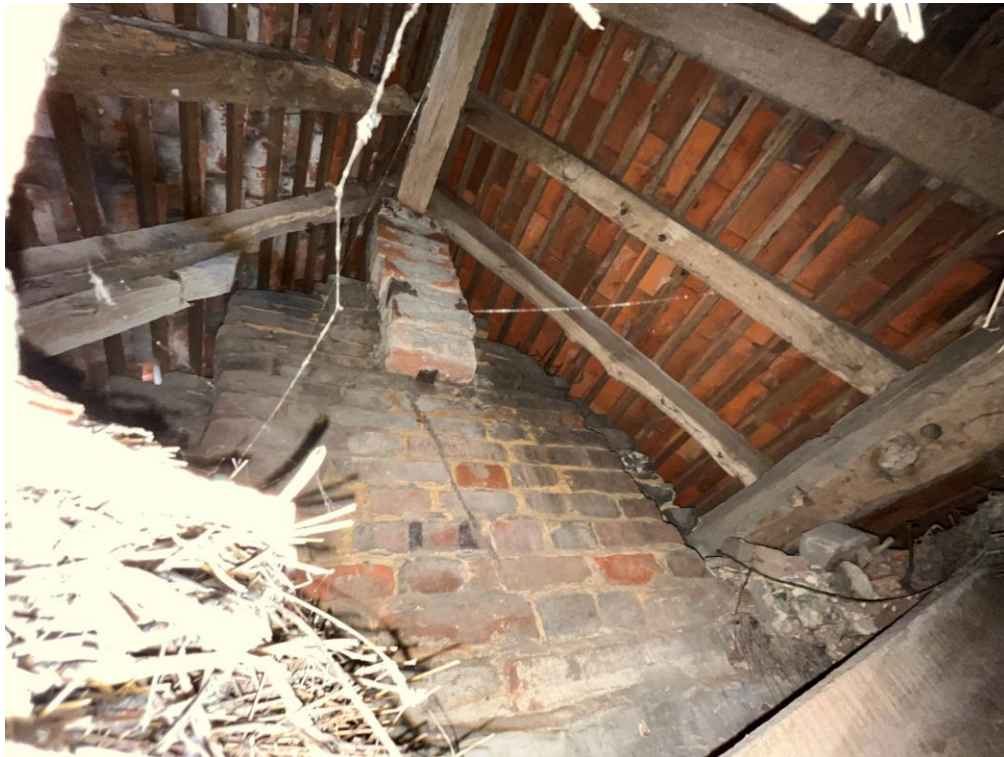
Southern Gable in 2 storey section. Corbelled brickwork propping ridge.

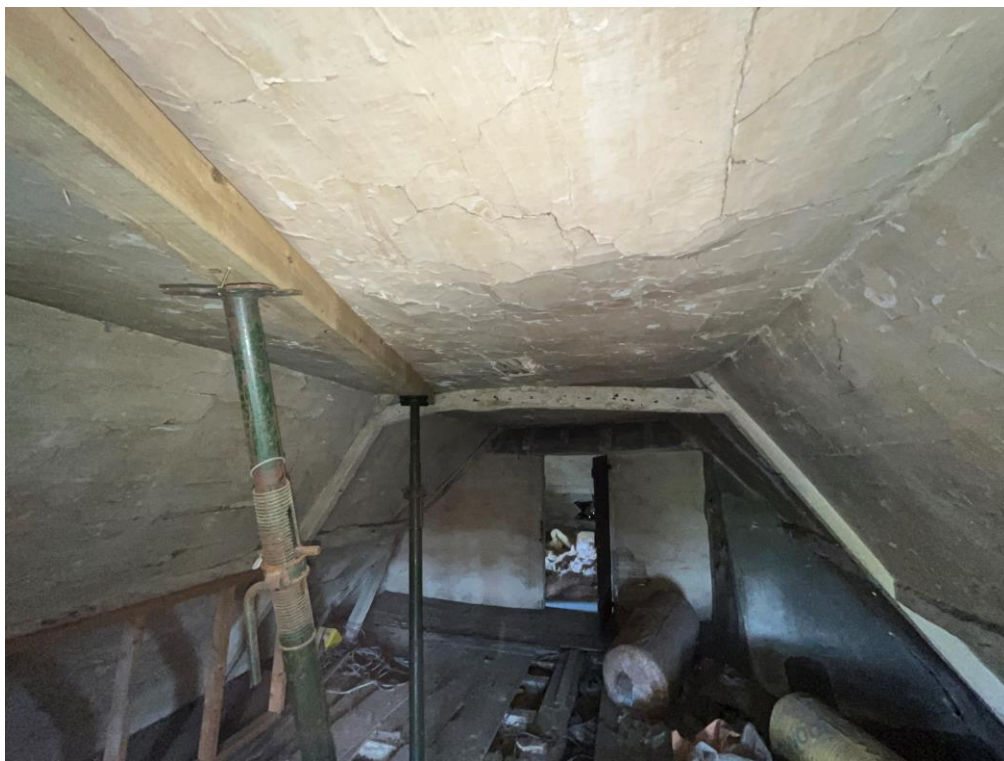
Part of the roof had lathe and plaster to the underside of the rafters. Much of this was spalling, was cracked, and had the potential to hamper ventilation around the rafters. There was some temporary Acrow props to the upper collars in this area of roof.

Propping to collars in roof space

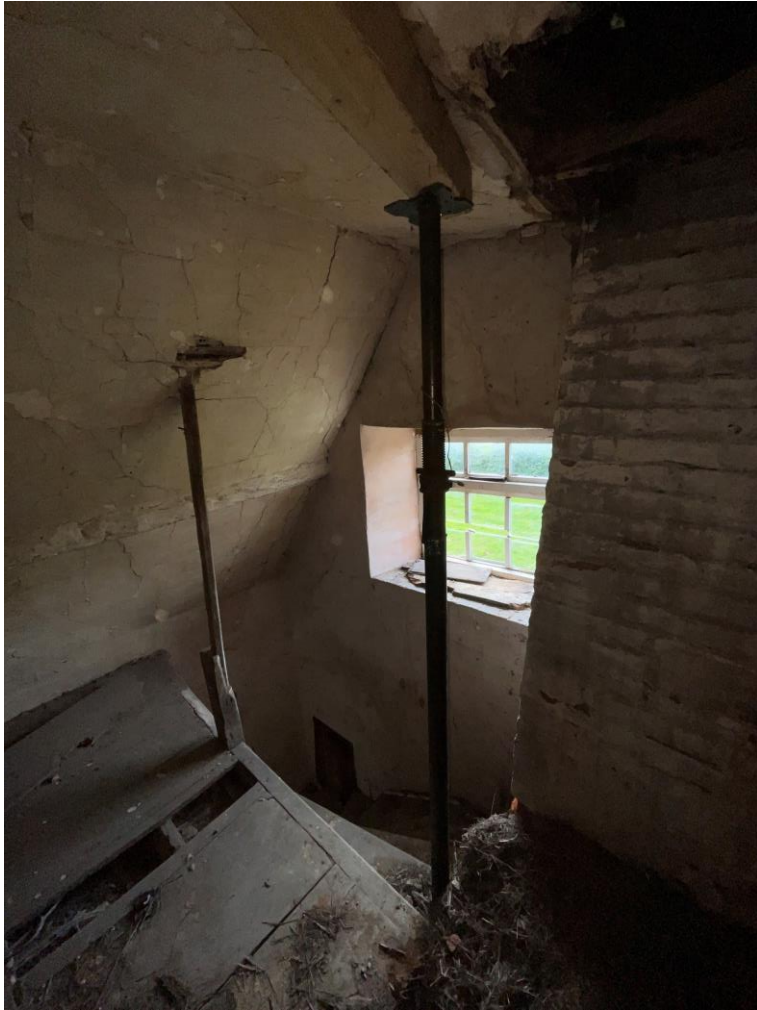
Propping roof space

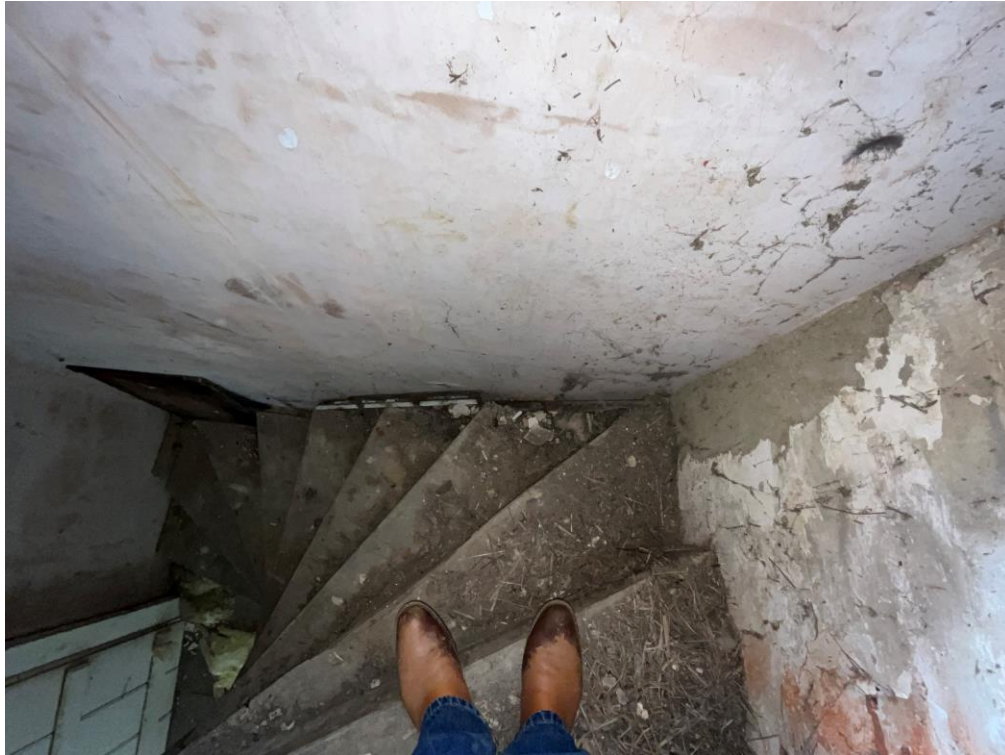
There was a significant vertical crack adjacent to the stairs in the chimney breast/cupboard. This had been stuffed with newspaper and was approx 15-20mm wide. The string of the stair up to 2nd floor was missing or there was just a clear gap formed between stair and gable. Similar was noted to the stair down to ground floor.

Gap between string and wall, Southern gable

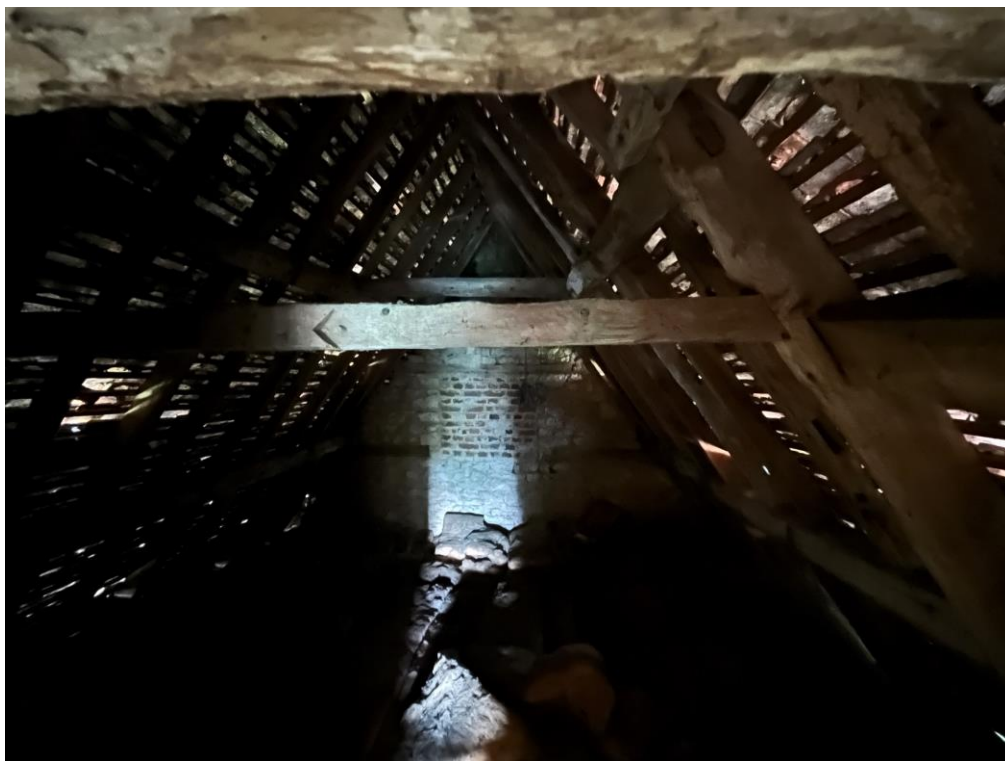
Non structural defects included daylight visible where there were broken or slipped plain tiles. There were also signs of water ingress to all the valleys, leading to some decay of timbers local to each valley.

Holes in tiling in roof space.

- 1) We would recommend removing and refitting the tiled roof as there were lots of visible holes, and it did appear there was some water ingress. It would be prudent to install a sarking felt. This may need to be bat friendly, and an ecologist may should be consulted with regards to timings of the work.

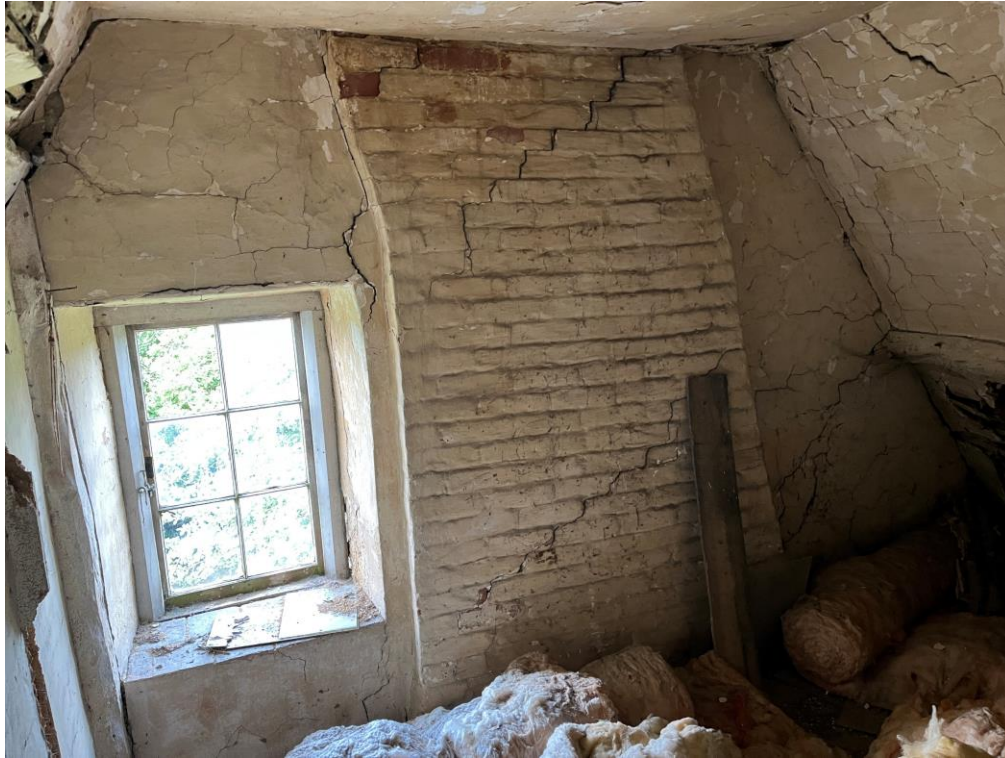
The Western gable end had visible horizontal cracks to the bed joints. It was also noticed there had been some racking of the roof toward this gable. The horizontal cracks are likely to be "tension cracks".

Tension cracks to masonry, Western Gable

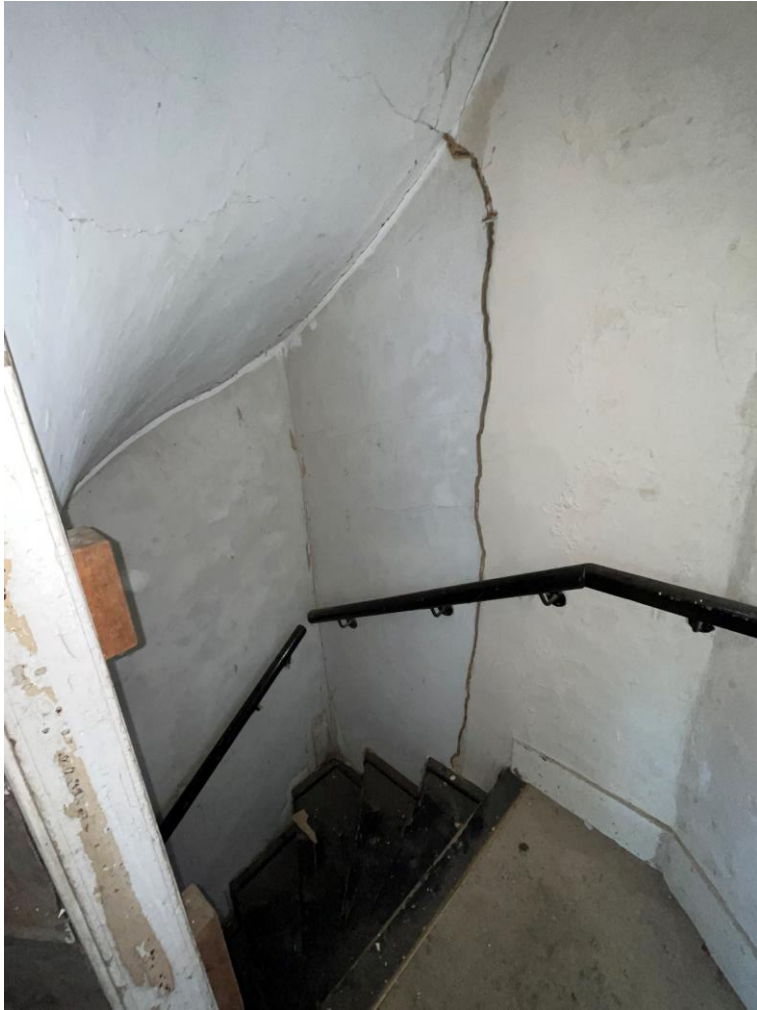
Vertical crack, ground to first floor stairwell (adjacent to southern gable)

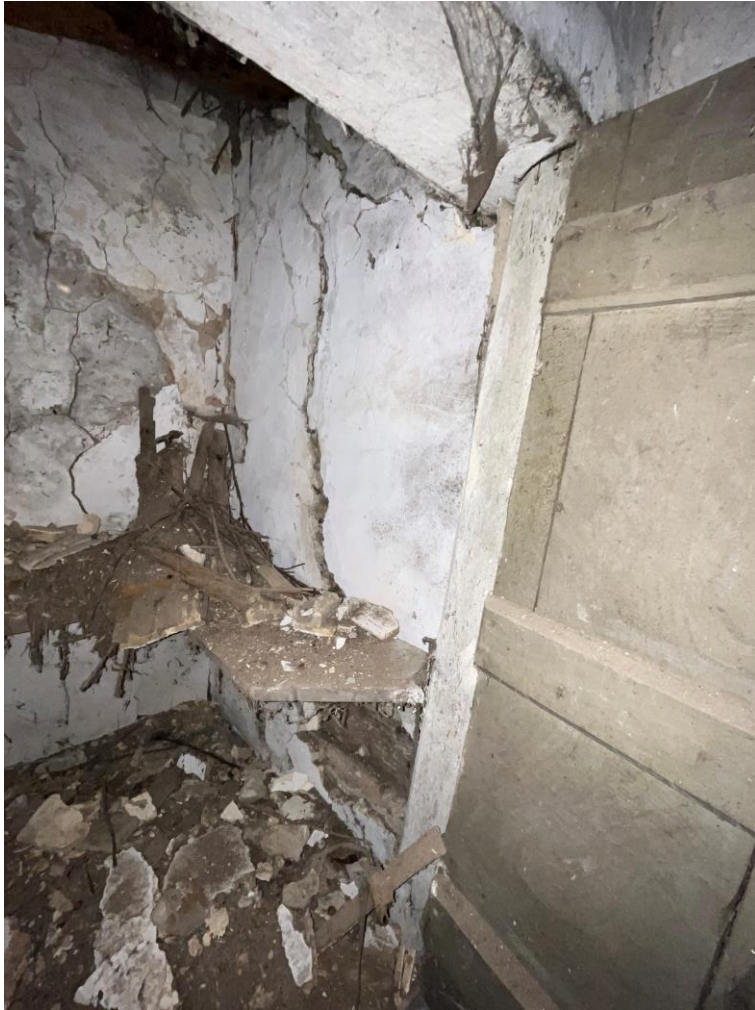
Wardrobe adjacent to the chimney breast, there was quite a bit of cracking noted to masonry in this cupboard to all walls. The vertical cracking in the external side wall was a continuation of cracking noted in Drawing room up to eaves. There was a timber plate within the masonry at approximately sill level. This was decayed. There was evidence of bulging outwards of the side wall, particularly just above first floor level.

Cracking in bedroom cupboard to Western elevation (adjacent to southern gable)

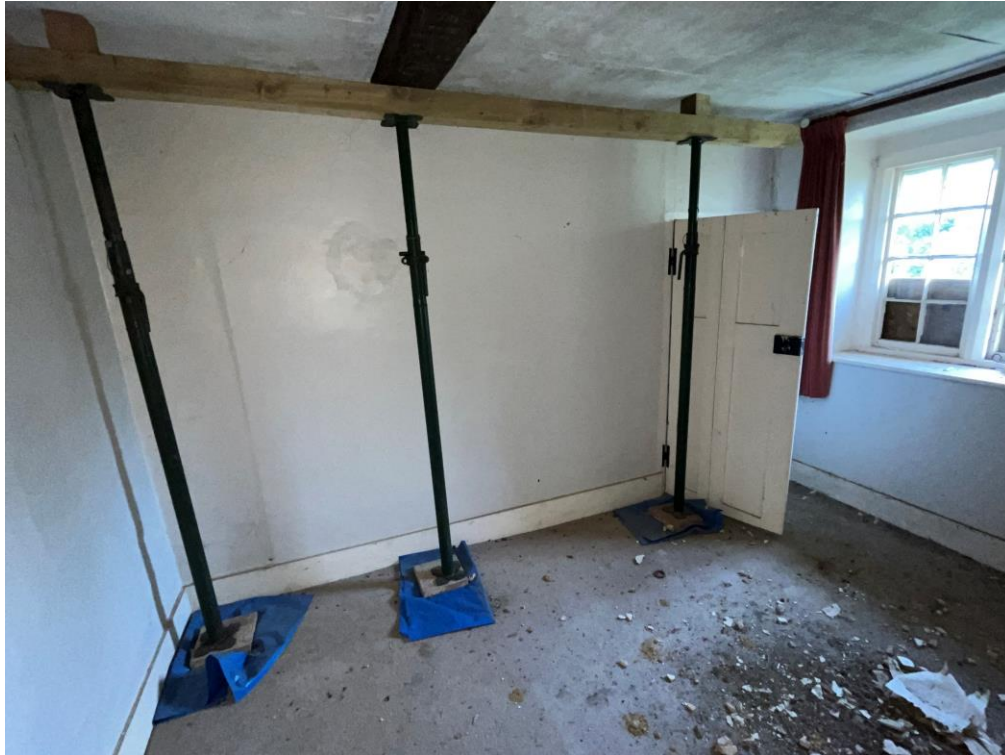
Propping to 2nd floor.

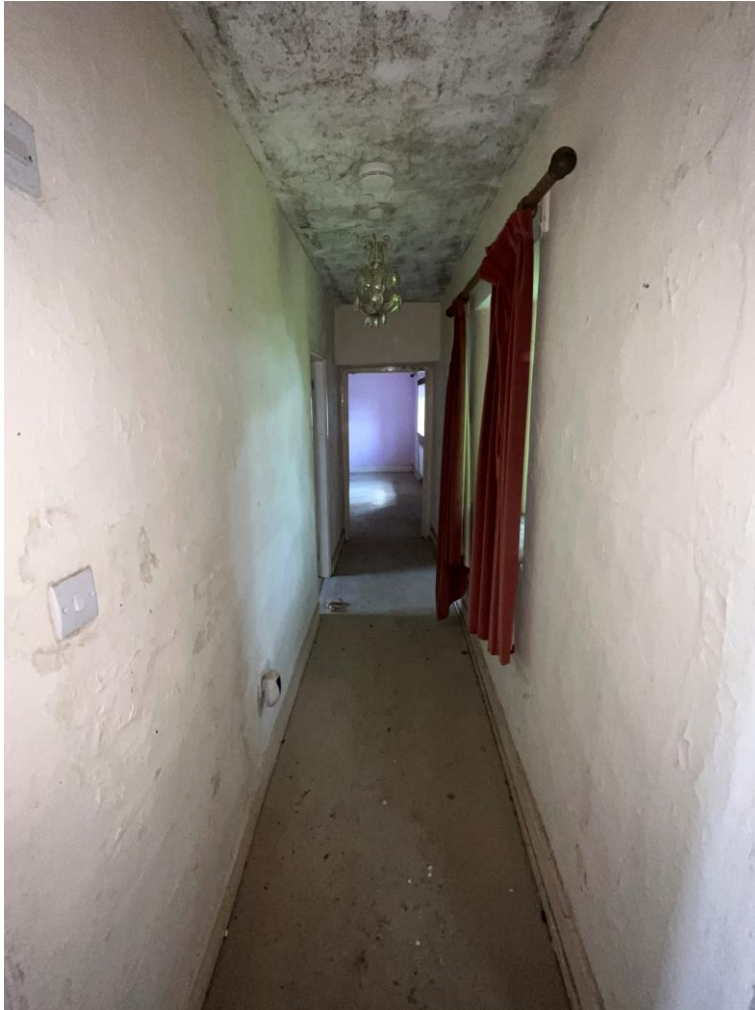
There was some diagonal cracking noted above the chimney. There was diagonal cracking noted to the partition with the adjacent bedroom. There was a vertical cracking noted to the bathroom partitions adjacent to the light switch. The door is out of square and is lower on the hanging side.

This photo doesn't show it clearly. But Main bedroom door out of Square, floors and door heads sloping. Also, walking uphill towards door.

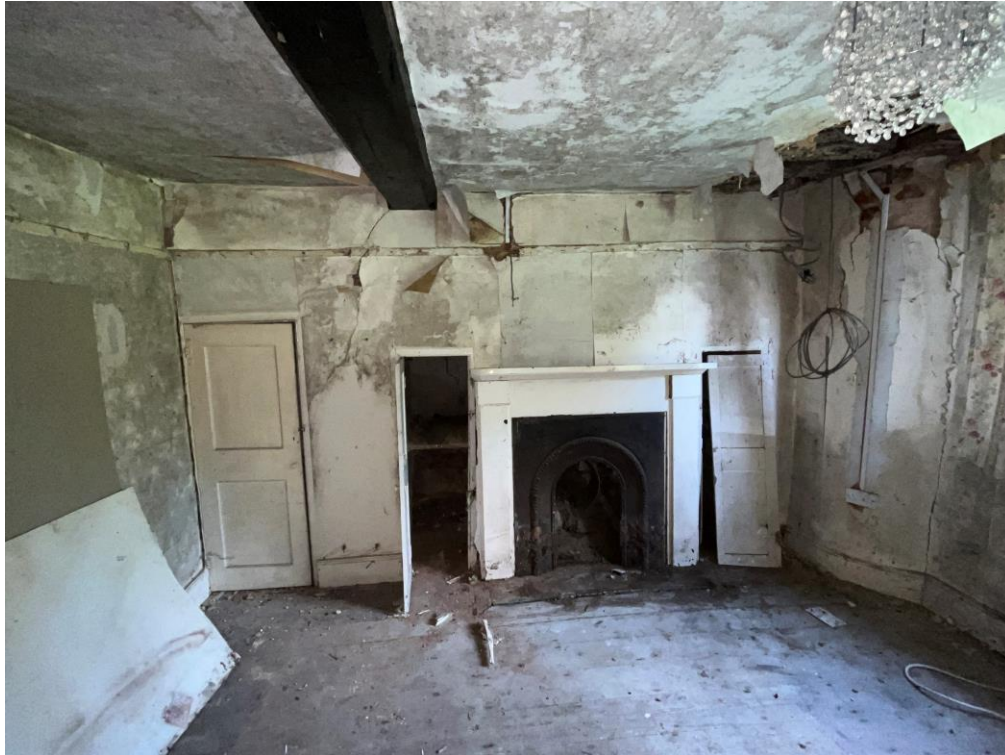
Southern Gable fireplace in drawing room.

The fire place / chimney breast also requires structural repair. This is now disused, we would suggest the removal of upper parts to remove load from structural elements below such as the bressummer beam that is concealed by plaster. This has had sleeper walls constructed to supported it approximately at third points along its span.

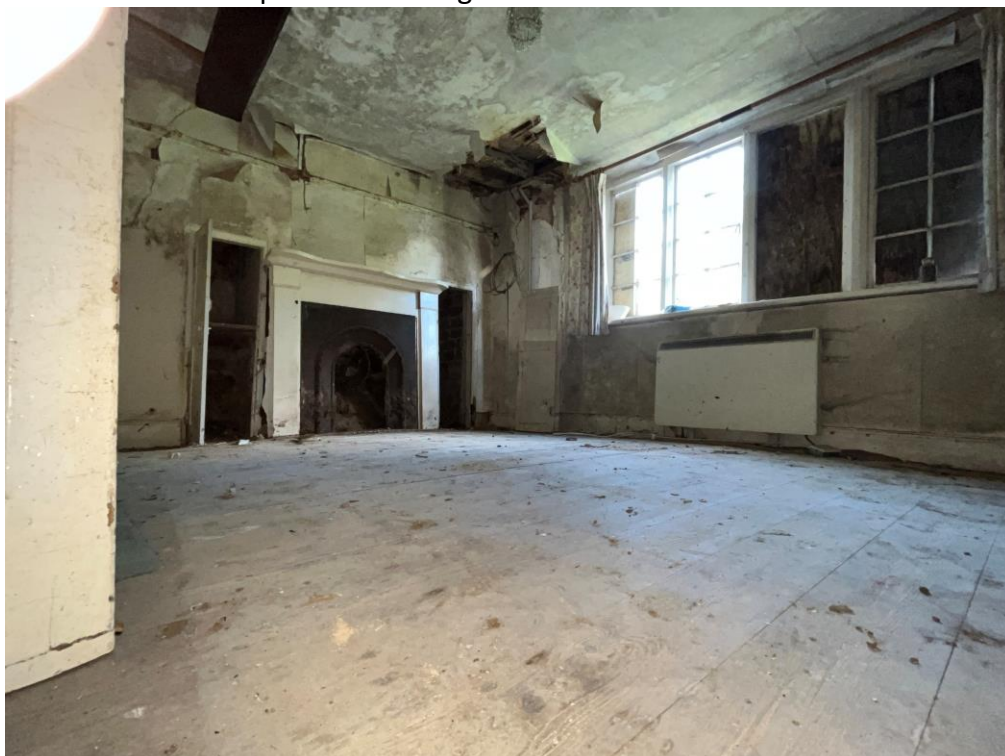
Floor bulging and dipping to Western elevation.

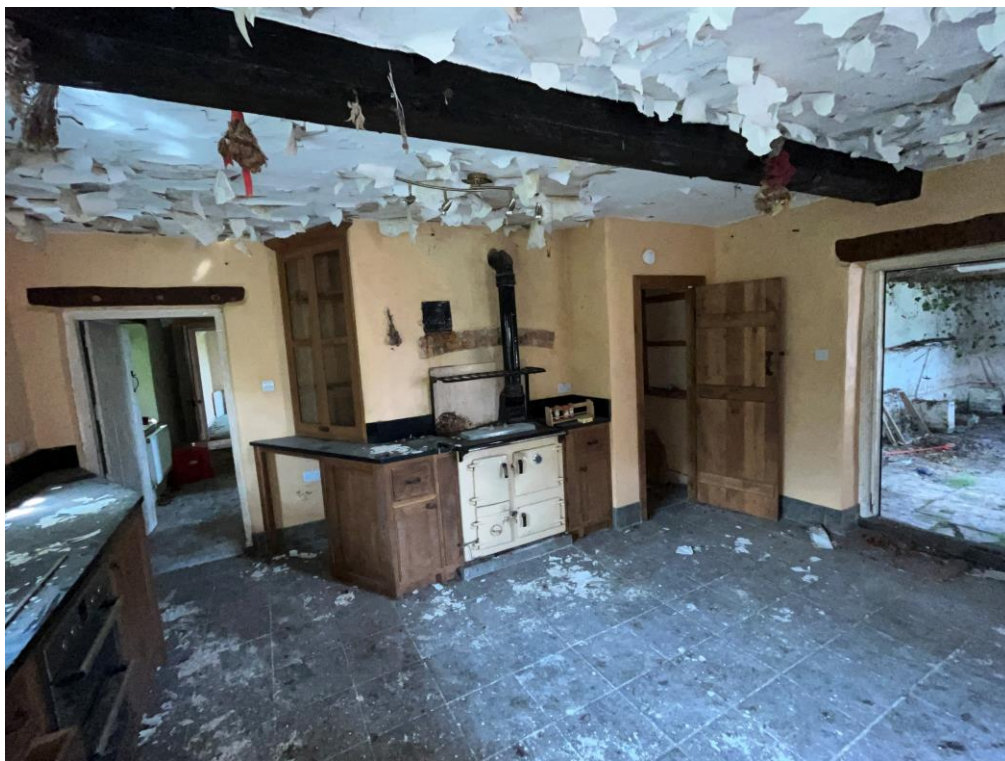
There were no obvious structural defects noted. The ceiling paint was hanging off the ceiling in sheets. There was dampness to the chimney breast behind the range cooker. Most walls and ceiling appeared to have surface mould.

Kitchen, dampness behind range, ceiling paint peeling.

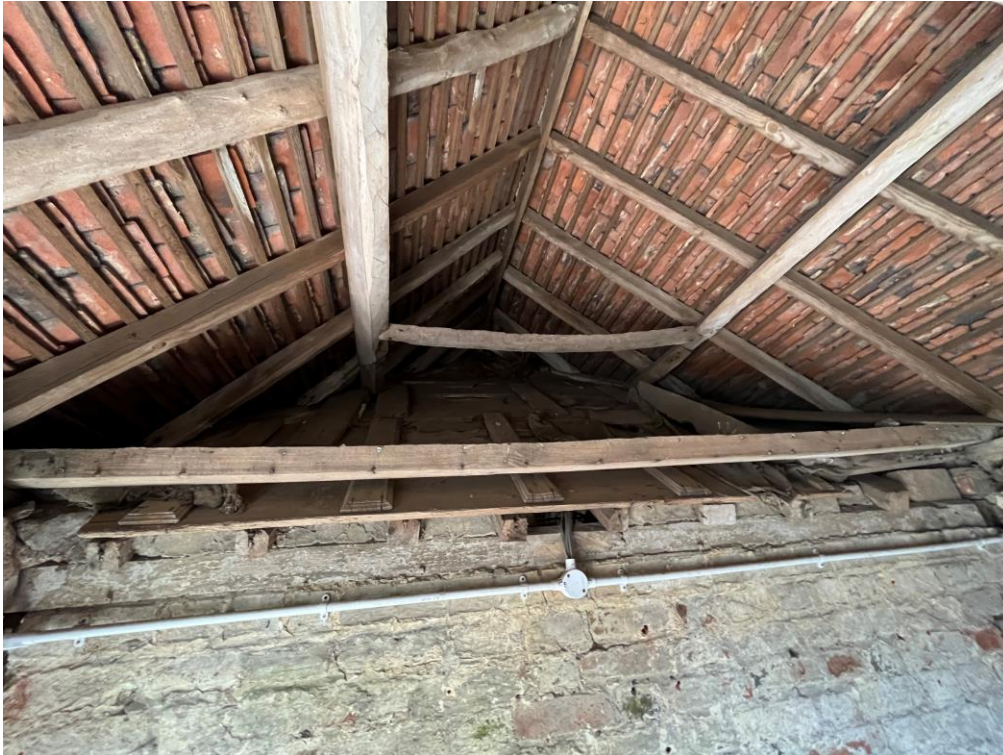
Over spanning purlins in forge.

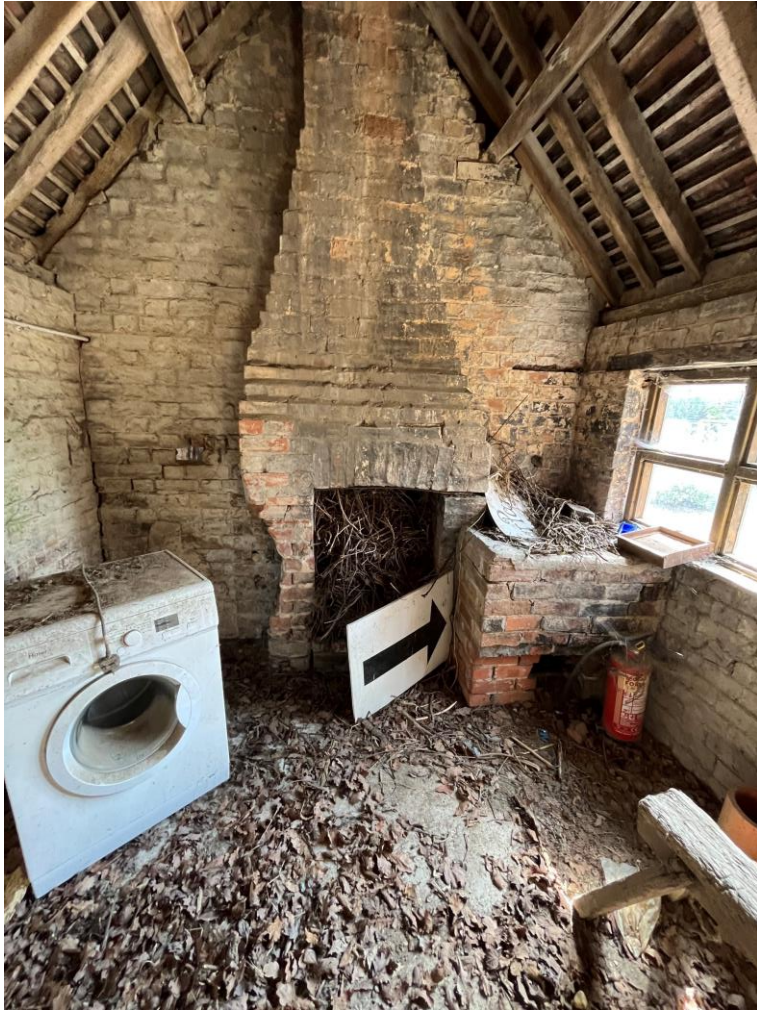
Roof spread to forge, cracking at vertical junctions of walls.

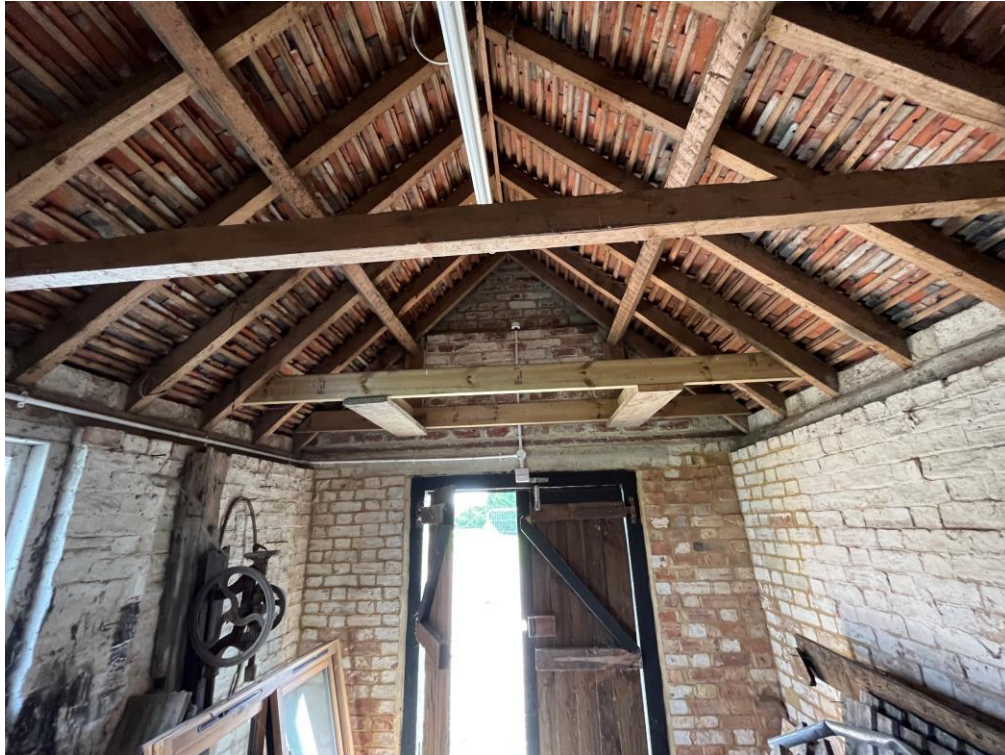
Storeroom with some additional ties and props to purlin bearings.

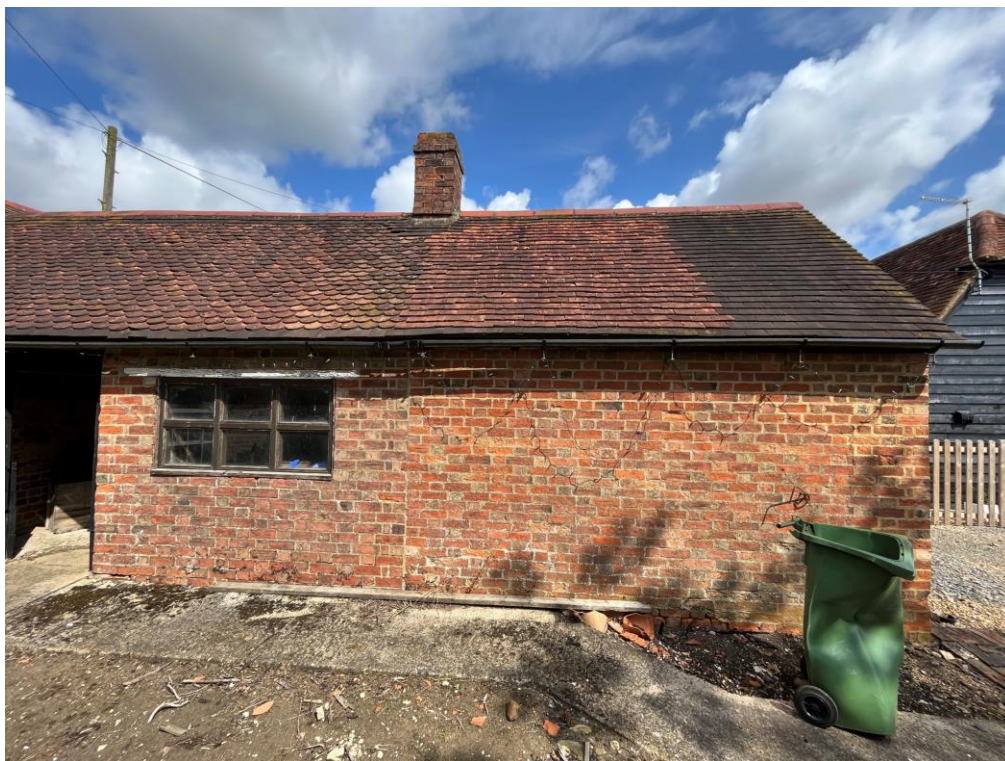
Storeroom roof externally, including mixture of tiles.
