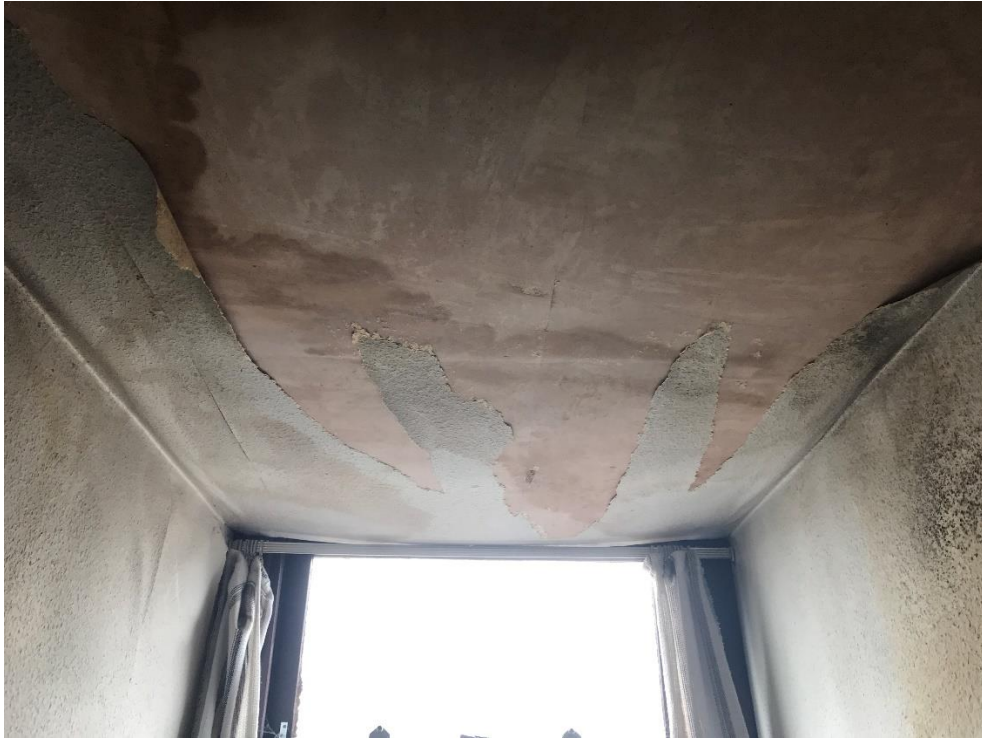
Photo 9 – Second Floor, Bedroom 1, front.
Failing flat roof of front dormer.

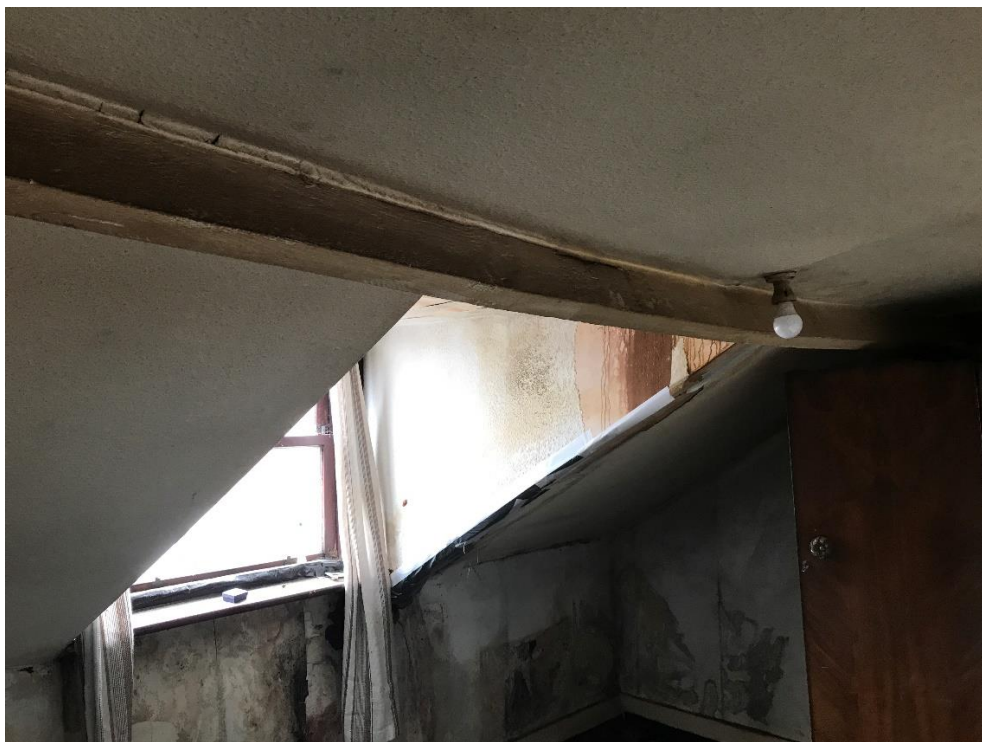
Photo 10 – Second Floor, Bedroom 1, front.
Front dormer and undersized purlin, deflecting roof slope.

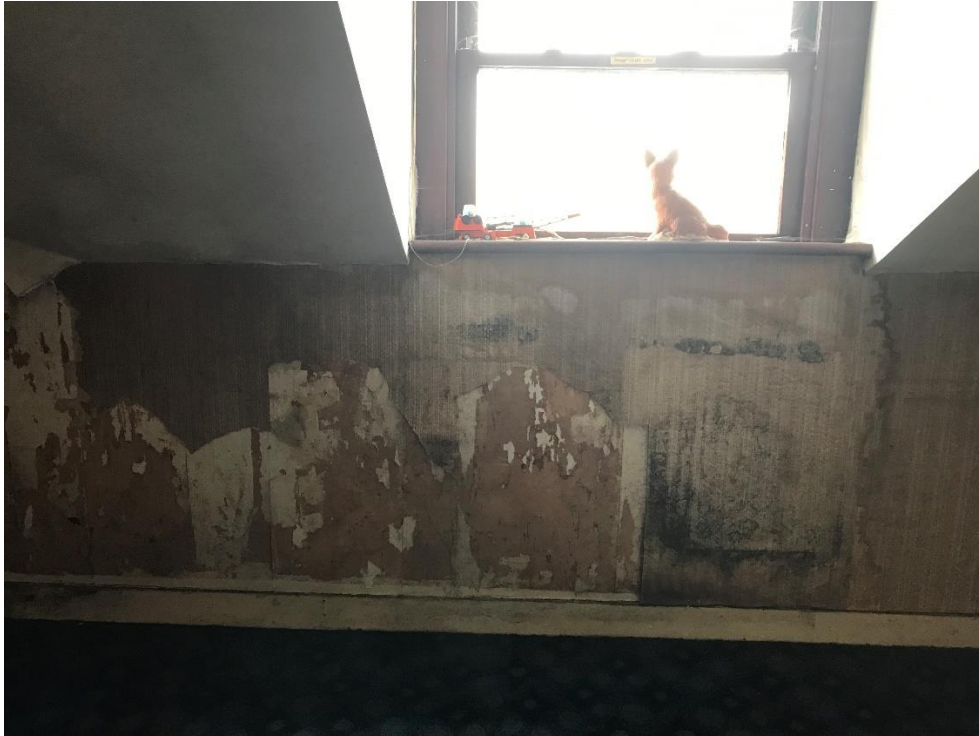
Photo 11 – Second Floor, Bedroom 1, front.
Front wall, damp penetration, failed finishes and cracked brickwork exposed.

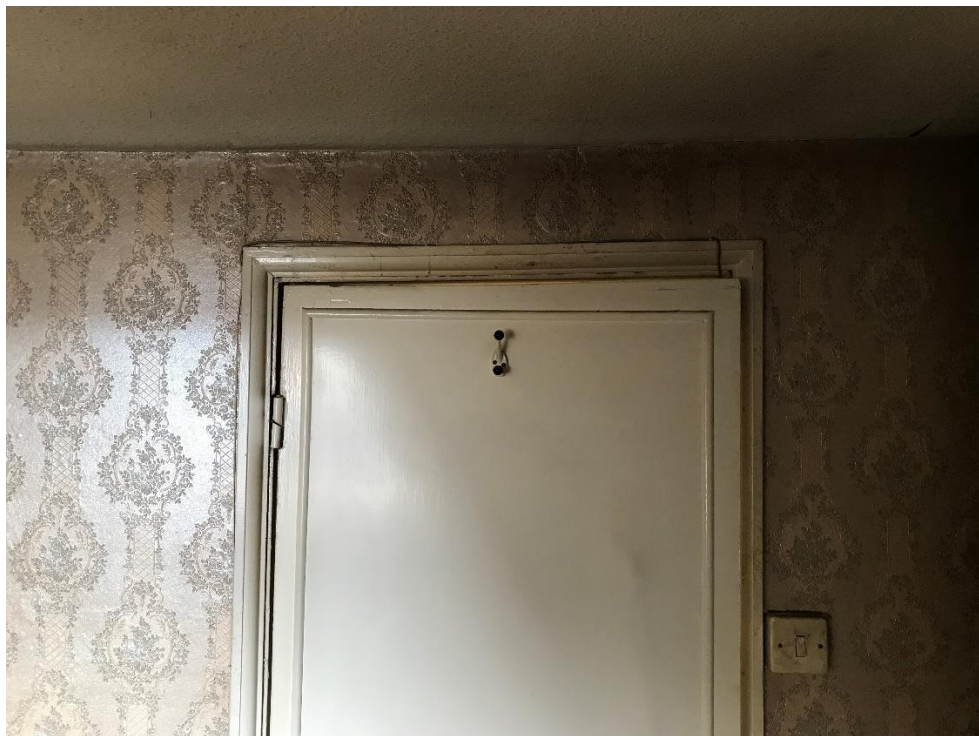
Photo 12 – Second Floor, Bedroom 1, front.
Door head slope to south-west.

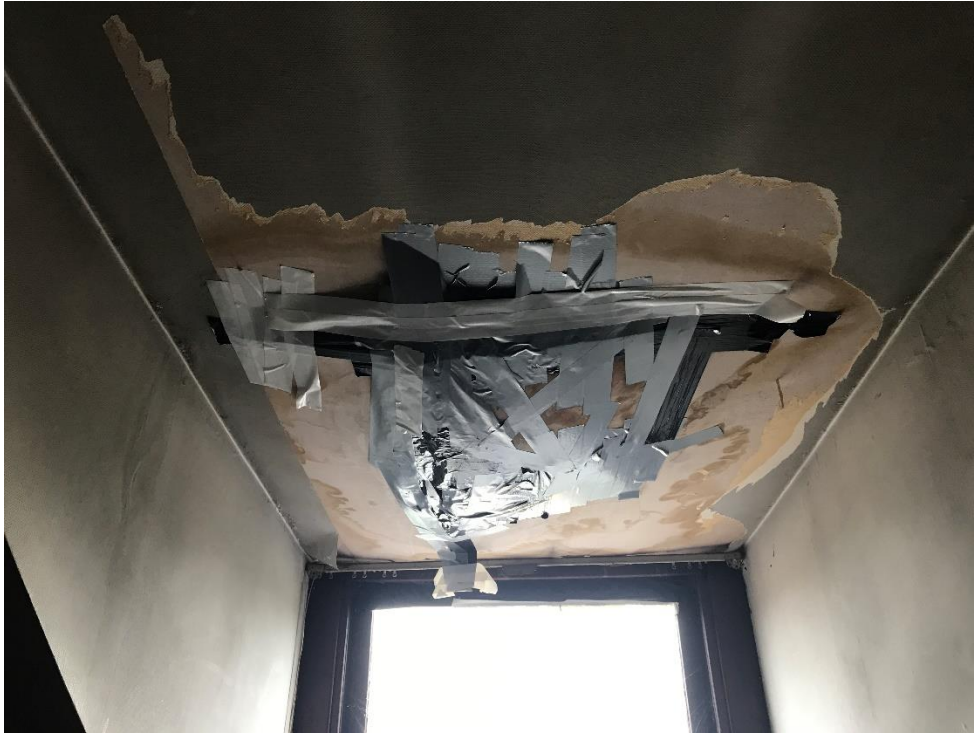
Photo 13 – Second Floor, Bedroom 3, rear.
Failing flat roof of rear dormer.

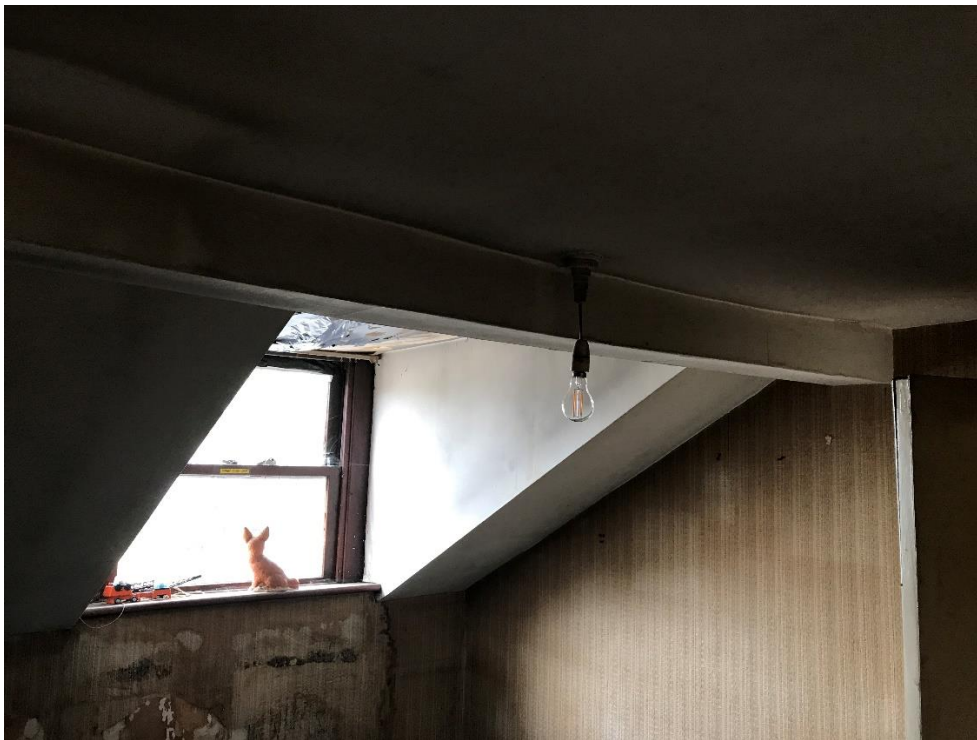
Photo 14 – Second Floor, Bedroom 3, rear.
Rear dormer and undersized purlin, deflecting roof slope.

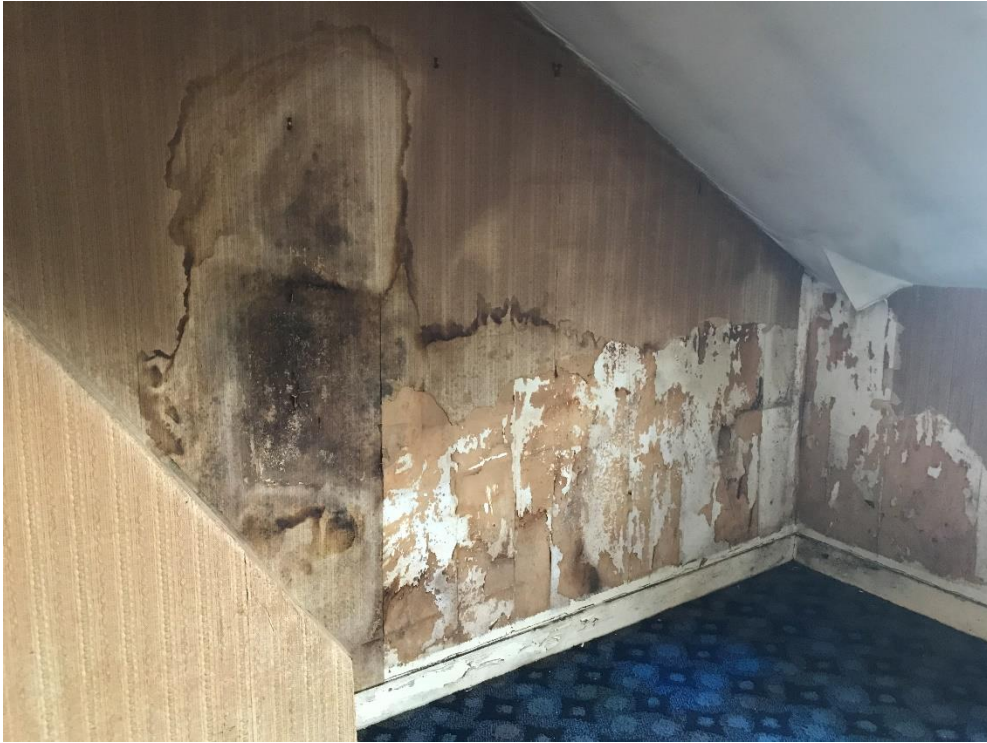
Photo 15 – Second Floor, Bedroom 3, rear.
Damp penetration and decay to gable and rear wall.

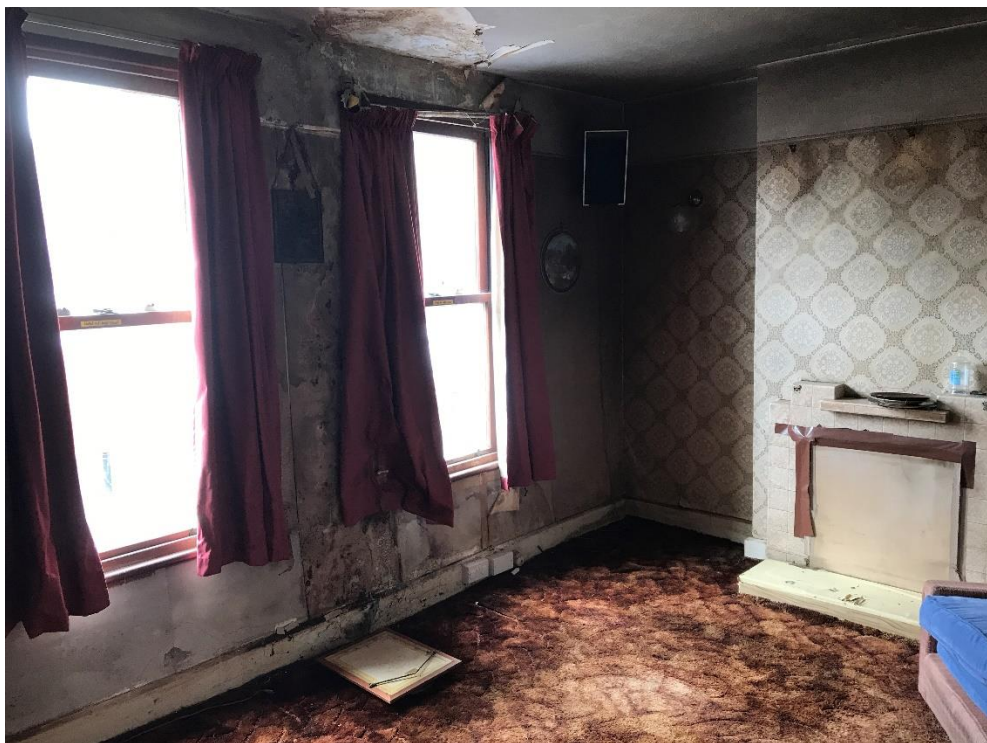
Photo 16 – First Floor, Sitting Room, front.
Cracked brickwork below window sill and floor deflection.

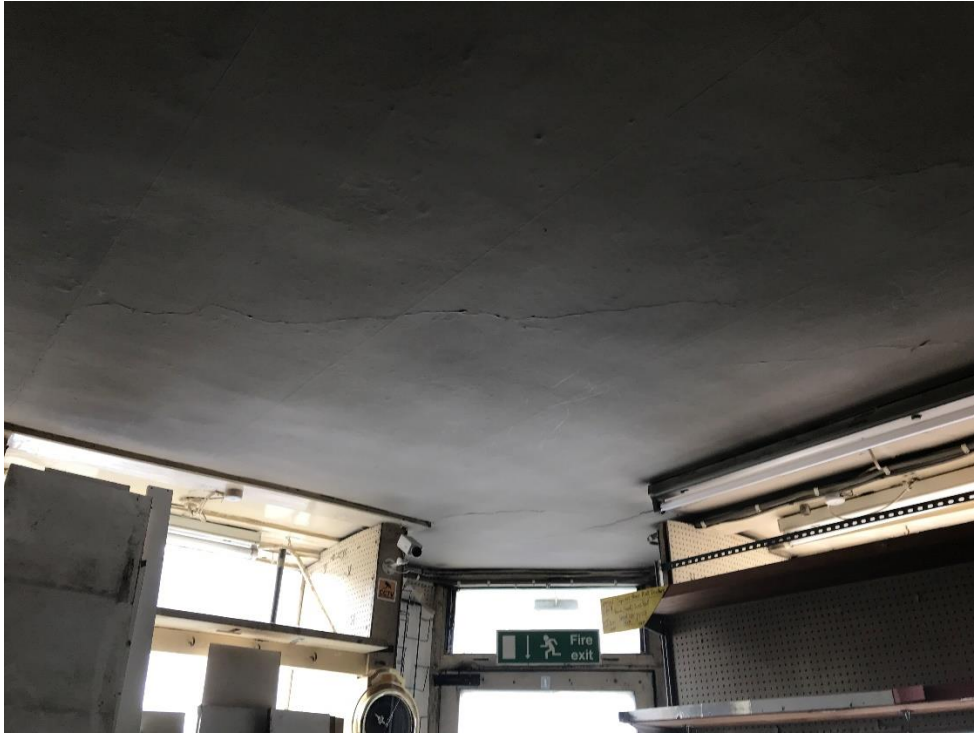
Photo 17 – Ground floor shop and front entrance.
Diagonal cracking through ceiling.

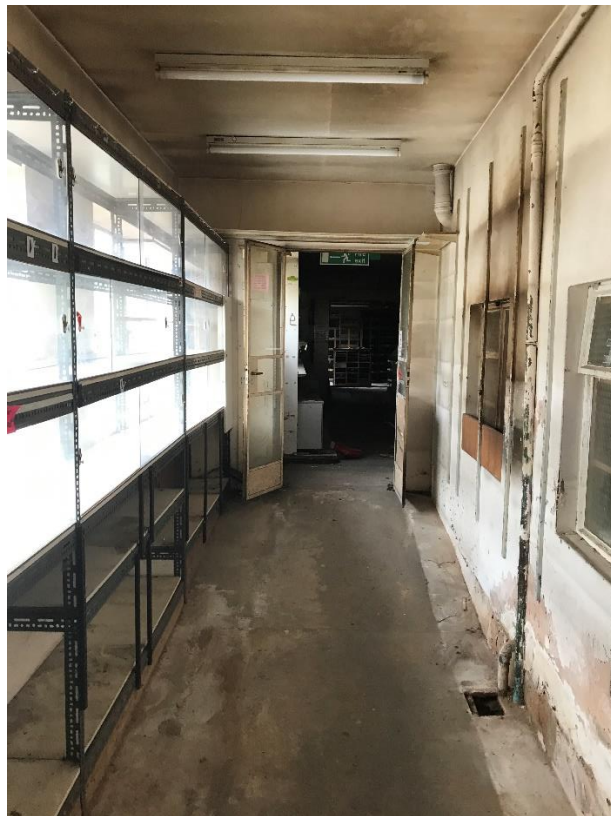
Photo 18 – Middle store/corridor.
Floor laid to fall with drain gully.

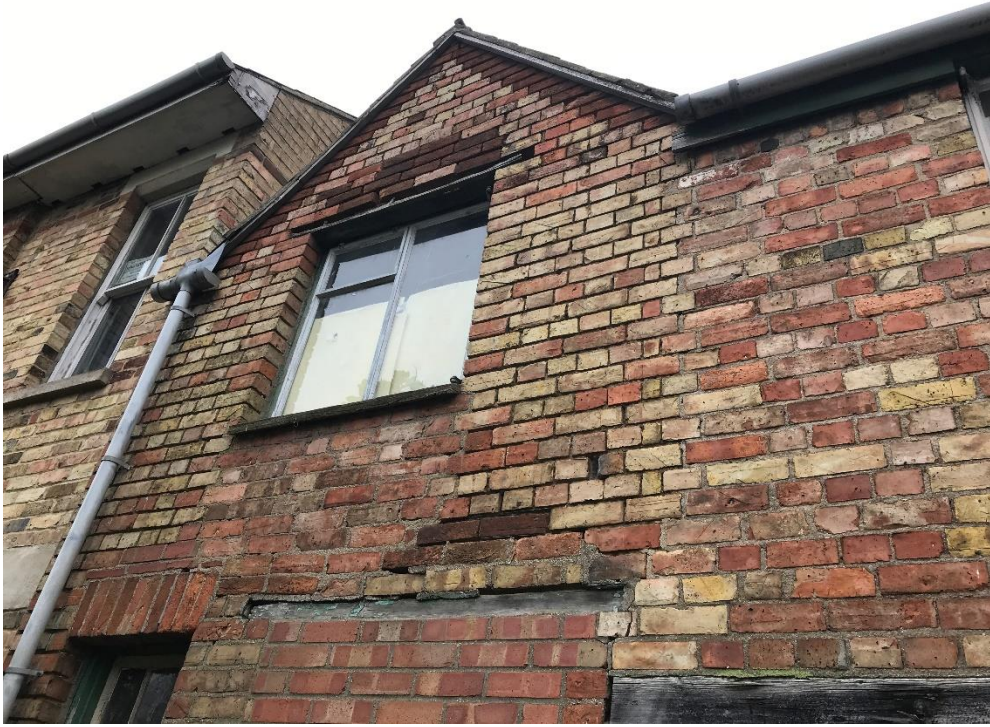
Photo 23 – Rear two storey building, south west gable.
Defective lintels and poor brick bonding.

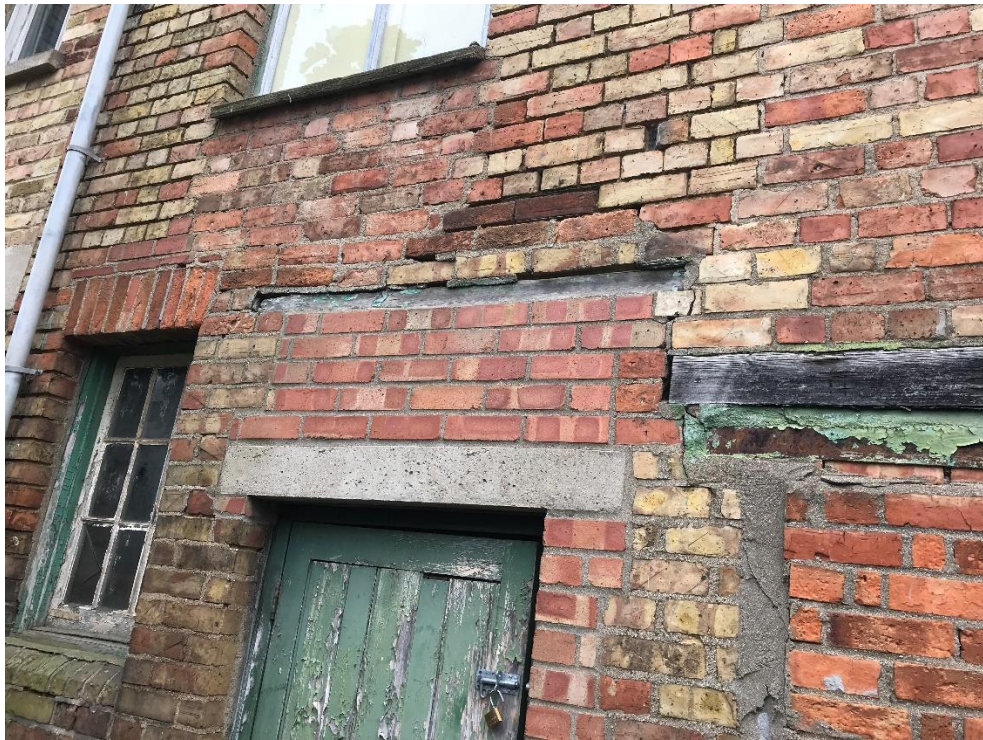
Photo 24 – Rear two storey building, south west elevation.
Defective lintels and poor brick bonding.

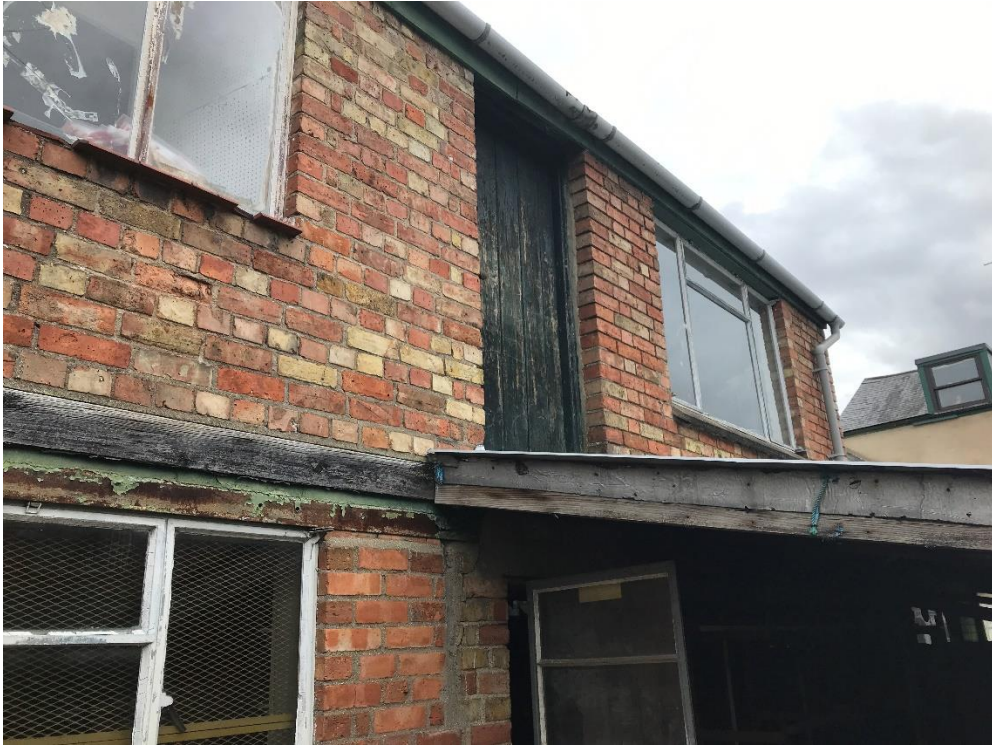
Photo 25 – Rear two storey building, south west elevation.
Wall leaning outward either side of “fire escape” door.

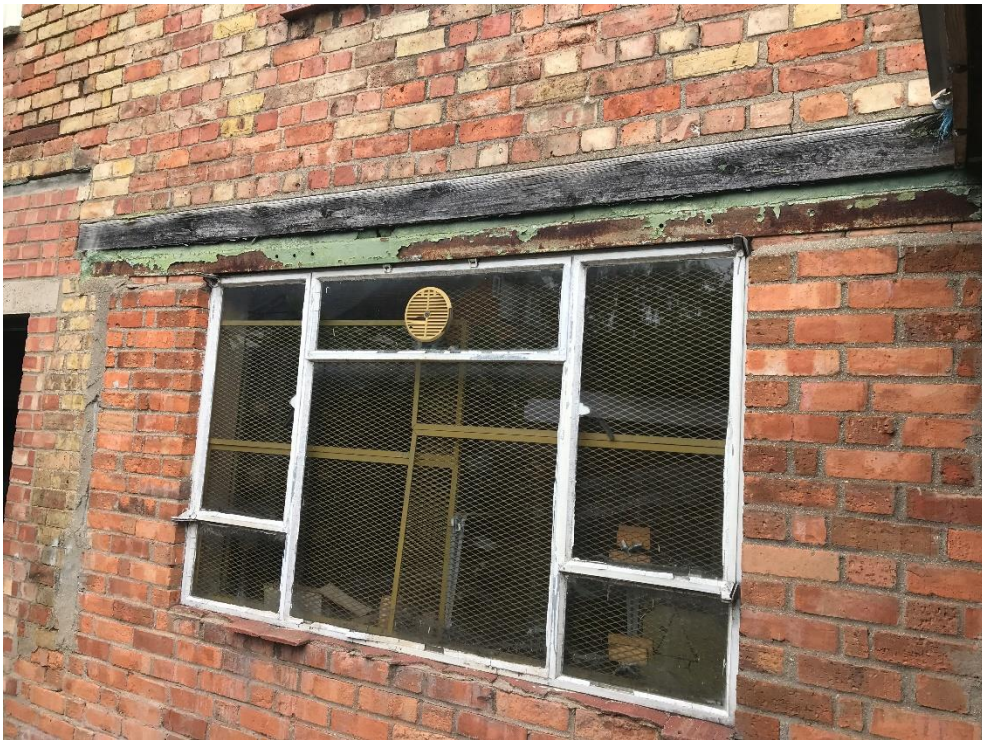
Photo 26 – Rear two storey building, south west elevation.
Defective lintels and poor brick bonding, straight mortar jointing.
