# BRITANNIA STRUCTURAL VISIT

Monday, 16 October 2023

23 Issues Identified

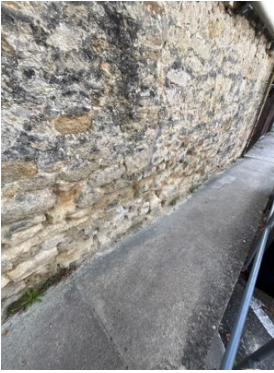
### ISSUE 1

Assigned To External Kitchen Wall

An experienced stone mason to replace stones where required and repoint in lime mortar

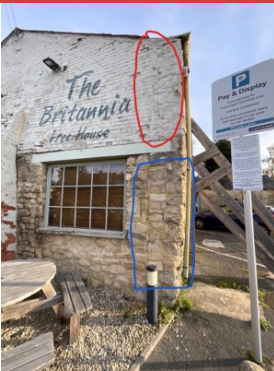
### ISSUE 2

Assigned To Corner Of Building, Lime Walk And Car Park  
Red shows cracking

Blue shows previous repair, not sufficient

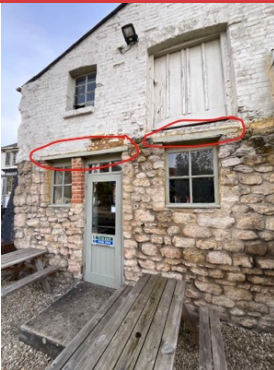
### ISSUE 3

Assigned To Lime Walk Elevation

Replace 2x lintels to BG spec

Contractor to provide propping details from own SE

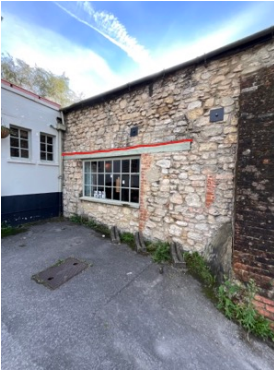
#### **ISSUE 4**

Assigned To London Road Elevation

Install drip detail to top of timber to stop further damage.

Mortar repairs around timber.

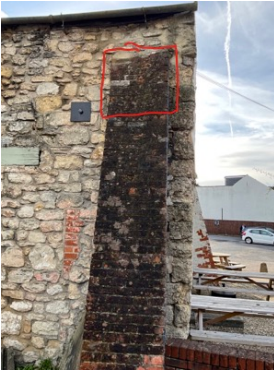
#### **ISSUE 5**

Assigned To London Road Elevation

Top 8 courses of pier to be removed, rebedded and tied into the wall. BG to provide detail.

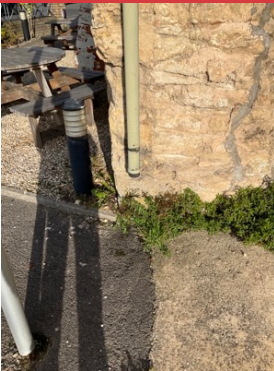
#### **ISSUE 6**

Assigned To Car Park Elevation

Downpipe to be extended and directed away from building

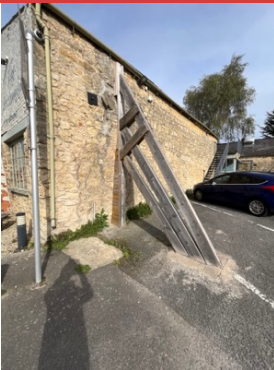
#### **ISSUE 7**

Assigned To Car Park Elevation

Temporary timber raking pier and wall ties installed 2020.

JTS to confirm whether needed to be removed or replaced. BG to provide detail if required.

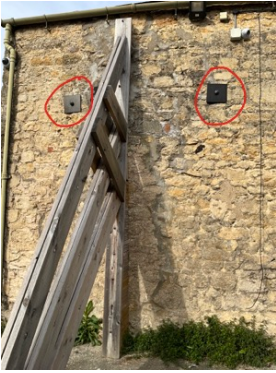
### **ISSUE 7**

Assigned To Car Park Elevation  
Showing wall ties

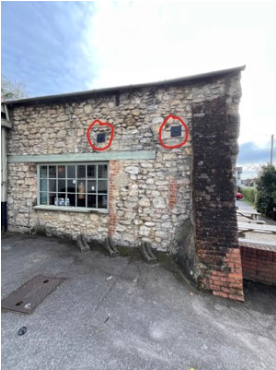
### **ISSUE 7**

Assigned To London Road Elevation  
Showing other end of wall ties

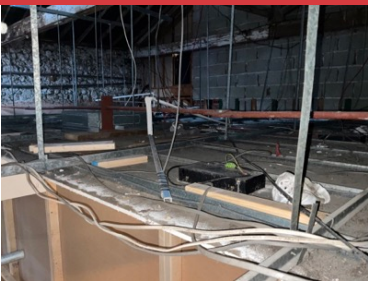
### **ISSUE 7**

Assigned To Internal  
Wall tie not installed to spec, should have been supported by truss, and not tight.

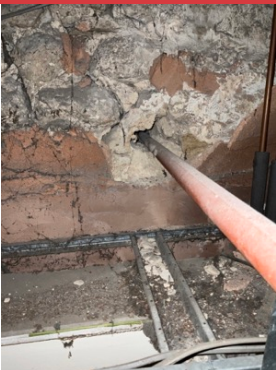
### **ISSUE 7**

Assigned To Internal  
Shows damage done to external wall when ties installed.

BG and JTS to recommend structural and heritage works, respectively.

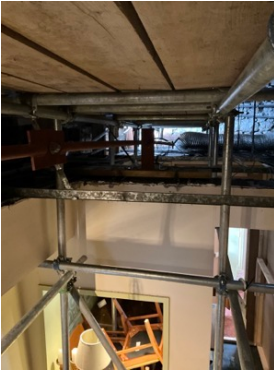
### **ISSUE 7**

Shows lack of restraint tie providing

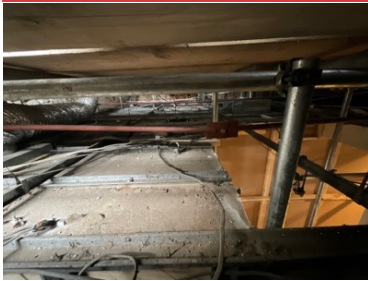
### **ISSUE 7**

As above, lack of restraint.

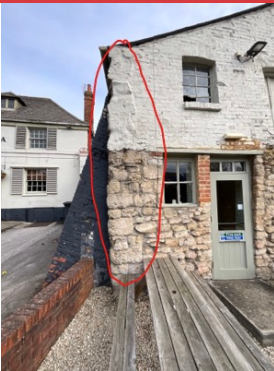
### **ISSUE 8**

Assigned To Lime Walk And London Road Corner

Cracking and poor pointing to corner

BG to specify repairs

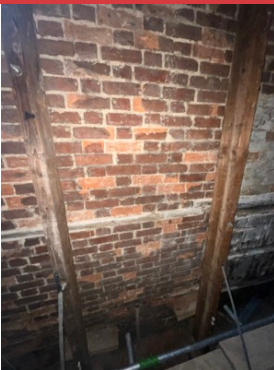
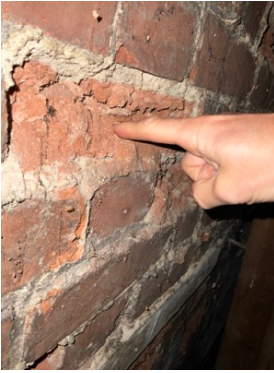
### **ISSUE 9**

Severe brick damage, presumed masonry bees

BG to specify amount of repair/replacement required

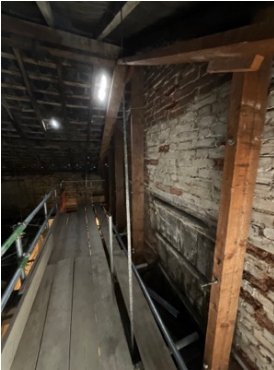
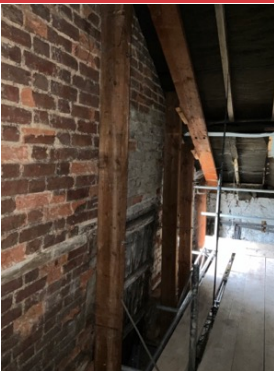
### **ISSUE 10**

Assigned To Internal  
Shows historic structural support, unsure of date installed.  
Designed to stop gable end bulging further and stop further roof spread.

BG to confirm whether sufficient and whether further works or replacement required

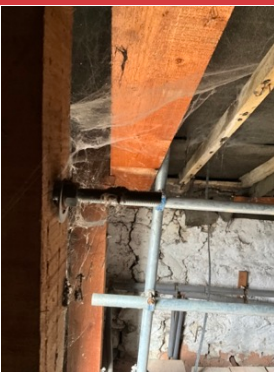
### **ISSUE 10**

Assigned To Internal  
Shows loose fixing, majority of fixings similar.

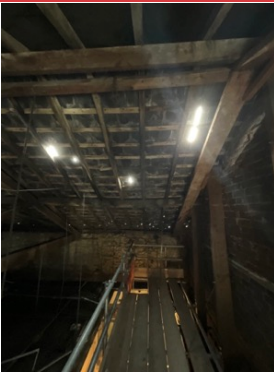
### **ISSUE 11**

Shows gaps in slates. Contractor to repair and fill gaps as much as possible without full replacement.

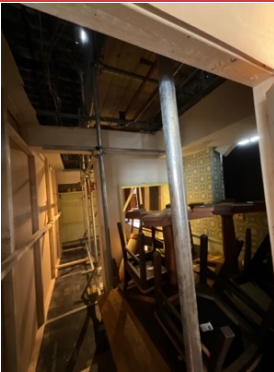
### **ISSUE 12**

Shows scaffold currently installed
