Structural Survey Report

The Britannia Inn
London Road
Headington
Oxford
OX3 7AA

Mitchells & Butlers Plc

223043/April 2023

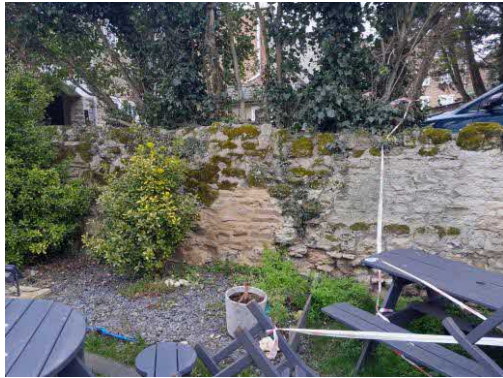
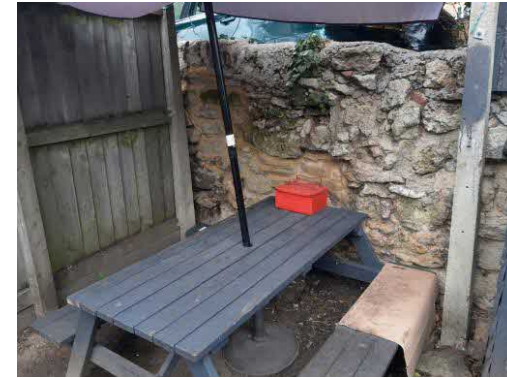
The wall is constructed from the local stone and has historically been repaired in places. See photo's 1 & 2.

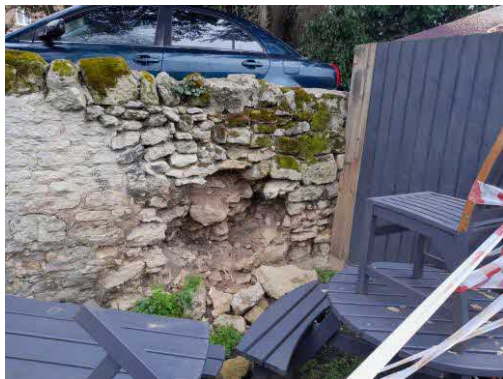
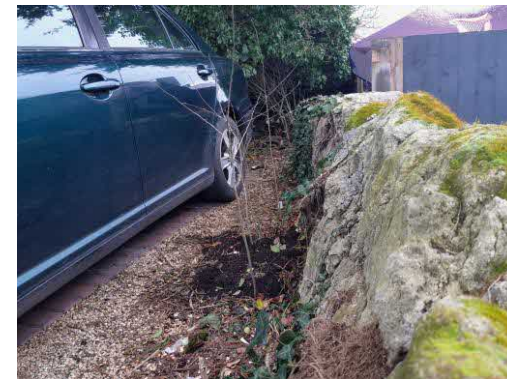
In one section the stonework has collapsed leaving a large cavity in the side of the wall. The ground level to the car park side was noted to still be stable with no signs of dipping being noted. See photo's 3 & 4.

As a priority the boundary retaining wall that has a large pocket within it should be reinstated with new stones that is fully embedded with a mortar matching the existing. As this is a boundary retaining wall appropriate approvals should be sought with adjoining owners.

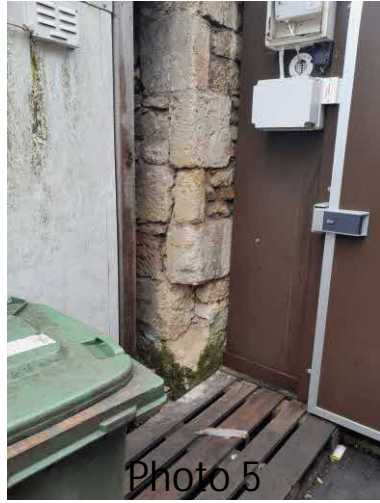
Photo 5

On the right hand side of the end corner of the building the bottom corner stone has broken away and there is a crack in the stonework extending up a couple of corner stone courses. See photo 5.

The walls to the kitchen building should have a new stone cut and placed for the corner repair along with some remedial Helical ties to stitch the crack that has developed.

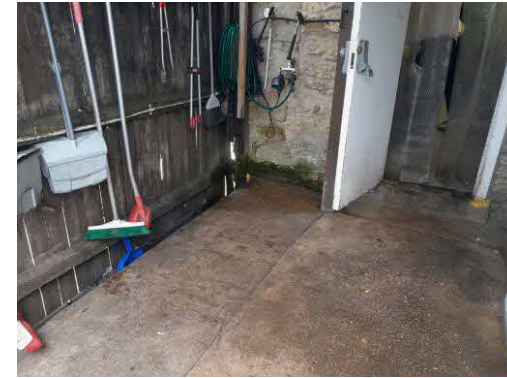
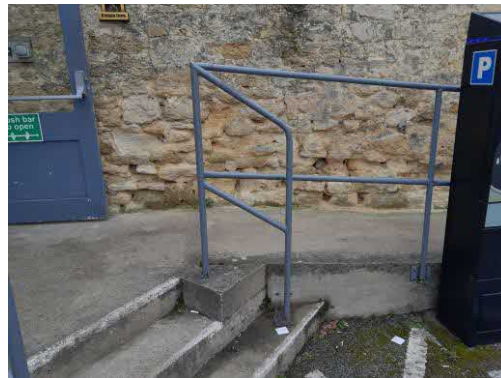
On the wall elevation facing the car park area at low level close to the disabled ramp there is an area of heavy mortar loss and some stone loss. See photo's 6 & 7.

The mortar and stone loss at low level to the elevation of the kitchen should have new stone and mortar introduced with effective bonding.

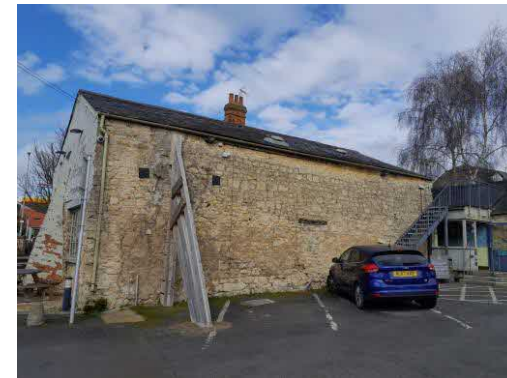
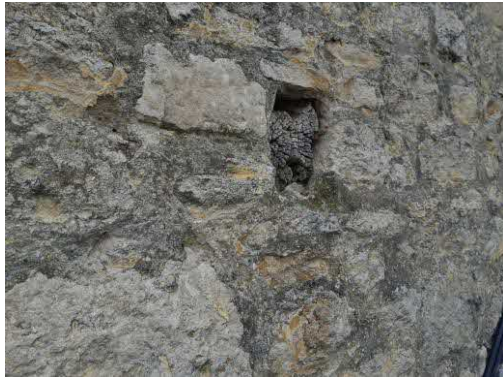
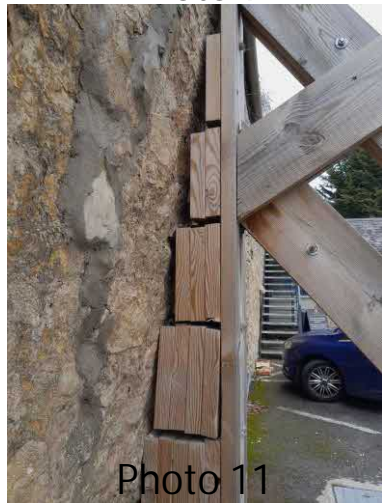
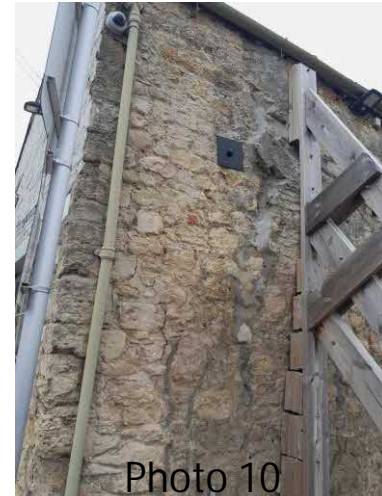
The wall is propped in one location with a timber raking shore that was provided to give restraint to some higher level bulging within the wall.

This shoring is blocked out with timber packers in places but this does not appear to be providing full restraint.

On the side corner there have been some more recent crack repairs carried out with a cementitious mortar.

In the area of the escape stair there is a pocket within the wall that has a loose timber. See photo's 8 – 11.

The rear elevation wall to the restaurant area should have the loose timber removed and the pocket infilled with a new piece of stone and mortared in place.

The timber raking shore should have additional timbers packers introduced to ensure full bearing between the wall and timber shore is provided.

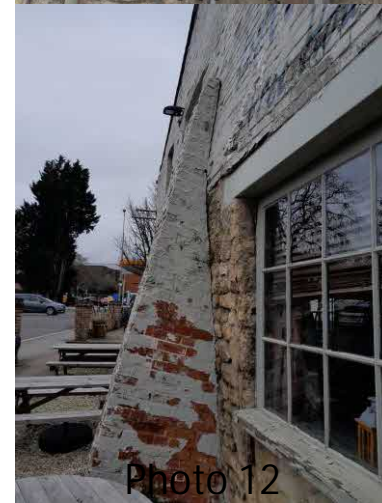
Photo 12

On the side elevation (gable end) the wall is heavily bowed and out of plumb particularly at 1st floor level.

There is a masonry raking pier that appears to have separated slightly from the main wall at high level. See photo 12.

The masonry raking pier that is separating slightly at its head should be retied to the wall with Helical ties.

The side wall at 1st floor has an extensive belly this will not have been aided with the removal of the original 1st floor. Internally the restraint of this wall seems limited and would recommend consideration is given to providing so additional back propping can only be realistically assessed if the current suspended ceiling is taken down.

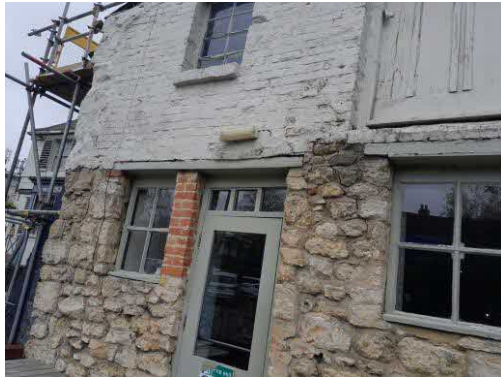
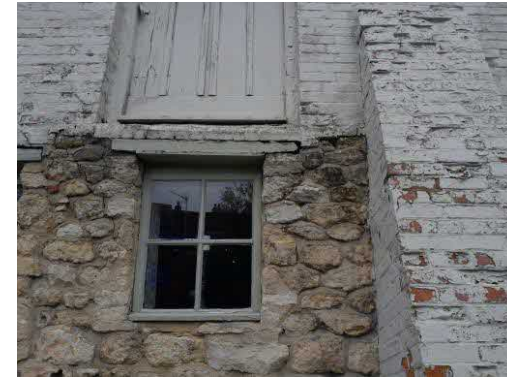
On this elevation there are 2 windows and a door at ground floor level that are provided with exposed timber lintels over. These lintels were showing signs of rot resulting in the stonework over to show signs of cracking.

Some historic mortar repairs were noted to be cracking in places. See photo's 13 & 14.

On the side elevation to the restaurant area the existing timber lintel that are currently showing signs of excessive rot should be replaced with new grade D40 oak of matching size.

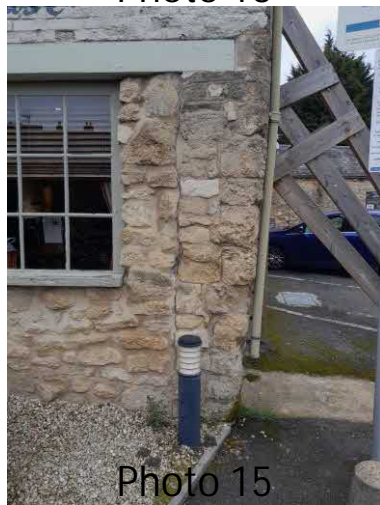
Photo 15

To the left hand side at ground floor level the window is a newer window that has been formed to the corner with the rear elevation there is a vertical crack between older and newer stonework. See photo 15.

Where there is the vertical crack at the junction of the older and new masonry this should be tied on the corner with Helical ties over its length.

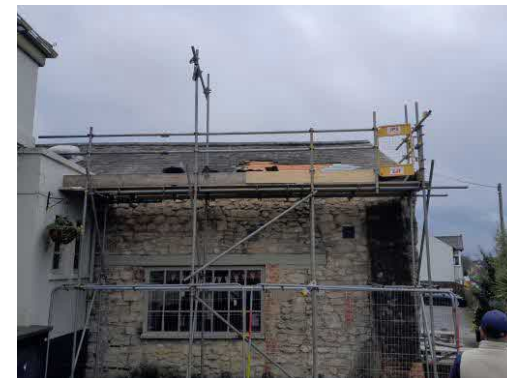
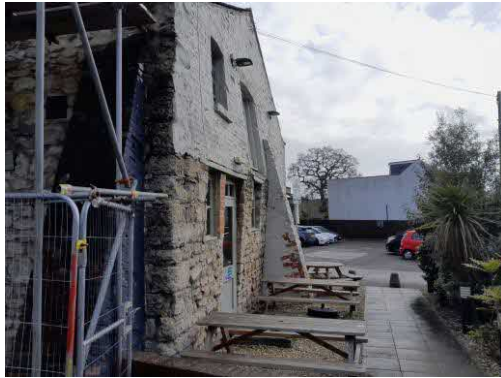
To the front elevation there is a raking masonry pier to the corner next to the side elevation. On the elevation there were no signs of distress to the wall. See photo's 16 & 17.

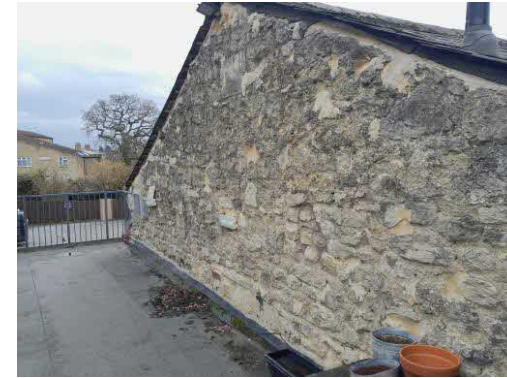
Photo 18

To the elevation at the top of the escape stairs there have been historic patch repairs with some being cementation repairs. The general condition of the wall was sound. See photo 18.

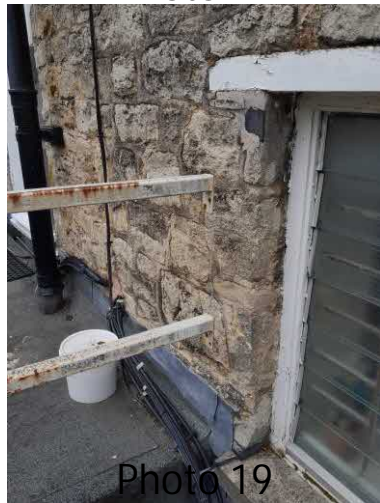
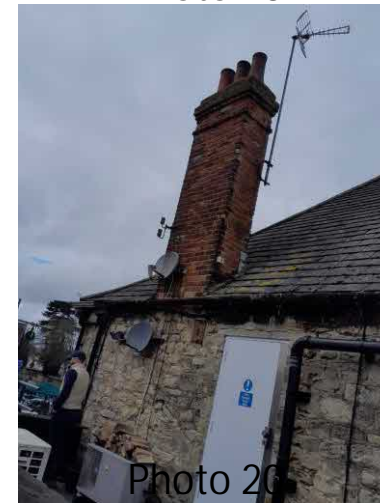
This was in a sound condition but it was noted that in one location a balustrade has detached from the wall. See photo 19 & 20.

In the area of the flat roof fire escape the handrailing that is currently not fixed to the wall should be reconnected with appropriate bolts.

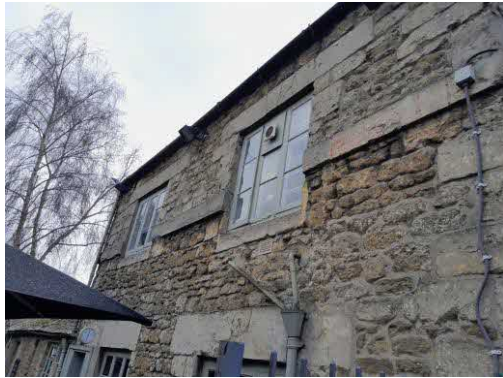
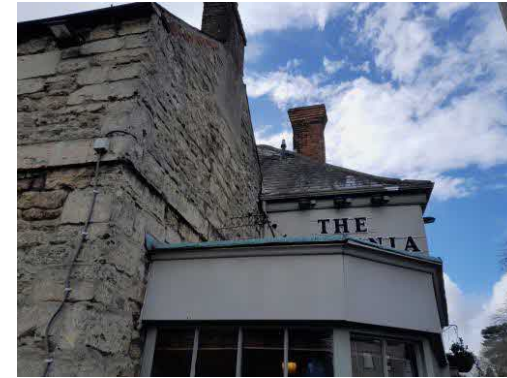
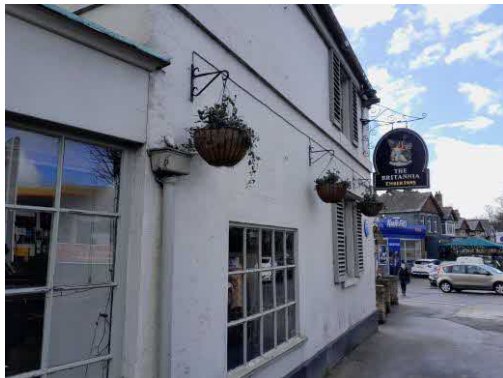
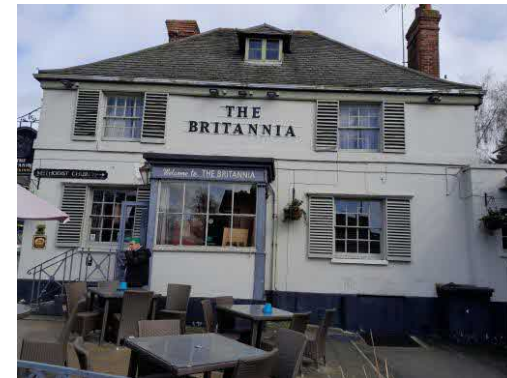
The elevation facing the beer garden was left as exposed stonework similar to the rear elevation. See photo's 21 – 24.

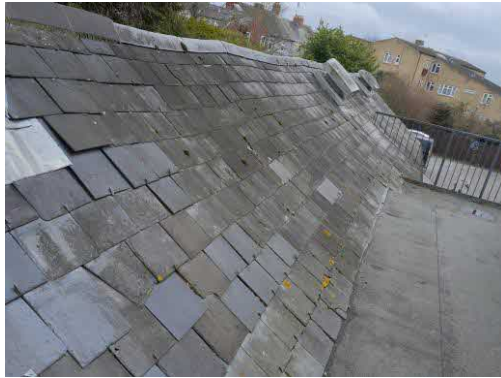
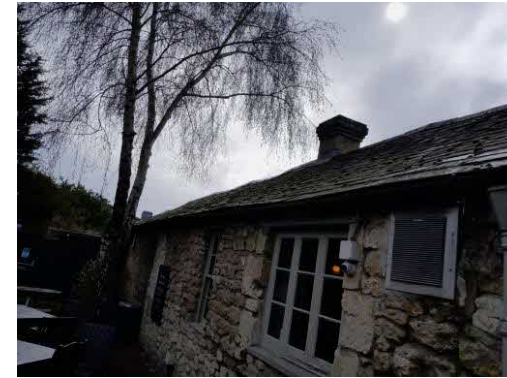
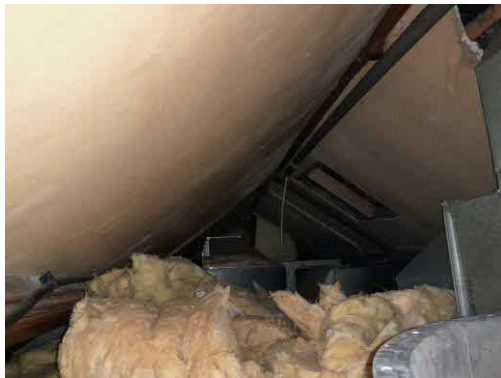
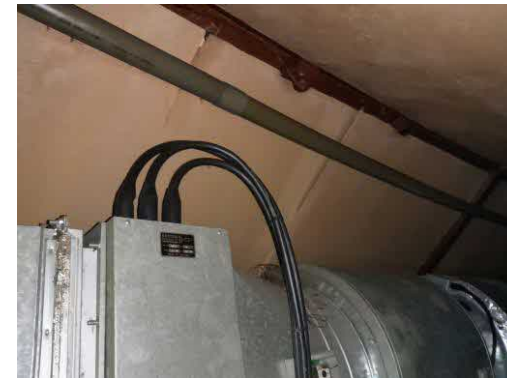
This roof is a slate tiled roof that could be seen to undulate over its length.

The tiles were in a generally good order.

Internally a visual inspection of the roof space showed this to have historically been plaster at rafter level. Where we were able to observe there were no indications of water ingress or distress. See photo's 25 – 28.

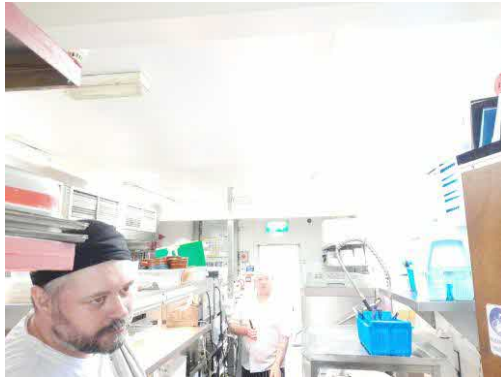
Photo 29

Within the kitchen the ceiling was noted to have a crack developing across it. See photo 29.

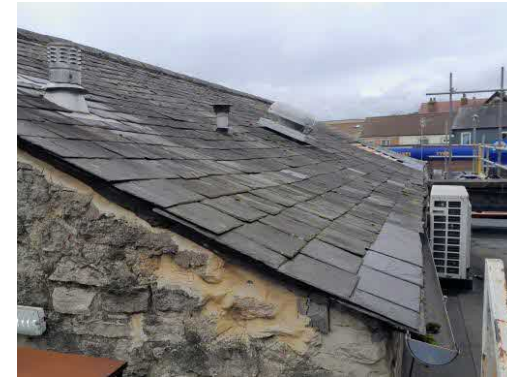
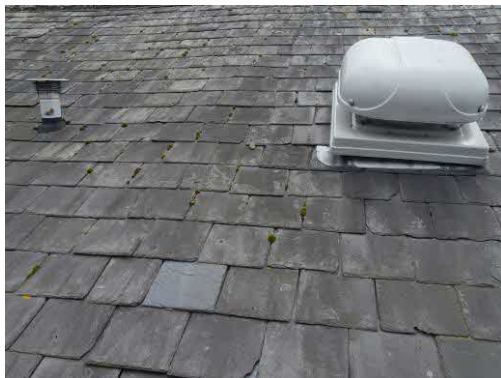
This roof was currently undergoing repairs as a result of defective flashing around a vent which had resulted in damp issues to the ceiling in the dining area. See photo's 30 & 31.

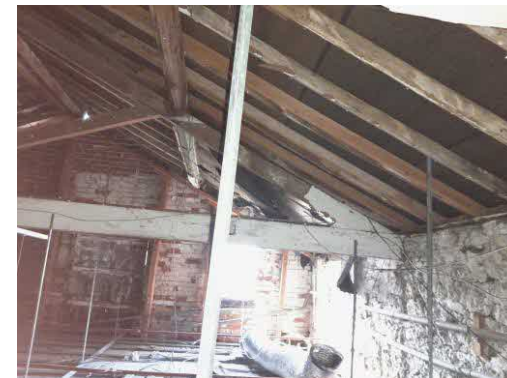
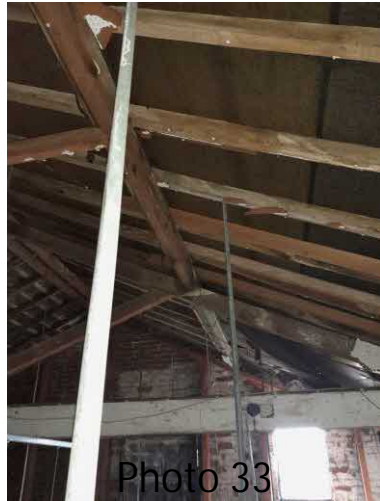
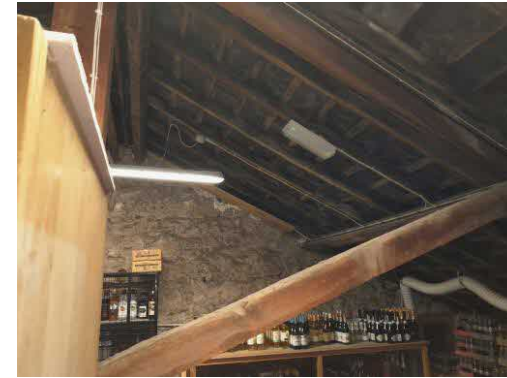
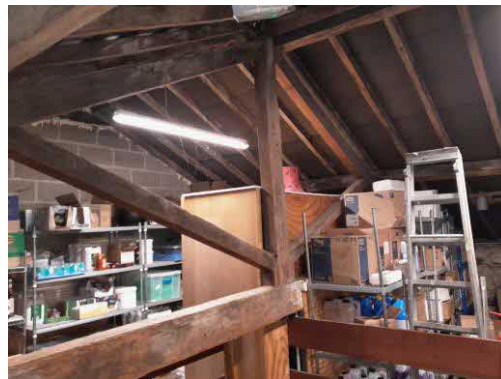
Internally to the front part of the roof the main roof structure appeared sound. The original first floor structure has been removed over the dining area and only has a suspended ceiling. Some of the rafter had signs of water staining with the back half of the roof retaining a floor area that was used as a spirits store. See photo's 32 - 35.

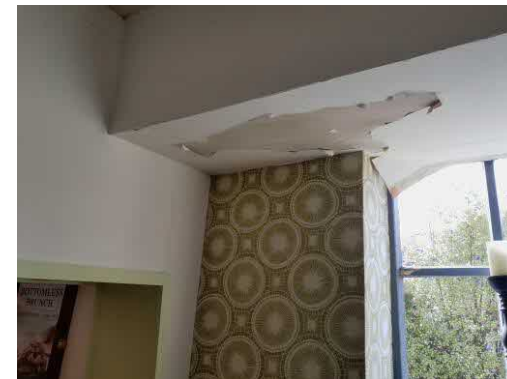
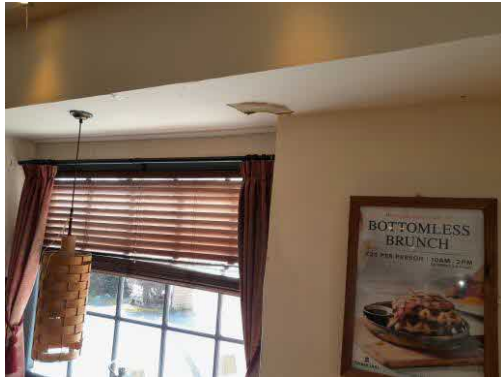
Within the dining area there were signs of further damp ingress issues to both the side elevation and back corner. See photo's 36 & 37.

The water ingress close to this elevation could be the result of water migrating laterally on the joint line of the window lintels.

We would recommend this area I stripped back to fully understand the cause prior to a solution being given.
