Arboricultural report – trees at proposed cabins site – Empshill Farm, Farmington, Gloucestershire GL54 3ND.

Report dated 9th November 2023

Appendix 2 Tree and hedge images – Empshill Farm, Farmington

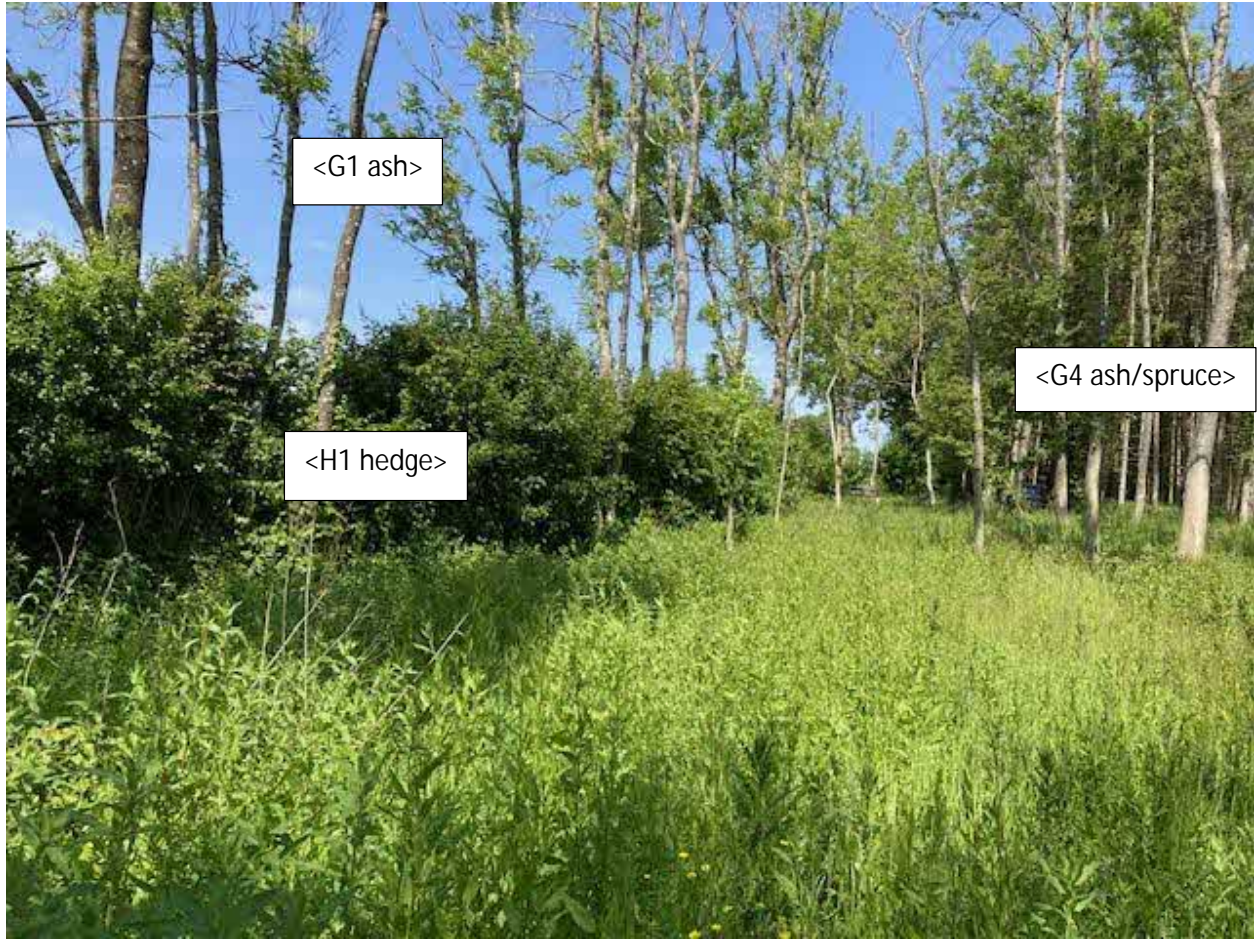
Within the hedges are groups of poor-quality , small-diameter Ash (*Fraxinus excelsior*) - shown as G1, G2 and G3 - showing clear and advanced symptoms of ash dieback (*Hymenoscyphus fraxineus*).

At G4 the declining/dead small-diameter spruce (*Picea abies*) and declining ash are not viable for retention in relation to the proposed development.

<G1 ash>

<G4 ash/spruce>

<H1 hedge>

It is recommended that these ash groups are selectively felled and replaced with more resilient hedgerow tree species such as Small-leaved lime (*Tilia cordata*), Wild cherry (*Prunus avium*), Holly (*Ilex aquifolium*) and Field maple (*Acer campestre*).

It is recommended that these trees are felled and replaced with locally-native species of trees and shrubs such as field maple, wild cherry, holly and dogwood, at the outer margins of the small-scale development as part of the soft landscaping for the project.

G1 – small-diameter diseased ash - fell from hedge H1 to facilitate construction of the access into site and western section of access track.

G4 – small-diameter diseased ash and small diameter dead/dying spruce – fell to facilitate construction of parking/turning areas for cabins and the cabin footprints.

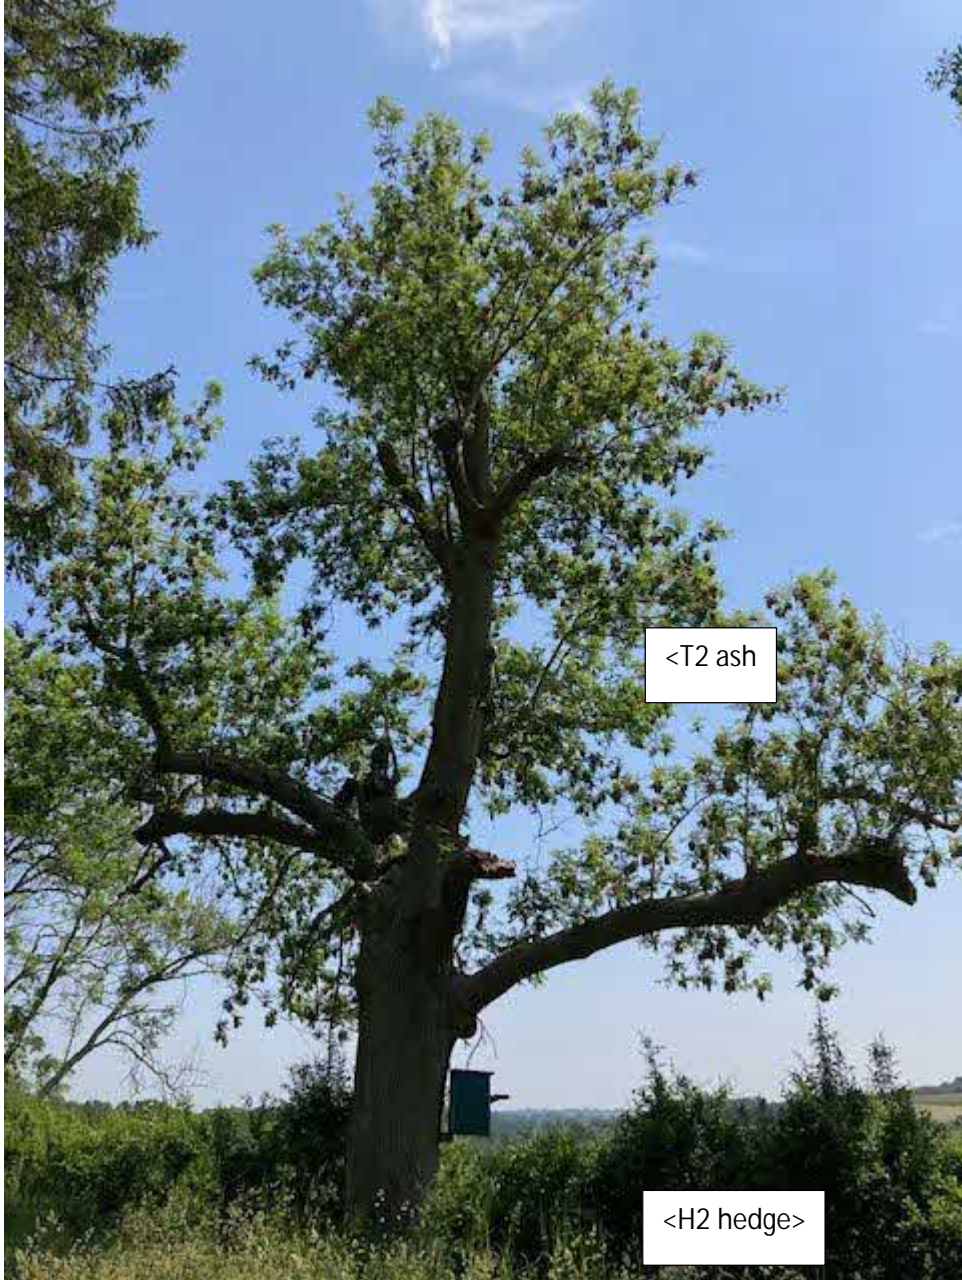
T2 ash – an overmature hedgerow ash with many old-growth features, some ash dieback symptoms and typical defects for a tree of its age and type. High habitat and landscape value and an owl box (apparently active) on its south facing lower stem.

<T2 ash

<H2 hedge>

Retain and protect T2 during development on site and use the recommended supplementary planting in hedgerow sections G2 and G3 to create medium-term ‘replacements’ for the tree as it continues to age.

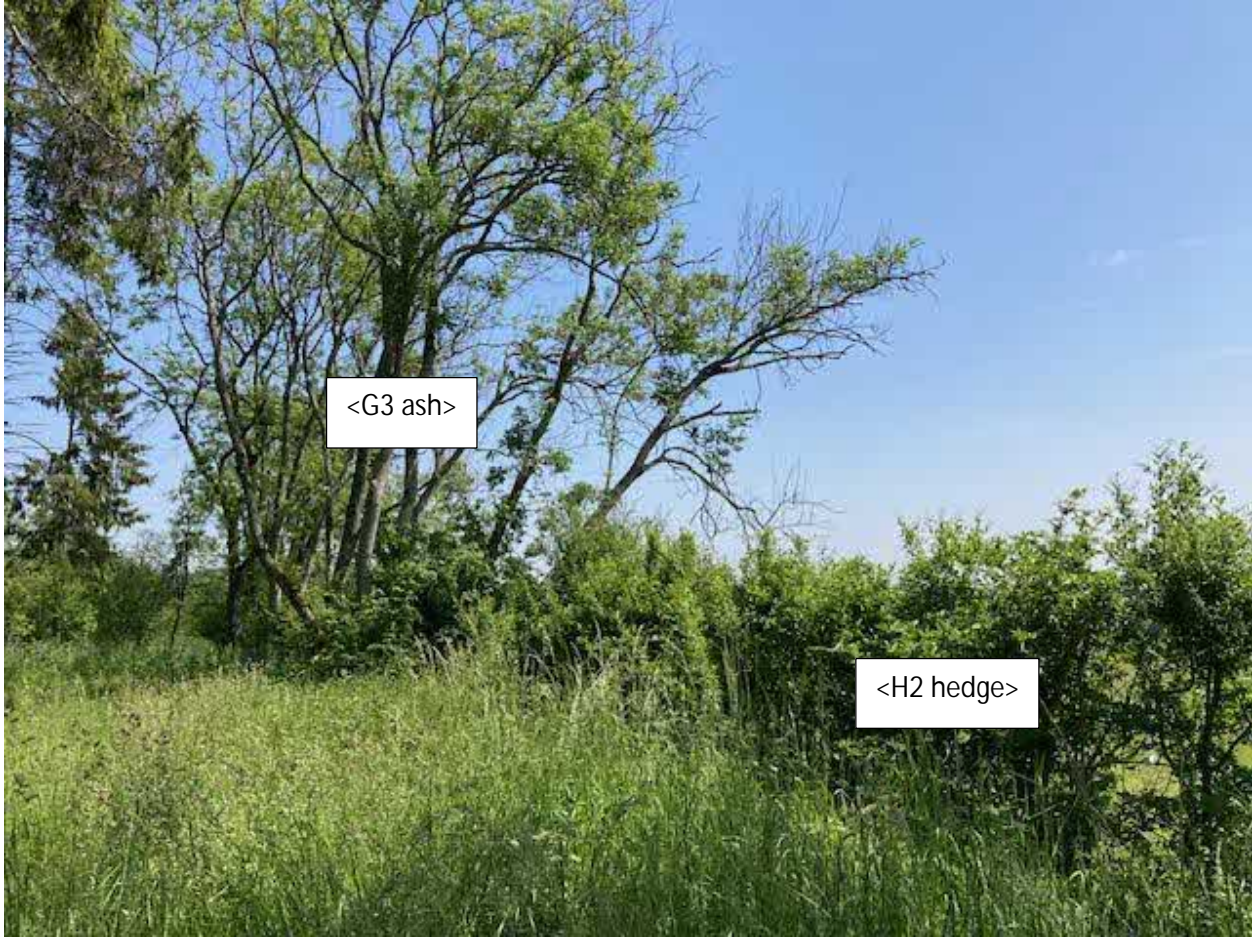
<G3 ash>

<H2 hedge>

G3 – small-diameter diseased ash – fell from hedge H2 northern section
