Arboricultural report – trees at proposed cabins site – Empshill Farm, Farmington, Gloucestershire GL54 3ND.

Report dated 21st June 2023

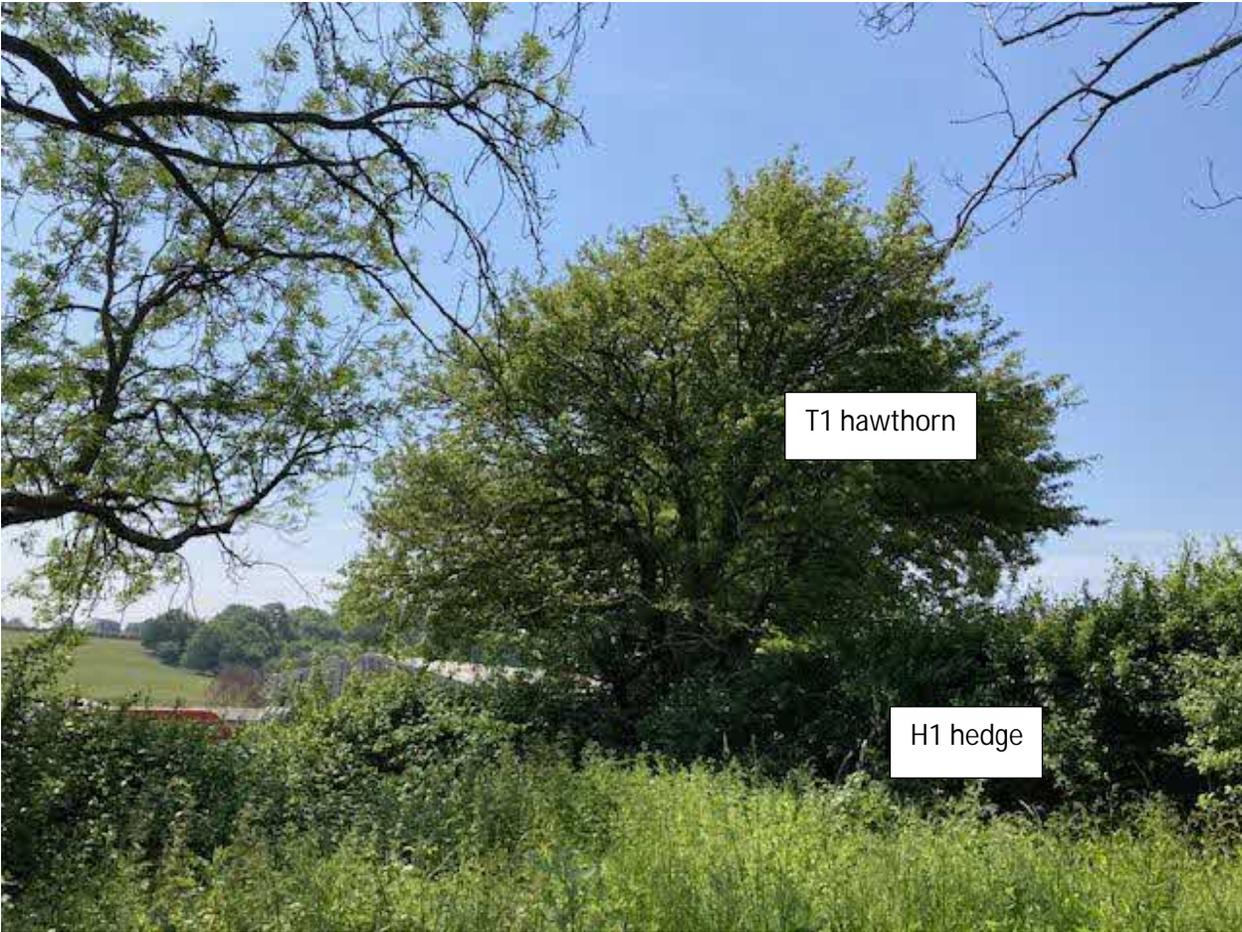
T1 hawthorn is located at the southern apex of the hedge chevron – it is sound and a valuable habitat, landscape and aesthetic feature. It should be retained and protected during any development on site.

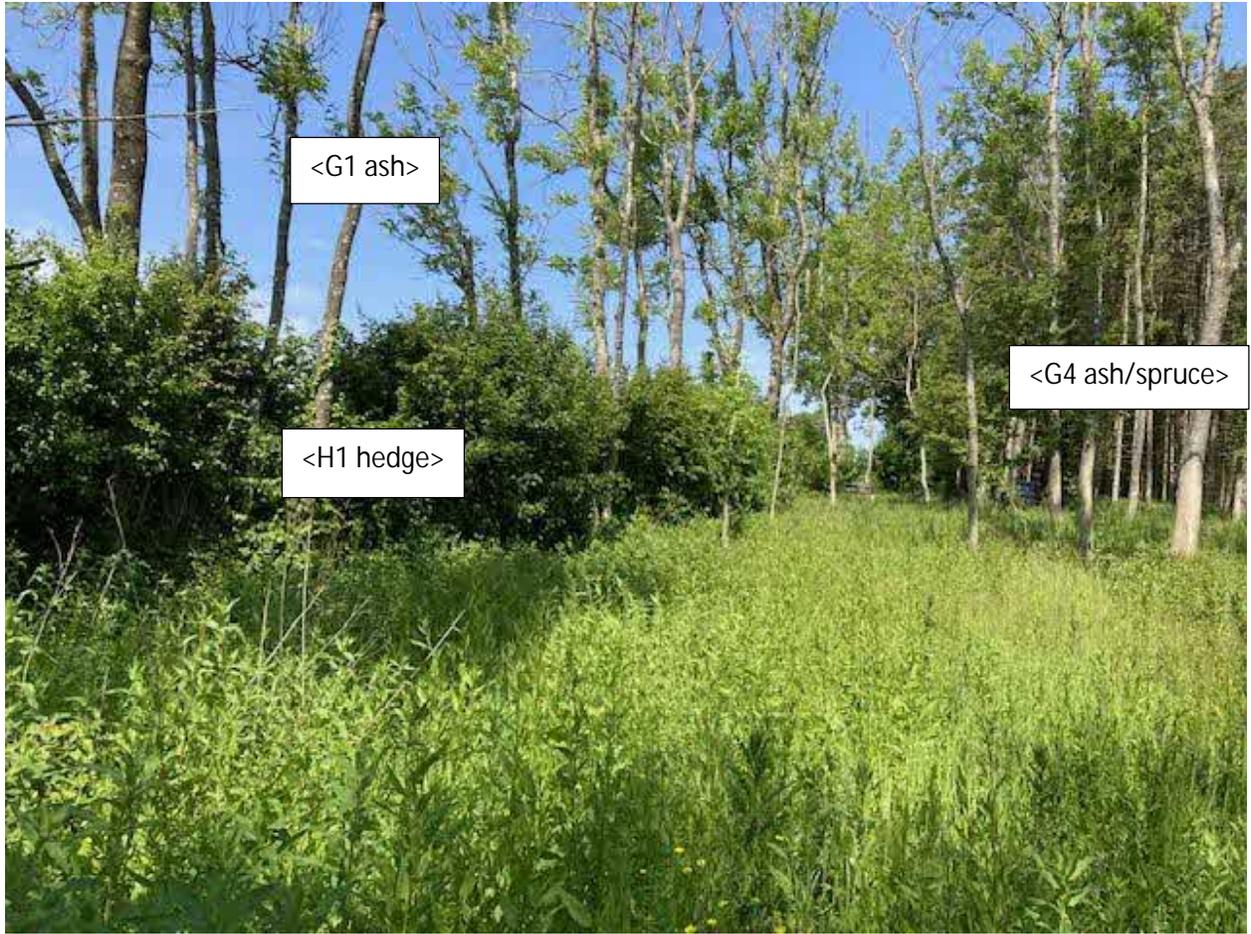
<G1 ash>

Within the hedges are groups of poor quality ash (shown as G1, G2 and G3) showing clear and advanced symptoms of ash dieback.

At G4 the declining/dead spruce and declining ash are not viable for retention in a small-scale development situation, presenting unacceptable levels of risk.

It is recommended that these ash are selectively felled and replaced with more resilient hedgerow tree species such as small-leaved lime, wild cherry and field maple.

It is recommended that these trees are felled and replaced with locally-native species of trees and shrubs such as field maple, wild cherry and dogwood.

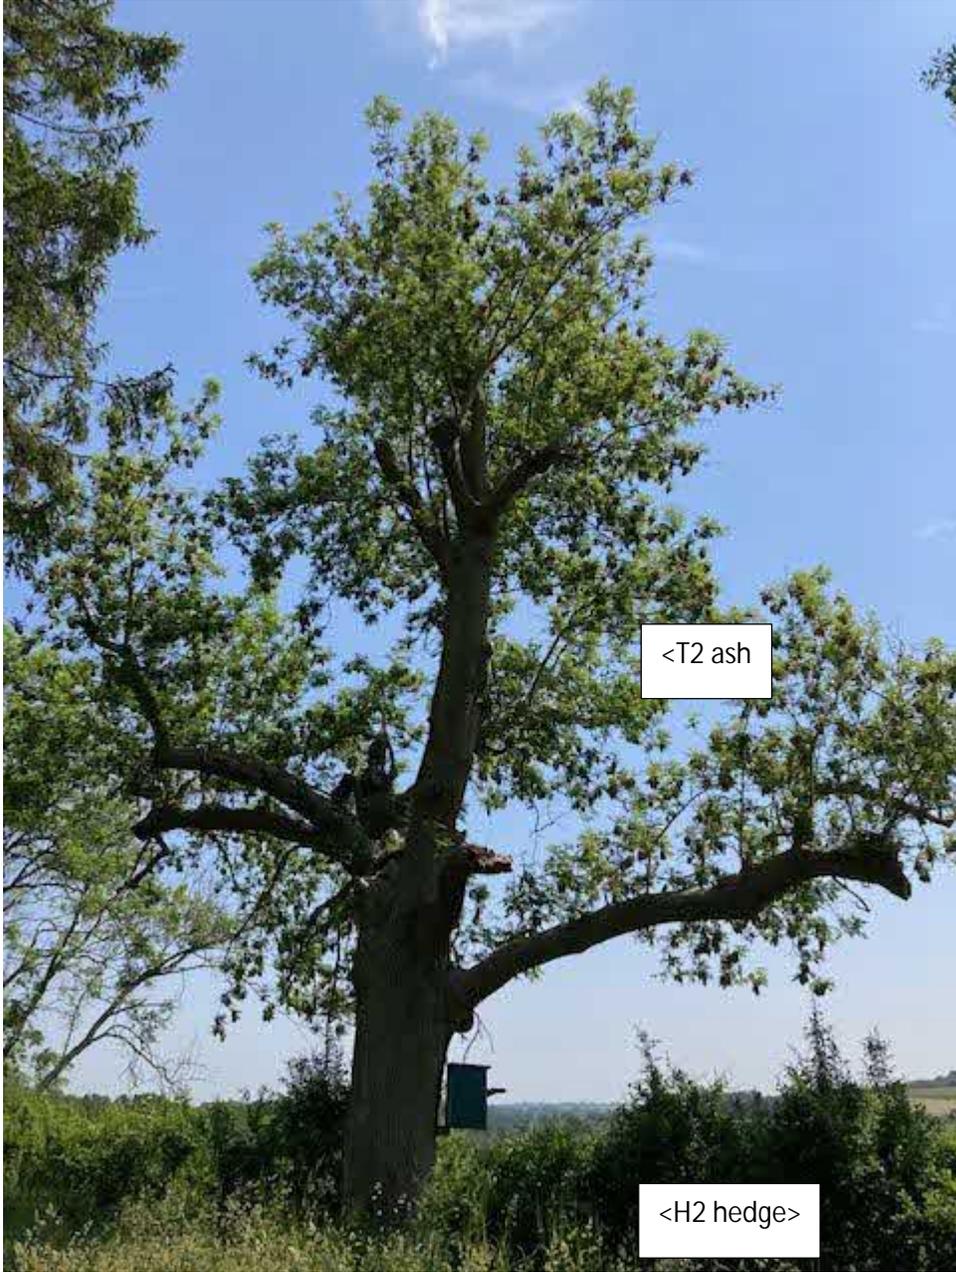
<T2 ash

T2 ash – an overmature hedgerow ash with many old-growth features, some ash dieback symptoms and typical defects for a tree of its age and type. High habitat and landscape value and an owl box (apparently active) on its south facing lower stem.

Retain and protect T2 during development on site and use the recommended supplementary planting in hedgerow sections G2 and G3 to create medium-term ‘replacements’ for the tree as it continues to age.
