Title - Survey Of 22 High Street

**Site Address – 22 High Street
Brigstock
Kettering
NN14 3HA**

Prepared By – Mark Vaudeau C.Build.E FCABE

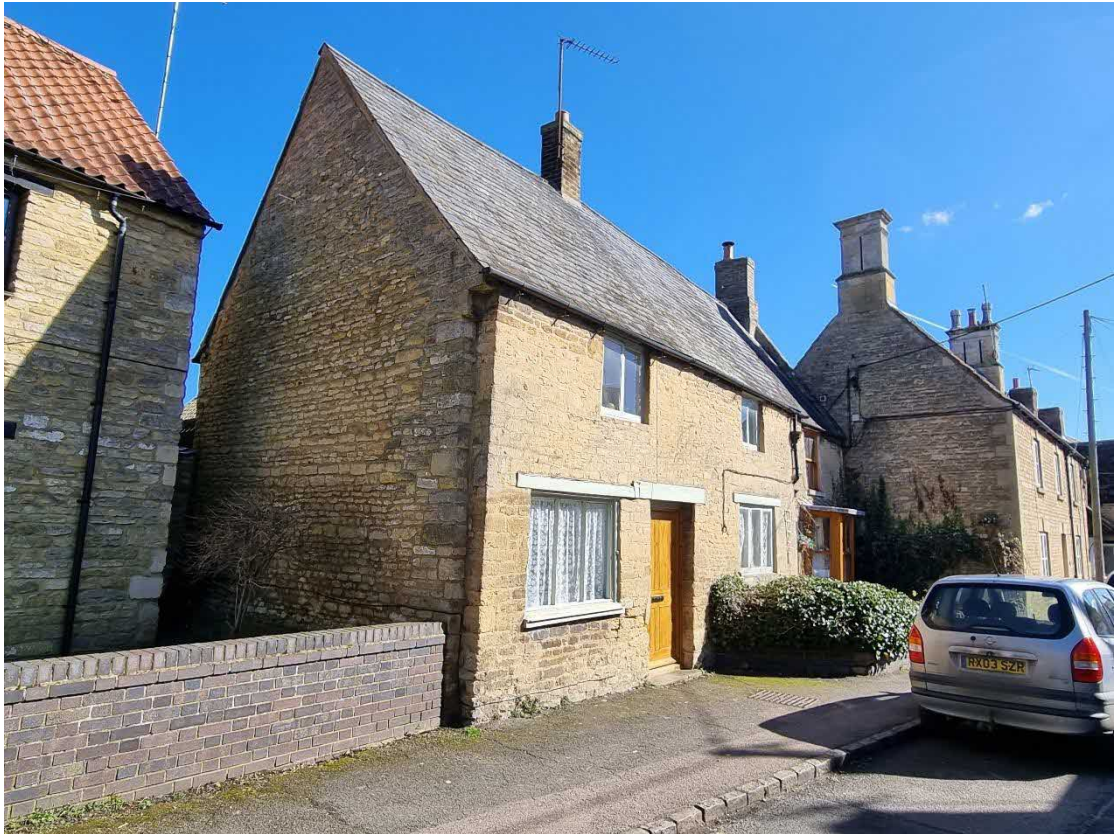
Photograph No. 1 – Front Elevation Viewed From Outside No. 24 High Street

- (1) Minor hairline cracking is present in some bed and perpend joints above the top left-hand side of the Lounge window opening. Some mortar from one joint area has spalled.
- (2) Minor horizontal hairline cracking is present in the wall panel to the left-hand side of the first floor front left-hand Bedroom window at cill level.
- (3) Minor hairline cracking is present in some bed and perpend joints above the top right-hand corner of the front door opening.
- (4) Some repointing has been carried out to a bed joint above the ground floor right-hand Bedroom window opening but no cracks have re-appeared.
- (5) The roof slopes either side of the dividing wall between the Bedrooms appears to dip slightly. The ridge line also dips slightly over the same areas.

- 1 - Mortar joints to the external elevations should be regularly checked and repointed as necessary.
- 2 - The condition of the timber to the roof construction should be checked for rot or infestation by a specialist company and treated accordingly. If the timber condition is found to be poor then strengthening the roof structurally should be considered.
- 3 - Damp to ground floor walls appears to be a problem and may be caused by either a lack of or breakdown in the damp-proof course. Older properties relied on the wall thickness to keep out damp and nor were they heated/ventilated/insulated to reduce the effects of condensation. It would be recommended that a damp specialist company check the walls and a damp-proof course (DPC) inserted or injected if necessary.
- 4 - Internal cracks should be repaired as part of normal decoration.

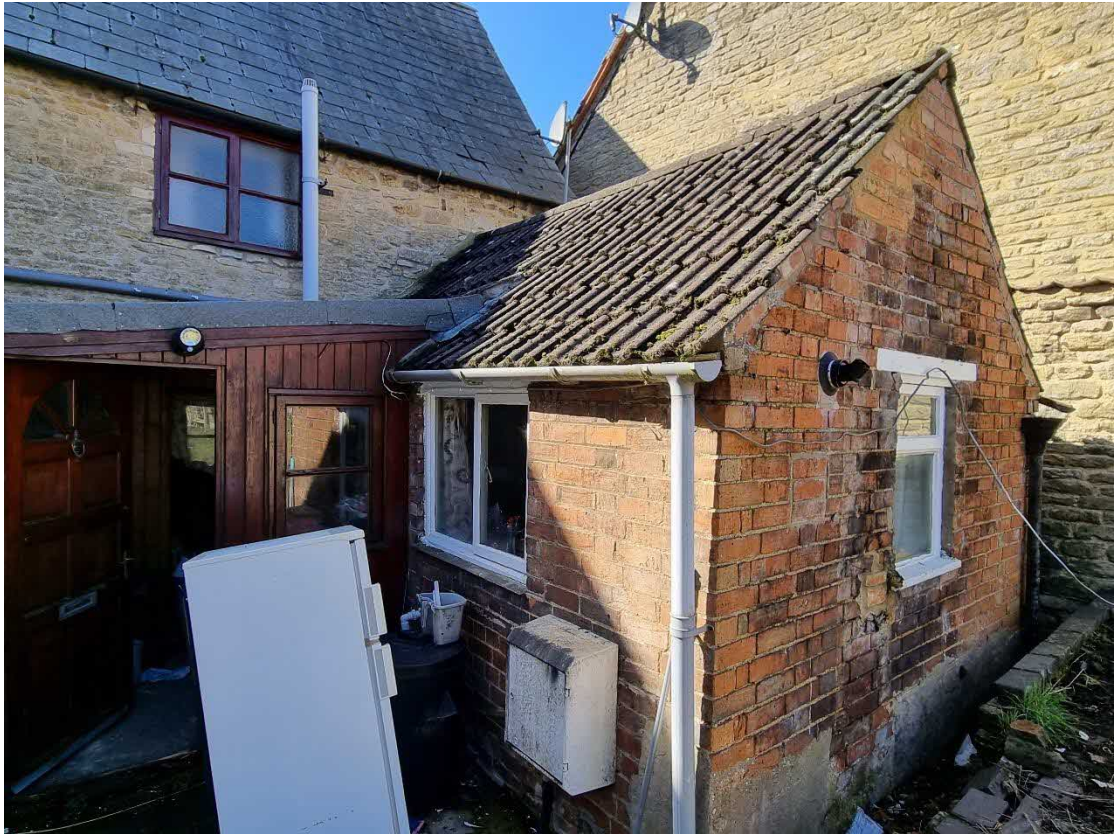
Photograph No. 3 – Rear Elevation

- (1) No discernable crack damage appears to be present to the rear elevation.
- (2) The roof slope above the rear Bathroom appears to dip slightly.

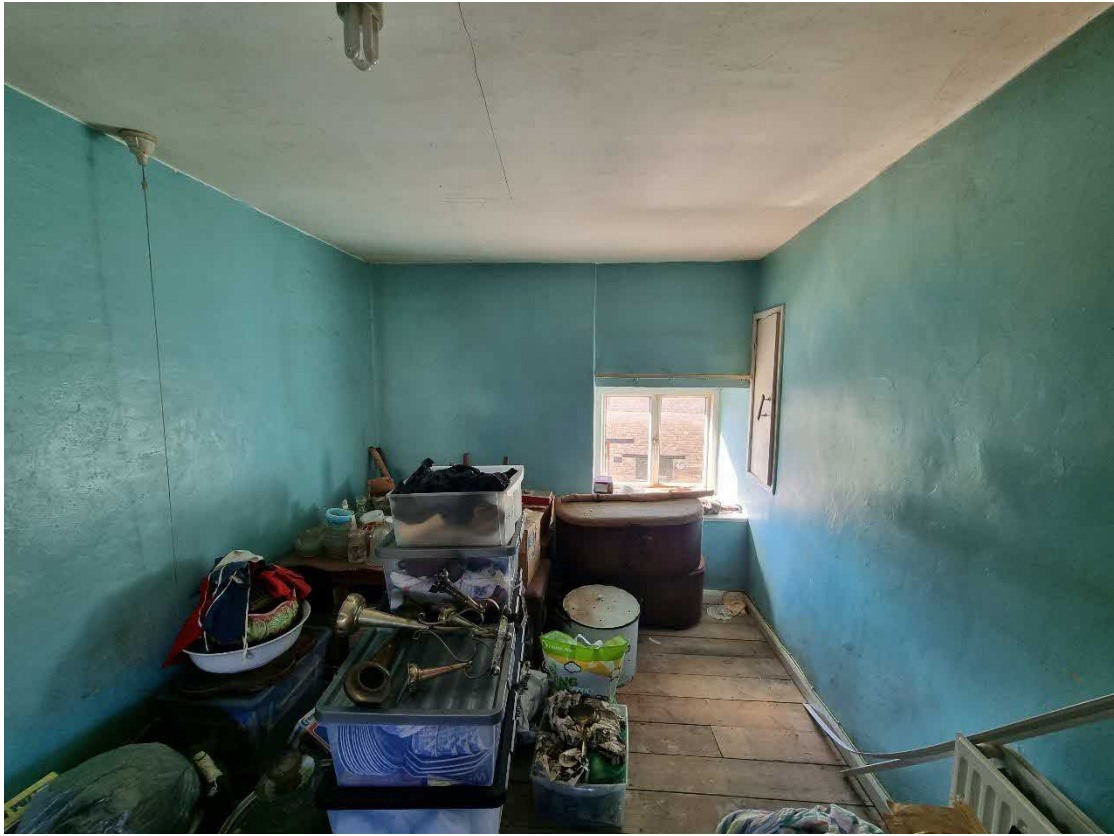
Photograph No. 11 – View On To Front Wall Of First Floor Right Hand Bedroom

- (a) The dividing wall/chimney construction to the left-hand side of the Bedroom was found to lean toward the adjacent Bedroom by approx. 5mm over the lower half of the wall and approx. 30mm to the upper half.
- (b) The rear wall, between the window and rear left-hand corner was found to lean in to the room over the upper half by approx. 15mm.
- (c) The right hand party wall, approx. half-way along its length, was found to lean in by approx. 15mm over the upper half.
- (d) The timber first floor construction was found to be level.
- (e) A 1mm wide vertical crack is present at the junction of the masonry above the front wall window and the left-hand reveal.

- (f) A vertical crack, up to 1mm in width, is present in the right-hand party wall toward the front of the property adjacent to the ceiling mounted pull switch.
- (g) A vertical hairline crack is present in the same right-hand party wall toward the rear of the property.
- (h) A hairline crack extends vertically up from the top left-hand corner of the rear wall window opening to the ceiling.
- (i) Vertical cracks are present above the door opening through to the landing. The plaster/render to one of the cracks has broken away.
- (j) There are numerous hairline cracks in the ceiling and these appear to be a plasterboard joints.

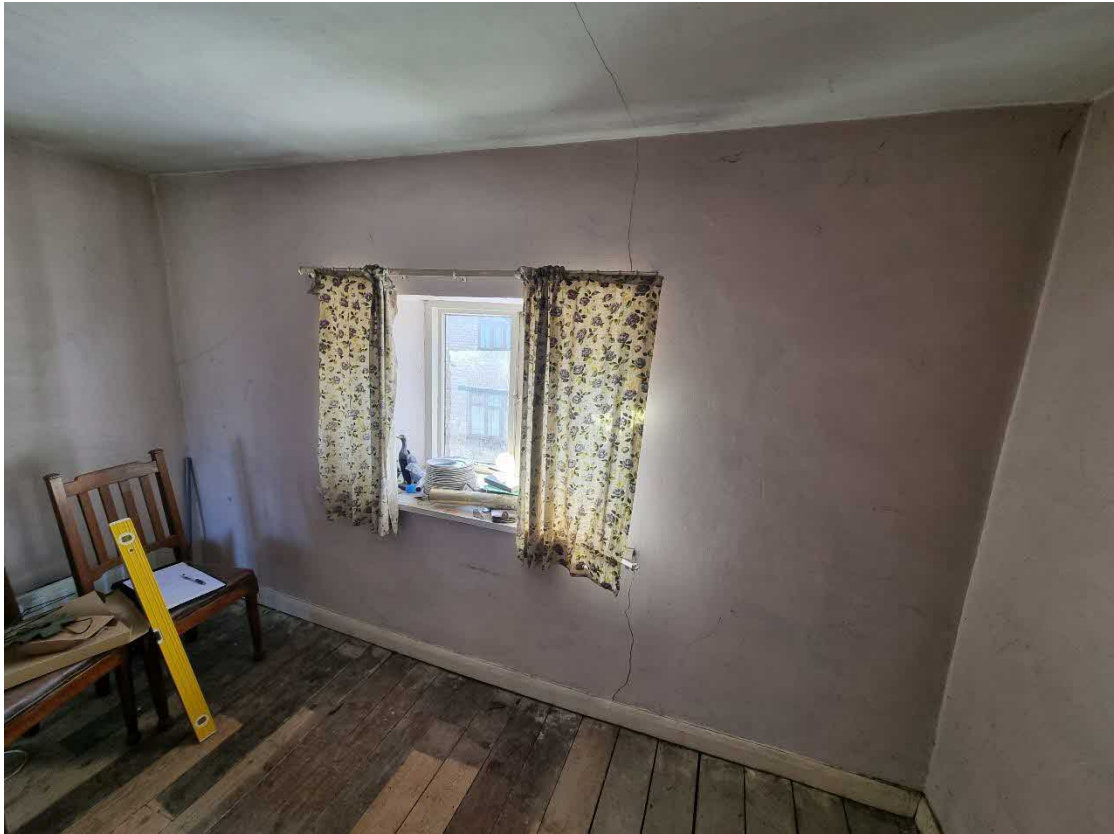
Photograph No. 13 – View On To Front Wall Of Front Bedroom

- (a) The front wall, between the window and right-hand Bedroom dividing wall/chimney, was found to be vertical over the lower half but lean in to the room over the upper half by approx. 15mm.

- (b) The front wall, between the window and left-hand gable wall, was found to lean out by approx. 10mm over the lower half and vertical to the top half.

- (c) The timber floor construction was found to slope down from the left-hand gable wall and the right-hand Bedroom/Chimney dividing wall toward the centre of the room.

- (d) Hairline ‘crazing’ type cracking is present to the plaster of the right-hand dividing wall between the left and right-hand Bedrooms.
- (e) A vertical crack, up to 1mm in width, is present at the front right-hand corner of the room at the junction formed by the right-hand dividing wall and front wall.

- (f) A diagonal hairline crack extends from the crack noted in Item (e) above from approx. mid-height of the wall toward the top left-hand corner of the front wall window opening.

- (g) A hairline crack extends up around the left-hand side of the front wall window opening to the ceiling.
- (h) A vertical crack, up to 1mm in width, extends up from the top right-hand corner of the front wall window opening to ceiling level. This crack then extends across the ceiling to the Bathroom dividing wall.

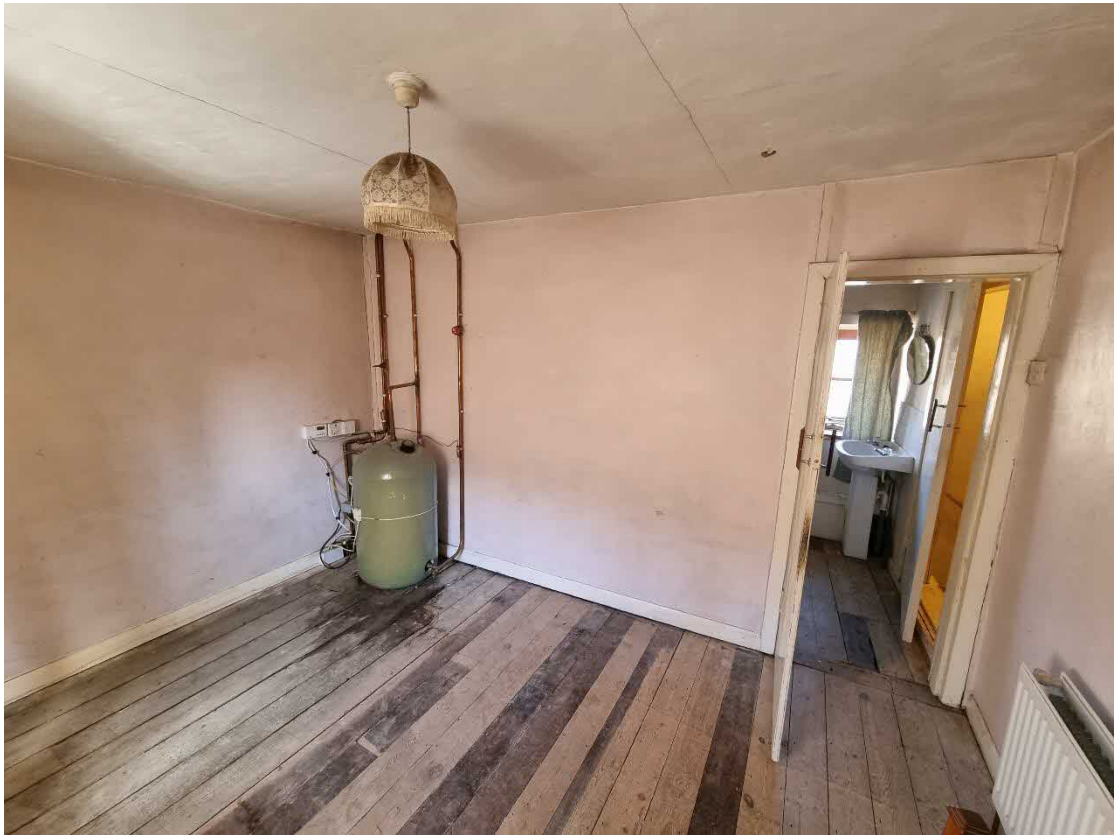
Photograph No. 14 – View On To Front Bedroom/Bathroom Dividing Wall

- (i) Two hairline near vertical cracks are present in the left-hand gable wall.
- (j) Vertical cracking, up to 2mm in width, is present to the junction of the left-hand gable wall and the Bathroom dividing stud wall.

- (k) A vertical crack, up to 1mm in width, is present in the timber studwork above the door opening to the rear Bathroom.
- (l) A crack, approx. 1mm in width, is present in the ceiling, similar to the one noted in Item (h) above, in line with the top left-hand corner of the front wall window opening.

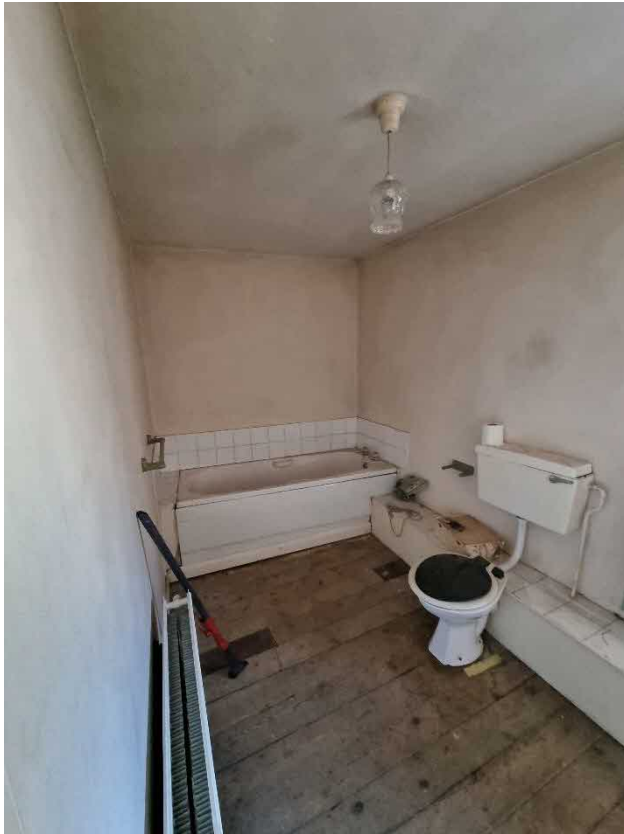
Photograph No. 15 – View On To Rear Bathroom Gable Wall

- (a) A vertical crack, up to 1mm in width, is present at the rear left-hand corner of the Bathroom. This crack extends across the ceiling, parallel with the left-hand gable wall, toward the front Bedroom dividing wall.
- (b) A vertical hairline crack is present in the front Bedroom dividing timber stud wall adjacent to the gable wall.

- (c) The floor construction was found to slope down from the left-hand gable wall toward the centre of the Bathroom and from the rear wall down toward the front Bedroom dividing wall.
