STRUCTURAL APPRAISAL AND REPORT ON
DETACHED BARN 1 AT BROOKSIDE FARM, MAIN ROAD,
PONTESFORD, SHREWSBURY SY5 0UA

Job Number: 21/120
Date: 20th October 2021

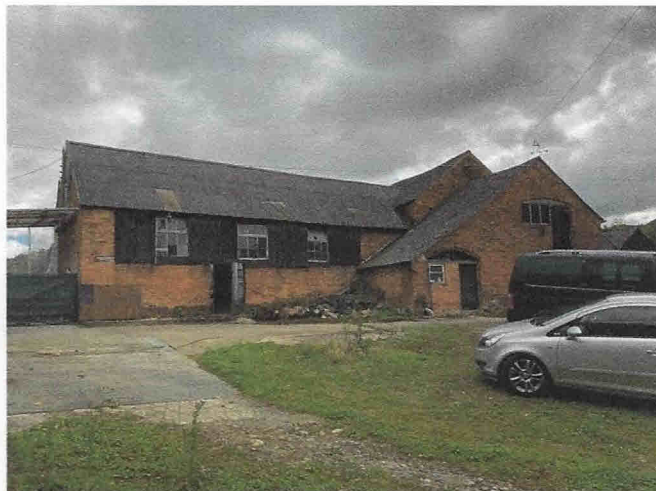
The triangular section of brick wall above the dairy roof line leaned outwards.

The lower section of wall to Cow Barn 4, adjacent to the ground, was showing signs of damp and weathering, with some perished bricks, but overall was considered to be in reasonable structural condition.

A tie bar was present to the South Western end, at wallplate level, coinciding with the area of distorted brickwork by the dairy, as noted in 4.1.1. This localised area of wall will require rebuilding during the works.

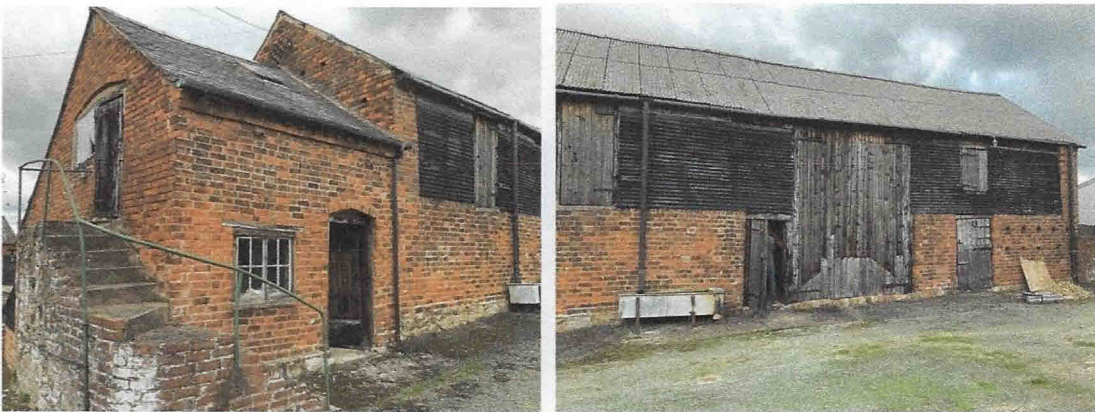
The roof covering to the tool shed/store was slate and there were undulations to the roof line, with a dip towards the eaves, indicating deflection of the supporting structure.

The timber lintel over the tool shed window opening sloped.

The main roof (over Cow Barns 1-3) was covered with some form of corrugated sheeting and the roof line undulated along its length, again suggesting deflection of the supporting structure.

The main elevation to the Barn was clad with metal sheeting above first floor level, with brickwork below. Whilst the brickwork was seen to be in relatively good condition, it leaned outwards below the sheeting line, likely to be due to roof spread and associated movement of the upper framing. This will need to be considered further.

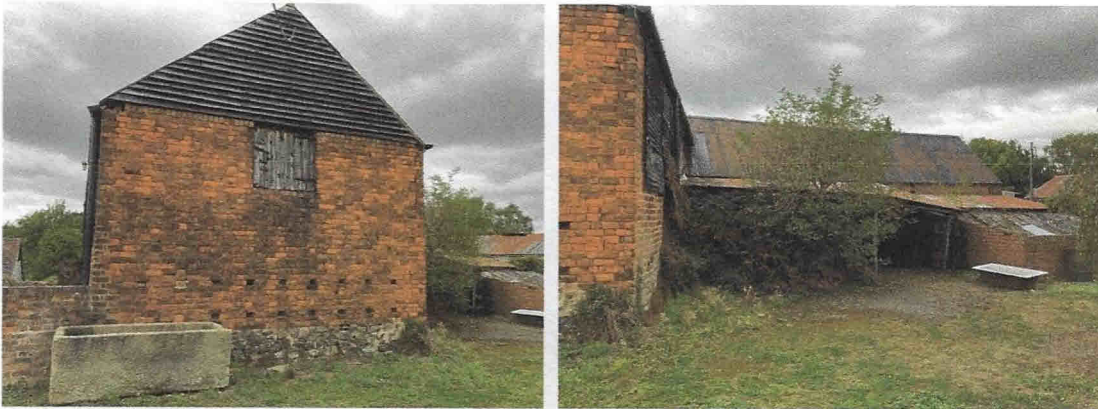
The apex of the gable to Cow Barn 3 was clad with timber and at both eaves positions, the ends of the wallplates were visible, with an adjacent area of weathered/cracked bricks, possibly due to water discharge.

Brickwork below the hatch opening to Hay Loft 2 was weathered, with open joints, although the remainder of the elevation was generally sound, including the stone band at low level.

The elevation was predominantly brickwork, with embedded timber posts. The right hand post was showing signs of decay at the top and will require attention or replacement.

Low level stonework was random and will require attention.

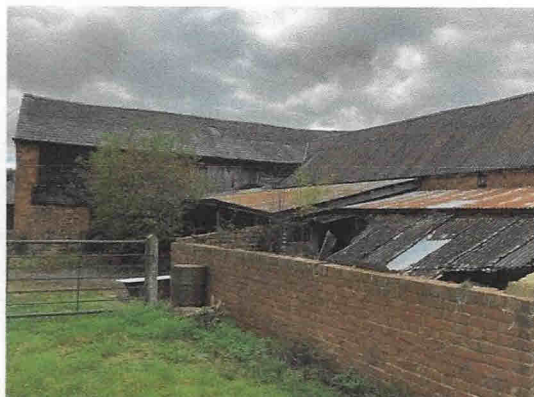
The lower section of wall to Cow Barn 3 bulged outwards significantly adjacent to the South Eastern gable and localised rebuilding will be required.

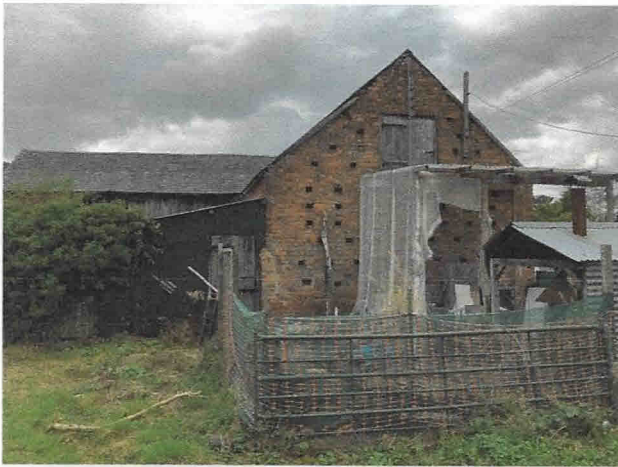
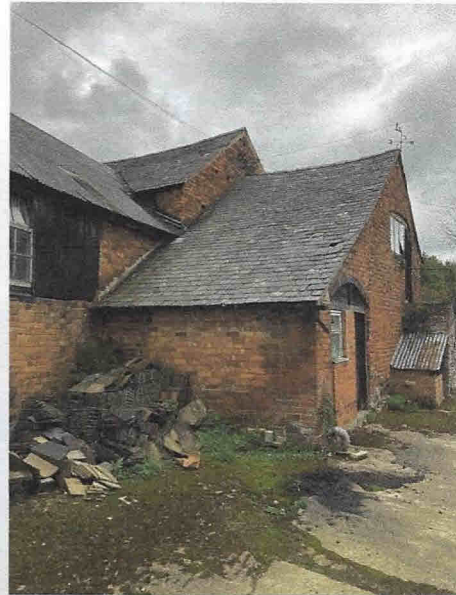
Brickwork to Cow Barn 4 gable apex was fractured above the hatch doors, indicating lack of adequate lintel support and this section will need to be carefully taken down and rebuilt.

Purlin ends were visible to the same gable and the remainder of the elevation was considered to be in acceptably sound structural condition.

The slated roof line and brickwork to the dairy were seen to be in reasonable structural condition.

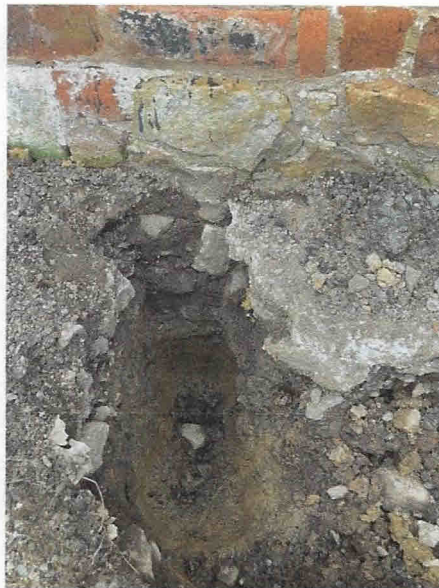
Adjacent to the South Western personnel door opening to Cow Barn 3, a trial pit had been excavated on my prior recommendation, to expose the existing foundation detail and nature of near-surface soils.

The pit revealed that the wall extended down with no spread, to approximately 400mm below external ground level, bearing in to stiff yellow/grey/brown clay.

The foundation detail exposed in the trial pit adjacent to Cow Barn 3 was considered to be reasonable for the type of building, but will require enhancing as part of the conversion to habitable accommodation.

- 6.7 Install suitably designed lintels over structural openings. Timber lintels to the external wall face will not be acceptable and should be removed. Designed steel beams will be required where it is proposed to remove walls.
- 6.8 Excavate further trial pits to establish foundation details and depths throughout and carry out remedial works as deemed appropriate. Should depths and conditions permit, it may be feasible to provide a thickened edge to a new concrete floor slab, connected to existing walls using drilled and resin grouted dowels, thus providing a monolithic slab/wall diaphragm.
- Alternatively, if levels/conditions do not permit this, underpinning will be required.
- 6.9 Provide new ground floor slab and damp proofing.
