Tree Condition Assessment for Lady Smyth's Almshouses, Long Ashton

28th November 2023

Lady Smyth's Almshouses
13-27 Long Ashton Road
Long Ashton
Bristol
BS41 9HW

Almshouses_Cedar_TCA_112023

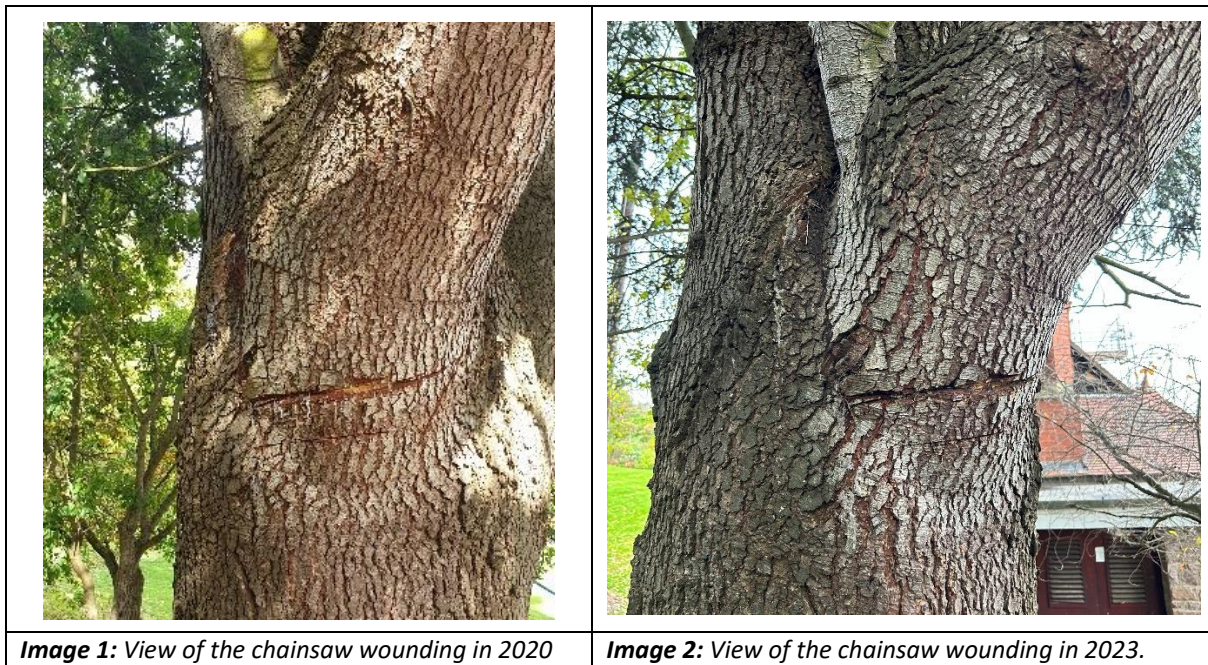
- 5.4 There is a large south facing limb at 2 metres that was deliberately and significantly wounded in 2020 with a chainsaw at the branch collar (images 1 and 2). Following my 2020 assessment I considered it likely that the large south facing limb would slowly die back from the ends and potentially die altogether, this has not happened and the foliage on the south facing limb appears relatively unaffected with normal size needles, no dieback and dead wood that is relatively normal for the species.

- 6.1 The chainsaw wounding inflicted on T01 in 2020 has had remarkably little impact on the branch and has not resulted in the anticipated level of dieback and dead wood. Considering the current condition of the branch I do not consider any mitigation works are now necessary in response to the wounding.

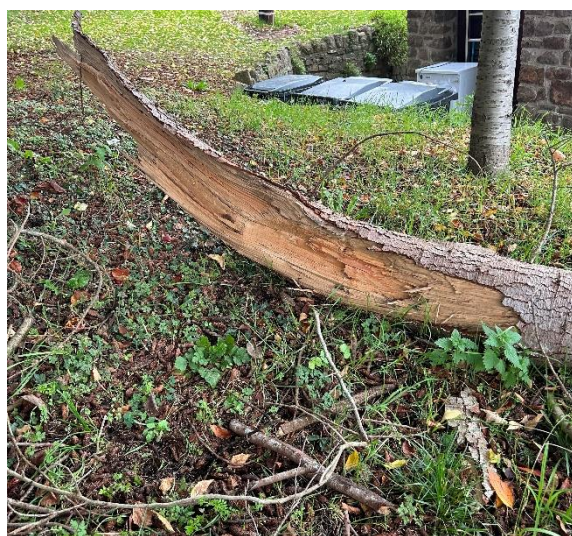
- 5.5 A large scaffold branch had recently failed from the east side of the crown causing significant damage to the adjacent building and bringing down power lines and a utility pole. The fallen branch had been stacked at the base of the tree so I was able to inspect the failure wound and I found there was no decay evident at the point of failure (image 3). A resident informed me that the branch failed the day after a 'very windy day' and a further resident showed me photographs taken of the failed branch on the 29th September suggesting that the failure occurred at between 3.00am and 4.00am on the 29th.

- 5.6 Storm Agnes impacted the UK on the 27th and 28th September, although winds in the south-west were not particularly strong, with wind speeds recorded at the Bristol Airport Station¹ of 22mph with gusts of up to 37mph (moderate gale). It is likely that these winds resulted in damage to the limb on the 28th that resulted in the subsequent failure on the 29th.

Image 3: The recently failed east facing limb with no visible decay at the point of failure.

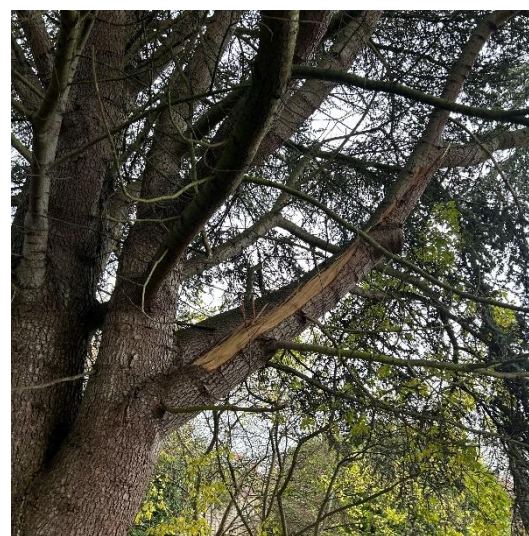
Image 4: The remaining stub of the failed east facing limb with no visible decay at the point of failure.

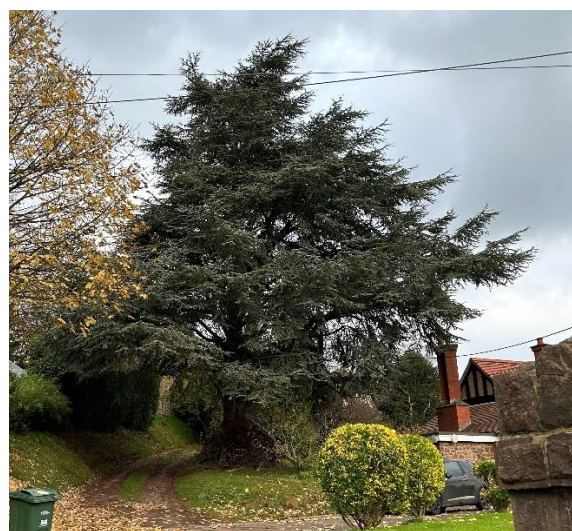
5.7 In my 2020 assessment the limb that recently failed along with three further limbs were identified as protruding from the crown form, with heavy end weight and in a position exposed to wind stress. A recommendation was included for the reduction of the length and end weight of these branches in combination with the removal of the wounded branch, the recommendations were not implemented. Following the recent failure of the large west facing limb, there are now three remaining branches that are extended from the crown form (images 5 and 6) and are exposed to a significant increase in wind stress with potential for failure during future high wind events.

Image 5: View of T01 from the south with exposed branches extended from the crown form to the east (right of picture).

- 6.2 The recent large limb failure to the east has exposed the remaining east facing branches to a significant change in wind stress dynamics and it is likely that if left unpruned there will be further branch failures to the east which have the potential to cause significant issues as the branches overhang the building and power lines that have recently been repaired.

- 7.1 Reduce 3 x extended and exposed lateral limbs to the east by 3-4 metres to create a uniform crown shape as feasible.
- 7.2 Reduce all limbs extended from the crown form around the remainder of the crown by 1-2 metres to create a uniform crown shape as feasible.
- 7.3 Reduce height by 2 metres.
- 7.4 Tree works must be carried out by reputable, skilled and insured tree work contractors working in accordance with the guidance contained within BS3998: 2010 Recommendations for Tree Work. A list of contractors approved by the Arboricultural Association can be found at the following link: <https://www.trees.org.uk/ARB-Approved-Contractor-Directory>

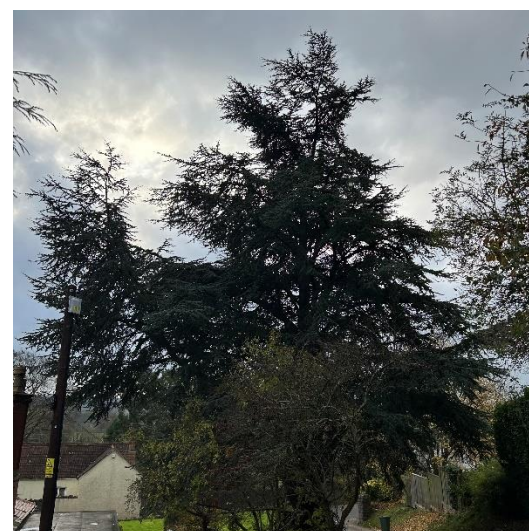
Image 6: View of T01 from the north with exposed branches extended from the crown form to the east (left of picture).

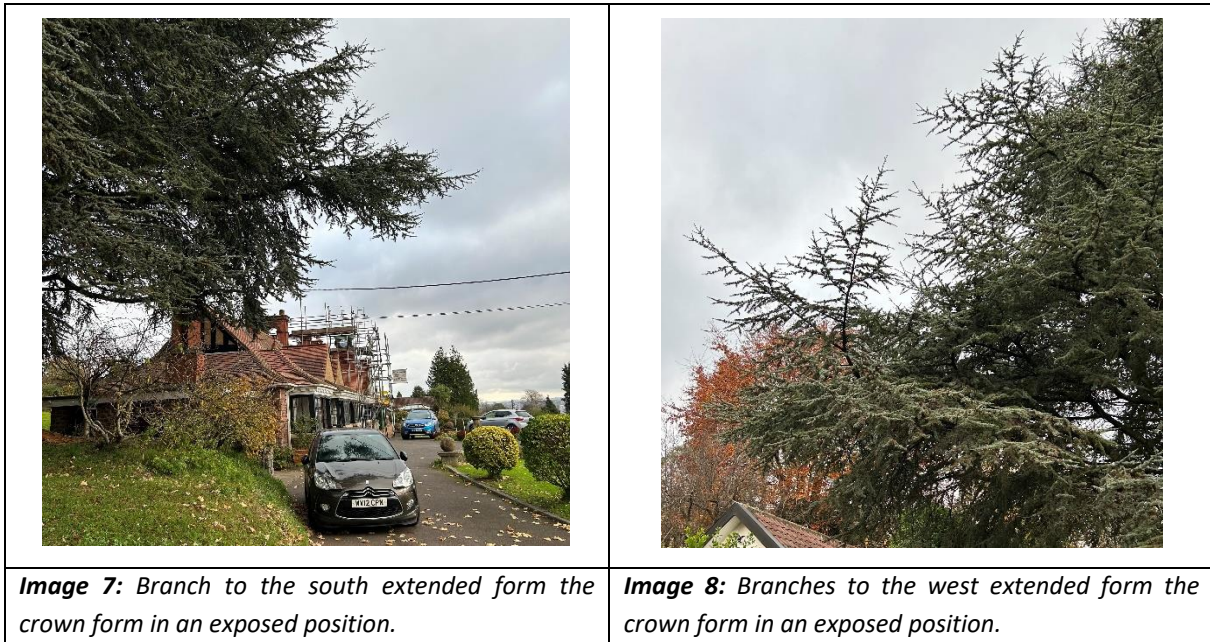
- 5.8 There are several branches around the remainder of the crown (images 7 and 8) that are also extended from the general crown form and subject to wind stress which could potentially cause failure, which would result in small diameter branches failing into the access roads to the south and west.

- 6.3 The exposed branches around the remainder of the crown have potential for failure but with less consequence than the branches to the east that overhang the building and electrical infrastructure. A minor reduction of extended branches to create a uniform crown shape will help to evenly dissipate wind stress and help prevent further branch failures as a result of high winds. Images 09 and 10 below are an approximate indication of where pruning will be necessary to produce a uniform crown shape. This is an indication only and the exact location of pruning cuts will have to be determined by a skilled climbing arborist.
