**APPENDIX B**  
**CK CONSULTING AND GEOTECHNICAL LIMITED**  
**GEOTECHNICAL REPORT ON GROUND CONDITIONS**  
**NOVEMBER 2022**

The subject site is located at 15 Gordon Close, Sandown, Isle of Wight and comprises a detached bungalow with garden areas to the north and south of the property. The building has undergone movement causing cracking of external and internal walls, over the entire property, of varying magnitude. A ground investigation was requested by the appointed consultant engineer, Frankham Consultancy Group Ltd, to provide information on the ground conditions underlying the site, existing foundation type and likely cause(s) of building movement.

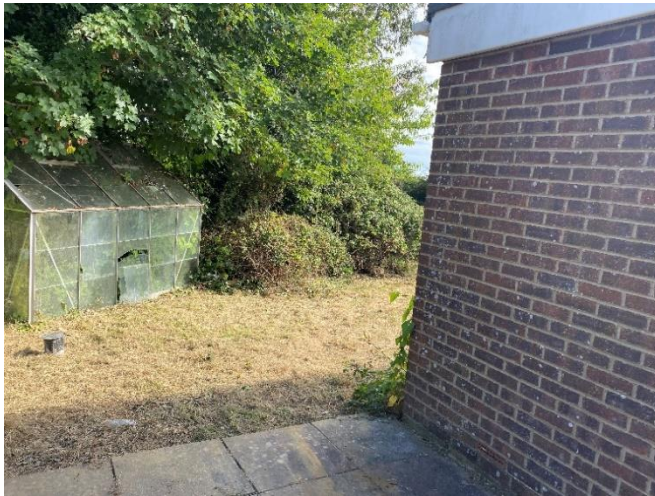
*Photo 45: Trees and vegetation adjacent to the rear elevation of the property*

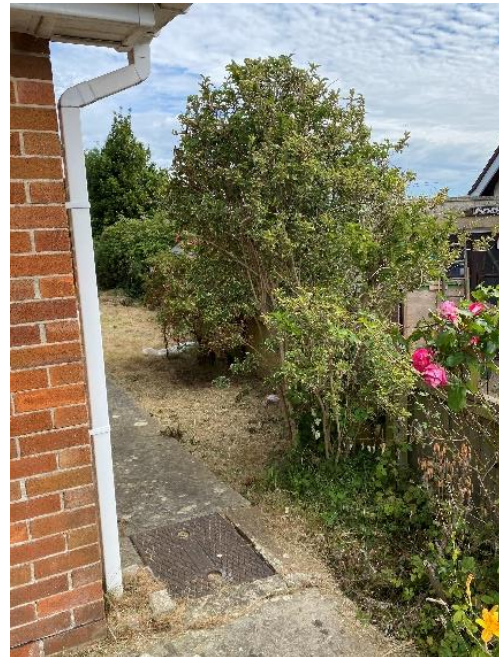
*Photo 46: Trees and vegetation adjacent to the right hand side elevation of the property*

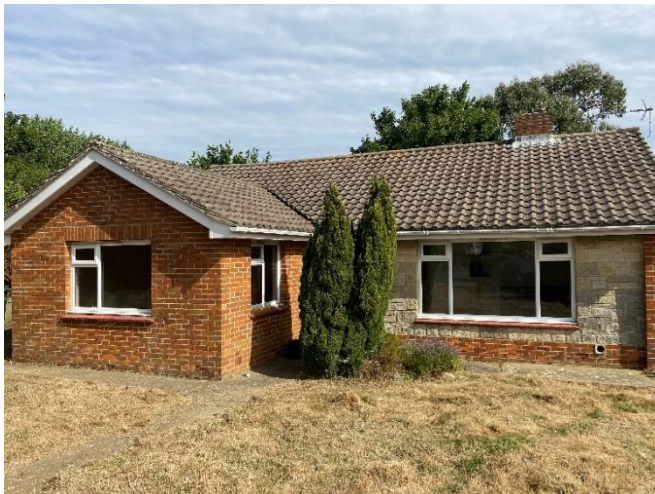
*Photo 47: Conifer adjacent to the front right hand corner of the front projection*

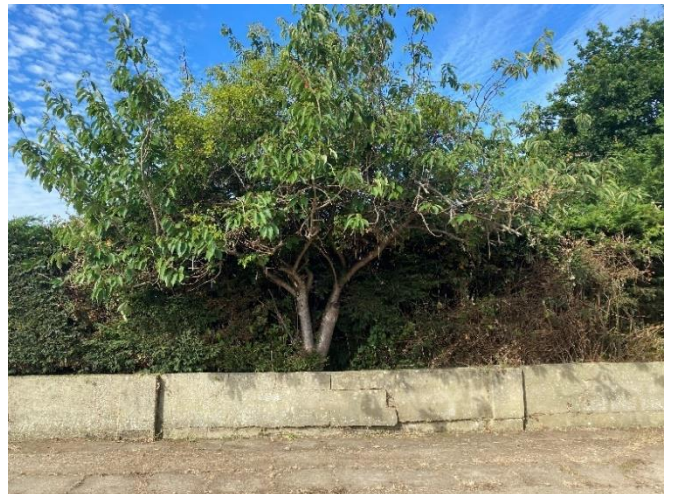
*Photo 48: Cracking and movement to the boundary wall to the left hand side of the property*

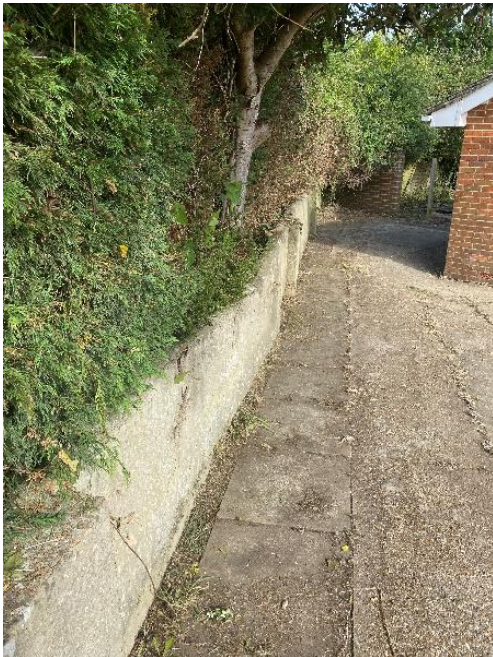
*Photo 49: Cracking and movement to the boundary wall to the left hand side of the property. Damage at location of Cherry tree*

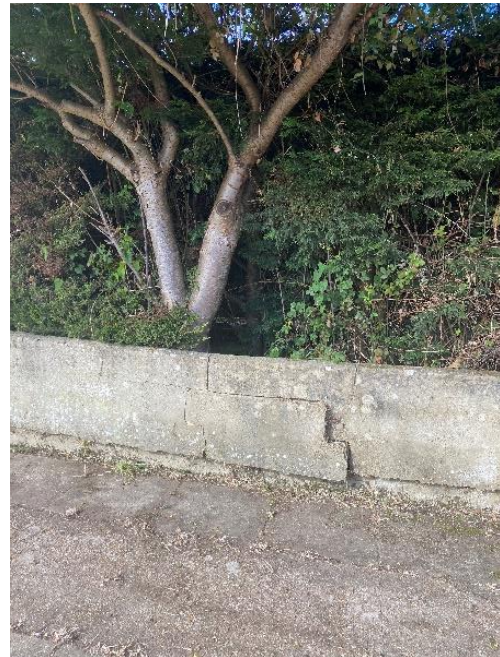
*Photo 50: Cracking and movement to the boundary wall to the left hand side of the property. Damage at location of Cherry tree*

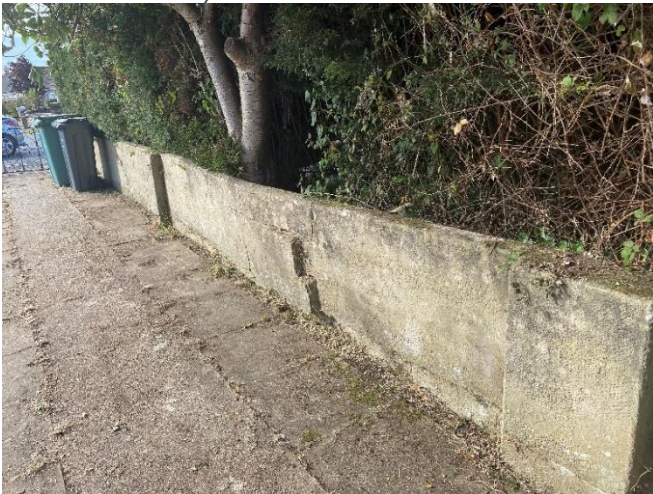
*Photo 51: Cracking and movement to the boundary wall to the left-hand side of the property. Damage at location of Cherry tree*

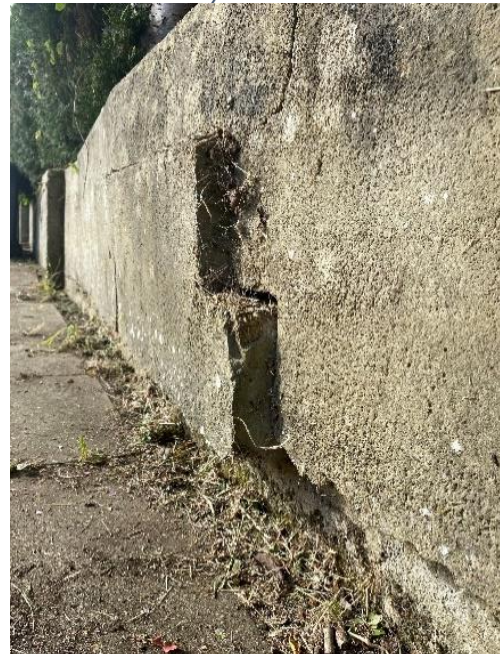
*Photo 52: Cracking and movement to the boundary wall to the left-hand side of the property. Damage at location of Cherry tree*

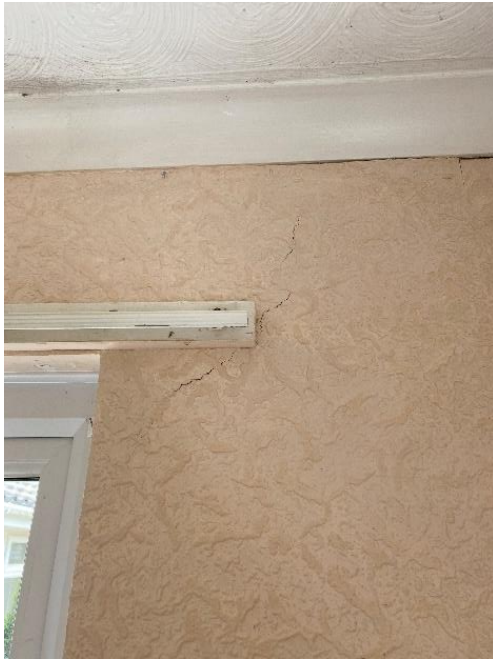
*Photo 53: Isolated diagonal crack above the South side of the window to the side elevation of the Front Bedroom*

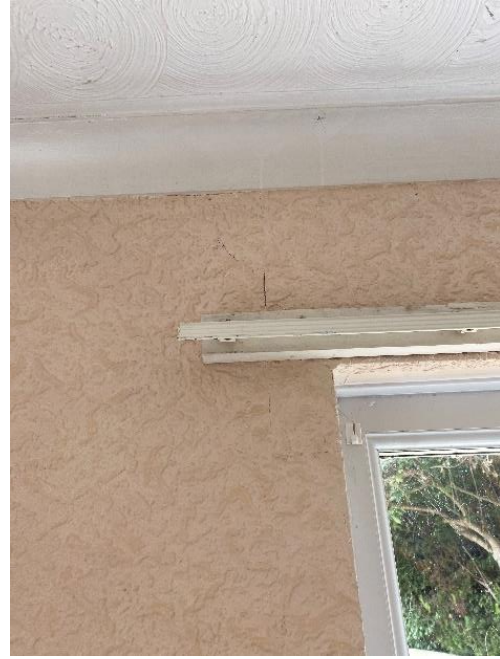
*Photo 54: Isolated diagonal crack above the East side of the window to the front elevation of the Front Bedroom*

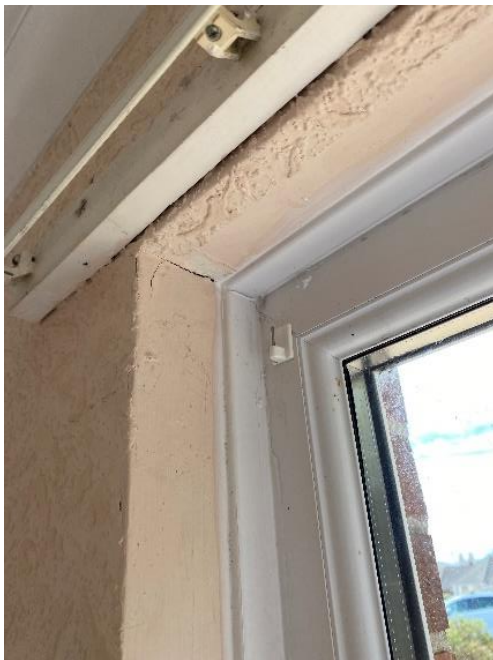
*Photo 55: Crack at high level to the East side of the window to the front elevation of the Front Bedroom*

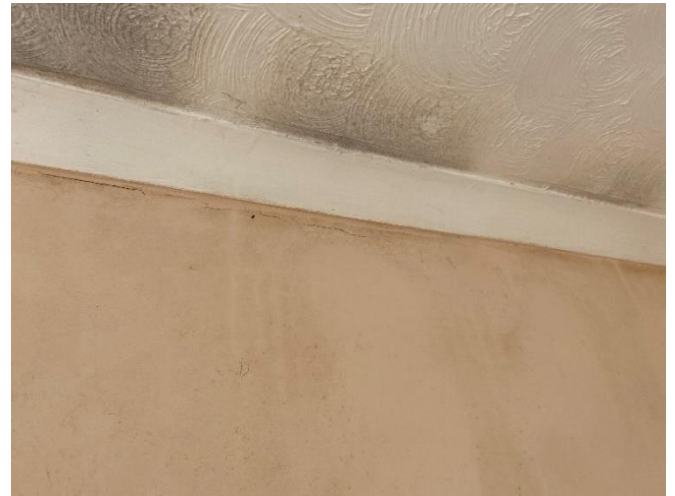
*Photo 56: Cracking at high level to the West side wall of the Front Bedroom*

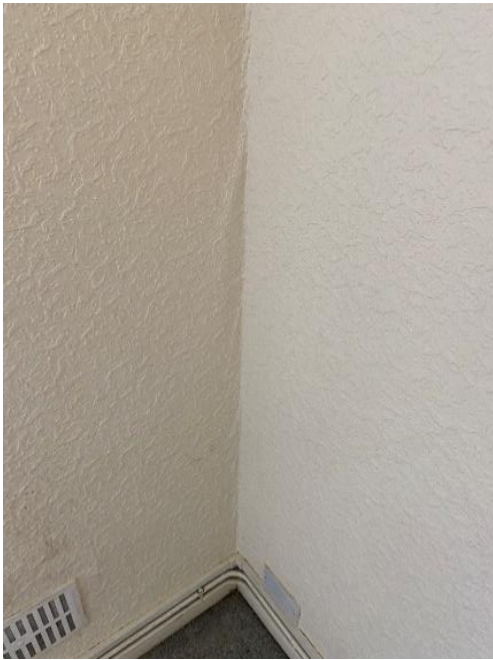
*Photo 57: Stressing to the wallpaper at the junction between the Rear Bedroom wall and the external wall within the Middle Bedroom*

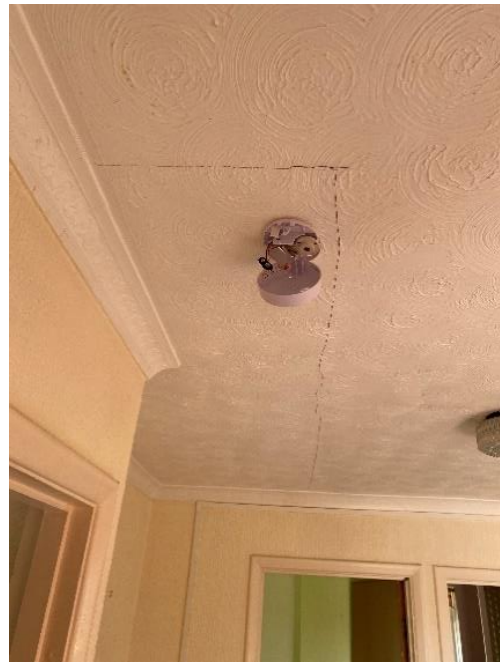
*Photo 58: Cracking to the ceiling above the Entrance*

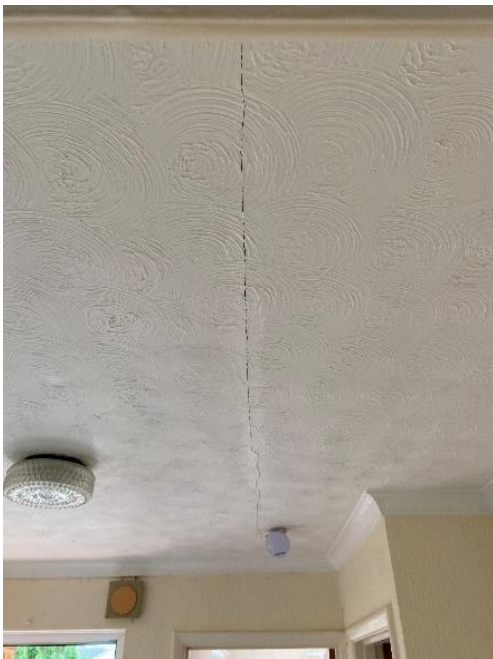
*Photo 59: Cracking to the Entrance Hall ceiling*

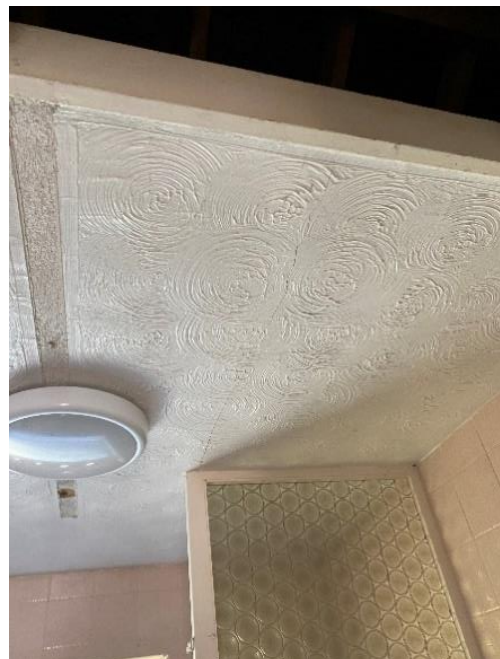
*Photo 60: Cracking to the Bathroom ceiling*

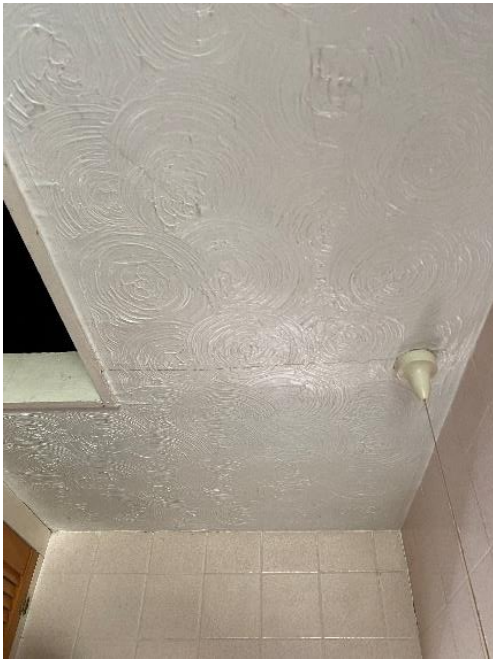
*Photo 61: Cracking to the Bathroom ceiling*

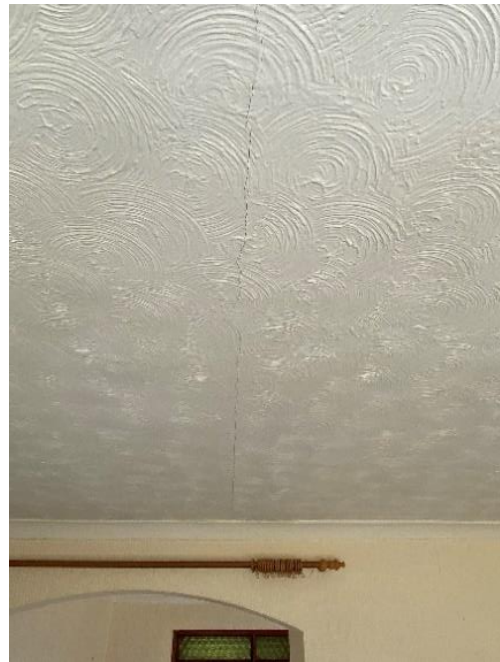
*Photo 62: Cracking to the Front Reception Room ceiling*

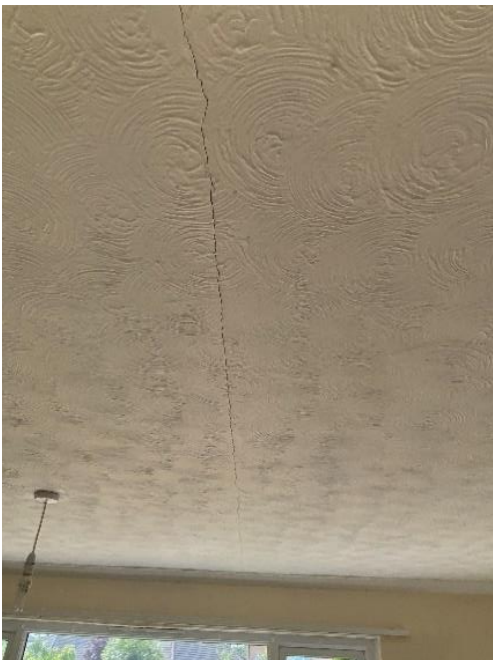
*Photo 63: Cracking to the Front Reception Room ceiling*

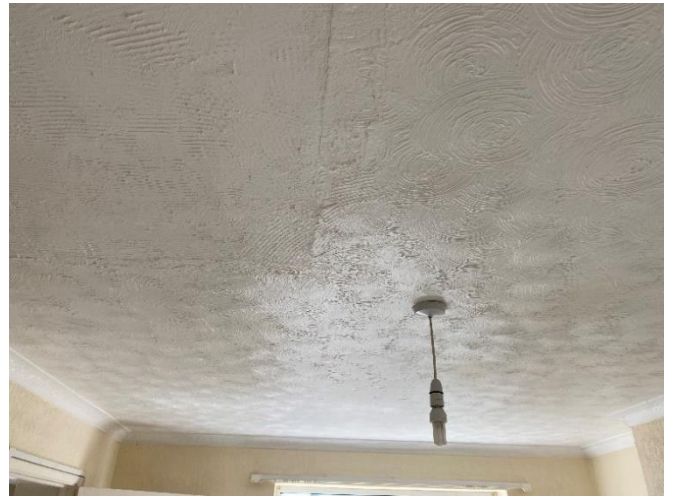
*Photo 64: Cracking to the Rear Reception Room ceiling*

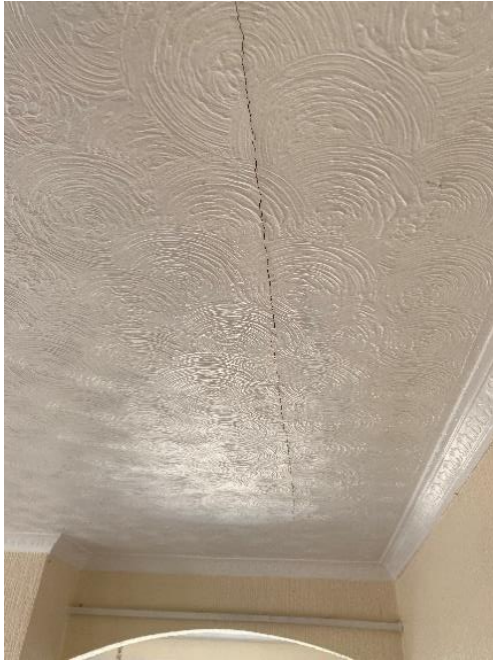
*Photo 65: Cracking to the Rear Reception Room ceiling*

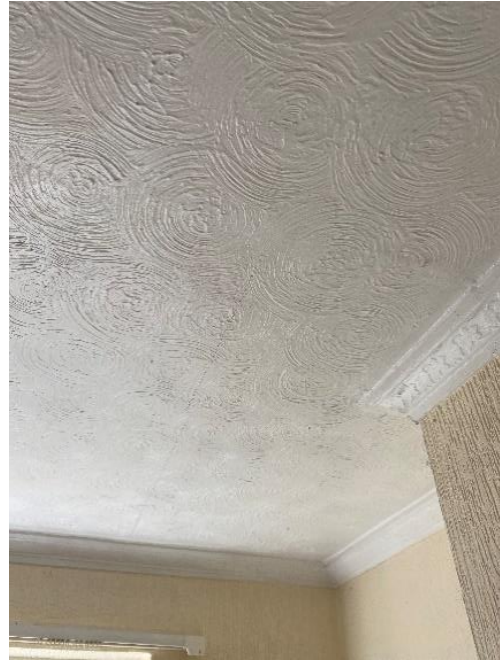
*Photo 66: Cracking to the Rear Reception Room ceiling*

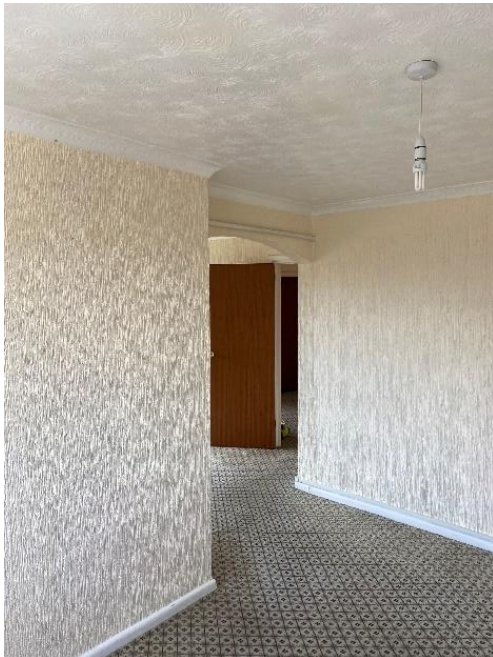
*Photo 67: Opening within the wall which separates the Reception Rooms*

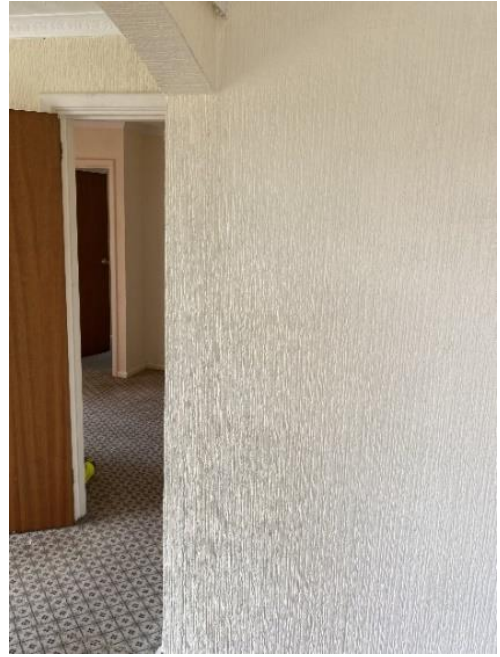
*Photo 68: Tapered vertical crack to the reveal to the side of the opening within the wall which separates the Reception Rooms*

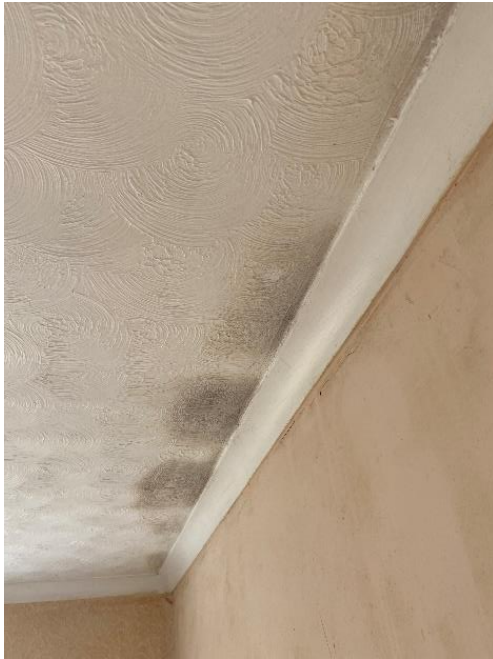
*Photo 69: Damp staining to the ceiling*

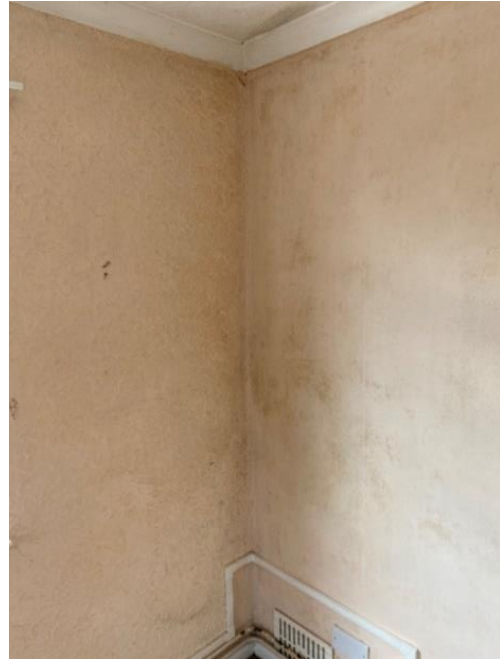
*Photo 70: Damp staining to the external walls*

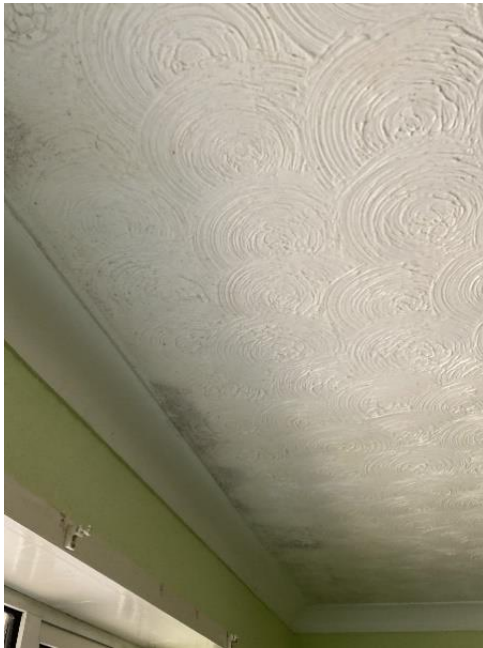
*Photo 71: Damp staining to the ceiling*

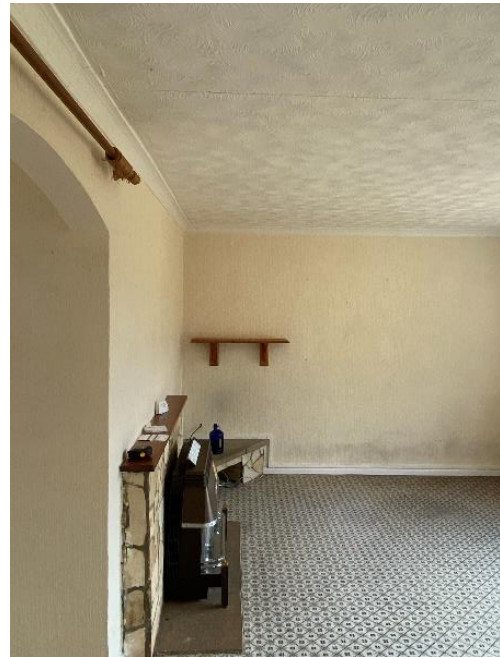
*Photo 72: Damp staining at low level to the external walls*

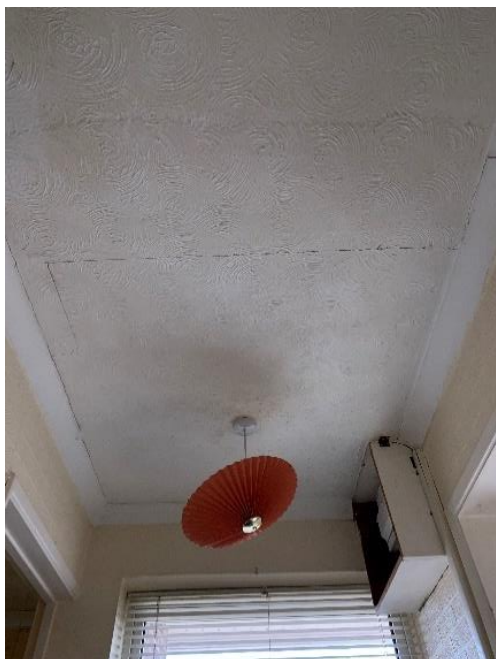
*Photo 73: Cracking to the Kitchen ceiling within the extension*

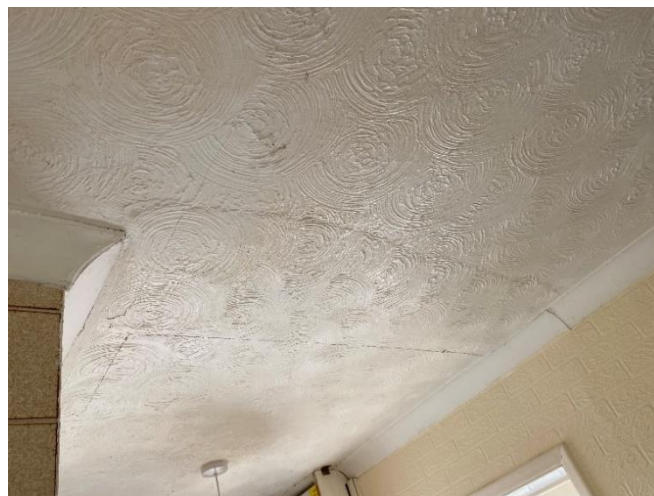
*Photo 74: Cracking to the Kitchen ceiling within the extension*

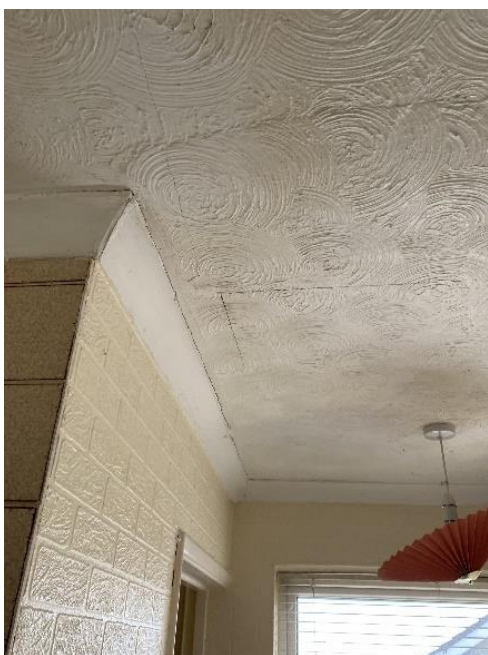
*Photo 75: Cracking to the Kitchen ceiling within the extension*

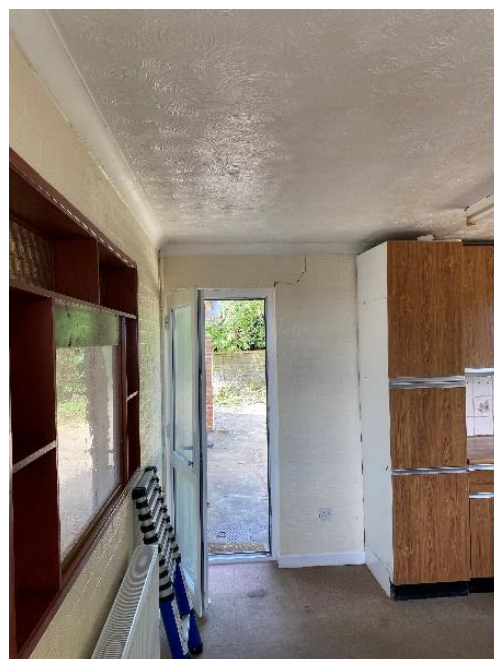
*Photo 76: Stepped crack above the back door to the Kitchen*

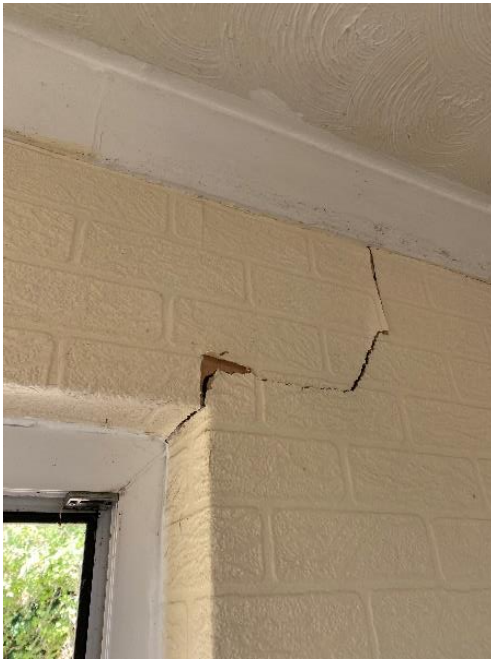
*Photo 77: Stepped crack above the back door to the Kitchen*

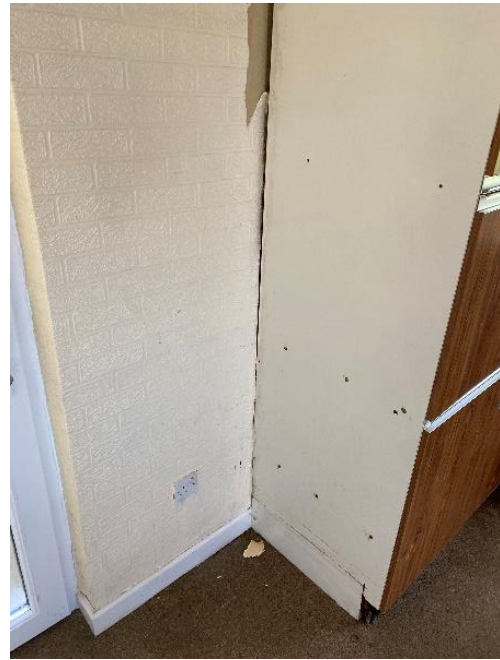
*Photo 78: Movement to the external wall to the side of the back door to the Kitchen*

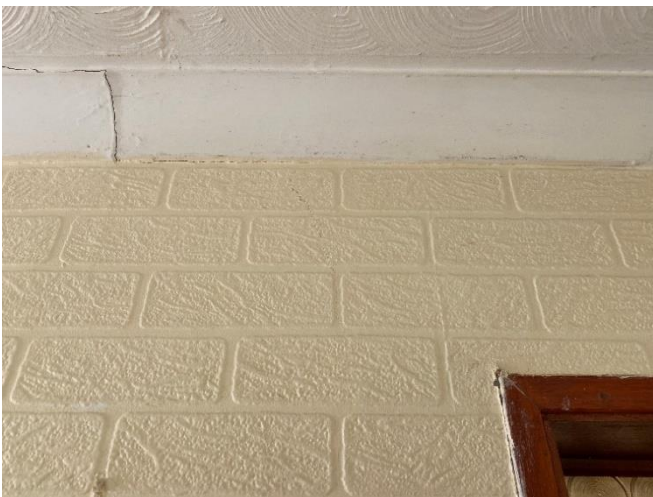
*Photo 79: Hairline crack at high level to the rear external elevation of the main property within the Kitchen*

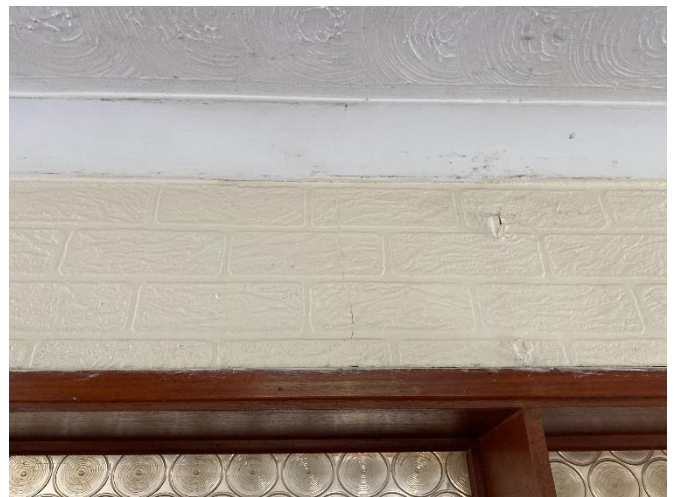
*Photo 80: Hairline crack at high level to the rear external elevation of the main property within the Kitchen*

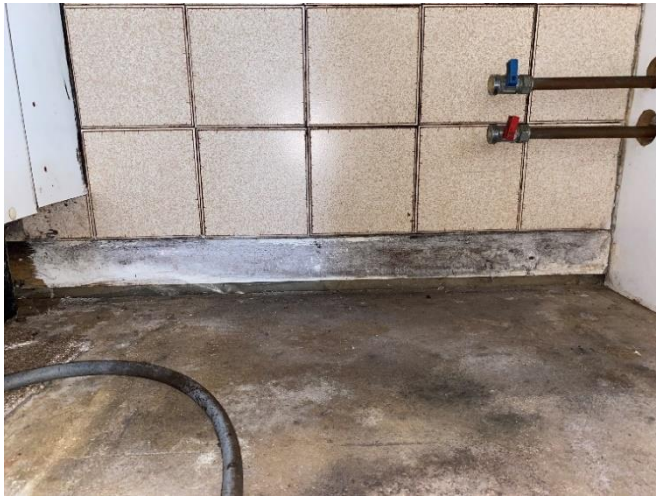
*Photo 81: Gap between the underside of the skirting board to the rear external wall and the Kitchen floor below*

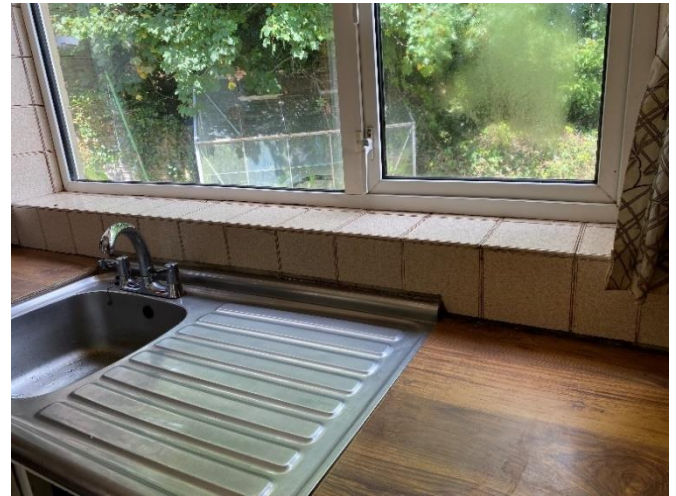
*Photo 82: Gap between the top of the worktops and the wall tiles above to the rear external wall of the Kitchen*

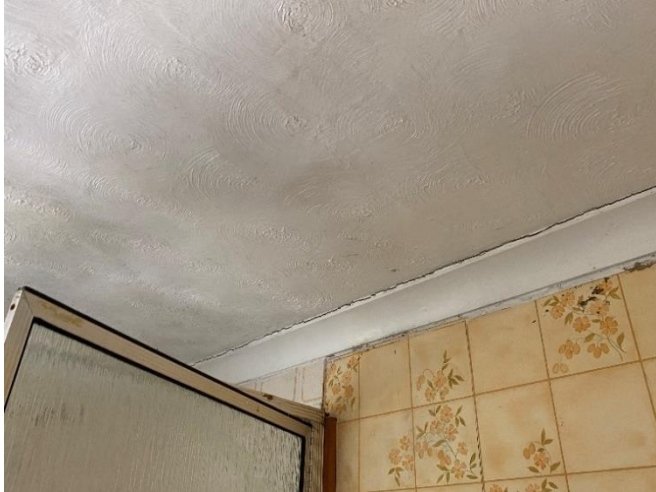
*Photo 83: Cracking between the ceiling and the coving to the external walls within the Shower Room to the extension*

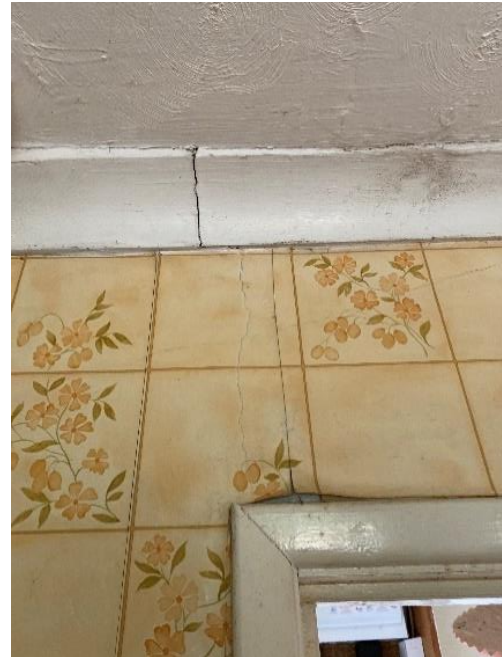
*Photo 84: Cracking above the Kitchen door within the Shower Room*

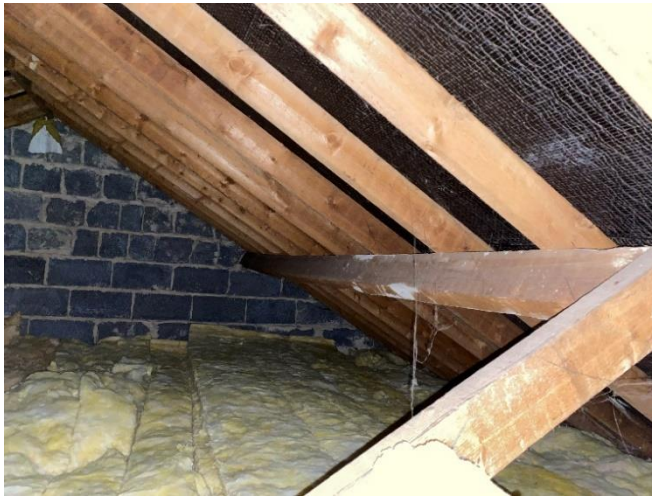
*Photo 89: Deflection of supporting purlin to the rear roof slope*

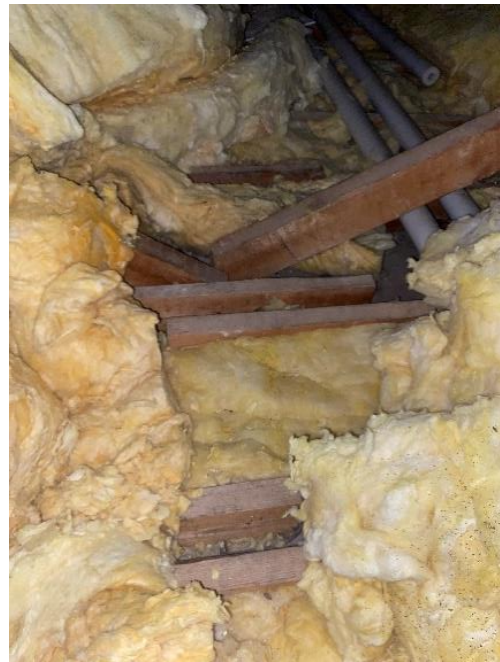
*Photo 90: Raking struts to the East side of the roof space are not opposite or acting against each other*

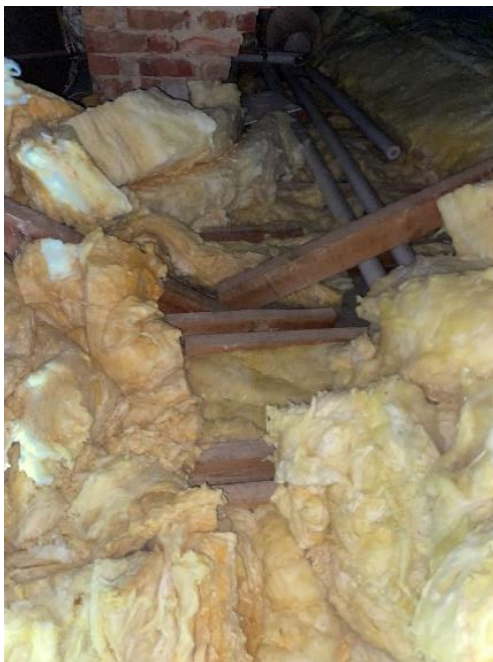
*Photo 91: The ceiling joists are not fixed together where they were spliced over the central spine wall*

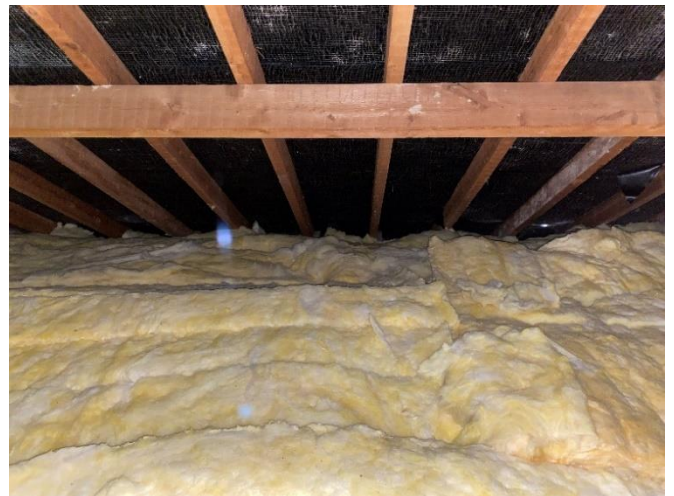
*Photo 92: Limited safe access due to the presence of insulation*

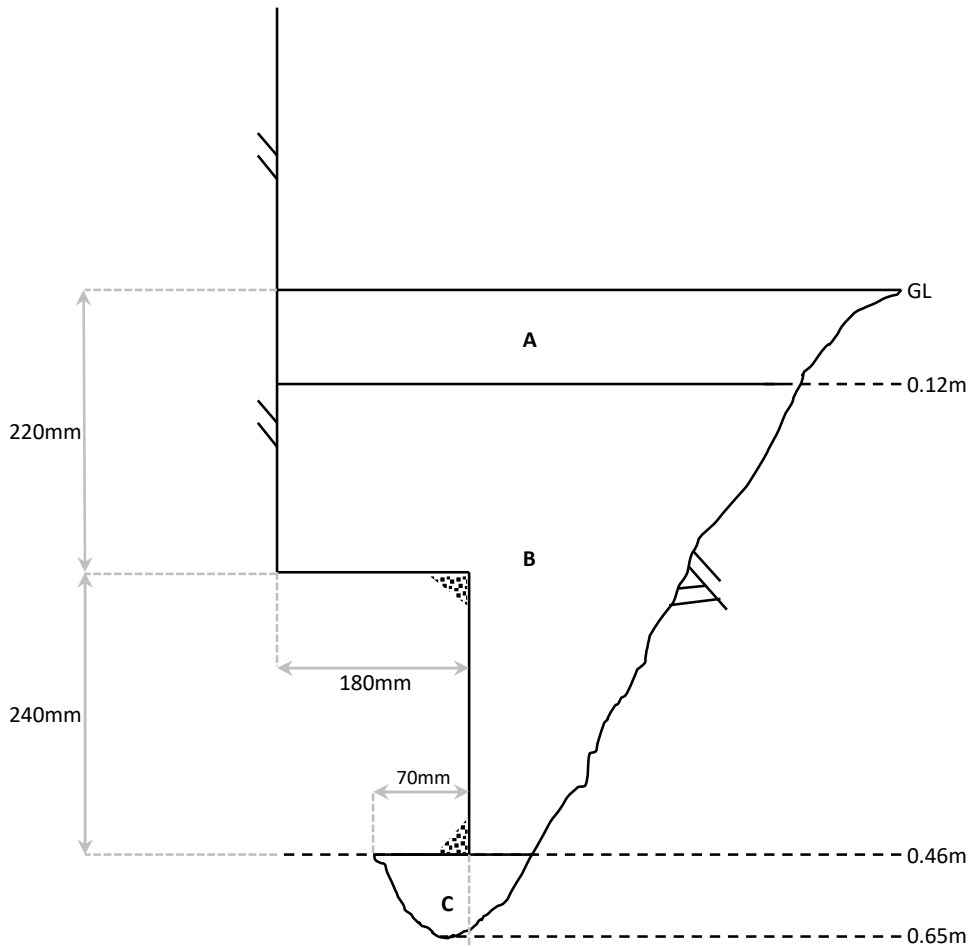
<b>FIG</b>	<b>TP01</b>	<b>CKConsulting and Geotechnical</b>
<b>A4</b>

TP01 established that the foundations supporting the front brick elevation, near the room designated as Bedroom 1, comprised 240mm of concrete. The foundations were proved to be bearing within the Weathered Vectis Formation at a depth of 0.46m below ground level.

The brick and concrete foundations forming the southern part of the property would appear to bear within the clayey Vectis Formation strata that have been impacted by changes in seasonal moisture content as well as variations in moisture uptake by nearby trees, bushes, etc.

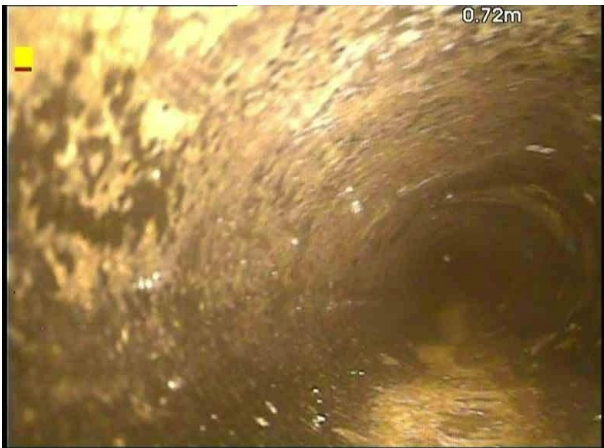
Sec\_5\_Insp\_1\_MH3X\_29315.jpg, 00:00:26, 0.72 m  
Deformed sewer or drain, 20%

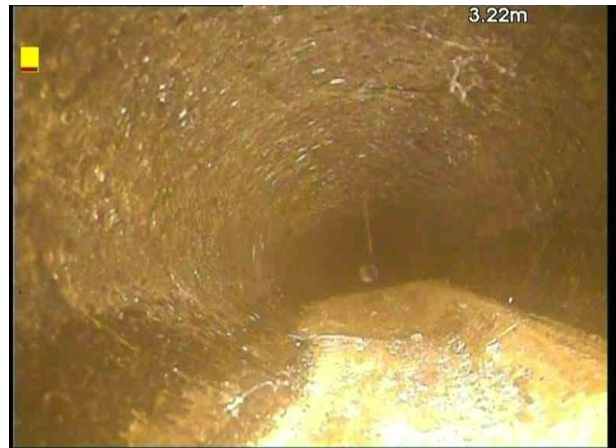
Sec\_5\_Insp\_1\_MH3X\_38867.jpg, 00:01:08, 3.22 m  
Deformed sewer or drain, 15%

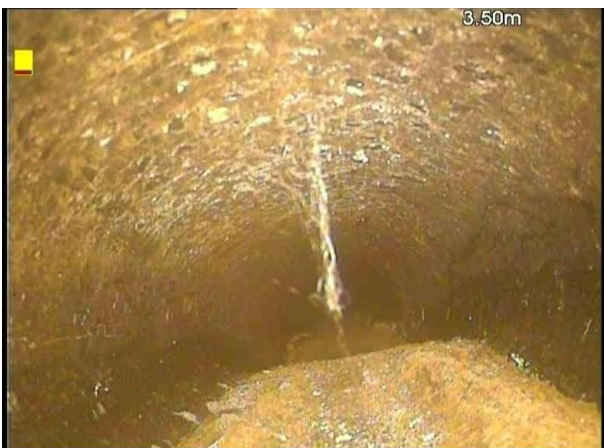
Sec\_5\_Insp\_1\_MH3X\_19791.jpg, 00:01:15, 3.50 m  
Deformed sewer or drain, 25%

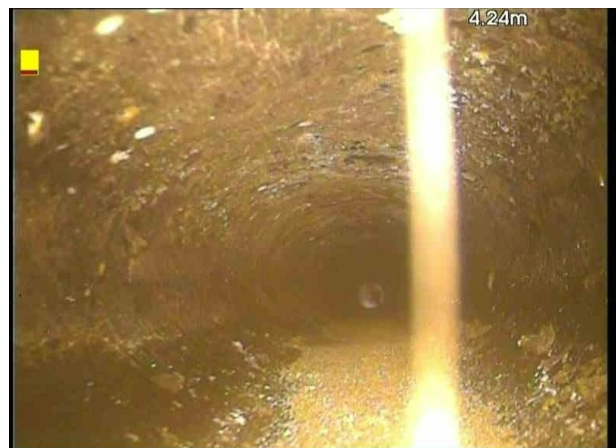
Sec\_5\_Insp\_1\_MH3X\_38101.jpg, 00:01:26, 4.24 m  
Deformed sewer or drain, 20%
