Section Pictures - 21/07/2022 - MH4X

Town or Village: Isle Of White	Inspection Direction: Downstream	Upstream Node: MH5
Road: 15 Gordon Close	Inspected Length: 11.15 m	Upstream Pipe Depth: 1.350 m
Location:	Total Length: 16.61 m	Downstream Node: MAIN
Surface Type:	Joint Length:	Downstream Pipe Depth:

Use: Foul	Pipe Shape: Circular
Type of Pipe:	Dia/Height: 150 mm
Flow Control: No flow control	Material: Vitrified clay
Year Constructed: Not Specified	Lining Type: No Lining
Inspection Purpose: Sample condition survey	Lining Material: No Lining

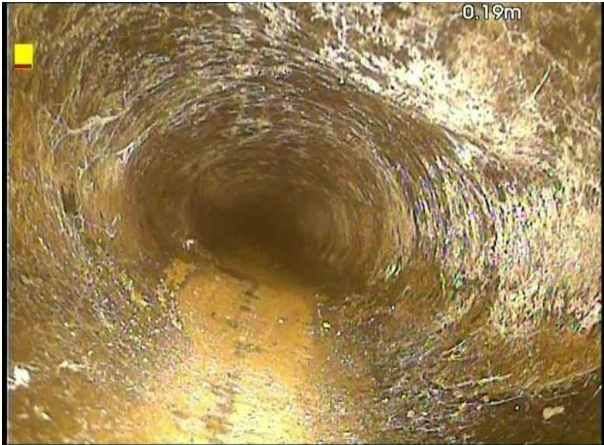
Sec_7_Insp_1_MH4X_9366.jpg, 00:00:23, 0.00 m
 Deformed sewer or drain, 20%, start

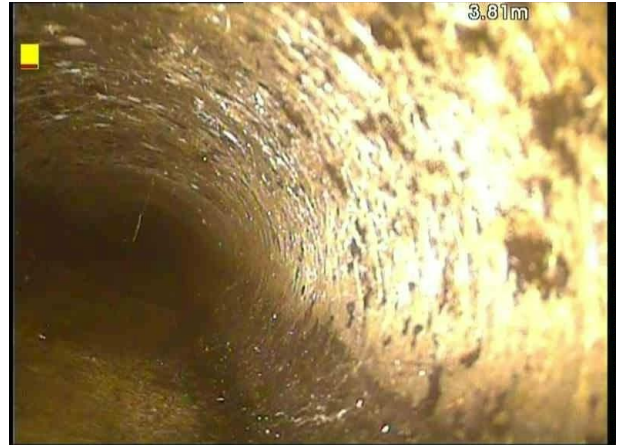
Sec_7_Insp_1_MH4X_36190.jpg, 00:01:05, 3.81 m
 Deformed sewer or drain, 30%, start

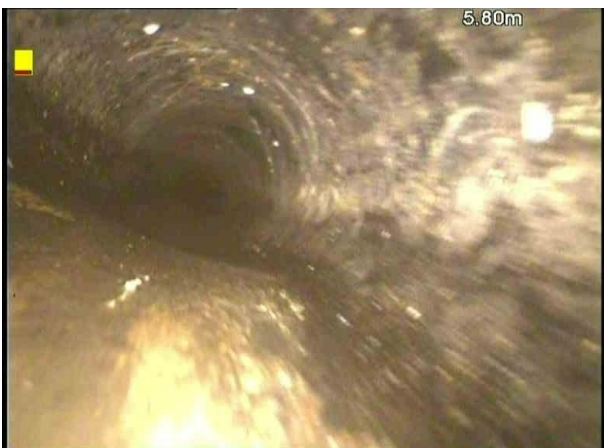
Sec_7_Insp_1_MH4X_46663.jpg, 00:01:20, 5.80 m
 Deformed sewer or drain, 15%

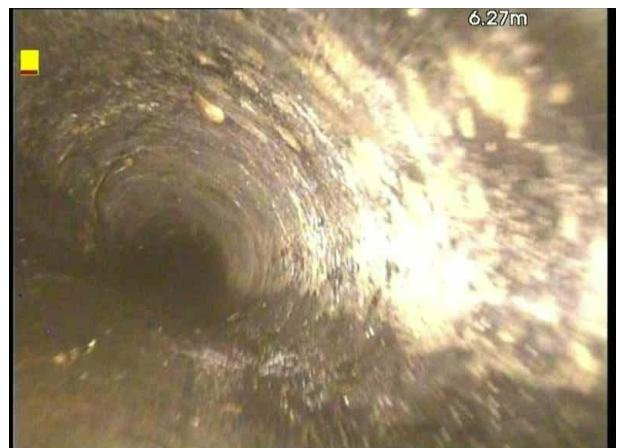
Sec_7_Insp_1_MH4X_20830.jpg, 00:01:23, 6.27 m
 Deformed sewer or drain, 15%

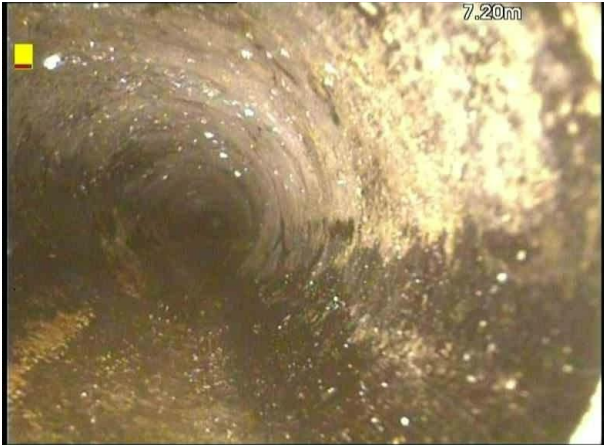
Sec_7_Insp_1_MH4X_820.jpg, 00:01:33, 7.20 m
Deformed sewer or drain, 10%

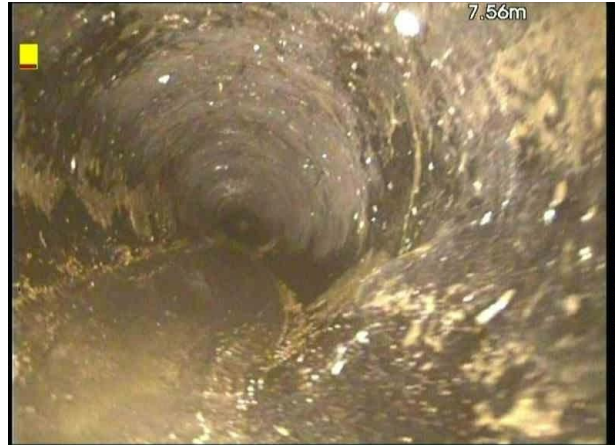
Sec_7_Insp_1_MH4X_15154.jpg, 00:01:37, 7.56 m
Deformed sewer or drain, 10%

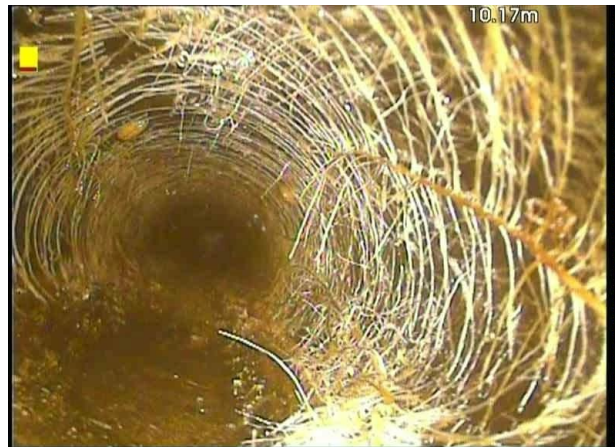
Sec_7_Insp_1_MH4X_42678.jpg, 00:02:13, 10.17 m
Roots, fine, start

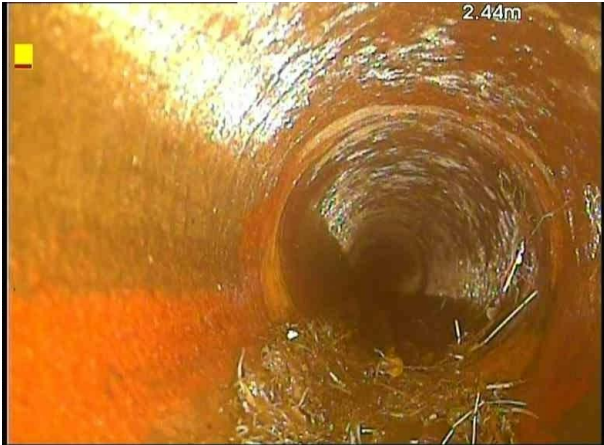
<table><tr> <td style="width: 10%;">0.00</td> <td style="width: 5%;">MH</td> <td style="width: 55%;">Start node, manhole, reference: MH5</td> <td style="width: 10%;">00:00:00</td> <td></td> <td></td> <td></td> </tr><tr> <td style="color: green;">2.44</td> <td style="color: green;">RFJ</td> <td style="color: green;">Roots, fine at joint</td> <td style="color: green;">00:00:41</td> <td></td> <td style="color: green;">Sec_8_Ins p_1_MH5 X_57050.j</td> <td style="color: green;">2</td> </tr></table>

Sec_8_Insp_1_MH5X_57050.jpg, 00:00:41, 2.44 m
 Roots, fine at joint

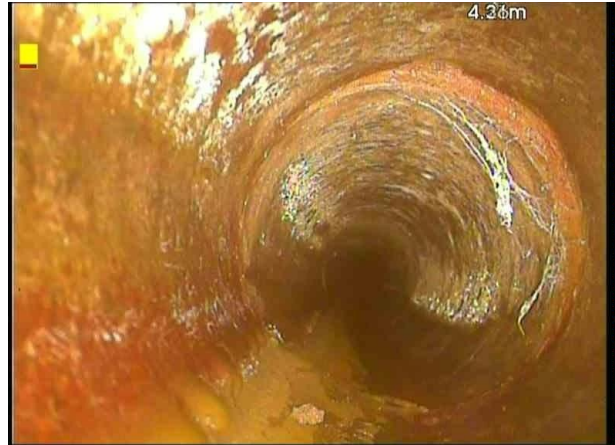
<table><tr> <td style="width: 10%;">0.00</td> <td style="width: 5%;">MH</td> <td style="width: 55%;">Start node, manhole, reference: MH5</td> <td style="width: 10%;">00:00:00</td> <td></td> <td></td> <td></td> </tr><tr> <td style="color: red;">4.36</td> <td style="color: red;">JDM</td> <td style="color: red;">Joint displaced, medium</td> <td style="color: red;">00:00:57</td> <td></td> <td style="color: red;">Sec_8_Ins p_1_MH5 X_65006.j</td> <td style="color: red;">1 / 3</td> </tr></table>

Sec_8_Insp_1_MH5X_65006.jpg, 00:00:57, 4.36 m
 Joint displaced, medium

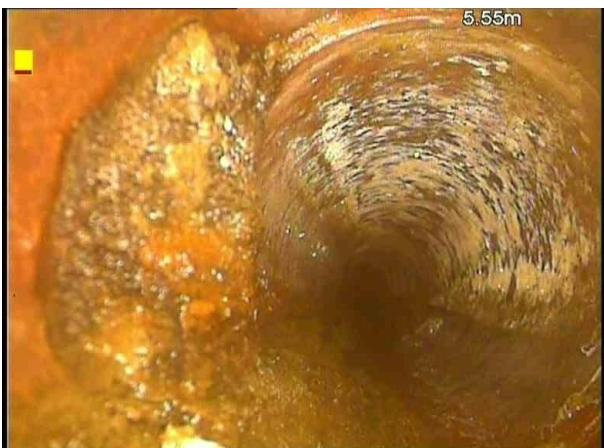
<table><tr> <td style="width: 10%;">0.00</td> <td style="width: 5%;">MH</td> <td style="width: 55%;">Start node, manhole, reference: MH5</td> <td style="width: 10%;">00:00:00</td> <td></td> <td></td> <td></td> </tr><tr> <td style="color: green;">5.55</td> <td style="color: green;">DEEJ</td> <td style="color: green;">Attached deposits, encrustation at joint from 7 o'clock to 11 o'clock, 15% cross-sectional area loss</td> <td style="color: green;">00:01:09</td> <td></td> <td style="color: green;">Sec_8_Ins p_1_MH5 X_30211.j</td> <td style="color: green;">3</td> </tr></table>

Sec_8_Insp_1_MH5X_30211.jpg, 00:01:09, 5.55 m
 Attached deposits, encrustation at joint from 7 o'clock to 11 o'clock, 15% cross-sectional area loss

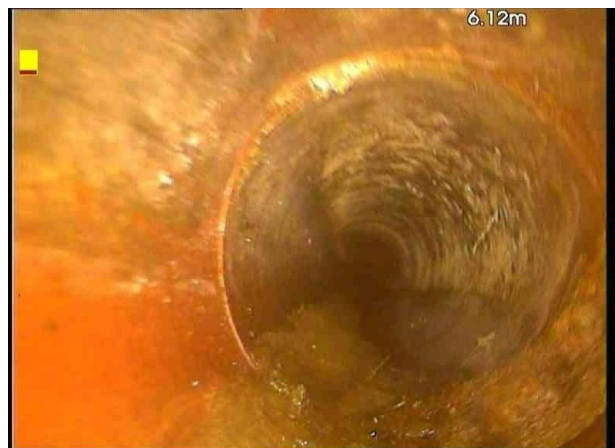
<table><tr> <td style="width: 10%;">0.00</td> <td style="width: 5%;">MH</td> <td style="width: 55%;">Start node, manhole, reference: MH5</td> <td style="width: 10%;">00:00:00</td> <td></td> <td></td> <td></td> </tr><tr> <td style="color: green;">6.12</td> <td style="color: green;">DEEJ</td> <td style="color: green;">Attached deposits, encrustation at joint from 4 o'clock to 6 o'clock, 5% cross-sectional area loss</td> <td style="color: green;">00:01:14</td> <td></td> <td style="color: green;">Sec_8_Ins p_1_MH5 X_36643.j</td> <td style="color: green;">3</td> </tr></table>

Sec_8_Insp_1_MH5X_36643.jpg, 00:01:14, 6.12 m
 Attached deposits, encrustation at joint from 4 o'clock to 6 o'clock, 5% cross-sectional area loss

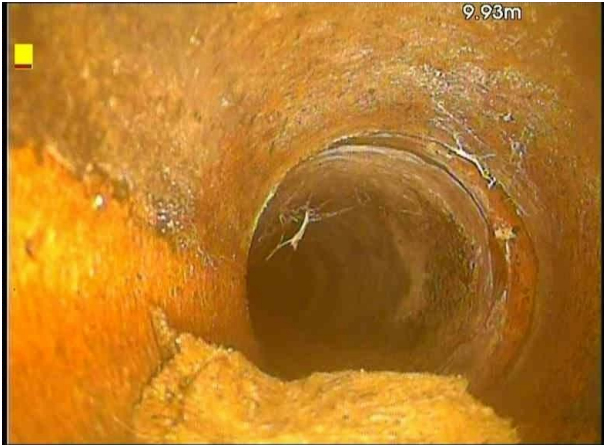
<table><tr> <td style="width: 10%;">0.00</td> <td style="width: 5%;">MH</td> <td style="width: 55%;">Start node, manhole, reference: MH5</td> <td style="width: 10%;">00:00:00</td> <td></td> <td></td> <td></td> </tr><tr> <td style="color: green;">9.93</td> <td style="color: green;">DER</td> <td style="color: green;">Settled deposits, coarse, 15% cross-sectional area loss</td> <td style="color: green;">00:01:59</td> <td></td> <td style="color: green;">Sec_8_Ins p_1_MH5 X_3755.jpg</td> <td style="color: green;">3</td> </tr></table>

Sec_8_Insp_1_MH5X_3755.jpg, 00:01:59, 9.93 m
Settled deposits, coarse, 15% cross-sectional area loss

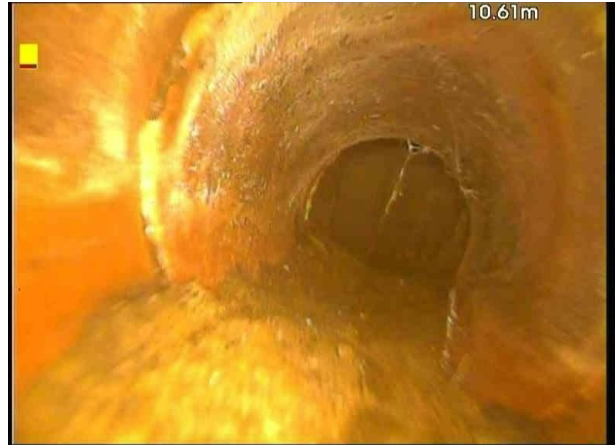
<table><tr> <td style="width: 10%;">0.00</td> <td style="width: 5%;">MH</td> <td style="width: 55%;">Start node, manhole, reference: MH5</td> <td style="width: 10%;">00:00:00</td> <td></td> <td></td> <td></td> </tr><tr> <td style="color: green;">10.61</td> <td style="color: green;">DEE</td> <td style="color: green;">Attached deposits, encrustation from 5 o'clock to 8 o'clock, 10% cross-sectional area loss</td> <td style="color: green;">00:02:07</td> <td></td> <td style="color: green;">Sec_8_Ins p_1_MH5 X_62410.j</td> <td style="color: green;">3</td> </tr></table>

Sec_8_Insp_1_MH5X_62410.jpg, 00:02:07, 10.61 m
Attached deposits, encrustation from 5 o'clock to 8 o'clock,
10% cross-sectional area loss

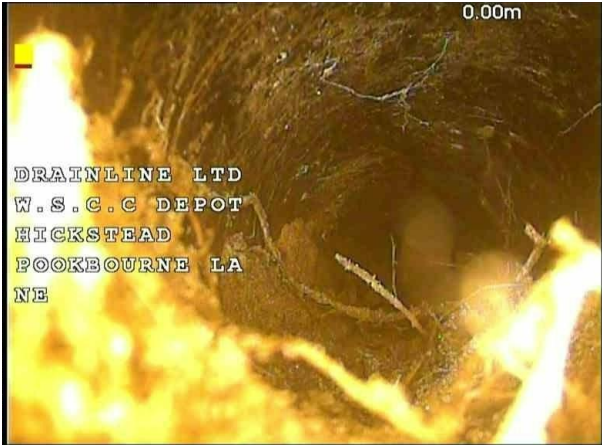
<table><tr> <td style="text-align: right;">0.00</td> <td>MH</td> <td>Start node, manhole, reference: MH5</td> <td>00:00:00</td> <td></td> <td></td> <td></td> </tr><tr> <td style="text-align: right;">0.10</td> <td>DES</td> <td>Settled deposits, fine, 15% cross-sectional area loss</td> <td>00:00:03</td> <td>Sec_9_Ins_p_1_Unkn_ownX_577</td> <td>3</td> <td></td> </tr></table>

Sec_9_Insp_1_UnknownX_57778.jpg, 00:00:03, 0.10 m
Settled deposits, fine, 15% cross-sectional area loss

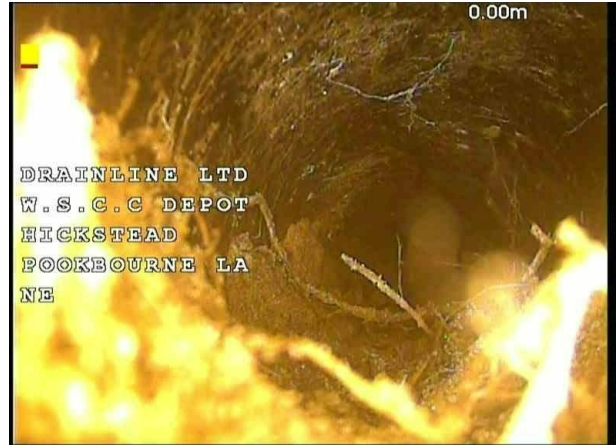
<table><tr> <td style="text-align: right;">0.00</td> <td>MH</td> <td>Start node, manhole, reference: MH5</td> <td>00:00:00</td> <td></td> <td></td> <td></td> </tr><tr> <td style="text-align: right;">0.10</td> <td>RF</td> <td>Roots, fine</td> <td>00:00:03</td> <td>Sec_9_Ins_p_1_Unkn_ownX_654</td> <td>2</td> <td></td> </tr></table>

Sec_9_Insp_1_UnknownX_654.jpg, 00:00:03, 0.10 m
Roots, fine

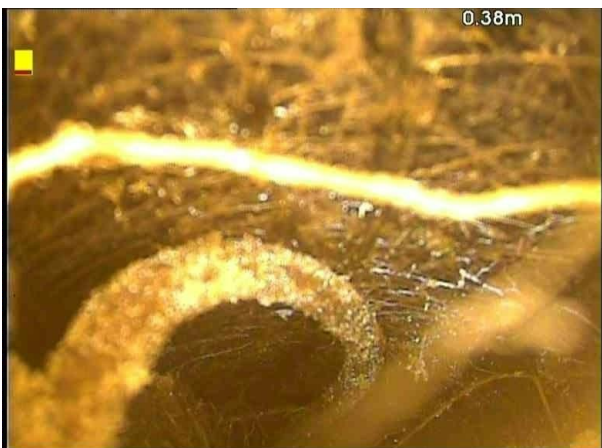
<table><tr> <td style="text-align: right;">0.00</td> <td>MH</td> <td>Start node, manhole, reference: MH5</td> <td>00:00:00</td> <td></td> <td></td> <td></td> </tr><tr> <td style="text-align: right;">0.38</td> <td>RT</td> <td>Roots, tap</td> <td>00:00:23</td> <td>Sec_9_Ins_p_1_Unkn_ownX_239</td> <td>4</td> <td></td> </tr></table>

Sec_9_Insp_1_UnknownX_23973.jpg, 00:00:23, 0.38 m
Roots, tap

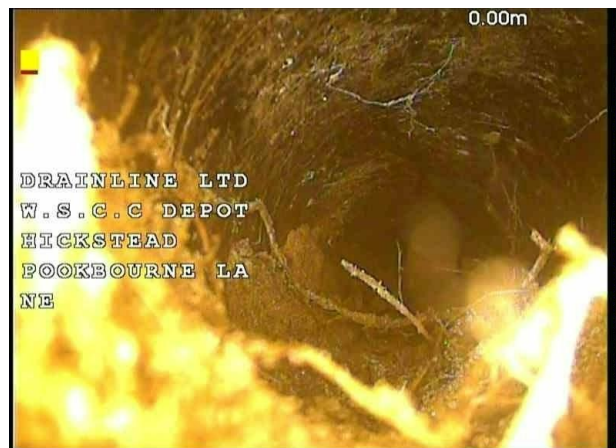
<table><tr> <td style="text-align: right;">0.00</td> <td>MH</td> <td>Start node, manhole, reference: MH5</td> <td>00:00:00</td> <td></td> <td></td> <td></td> </tr><tr> <td style="text-align: right;">0.38</td> <td>DES</td> <td>Settled deposits, fine, 30% cross-sectional area loss</td> <td>00:00:23</td> <td>Sec_9_Ins_p_1_Unkn_ownX_342</td> <td>4</td> <td></td> </tr></table>

Sec_9_Insp_1_UnknownX_3424.jpg, 00:00:23, 0.38 m
Settled deposits, fine, 30% cross-sectional area loss

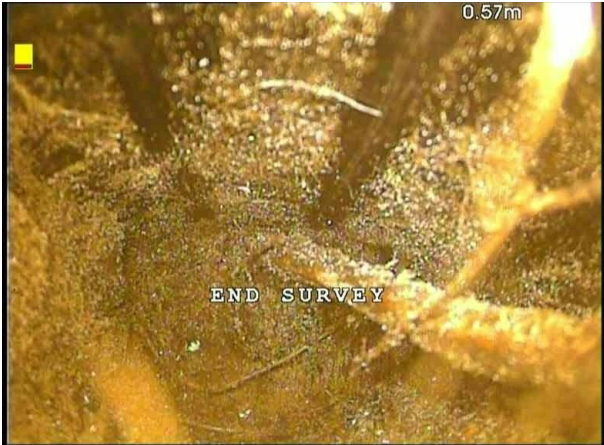
<table><tr> <td style="text-align: right;">0.00</td> <td>MH</td> <td>Start node, manhole, reference: MH5</td> <td>00:00:00</td> <td></td> <td></td> <td></td> </tr><tr> <td style="text-align: right;">0.57</td> <td>DES</td> <td>Settled deposits, fine, 100% cross-sectional area loss</td> <td>00:00:54</td> <td>Sec_9_Ins_p_1_Unkn_ownX_359</td> <td>5</td> <td></td> </tr><tr> <td style="text-align: right;">0.57</td> <td>SA</td> <td>Survey abandoned: Unable to pass silt</td> <td>00:00:54</td> <td></td> <td></td> <td></td> </tr></table>

Sec_9_Insp_1_UnknownX_35906.jpg, 00:00:54, 0.57 m
Settled deposits, fine, 100% cross-sectional area loss
