ADDENDUM REPORT

CRACKING AND MOVEMENT

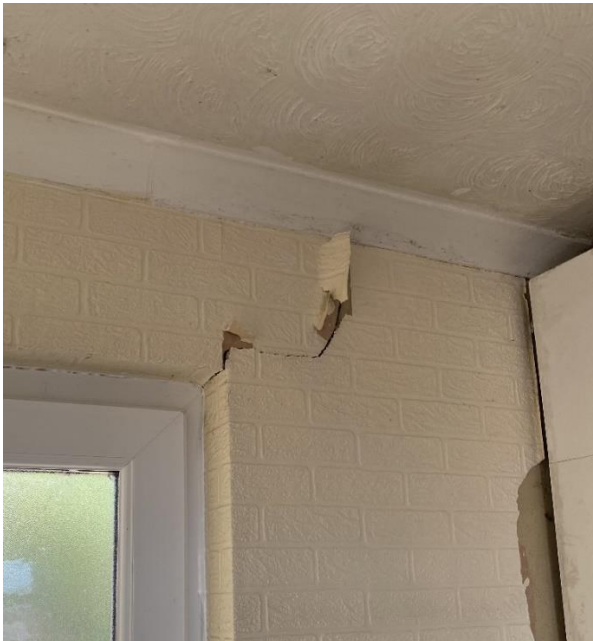
Photo 1: Crack above the back door to the West side elevation of the Kitchen extension - 13th July 2022

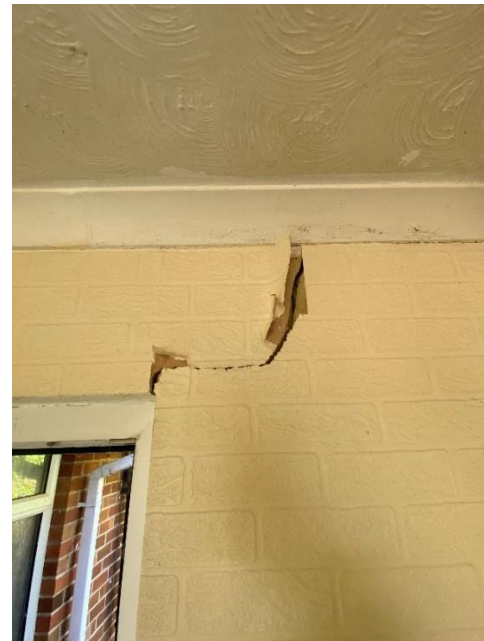
*Photo 2: Crack above the back door to the West side elevation of the Kitchen extension - 12th October 2022
Appeared to have increased in width since visit in July.*

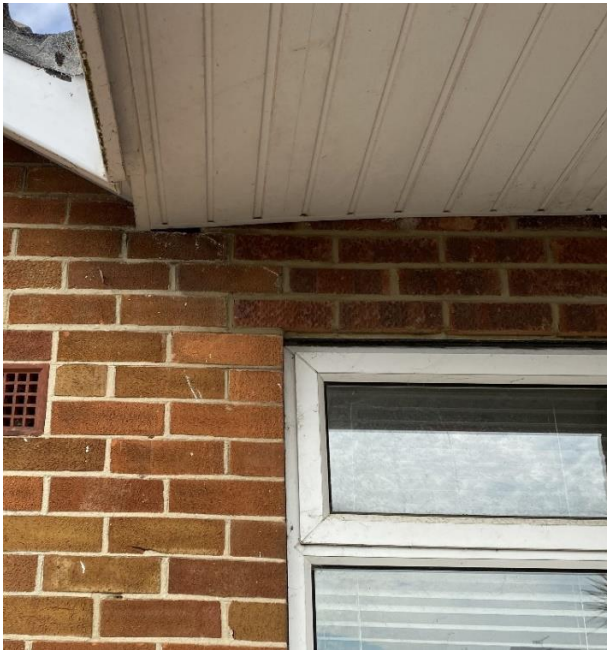
Photo 3: Wall above the window to the East side elevation of the Kitchen extension. At the junction between the main property and the extension to the rear - 13th July 2022

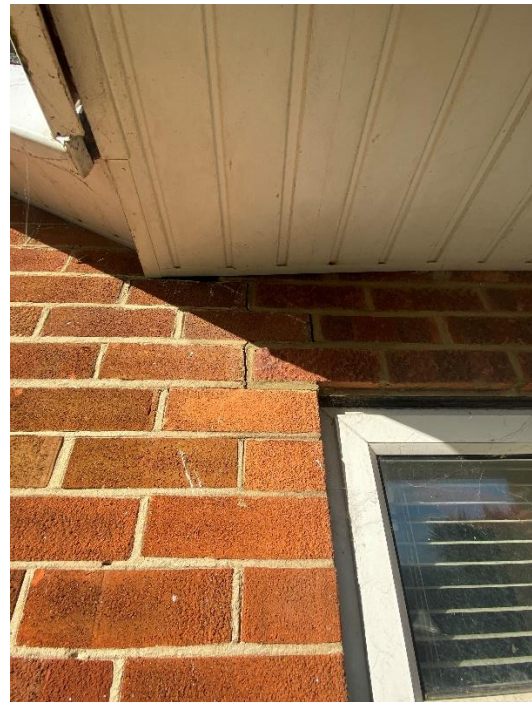
Photo 4: Crack to the wall above the window to the East side elevation of the Kitchen extension. At the junction between the main property and the extension to the rear - 13th October 2022

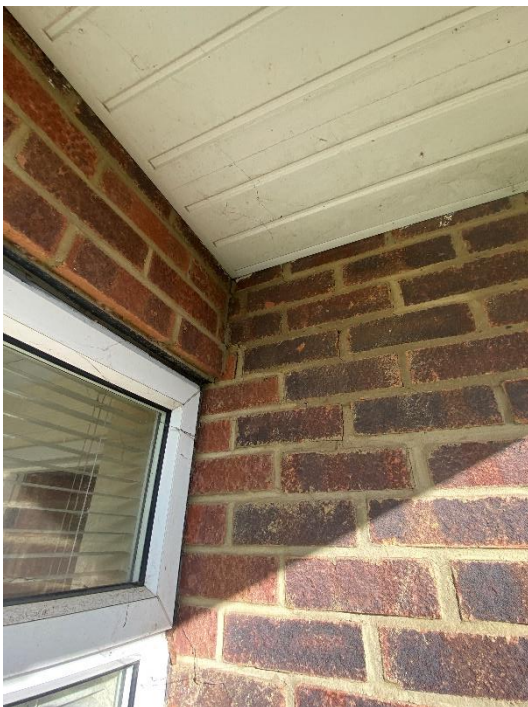
Photo 5: Crack above the window to the East side elevation of the Kitchen - Additional cracking - 12th October 2022

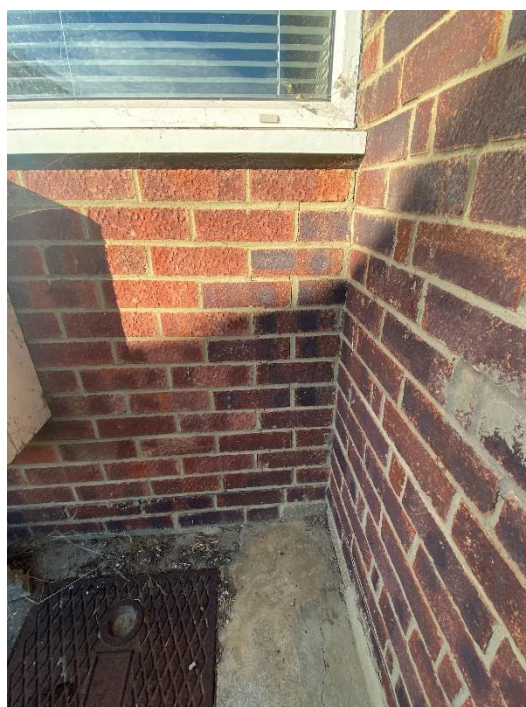
Photo 6: Crack below the window to the East side elevation of the Kitchen - Additional cracking - 12th October 2022

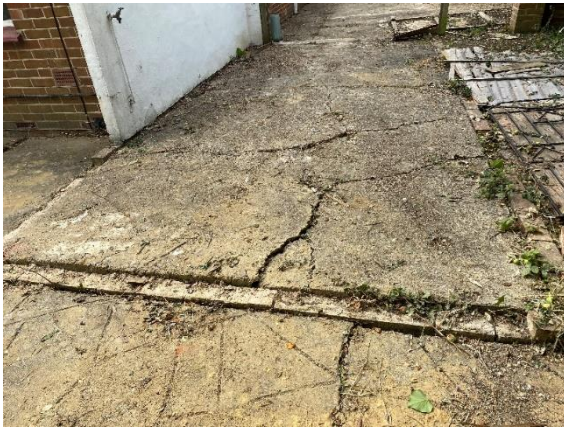
Photo 7: Crack to the concrete slab adjacent to the West side elevation of the property – 13th July 2022

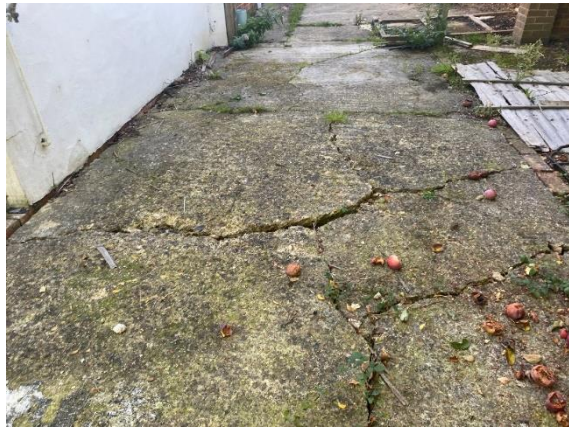
Photo 8: Appeared to have been widening of cracks and further movement to the concrete slab adjacent to the West side elevation of the property – 12th October 2022

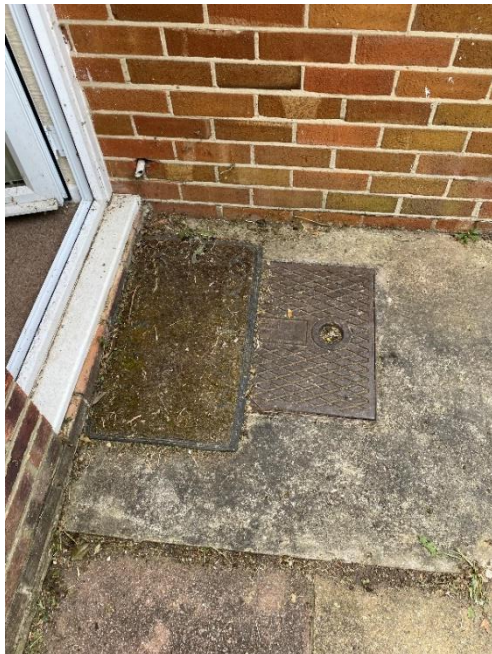
Photo 9: Inspection chamber adjacent to the back door to the West side elevation of Kitchen extension to the rear of the property

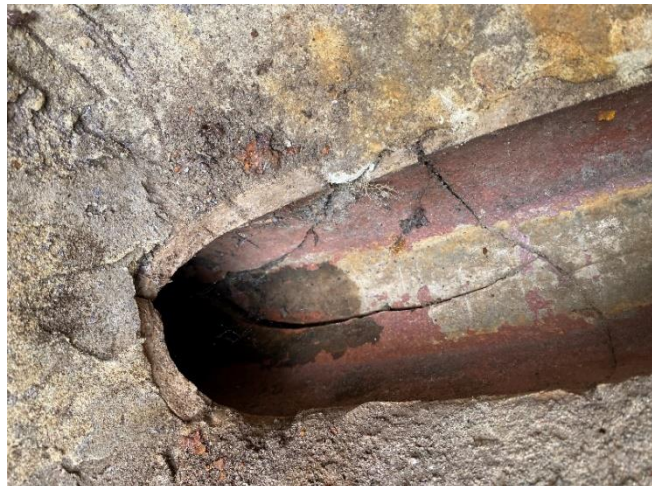
Photo 10: Cracking to the pipework to the drainage run which passed below the Kitchen extension. Within the inspection chamber adjacent to the back door

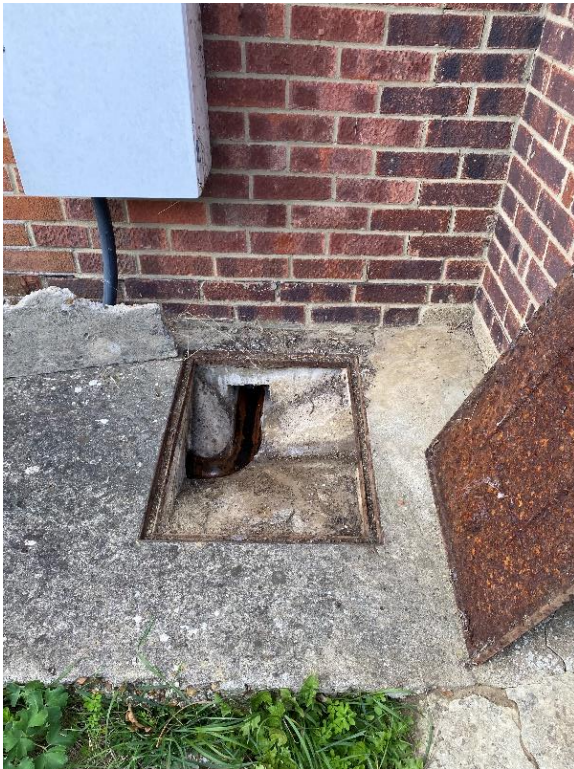
Photo 11: Inspection chamber below the Kitchen window to the East side elevation of the extension

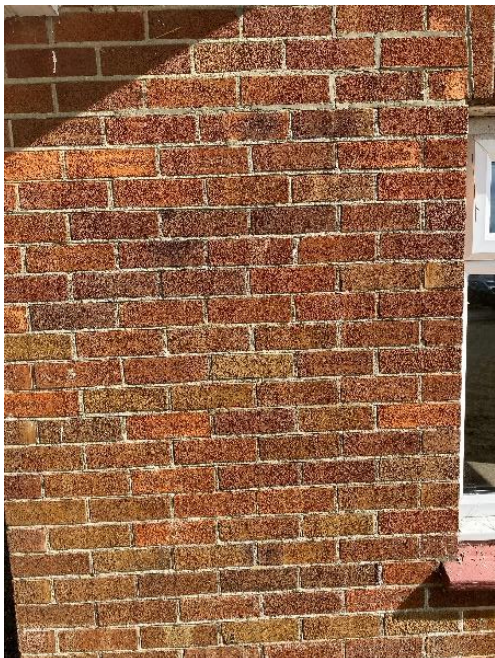
Photo 3: General condition of the brickwork to the external elevations of the property

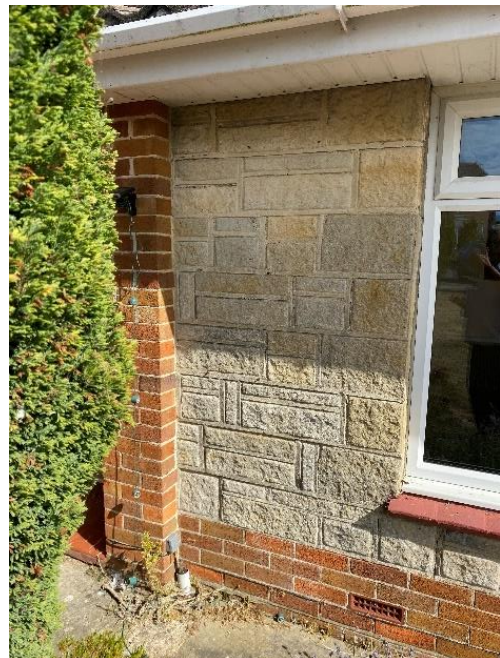
Photo 4: Cracking to the stonework to the front elevation of the Reception Room

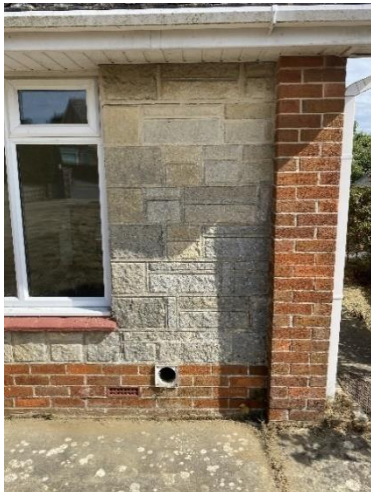
Photo 5: Cracking to the stonework to the front elevation of the Reception Room

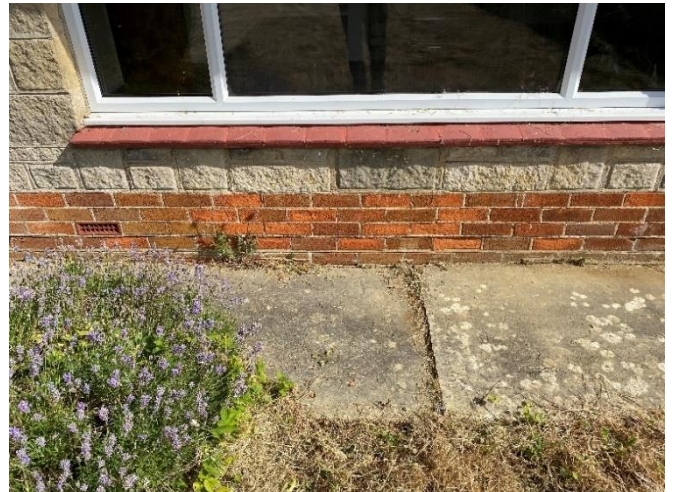
Photo 6: Spalling of brickwork below the Reception Room window

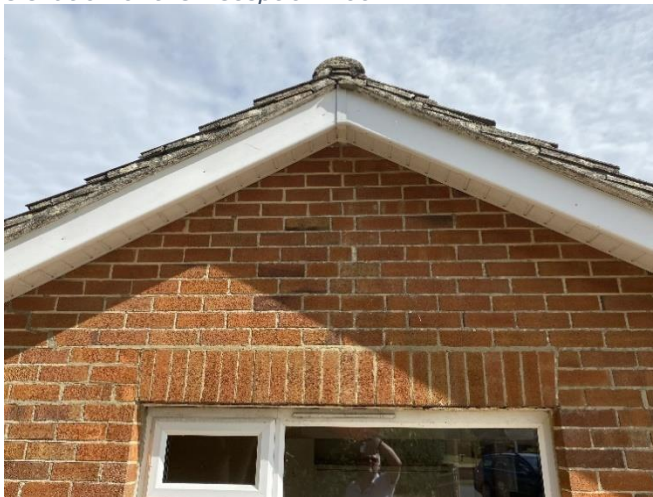
Photo 7: Repointing to the wall above the Front Bedroom window

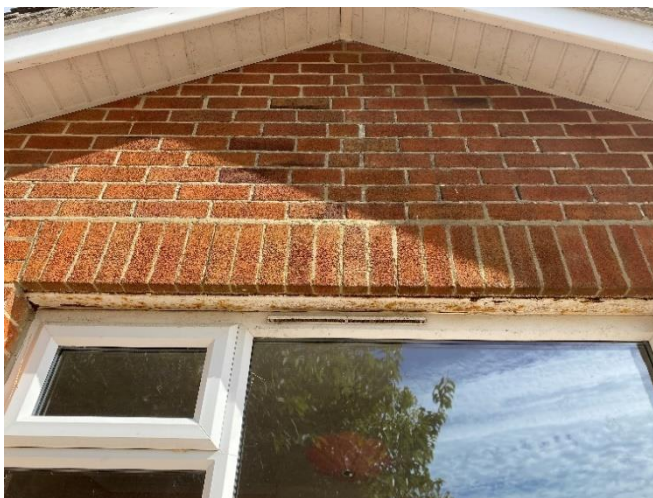
Photo 9: Corroded metal lintel above the Front Bedroom window

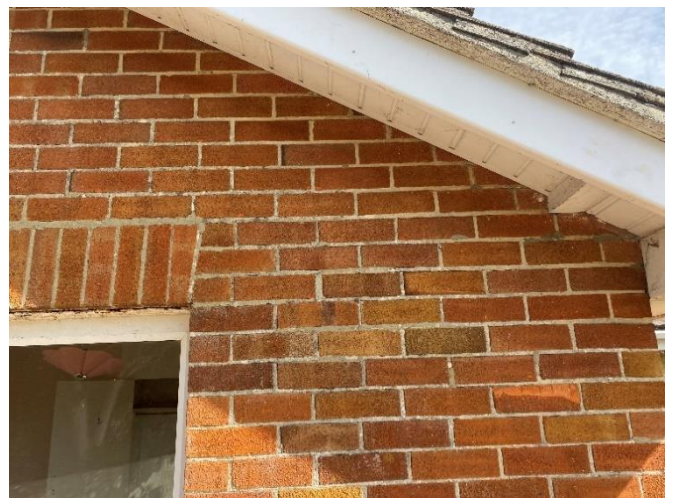
Photo 10: Repointing to the wall above the East side of the Front Bedroom window

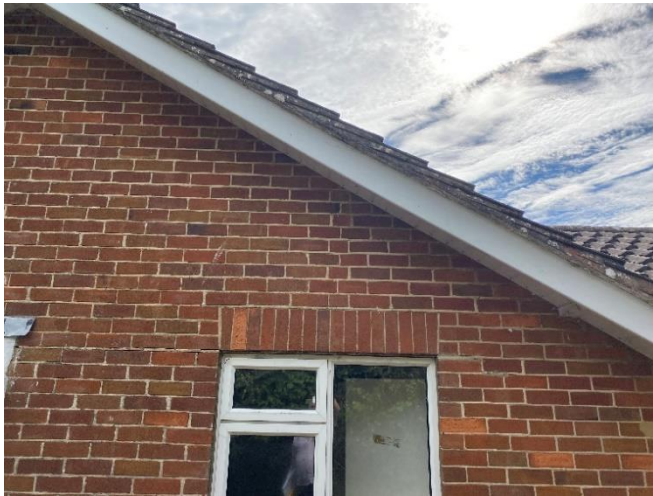
Photo 11: Cracking and repointing to the wall above the Middle Bedroom window

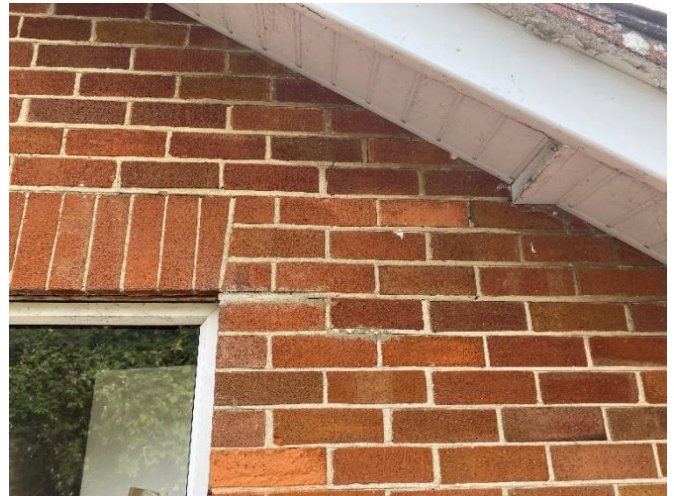
Photo 12: Cracking and repointing above the South side of the Middle Bedroom window

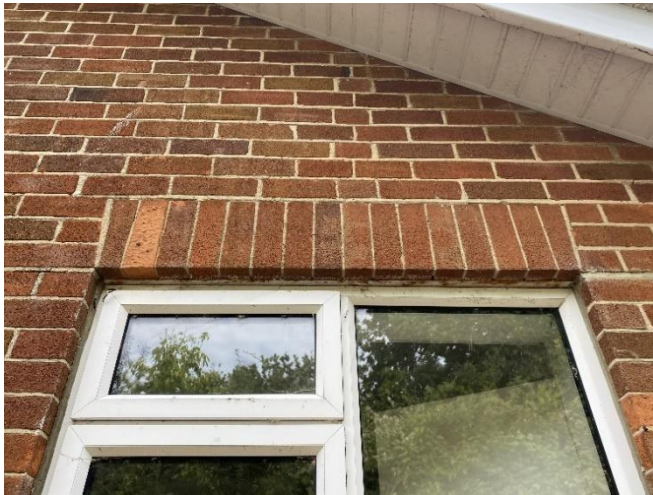
Photo 13: Corroded metal lintel above the Middle Bedroom window

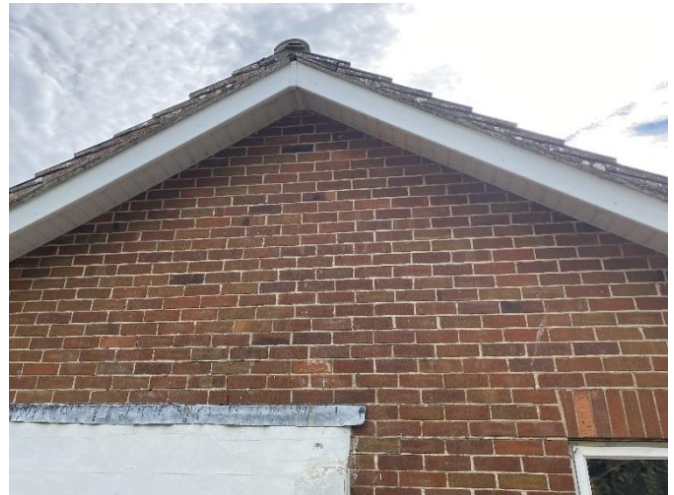
Photo 14: Cracking and repointing above the North side of the Middle Bedroom window

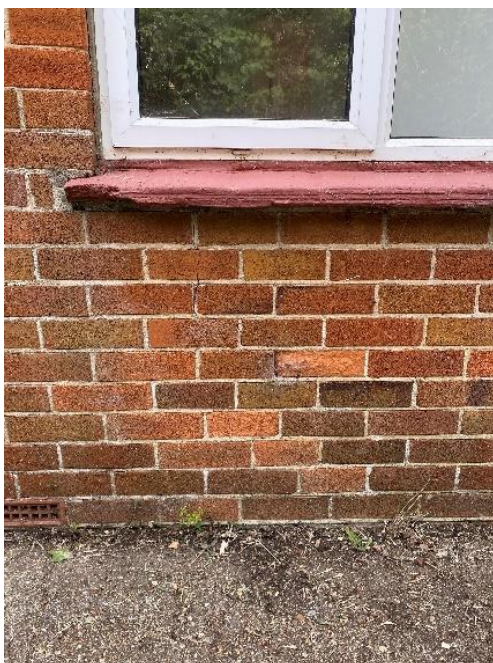
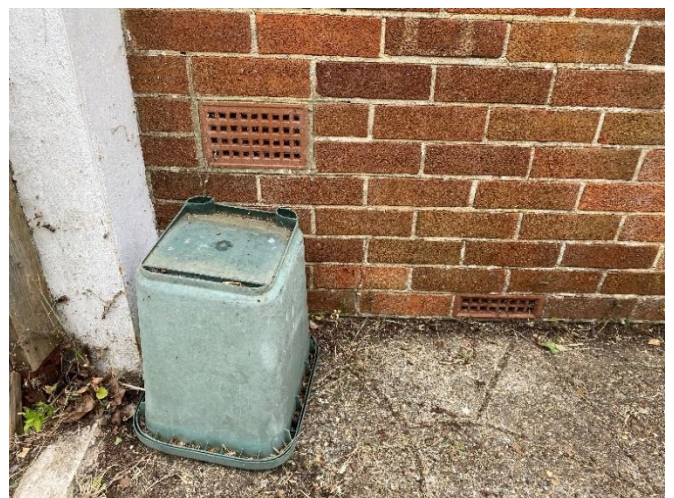
Photo 15: Vertical crack to the brickwork below the Middle Bedroom window

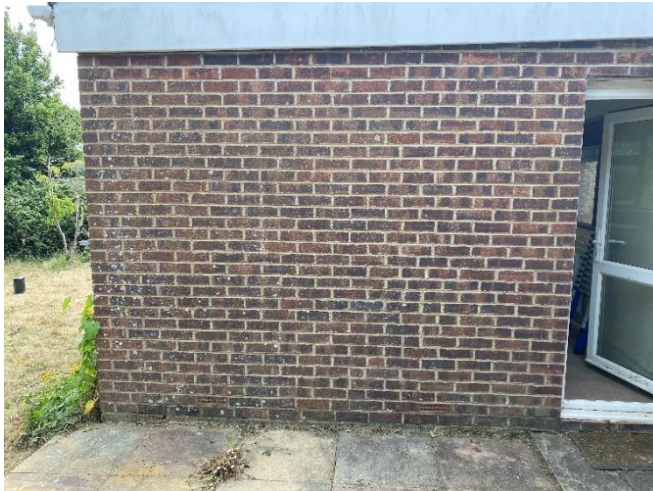
Photo 16: Vertical crack to the brickwork below the Middle Bedroom window

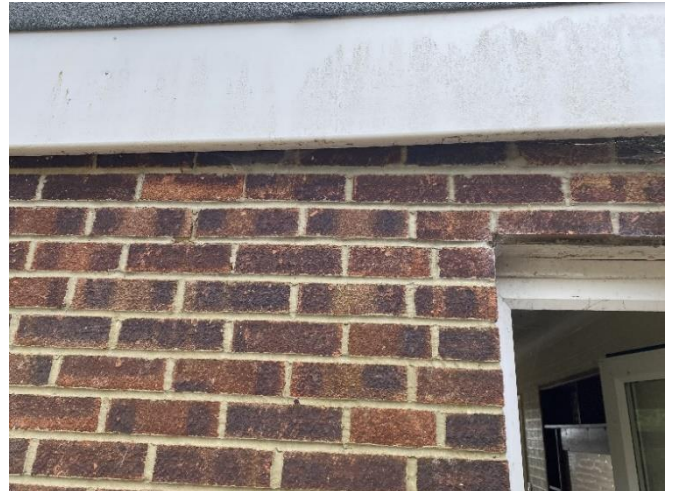
Photo 17: Repointed elevation to the West side of the extension to the rear of the property

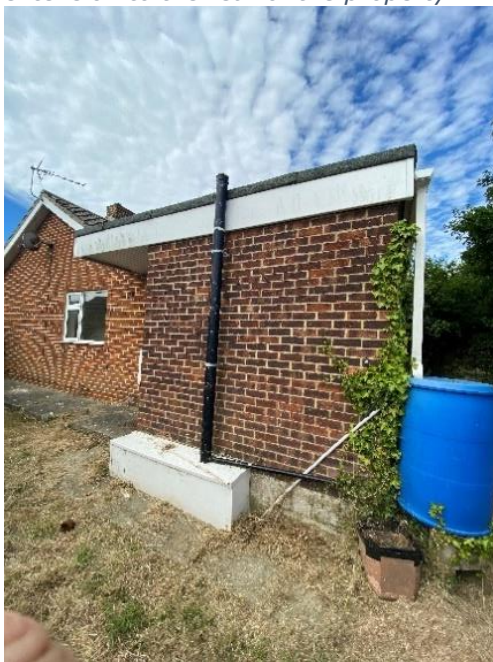
Photo 18: Area of missing pointing to the brickwork above the North side of the back door to the Kitchen

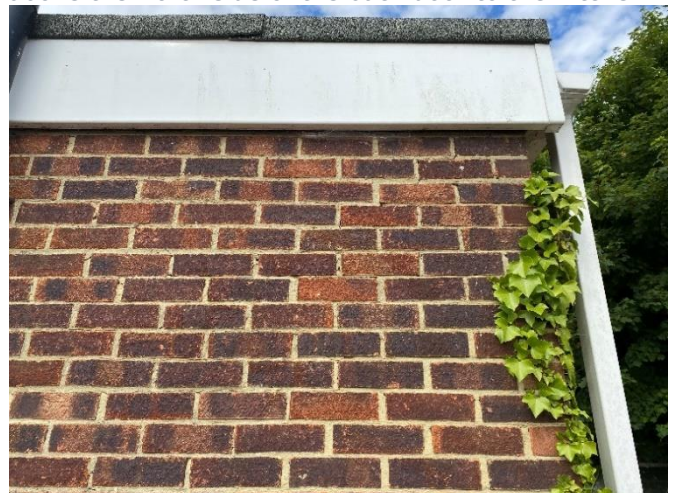
Photo 19: Weathered pointing to the brickwork to the East side of the extension to the rear of the property

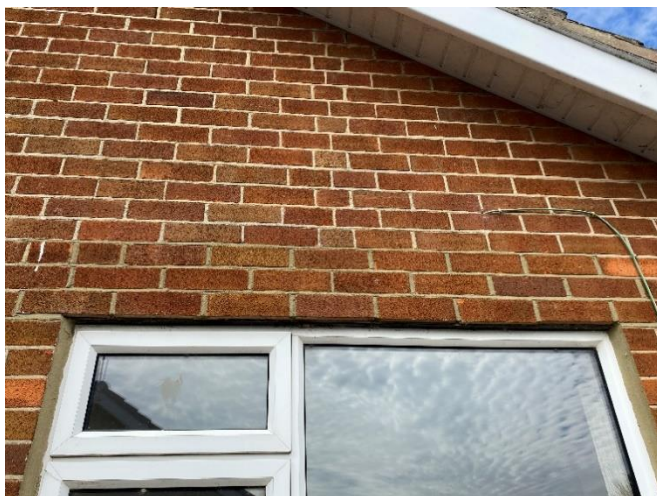
Photo 21: Brickwork and lintel (replaced) above the Rear Reception Room window

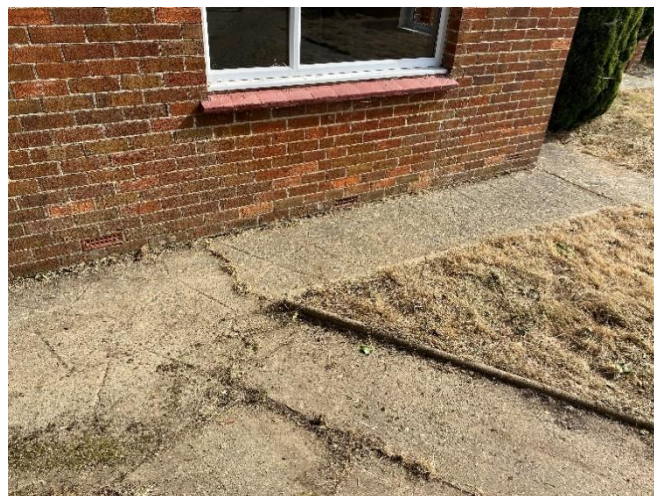
Photo 22: Damp proof course only 10mm above the path which falls towards the front of the property. Surface water was thought to pool on the path against the building

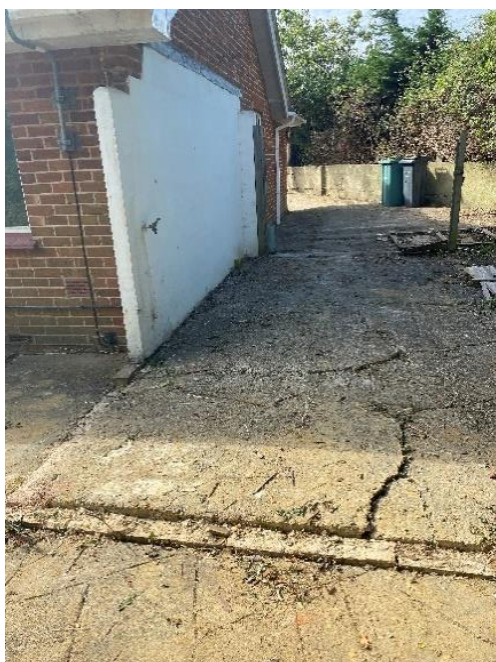
Photo 23: Cracked and dropped concrete slab to the rear of the property. Old garage removed. Surface water was thought to pool on the path against the building

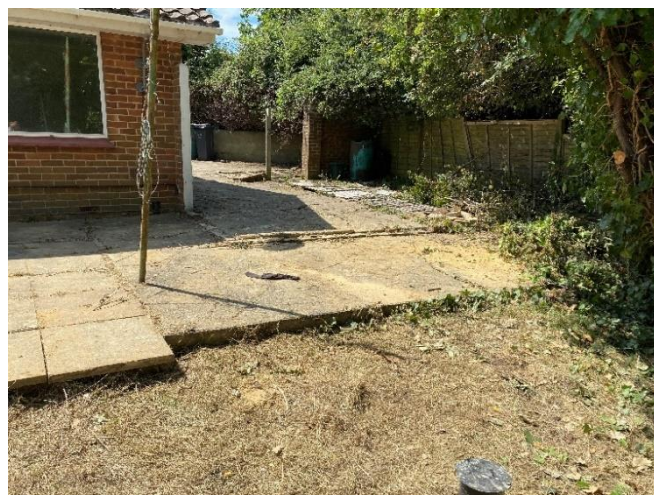
Photo 24: Cracked and dropped concrete slab to the rear of the property. Old garage removed.

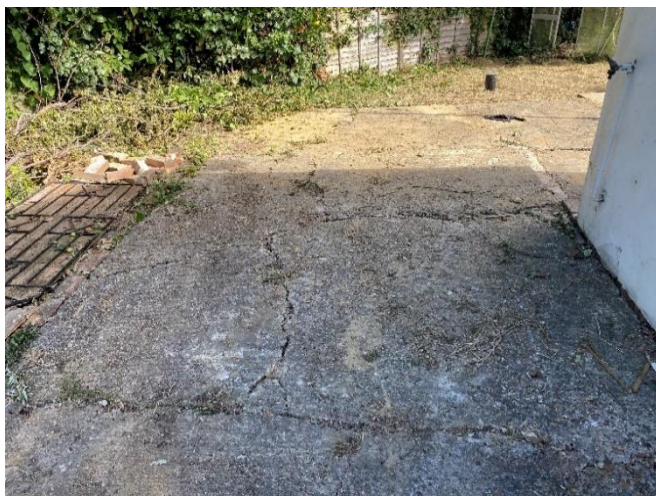
Photo 25: Cracked and dropped concrete slab to the rear of the property. Old garage removed.

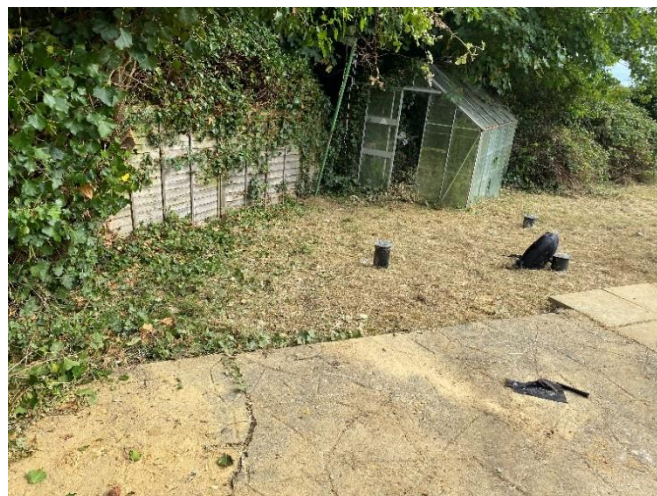
Photo 26: Slumped ground to the North West corner of the garden to the rear of the property

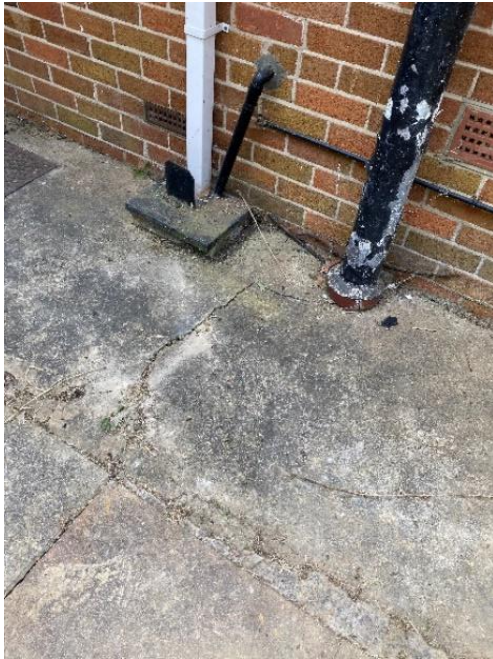
Photo 37: Foul and surface water downpipes with gully against the rear elevation of the main property, to the West side elevation of the extension. Cracked pipe and path

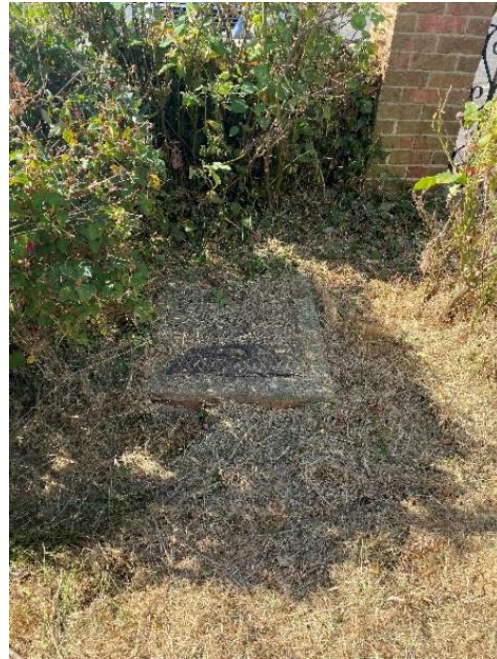
Photo 38: Inspection chamber to the South East corner of the front garden
