Addendum Arboricultural Report

Subsidence Damage Investigation at:

Ely St Mary's Junior School
 High Barns
 Ely
 CB7 4RB

CLIENT: Gateley Smithers Purslow
 CLIENT REF: 222801
 MWA REF: SUB230216-12412
 MWA CONSULTANT: Richard Percival (TechArborA)
 REPORT DATE: 01/11/2023

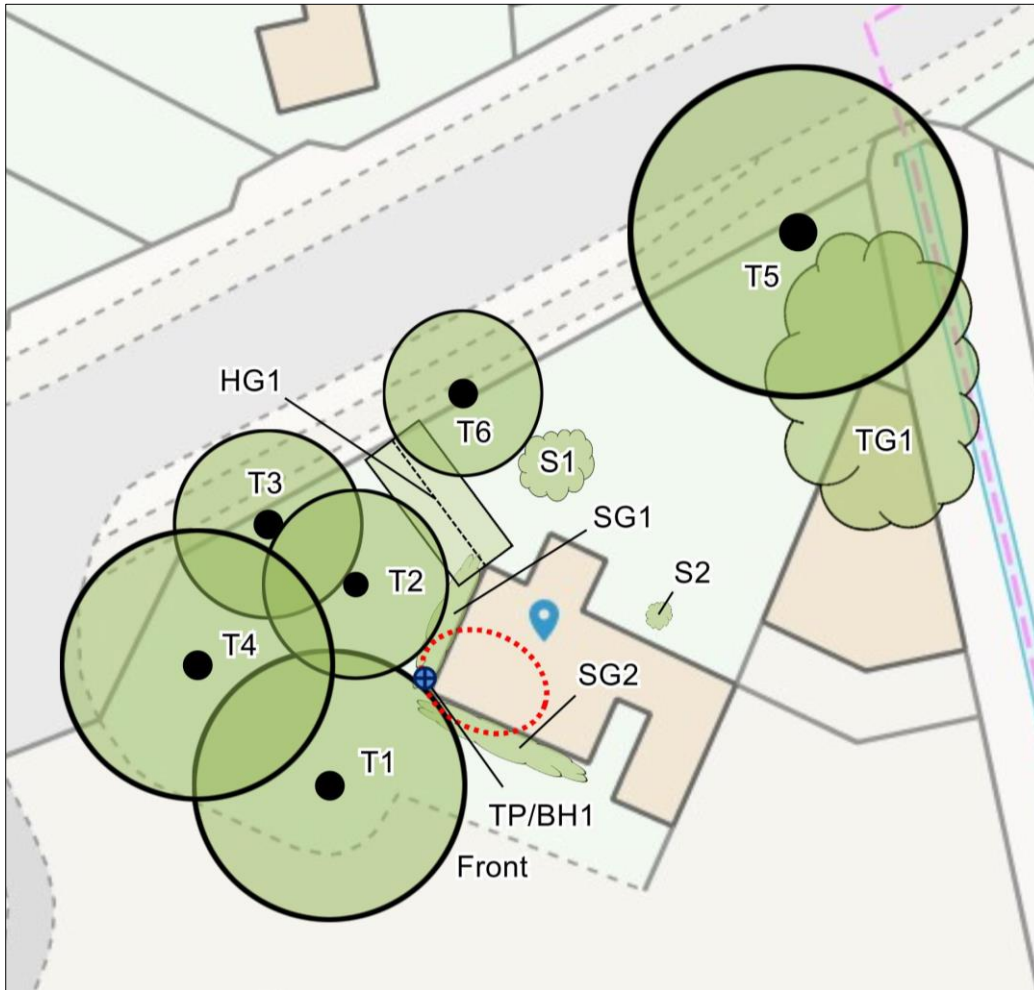
Site Plan

Approximate areas of damage
