Arboricultural Appraisal Report

Subsidence Damage Investigation at:

5a Moorland Road
Drighlington
Bradford
BD11 1JY

CLIENT:	360Globalnet
CLIENT REF:	085120277
MWA REF:	SUB230809-13881
MWA CONSULTANT:	John Graham B.Sc. Hons PhD
REPORT DATE:	31/08/2023

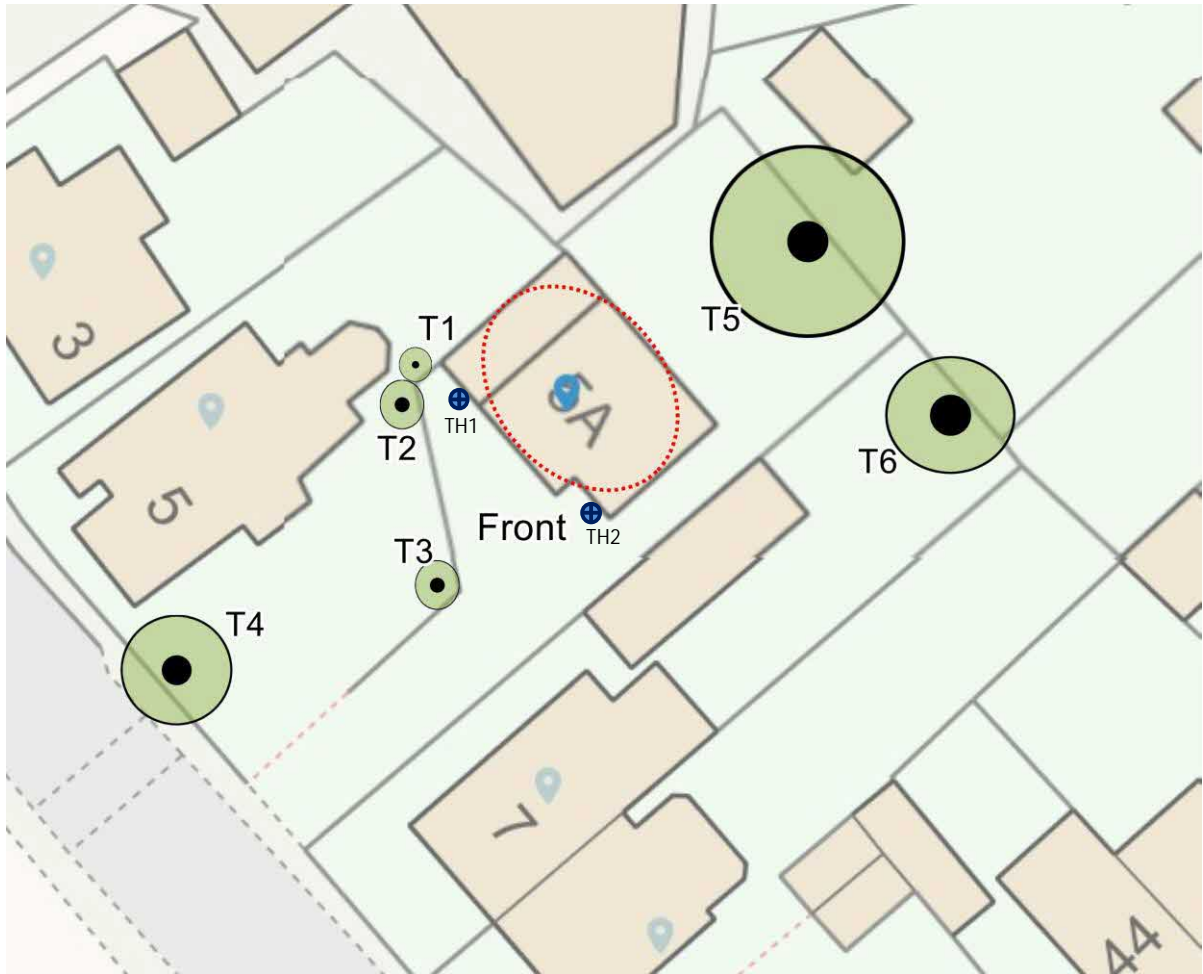
Site Plan

Approximate areas of damage

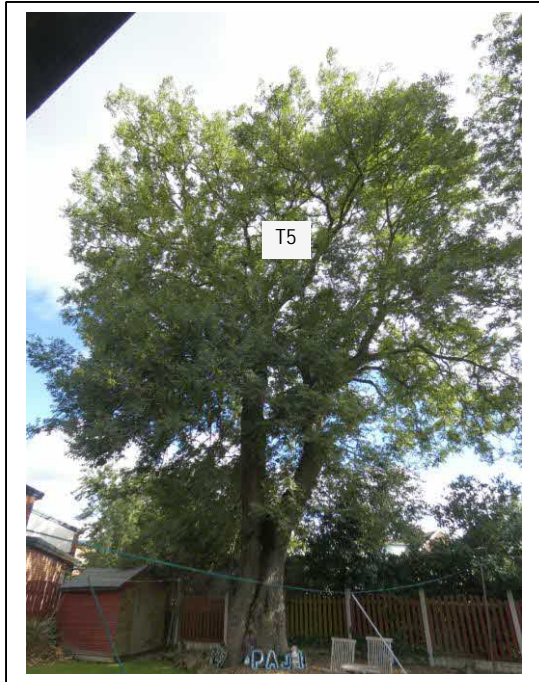
Roots were observed to a depth of 1,000mm bgl in TP/BH1 and recovered samples have been positively identified (using anatomical analysis) as ash, the origin of which will be T5 and/or T6.

Based on the technical reports currently available, engineering opinion and our own site assessment we conclude the damage is consistent with shrinkage of the clay subsoil related to moisture abstraction by vegetation. Having considered the information currently available, it is our opinion that T5 and T6 are the principal cause of or are materially contributing to the current subsidence damage.

View of T5.

If an arboricultural solution is to be implemented to mitigate the influence of the implicated trees, we recommend that T5 and T6 are removed. Other vegetation recorded presents a potential future risk to building stability and management is therefore recommended.

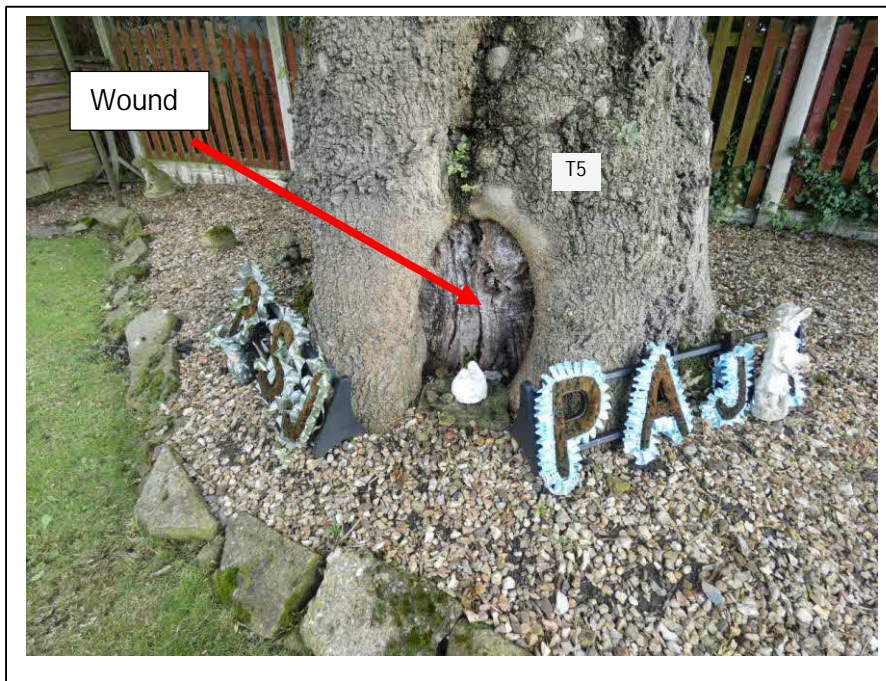
Tree No.	Species	Ht (m)	Dia (mm)	Crown Spread (m)	Dist. to building (m)	Age Classification	Ownership
T5	Ash	19	1120	15	8.5	Older than Property	Policy Holder
Management history		Subject to past management/pruning. This tree has a large wound/cavity with rot/soft wood that extends into the roots. The tree is a serious hazard that requires urgent management. See images.					
Recommendation		Remove (fell) on health and safety ground irrespective of being implicated in subsidence damage.					
T6	Ash	19 *	700 *	13 *	11	Older than Property	Third Party 7 Moorland Road BD11 1JY
Management history		Subject to past management/pruning.					
Recommendation		Remove (fell) to near ground level and treat stump to inhibit regrowth.

View of wound on T5.

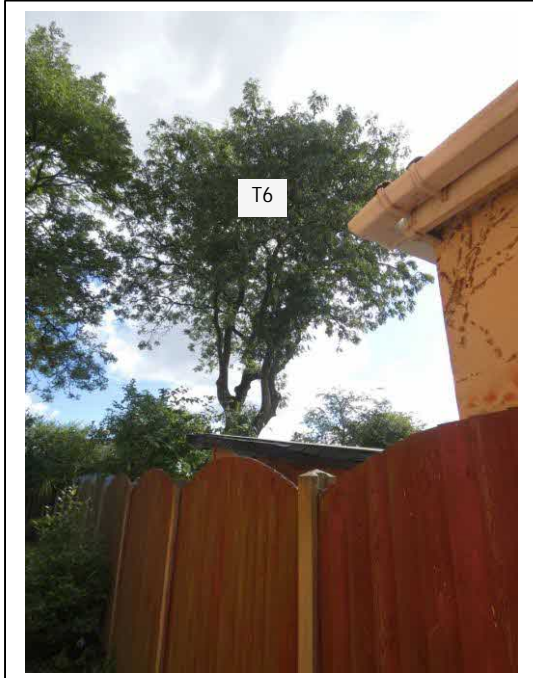
View of T6.

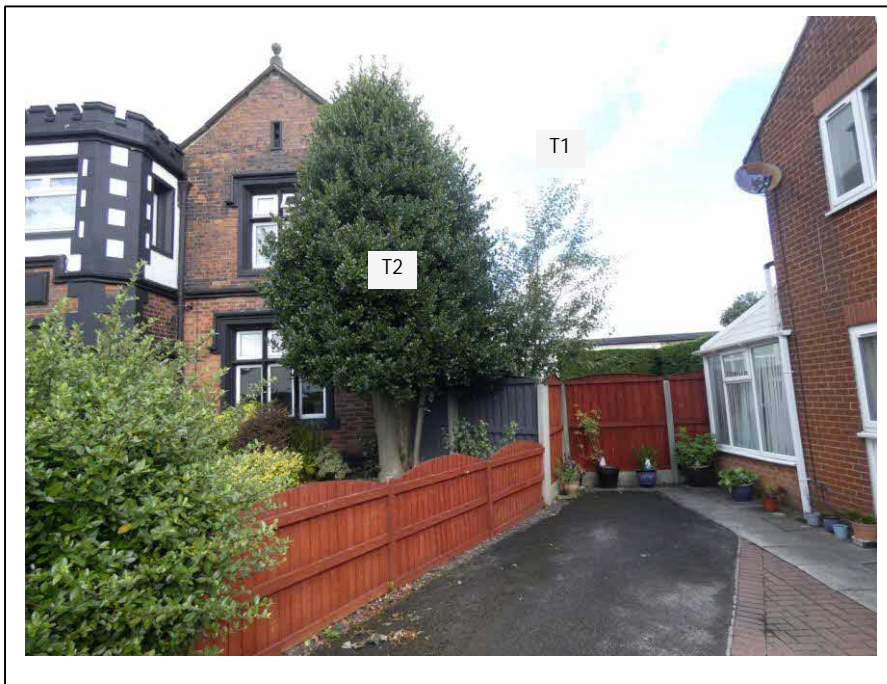
View of T1 and T2.

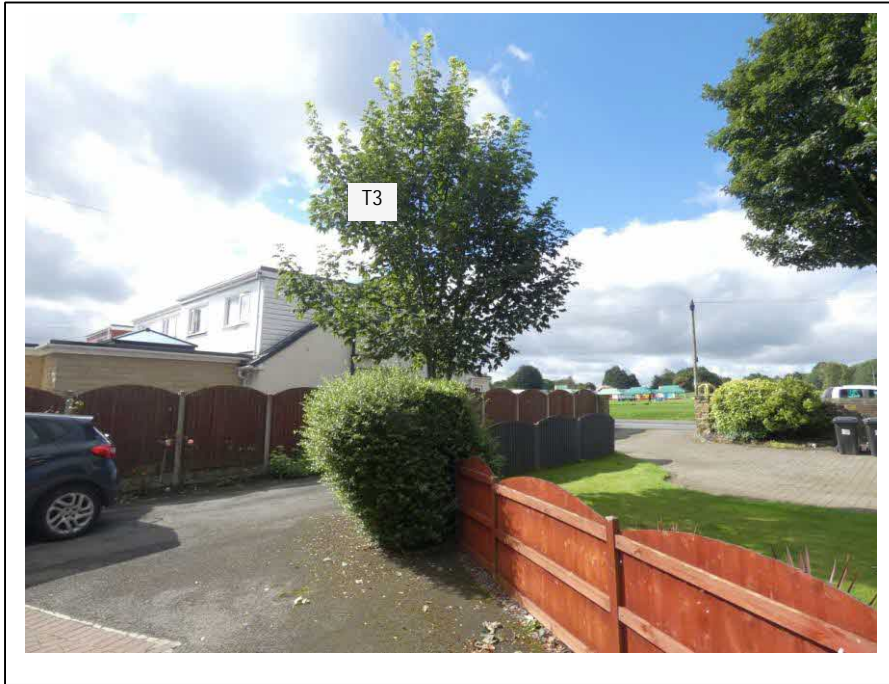
View of T3.

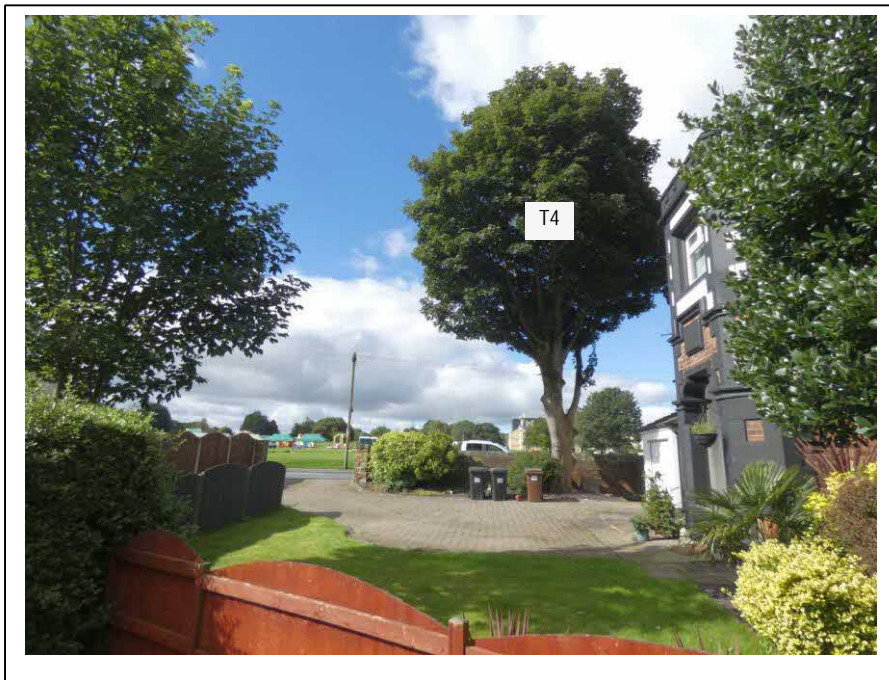
View of T4.

Management history		Subject to past management/pruning.					
Recommendation		No works required at present (subject to review if movement persists).
