Asbestos Demolition Survey

**Workshop Building
West Nottinghamshire College
Chesterfield Road
Mansfield
NG19 7BB**

AA Projects Limited

Project Number:	Survey Date:	Issue Date:
B-36545	07 April 2022	22 April 2022

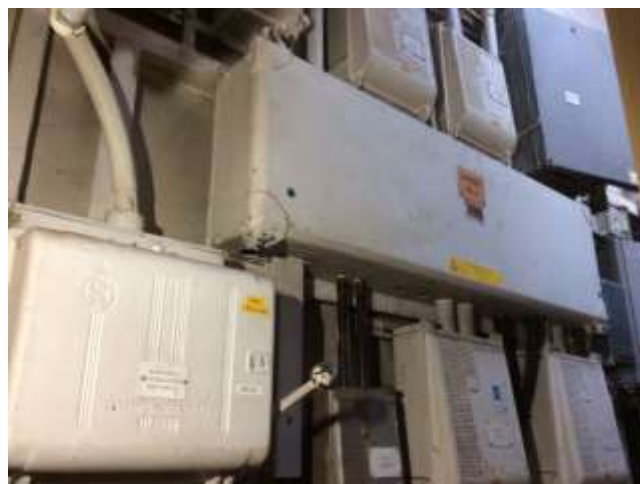
Building	Workshop Building
Floor	Ground Floor
Room	001 - Workshop
Description	Woven fuses tapes within electric boxes to north elevation. Presumed in all
Sample Reference	S001
Quantity	14 Units
Accessibility	Difficult

Analysis Result	Chrysotile	1
Product Type	Woven Textile	2
Condition	Good Condition	0
Surface Treatment	Sealed Woven	1

Material Risk Assessment Score
4
Risk Assessment Description
Very Low Risk

The asbestos containing material should be removed and disposed of in full accordance with current and relevant legislation.

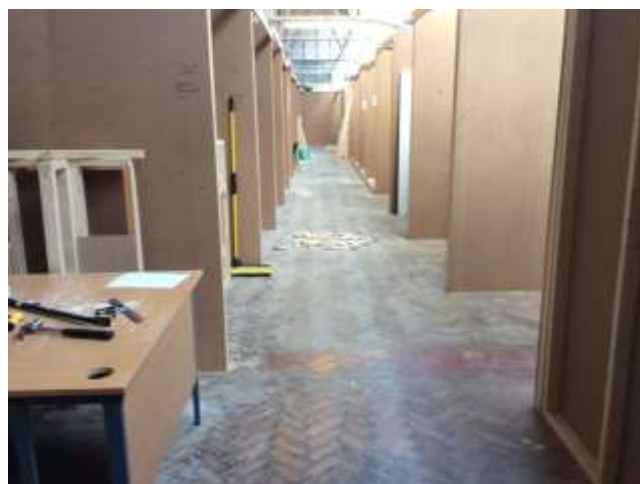
Building	Workshop Building
Floor	Ground Floor
Room	001 - Workshop
Description	Adhesive beneath parquet flooring
Sample Reference	S002
Quantity	220 Units
Accessibility	Difficult

Analysis Result	No Asbestos Detected	0
Product Type	Bitumen	1
Condition	Good Condition	0
Surface Treatment	Sealed Woven	1

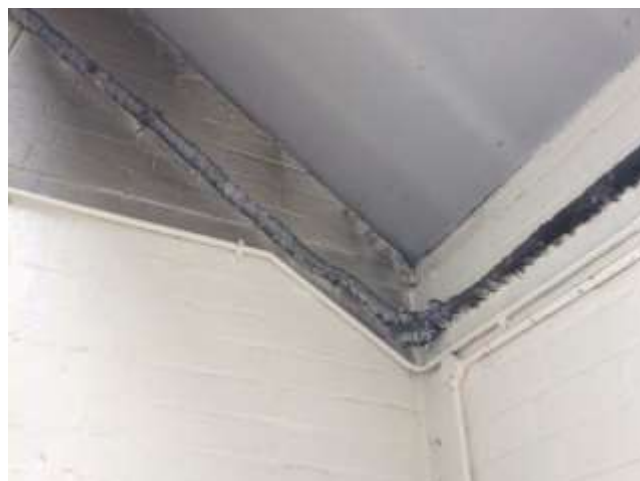
Building	Workshop Building
Floor	Ground Floor
Room	001 - Workshop
Description	String ties to textile pipe insulation from high level water tank
Sample Reference	S003
Quantity	10 Lin M
Accessibility	Difficult

Analysis Result	No Asbestos Detected	0
Product Type	Rope & String	2
Condition	Good Condition	0
Surface Treatment	Unsealed Woven	2

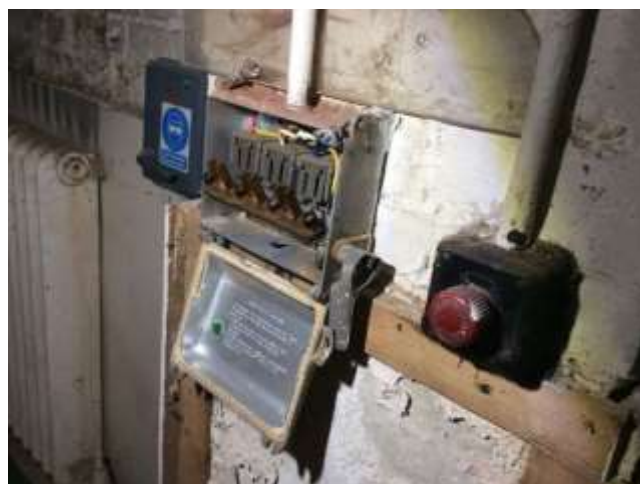
Building	Workshop Building
Floor	Ground Floor
Room	001 - Workshop
Description	String seal to switch box to east elevation
Sample Reference	S004
Quantity	1 Units
Accessibility	Difficult

Analysis Result	No Asbestos Detected	0
Product Type	Rope & String	2
Condition	Good Condition	0
Surface Treatment	Sealed Woven	1

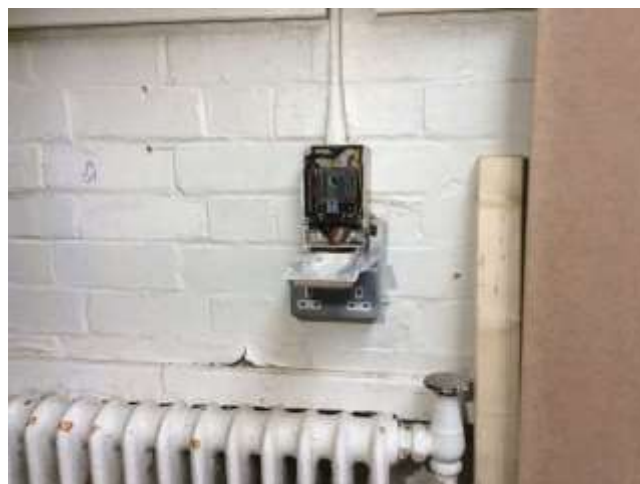
Building	Workshop Building
Floor	Ground Floor
Room	001 - Workshop
Description	Woven fuses tape within electric box to south elevation below water tank
Sample Reference	S005
Quantity	1 Units
Accessibility	Difficult

Analysis Result	Chrysotile	1
Product Type	Woven Textile	2
Condition	Good Condition	0
Surface Treatment	Sealed Woven	1

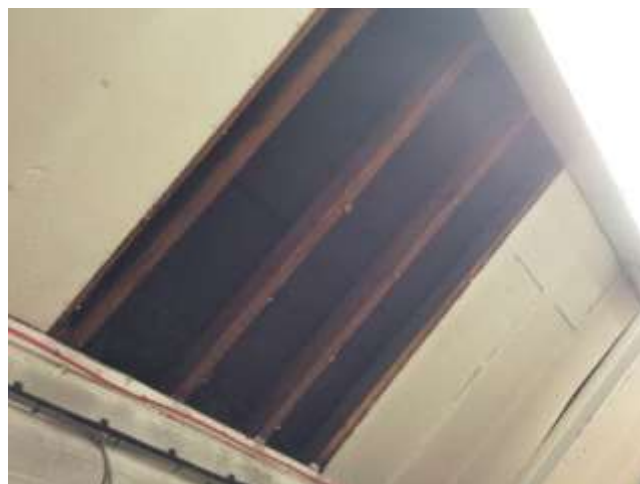
Building	Workshop Building
Floor	Ground Floor
Room	001 - Workshop
Description	Sarking felt to underside of the roof above fibreboard panels
Sample Reference	S006
Quantity	220 m ²
Accessibility	Difficult

Analysis Result	No Asbestos Detected	0
Product Type	Felt	1
Condition	Good Condition	0
Surface Treatment	Composite (Self Sealed)	0

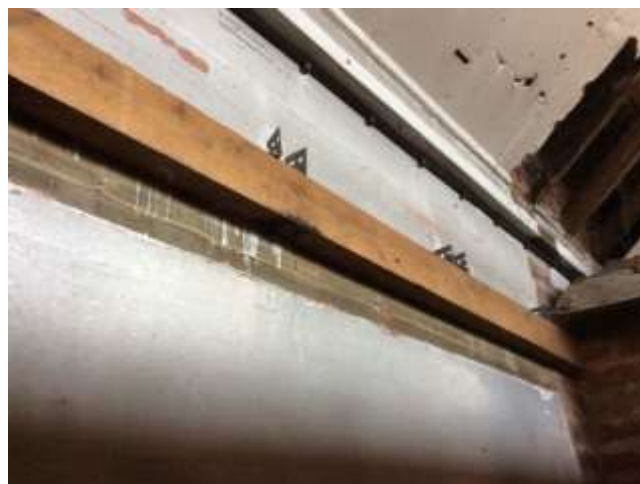
Building	Workshop Building
Floor	Ground Floor
Room	001 - Workshop
Description	Insulating board debris within nail holes to timber baton to external East elevation wall.
Sample Reference	S025
Quantity	2 Lin M
Accessibility	Easy

Analysis Result	Amosite, Chrysotile	2
Product Type	Insulating Board	2
Condition	High Damage	3
Surface Treatment	Unsealed Board	2

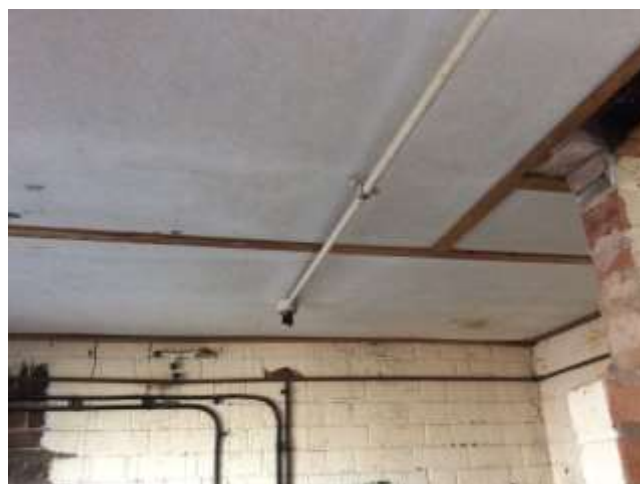
Building	Workshop Building
Floor	Ground Floor
Room	003 - Store
Description	Insulating board ceiling
Sample Reference	S007
Quantity	6 m ²
Accessibility	Easy

Analysis Result	No Asbestos Detected	0
Product Type	Insulating Board	2
Condition	Low Damage	1
Surface Treatment	Unsealed Board	2

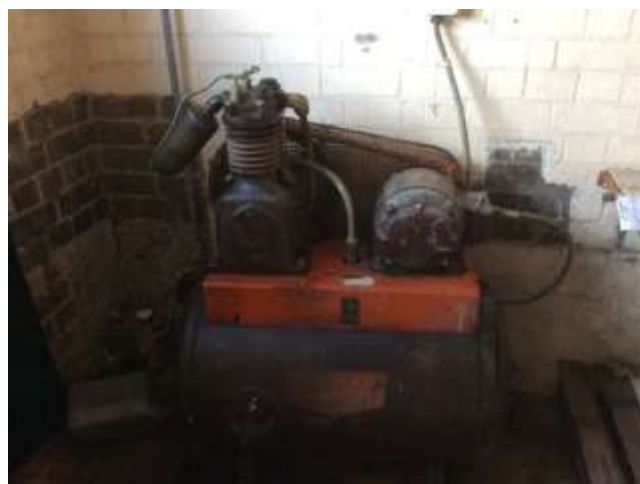
Building	Workshop Building
Floor	Ground Floor
Room	003 - Store
Description	Gaskets to compressor
Sample Reference	S008
Quantity	1 Units
Accessibility	Easy

Analysis Result	No Asbestos Detected	0
Product Type	Gaskets	2
Condition	Good Condition	0
Surface Treatment	Sealed Gasket	1

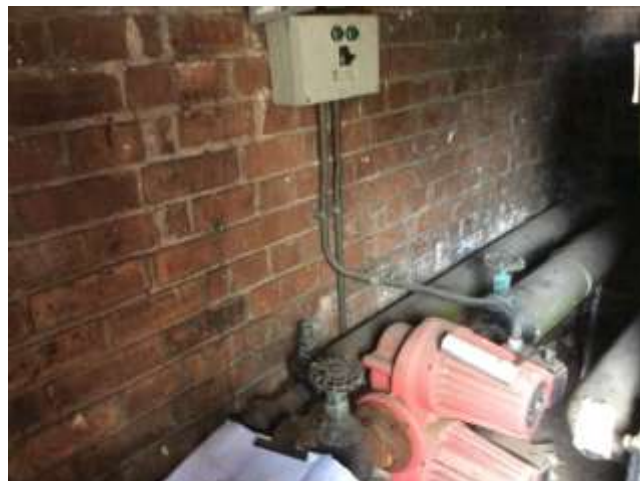
Building	Workshop Building
Floor	Ground Floor
Room	004 - Boiler Room
Description	Insulation debris to walls. Room area approx 12m²
Sample Reference	S009
Quantity	12 m ²
Accessibility	Easy

Analysis Result	Amosite, Chrysotile	2
Product Type	Thermal Insulation	3
Condition	High Damage	3
Surface Treatment	Unsealed Insulation	3

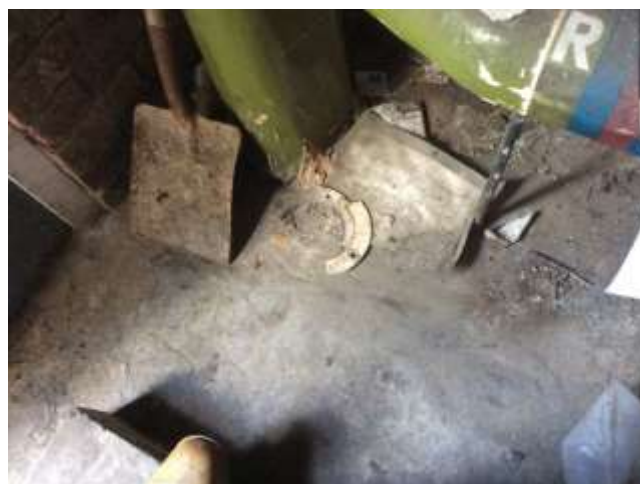
Building	Workshop Building
Floor	Ground Floor
Room	004 - Boiler Room
Description	Gasket debris to floor. Room area approx 12m²
Sample Reference	S010
Quantity	<1 m ²
Accessibility	Easy

Analysis Result	Chrysotile	1
Product Type	Gaskets	2
Condition	Low Damage	1
Surface Treatment	Unsealed Gasket	2

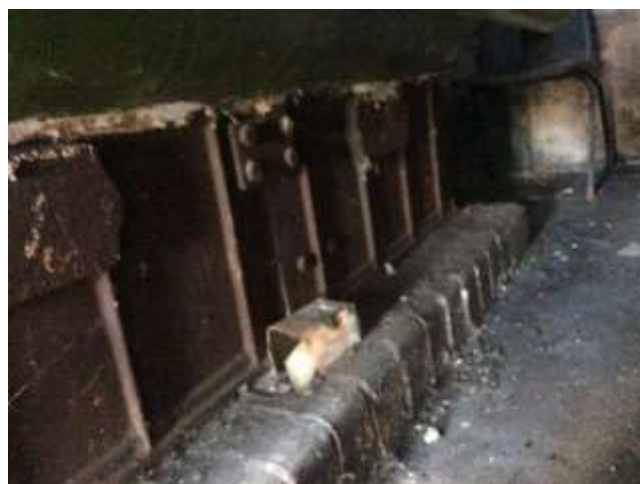
Building	Workshop Building
Floor	Ground Floor
Room	004 - Boiler Room
Description	Insulation debris to boiler. Room area approx 12m²
Sample Reference	S011
Quantity	12 m ²
Accessibility	Easy

Analysis Result	Amosite, Chrysotile	2
Product Type	Thermal Insulation	3
Condition	High Damage	3
Surface Treatment	Unsealed Insulation	3

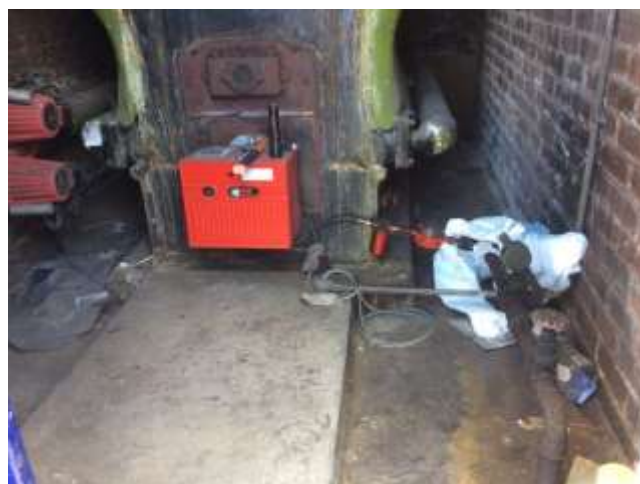
Building	Workshop Building
Floor	Ground Floor
Room	004 - Boiler Room
Description	Insulation debris to floor. Room area approx 12m²
Sample Reference	S012
Quantity	12 m ²
Accessibility	Easy

Analysis Result	Chrysotile	1
Product Type	Thermal Insulation	3
Condition	High Damage	3
Surface Treatment	Unsealed Insulation	3

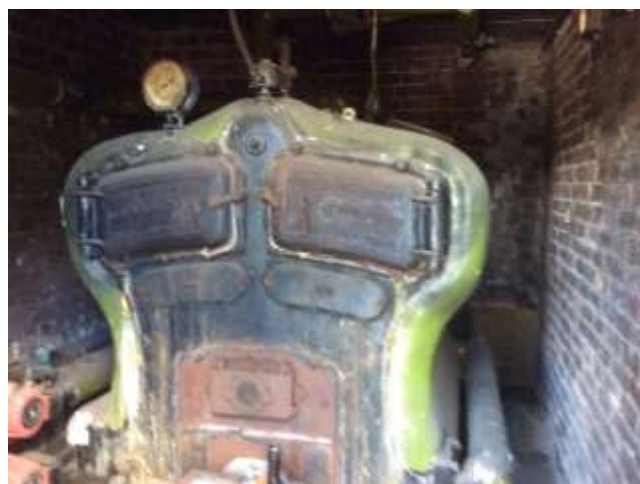
Building	Workshop Building
Floor	Ground Floor
Room	004 - Boiler Room
Description	Insulation debris to boiler. Room area approx 12m²
Sample Reference	S013
Quantity	12 m ²
Accessibility	Easy

Analysis Result	Amosite, Chrysotile	2
Product Type	Thermal Insulation	3
Condition	High Damage	3
Surface Treatment	Unsealed Insulation	3

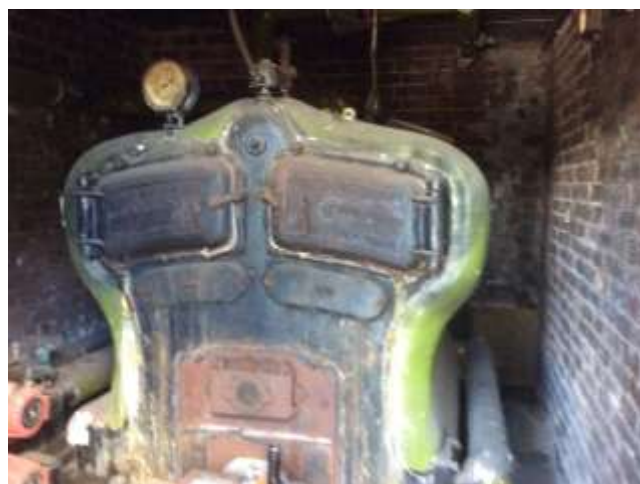
Building	Workshop Building
Floor	Ground Floor
Room	004 - Boiler Room
Description	Insulation debris to boiler. Room area approx 12m²
Sample Reference	S014
Quantity	12 m ²
Accessibility	Easy

Analysis Result	Amosite, Chrysotile	2
Product Type	Thermal Insulation	3
Condition	High Damage	3
Surface Treatment	Unsealed Insulation	3

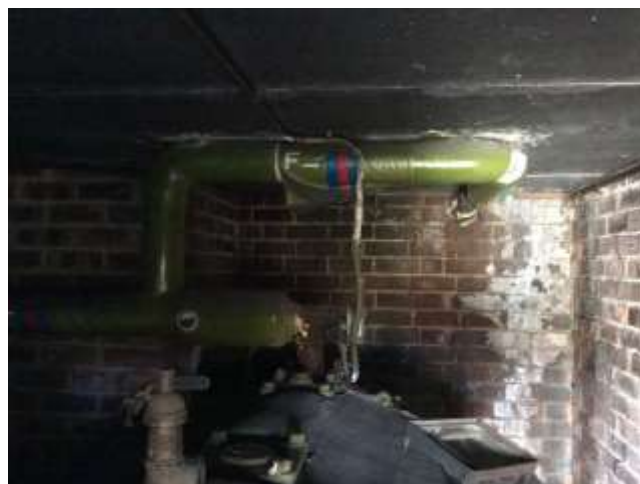
Building	Workshop Building
Floor	Ground Floor
Room	004 - Boiler Room
Description	Insulation debris to boiler hangers. Room area approx 12m²
Sample Reference	S015
Quantity	12 m ²
Accessibility	Easy

Analysis Result	Amosite	2
Product Type	Thermal Insulation	3
Condition	High Damage	3
Surface Treatment	Unsealed Insulation	3

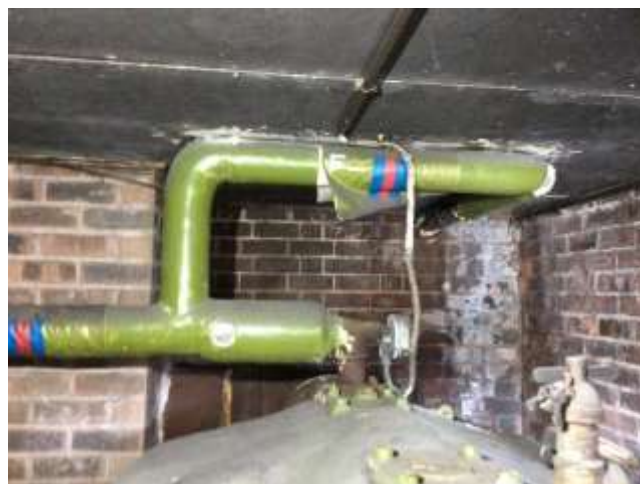
Building	Workshop Building
Floor	Ground Floor
Room	004 - Boiler Room
Description	Insulation debris to pipework over boiler. Room area approx 12m²
Sample Reference	S016
Quantity	12 m ²
Accessibility	Easy

Analysis Result	No Asbestos Detected	0
Product Type	Thermal Insulation	3
Condition	High Damage	3
Surface Treatment	Unsealed Insulation	3

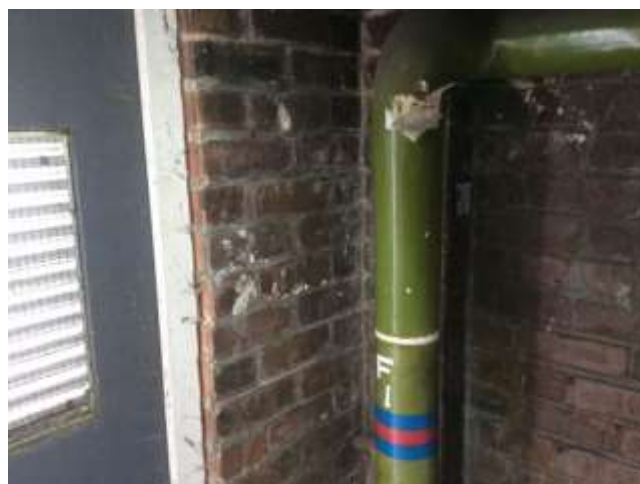
Building	Workshop Building
Floor	Ground Floor
Room	004 - Boiler Room
Description	Insulation debris to walls. Room area approx 12m²
Sample Reference	S017
Quantity	12 m ²
Accessibility	Easy

Analysis Result	Amosite	2
Product Type	Thermal Insulation	3
Condition	High Damage	3
Surface Treatment	Unsealed Insulation	3

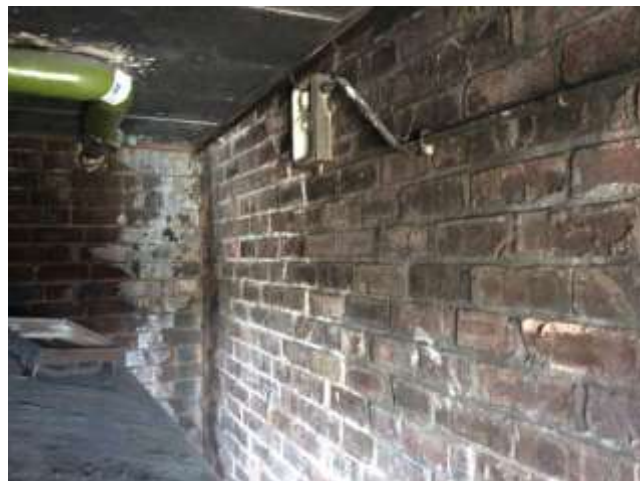
Building	Workshop Building
Floor	Ground Floor
Room	004 - Boiler Room
Description	Insulation debris to walls. Room area approx 12m²
Sample Reference	S018
Quantity	12 m ²
Accessibility	Easy

Analysis Result	Amosite, Chrysotile	2
Product Type	Thermal Insulation	3
Condition	High Damage	3
Surface Treatment	Unsealed Insulation	3

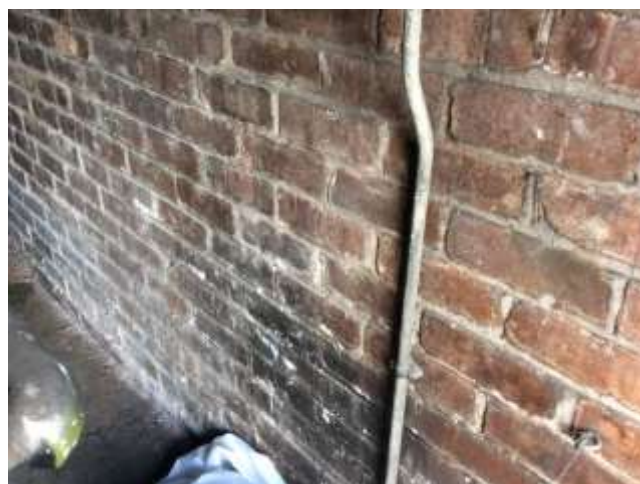
Building	Workshop Building
Floor	Ground Floor
Room	004 - Boiler Room
Description	Insulation debris to walls. Room area approx 12m²
Sample Reference	S019
Quantity	12 m ²
Accessibility	Easy

Analysis Result	Amosite	2
Product Type	Thermal Insulation	3
Condition	High Damage	3
Surface Treatment	Unsealed Insulation	3

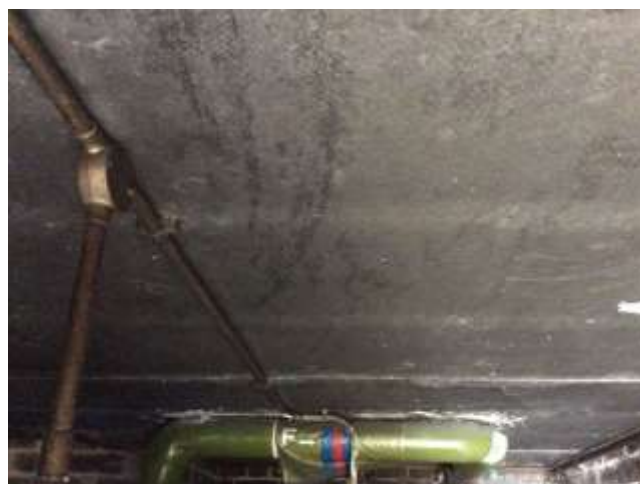
Building	Workshop Building
Floor	Ground Floor
Room	004 - Boiler Room
Description	Cement panels to ceiling
Sample Reference	S020
Quantity	12 m ²
Accessibility	Easy

Analysis Result	Chrysotile	1
Product Type	Cement	1
Condition	Good Condition	0
Surface Treatment	Sealed Cement	1

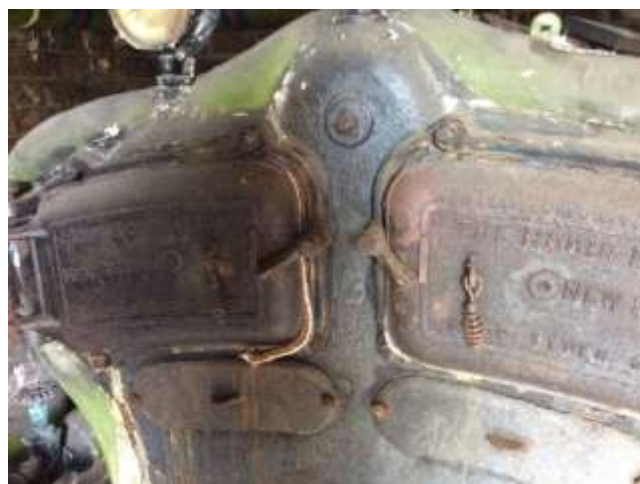
Building	Workshop Building
Floor	Ground Floor
Room	004 - Boiler Room
Description	Rope seals to boiler and rear flues
Sample Reference	S021
Quantity	1 m ²
Accessibility	Easy

Analysis Result	No Asbestos Detected	0
Product Type	Rope & String	2
Condition	Good Condition	0
Surface Treatment	Unsealed Woven	2

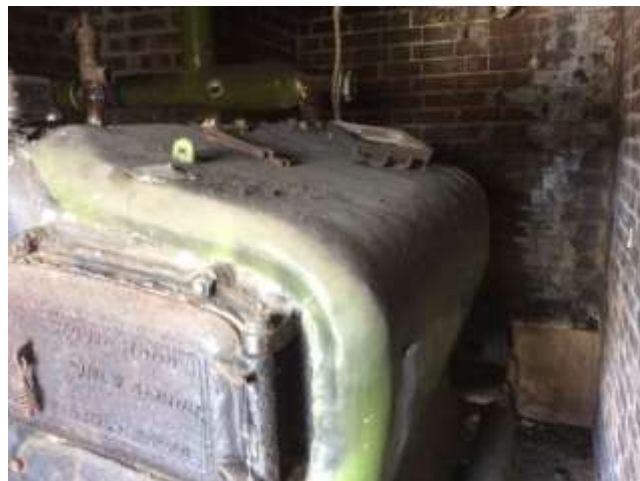
Building	Workshop Building
Floor	Ground Floor
Room	004 - Boiler Room
Description	Insulation to boiler
Sample Reference	S022
Quantity	10 m ²
Accessibility	Easy

Analysis Result	No Asbestos Detected	0
Product Type	Thermal Insulation	3
Condition	Good Condition	0
Surface Treatment	Unsealed Woven	2

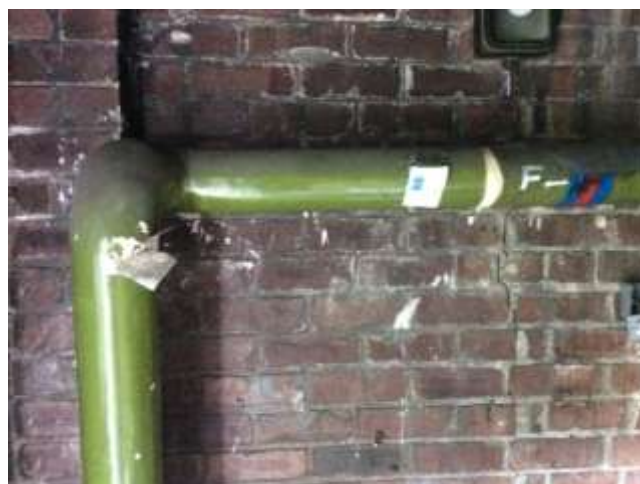
Building	Workshop Building
Floor	Ground Floor
Room	004 - Boiler Room
Description	Insulation to pipework
Sample Reference	S023
Quantity	20 m ²
Accessibility	Easy

Analysis Result	No Asbestos Detected	0
Product Type	Thermal Insulation	3
Condition	Good Condition	0
Surface Treatment	Unsealed Woven	2

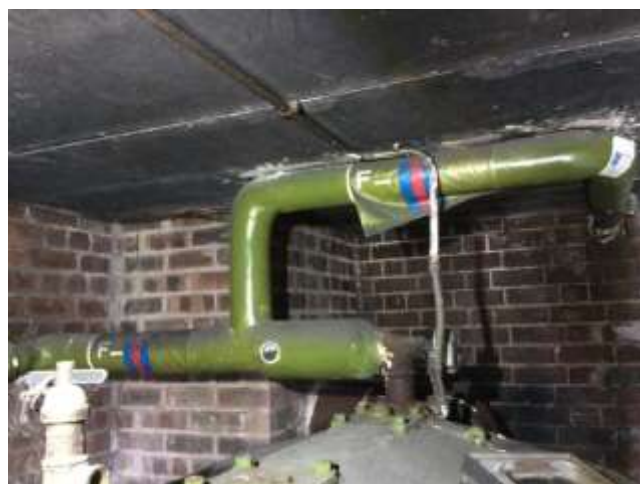
Building	Workshop Building
Floor	Ground Floor
Room	004 - Boiler Room
Description	Insulation to pipework
Sample Reference	S024
Quantity	20 m ²
Accessibility	Easy

Analysis Result	No Asbestos Detected	0
Product Type	Thermal Insulation	3
Condition	Good Condition	0
Surface Treatment	Unsealed Woven	2

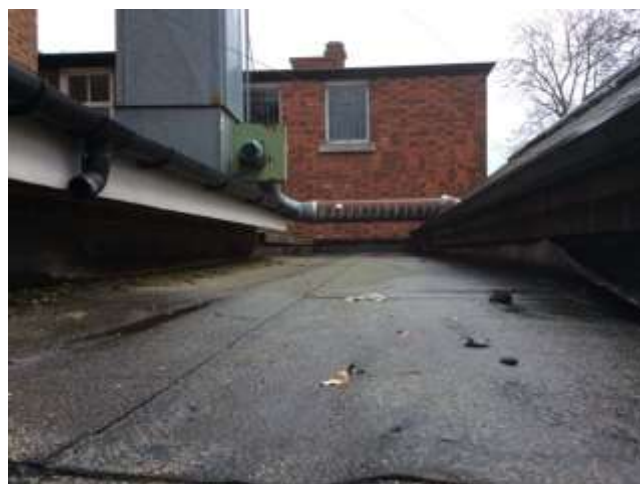
Building	Workshop Building
Floor	External
Room	99 - External
Description	Roof felt over flat roof areas
Sample Reference	S026
Quantity	50 m ²
Accessibility	Easy

Analysis Result	No Asbestos Detected	0
Product Type	Felt	1
Condition	Good Condition	0
Surface Treatment	Composite (Self Sealed)	0

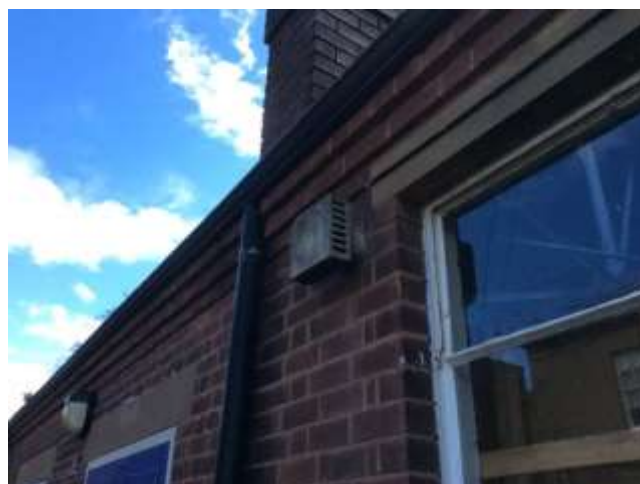
Building	Workshop Building
Floor	External
Room	99 - External
Description	Cement cowl to west elevation
Sample Reference	S027
Quantity	1 Units
Accessibility	Easy

Analysis Result	Chrysotile	1
Product Type	Cement	1
Condition	Good Condition	0
Surface Treatment	Unsealed Cement	1

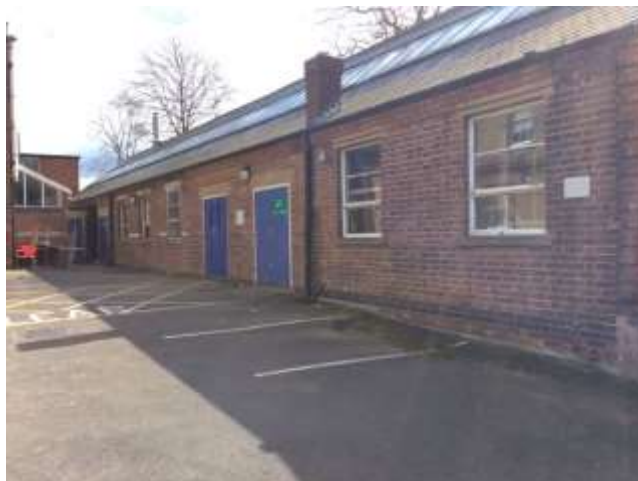
Building	Workshop Building
Floor	External
Room	99 - External
Description	Glazing putty to windows
Sample Reference	S028
Quantity	5 Units
Accessibility	Easy

Analysis Result	No Asbestos Detected	0
Product Type	Putty	1
Condition	Good Condition	0
Surface Treatment	Composite (Self Sealed)	0
