Asbestos Refurbishment Survey

**Ashfield House
West Nottinghamshire College
Chesterfield Road
Mansfield
NG19 7BB**

AA Projects Limited

Project Number:	Survey Date:	Issue Date:
B-36548	08 April 2022	22 April 2022

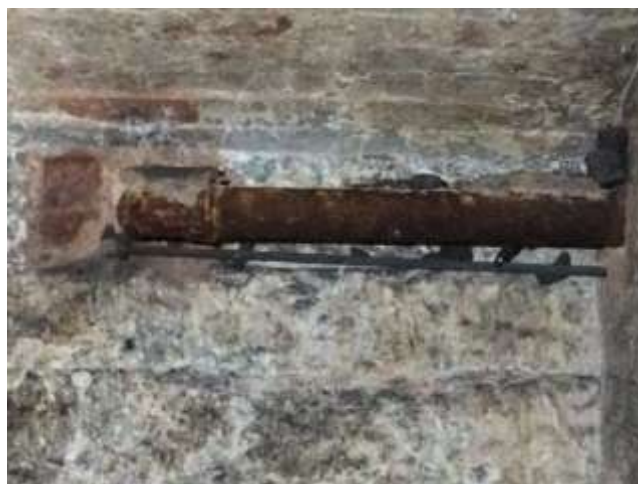
Building	Ashfield House
Floor	Basement
Room	B01 - Boiler Room
Description	Insulation to pipework within left hand chamber to back wall. Room Area approx 50m²
Sample Reference	S007
Quantity	1 Lin M

Analysis Result	
Amosite, Chrysotile	2
Product Type	
Thermal Insulation	3

Condition	
High Damage	3
Surface Treatment	
Unsealed Insulation	3

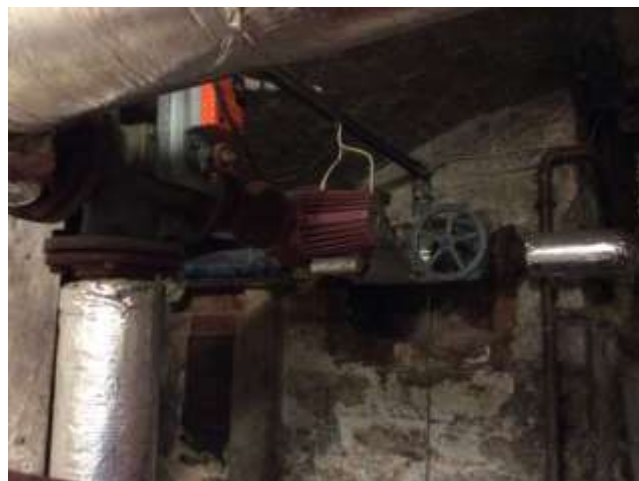
Building	Ashfield House
Floor	Basement
Room	B01 - Boiler Room
Description	Insulation residues to pipework over boiler. Room Area approx 50m²
Sample Reference	S008
Quantity	10 Lin M

Analysis Result	
Amosite	2
Product Type	
Thermal Insulation	3

Condition	
High Damage	3
Surface Treatment	
Unsealed Insulation	3

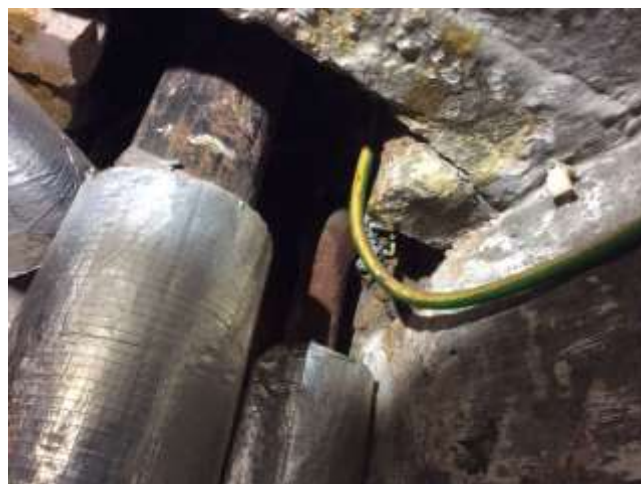
Building	Ashfield House
Floor	Basement
Room	B01 - Boiler Room
Description	Corrugated paper insulation to pipework through ceiling rear of boiler. Room Area approx 50m²
Sample Reference	S009
Quantity	1 Lin M

Analysis Result	
Chrysotile	1
Product Type	
Thermal Insulation	3

Condition	
High Damage	3
Surface Treatment	
Unsealed Insulation	3

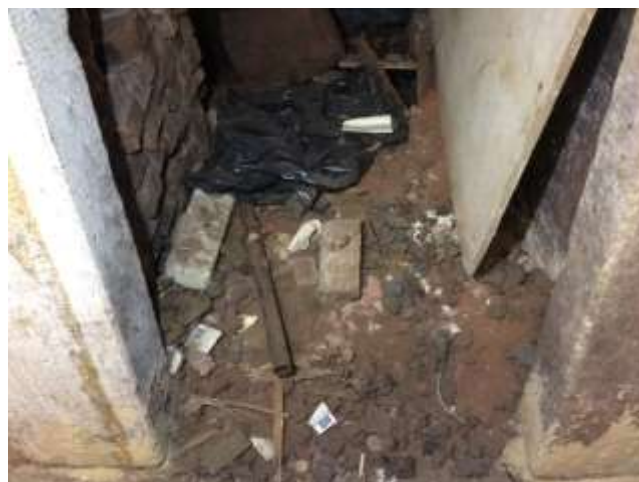
Building	Ashfield House
Floor	Basement
Room	B01 - Boiler Room
Description	Insulation debris to floor within left hand chamber entrance. Room Area approx 50m²
Sample Reference	S010
Quantity	50 m ²

Analysis Result	
Amosite, Chrysotile	2
Product Type	
Thermal Insulation	3

Condition	
High Damage	3
Surface Treatment	
Unsealed Insulation	3

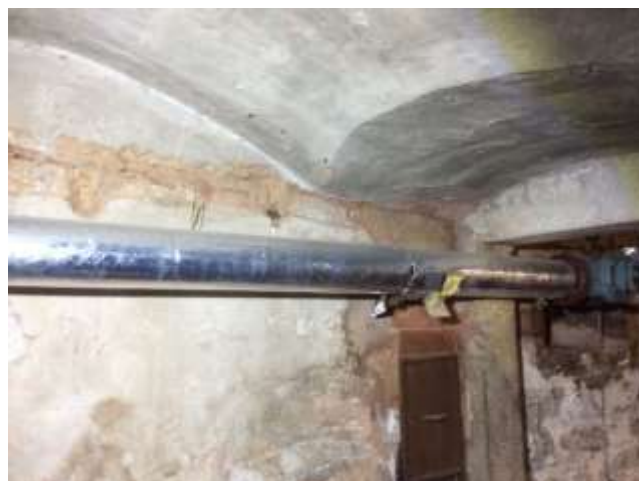
Building	Ashfield House
Floor	Basement
Room	B01 - Boiler Room
Description	Insulation debris to walls within RH chamber. Presumed throughout boiler room. Room Area approx 50m²
Sample Reference	S011
Quantity	50 Lin M

Analysis Result	
Amosite	2
Product Type	
Thermal Insulation	3

Condition	
High Damage	3
Surface Treatment	
Unsealed Insulation	3

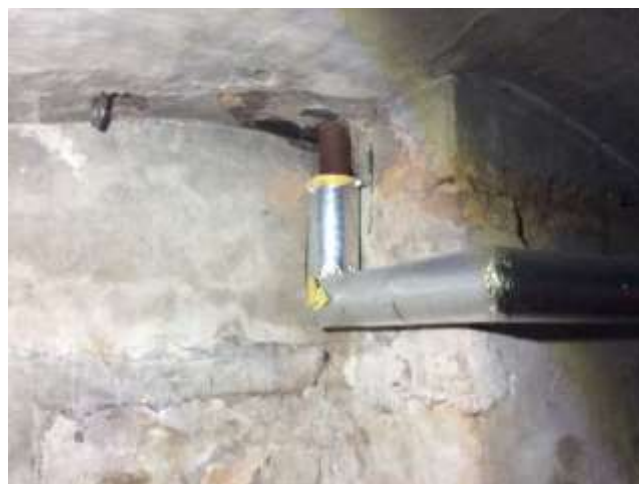
Building	Ashfield House
Floor	Basement
Room	B01 - Boiler Room
Description	Insulation debris to walls within RH chamber. Presumed throughout boiler room. Room Area approx 50m²
Sample Reference	S012
Quantity	50 m ²

Analysis Result	
Amosite, Chrysotile	2
Product Type	
Thermal Insulation	3

Condition	
High Damage	3
Surface Treatment	
Unsealed Insulation	3

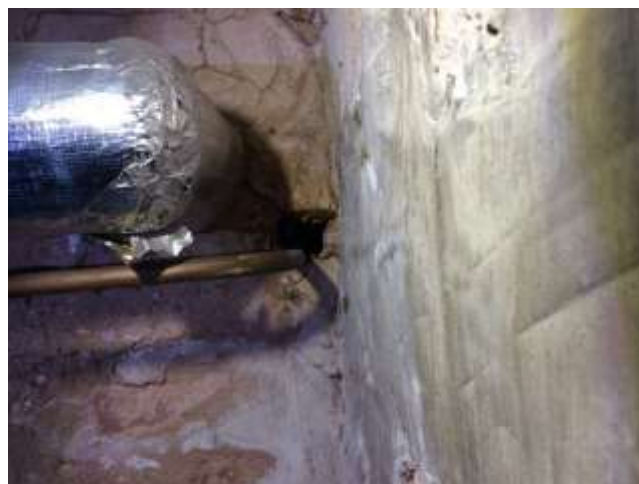
Building	Ashfield House
Floor	Basement
Room	B01 - Boiler Room
Description	Corrugated paper insulation to pipework through wall penetration. Room Area approx 50m²
Sample Reference	S013
Quantity	1 Lin M

Analysis Result	
Chrysotile	1
Product Type	
Thermal Insulation	3

Condition	
High Damage	3
Surface Treatment	
Unsealed Insulation	3

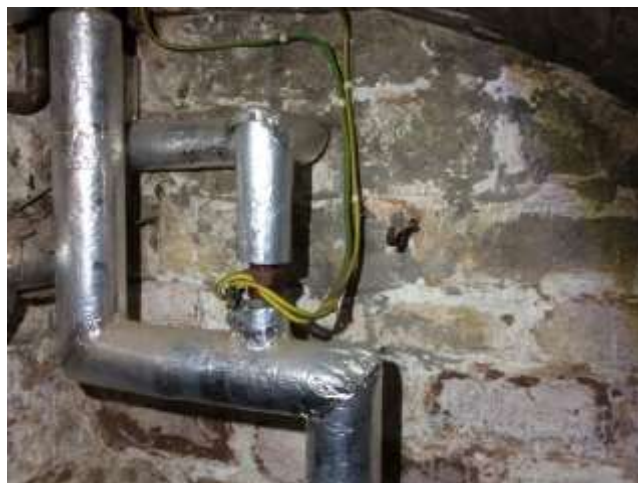
Building	Ashfield House
Floor	Basement
Room	B01 - Boiler Room
Description	Insulation debris to walls and brackets rear of boiler. Room Area approx 50m²
Sample Reference	S014
Quantity	50 m ²

Analysis Result	
Amosite	2
Product Type	
Thermal Insulation	3

Condition	
High Damage	3
Surface Treatment	
Unsealed Insulation	3

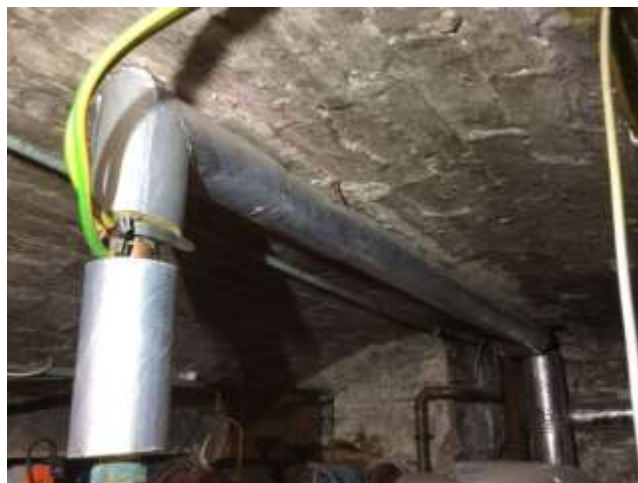
Building	Ashfield House
Floor	Basement
Room	B01 - Boiler Room
Description	Insulation debris to ceiling. Room Area approx 50m²
Sample Reference	S015
Quantity	50 m ²

Analysis Result	
No Asbestos Detected	0
Product Type	
Thermal Insulation	3

Condition	
High Damage	3
Surface Treatment	
Unsealed Insulation	3

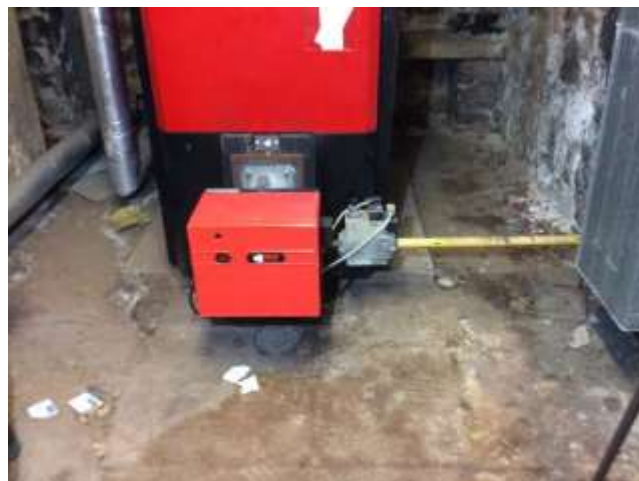
Building	Ashfield House
Floor	Basement
Room	B01 - Boiler Room
Description	Insulation debris to floor. Room Area approx 50m²
Sample Reference	S016
Quantity	50 m ²

Analysis Result	
Amosite	2
Product Type	
Thermal Insulation	3

Condition	
High Damage	3
Surface Treatment	
Unsealed Insulation	3

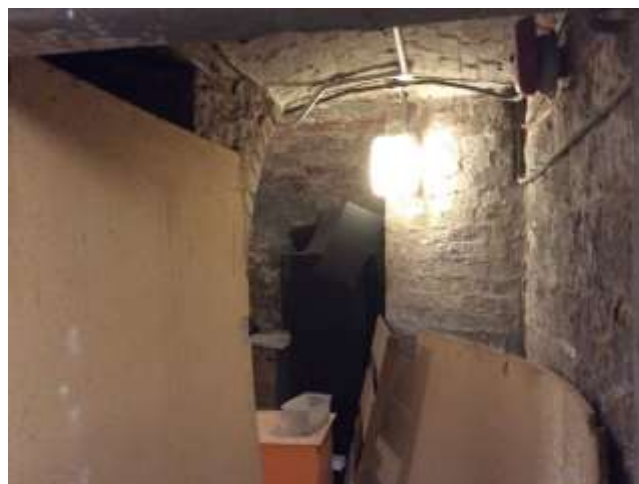
Building	Ashfield House
Floor	Basement
Room	B01 - Boiler Room
Description	Insulation debris to walls. Presumed throughout boiler room. Room Area approx 50m²
Sample Reference	S017
Quantity	50 m ²

Analysis Result	
No Asbestos Detected	0
Product Type	
Thermal Insulation	3

Condition	
High Damage	3
Surface Treatment	
Unsealed Insulation	3

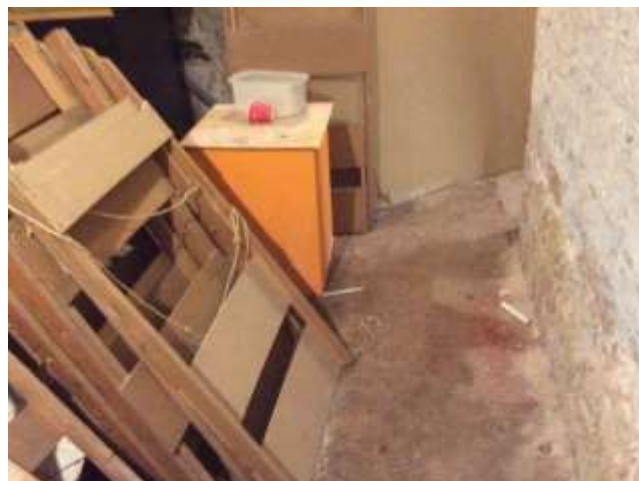
Building	Ashfield House
Floor	Basement
Room	B01 - Boiler Room
Description	Insulation debris to floor. Room Area approx 50m²
Sample Reference	S018
Quantity	50 m ²

Analysis Result	
Amosite	2
Product Type	
Thermal Insulation	3

Condition	
High Damage	3
Surface Treatment	
Unsealed Insulation	3

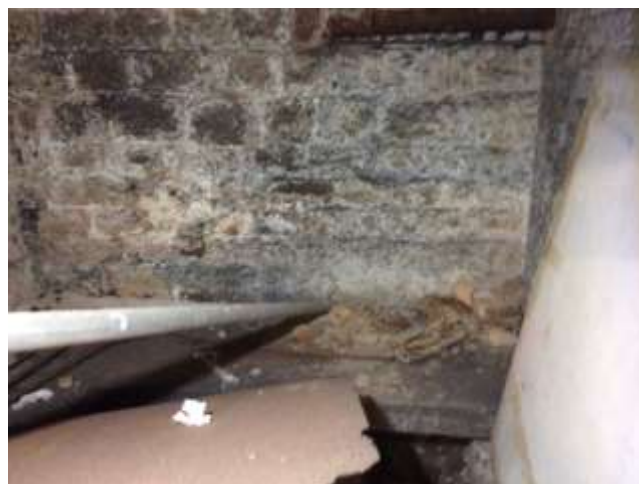
Building	Ashfield House
Floor	Basement
Room	B01 - Boiler Room
Description	Insulation debris beneath pipework within left hand chamber. Room Area approx 50m²
Sample Reference	Ref S007
Quantity	50 m ²

Analysis Result	
Amosite, Chrysotile	2
Product Type	
Thermal Insulation	3

Condition	
High Damage	3
Surface Treatment	
Unsealed Insulation	3

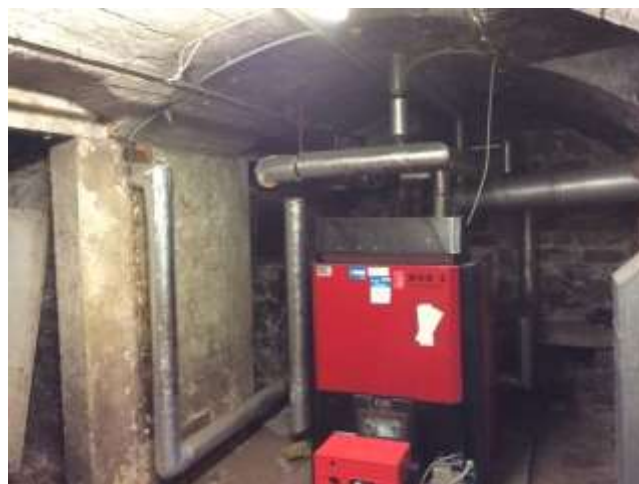
Building	Ashfield House
Floor	Basement
Room	B01 - Boiler Room
Description	All surfaces throughout the Boiler Room and adjacent areas are deemed contaminated with thermal insulation
Sample Reference	Ref S012
Quantity	50 m ²

Analysis Result	
Amosite, Chrysotile	2
Product Type	
Thermal Insulation	3

Condition	
High Damage	3
Surface Treatment	
Unsealed Insulation	3

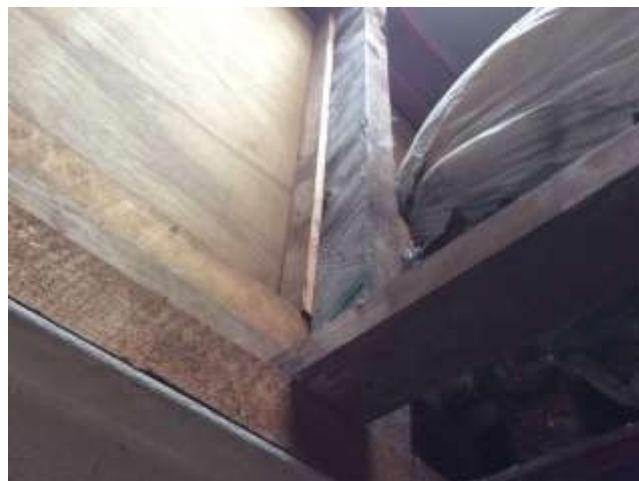
Building	Ashfield House
Floor	Ground Floor
Room	FWC - Female WC
Description	Insulation debris to timber frame housing cylinder over ceiling tiles.
Sample Reference	S003
Quantity	2 m ²

Analysis Result	
Amosite, Chrysotile	2
Product Type	
Thermal Insulation	3

Condition	
High Damage	3
Surface Treatment	
Unsealed Insulation	3

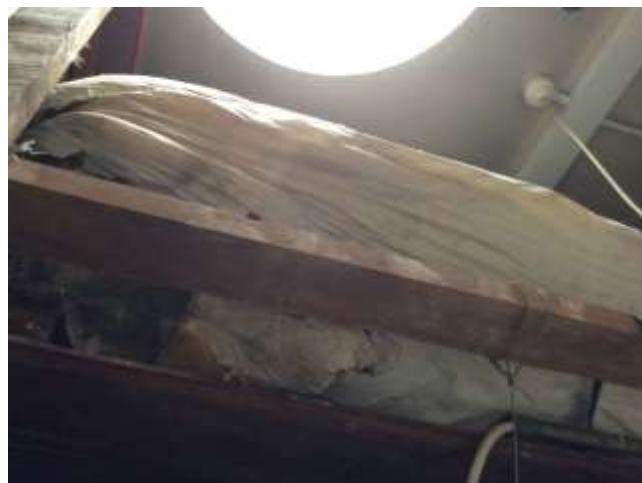
Building	Ashfield House
Floor	Ground Floor
Room	FWC - Female WC
Description	Insulation debris to cylinder over ceiling tiles
Sample Reference	S004
Quantity	2 m ²

Analysis Result	
Amosite, Chrysotile	2
Product Type	
Thermal Insulation	3

Condition	
High Damage	3
Surface Treatment	
Unsealed Insulation	3

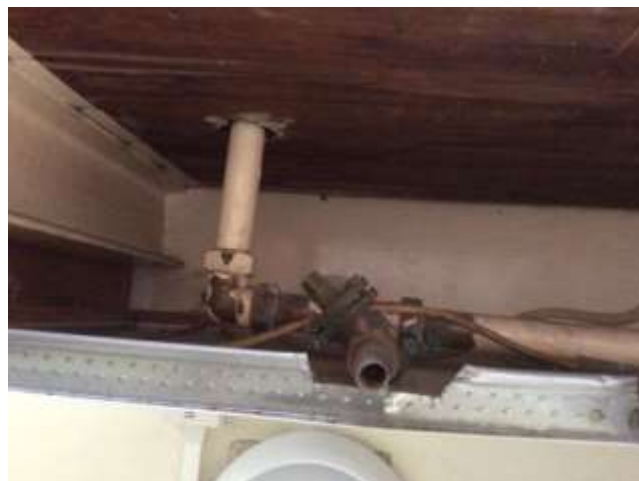
Building	Ashfield House
Floor	Ground Floor
Room	FWC - Female WC
Description	Insulation debris over MMMF ceiling tiles
Sample Reference	S005
Quantity	2 m ²

Analysis Result	
Amosite, Chrysotile	2
Product Type	
Thermal Insulation	3

Condition	
High Damage	3
Surface Treatment	
Unsealed Insulation	3

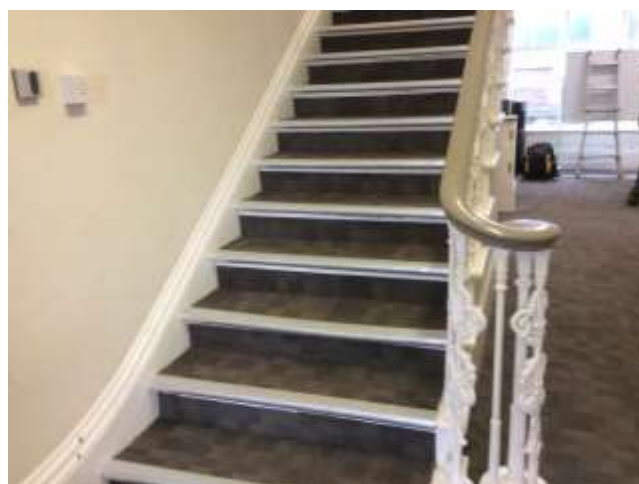
Building	Ashfield House
Floor	Ground Floor
Room	L01 - Entrance Hall
Description	Bitumen adhesive beneath carpet to stairs
Sample Reference	S021
Quantity	15 m ²

Analysis Result	
Chrysotile	1
Product Type	
Bitumen	1

Condition	
Good Condition	0
Surface Treatment	
Composite (Self Sealed)	0

Whilst the asbestos containing material continues to remain undisturbed, no immediate action is required. However a system of ongoing management should be implemented which includes routine condition inspections. Although not a legal requirement, labelling the material as asbestos should be considered to reduce the risk of accidental disturbance. If however the asbestos containing material is likely to be disturbed during the refurbishment works then it should be removed and disposed of in full accordance with current and relevant legislation prior to the refurbishment works being undertaken.

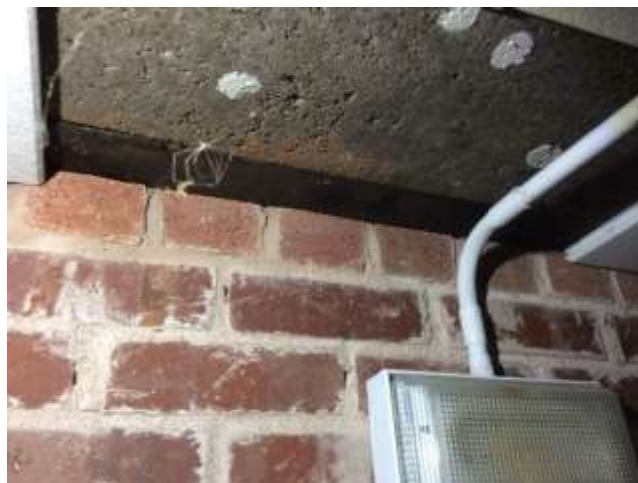
Building	Ashfield House
Floor	Ground Floor
Room	ST03 - External Store
Description	Felt to underside of concrete ceiling above polystyrene ceiling tiles.
Sample Reference	S023
Quantity	3 Lin M

Analysis Result	
Chrysotile	1
Product Type	
Felt	1

Condition	
Good Condition	0
Surface Treatment	
Composite (Self Sealed)	0

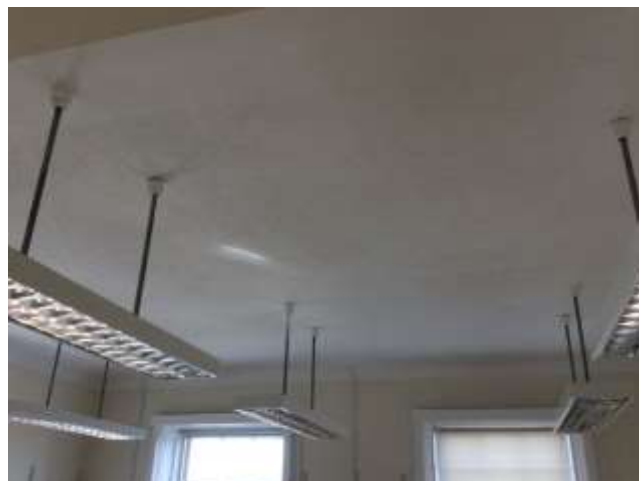
Building	Ashfield House
Floor	1st Floor
Room	101 - Classroom
Description	Textured coating to ceiling (part)
Sample Reference	S001
Quantity	25 m ²

Analysis Result	
No Asbestos Detected	0
Product Type	
Textured Coating	1

Condition	
Low Damage	1
Surface Treatment	
Composite (Self Sealed)	0

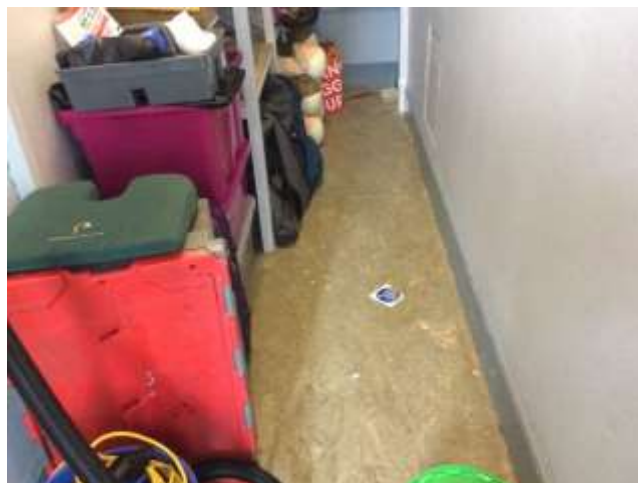
Building	Ashfield House
Floor	1st Floor
Room	ST01 - Store
Description	Vinyl floor covering
Sample Reference	S002
Quantity	4 m ²

Analysis Result	
No Asbestos Detected	0
Product Type	
Vinyl	1

Condition	
Low Damage	1
Surface Treatment	
Composite (Self Sealed)	0

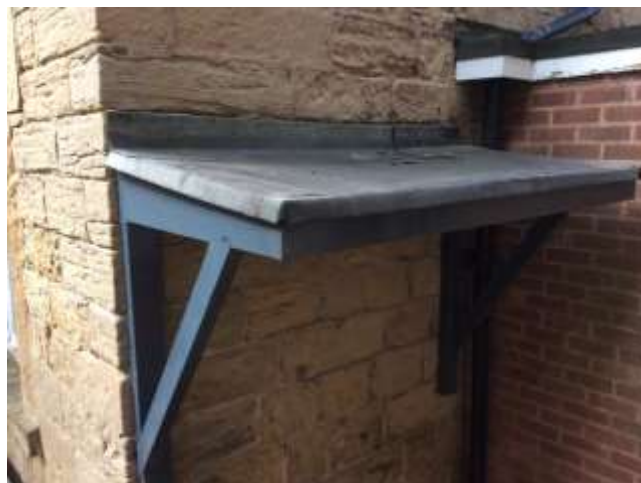
Building	Ashfield House
Floor	External
Room	99 - External
Description	Felt roof canopy over lean-to to rear yard.
Sample Reference	S019
Quantity	2 m ²

Analysis Result	
Chrysotile	1
Product Type	
Felt	1

Condition	
Good Condition	0
Surface Treatment	
Composite (Self Sealed)	0

Whilst the asbestos containing material continues to remain undisturbed, no immediate action is required. However a system of ongoing management should be implemented which includes routine condition inspections.

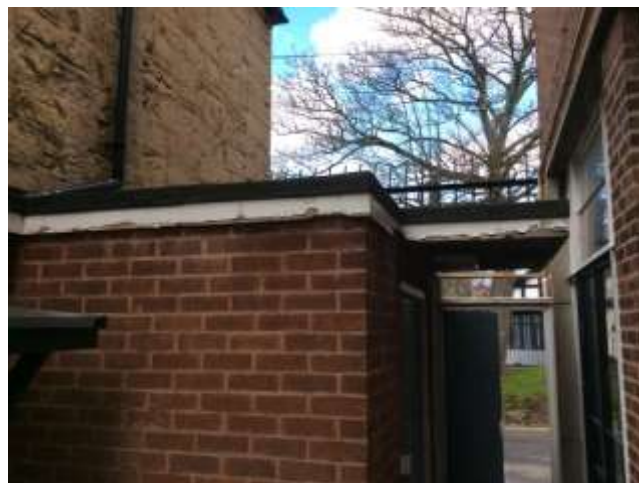
Building	Ashfield House
Floor	External
Room	99 - External
Description	Felt to felt roof in rear yard
Sample Reference	S020
Quantity	8 m ²

Analysis Result	
No Asbestos Detected	0
Product Type	
Felt	1

Condition	
Good Condition	0
Surface Treatment	
Composite (Self Sealed)	0

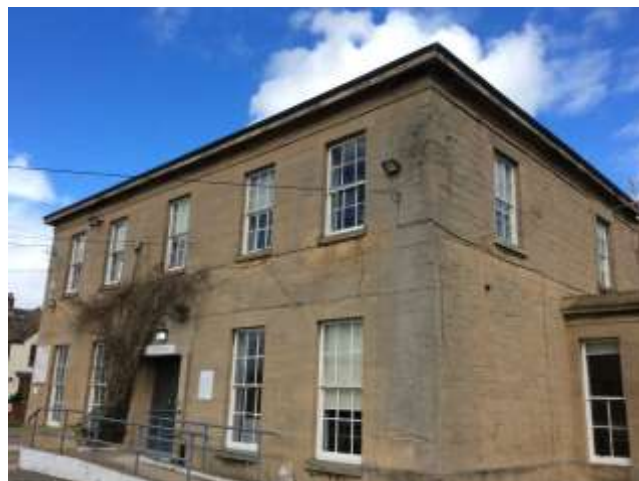
Building	Ashfield House
Floor	External
Room	99 - External
Description	Glazing putty to windows, presumed to all.
Sample Reference	S022
Quantity	40 m ²

Analysis Result	
No Asbestos Detected	0
Product Type	
Putty	1

Condition	
Good Condition	0
Surface Treatment	
Composite (Self Sealed)	0
