Asbestos Demolition Survey

**Art Building
West Nottinghamshire College
Chesterfield Road
Mansfield
NG19 7BB**

AA Projects Limited

Project Number:	Survey Date:	Issue Date:
B-36461s2	28 June 2022	04 July 2022

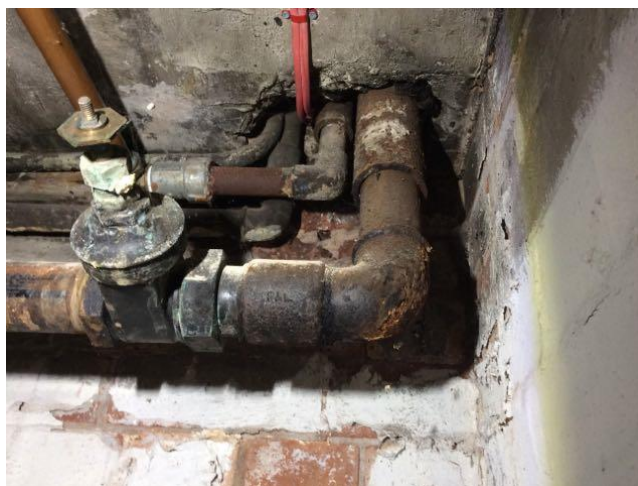
Building	Art Building
Floor	Basement
Room	B01 - Boiler Room
Description	Debris to pipework. Presumed to all surfaces. Room area approx 50m ²
Sample Reference	S017
Quantity	50 m ²
Accessibility	Easy

Analysis Result	Amosite, Chrysotile	2
Product Type	Thermal Insulation	3
Condition	High Damage	3
Surface Treatment	Unsealed Insulation	3

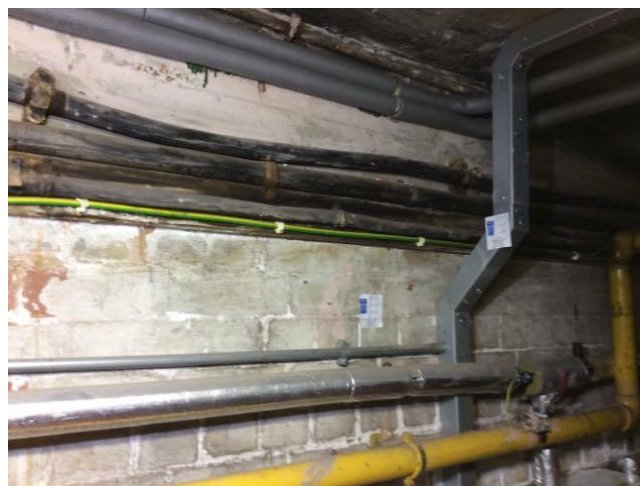
Building	Art Building
Floor	Basement
Room	B01 - Boiler Room
Description	Insulation debris to walls / cables. Presumed to all surfaces. Room area approx 50m ²
Sample Reference	S018
Quantity	50 m ²
Accessibility	Easy

Analysis Result	Amosite, Chrysotile	2
Product Type	Thermal Insulation	3
Condition	High Damage	3
Surface Treatment	Unsealed Insulation	3

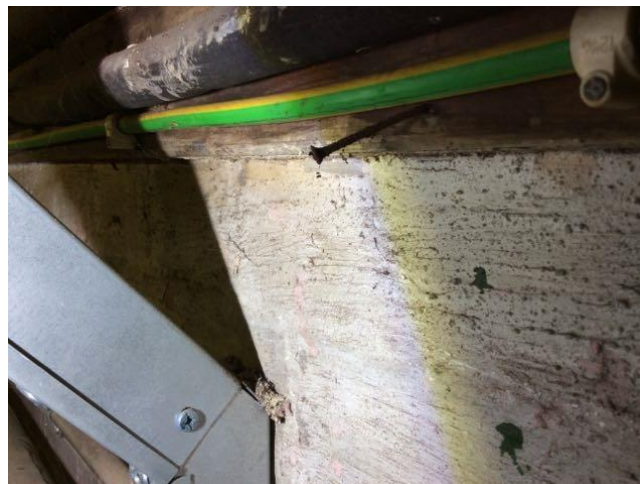
Building	Art Building
Floor	Basement
Room	B01 - Boiler Room
Description	Insulation debris to walls / cables. Presumed to all surfaces. Room area approx 50m ²
Sample Reference	S019
Quantity	50 m ²
Accessibility	Easy

Analysis Result	Amosite, Chrysotile, Crocidolite	3
Product Type	Thermal Insulation	3
Condition	High Damage	3
Surface Treatment	Unsealed Insulation	3

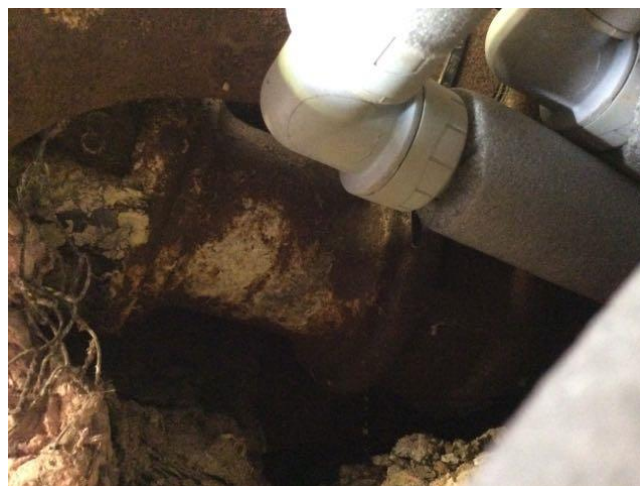
Building	Art Building
Floor	Basement
Room	B01 - Boiler Room
Description	Debris to pipework. Presumed beneath non-asbestos insulation throughout Boiler Room.
Sample Reference	S020
Quantity	50 m ²
Accessibility	Easy

Analysis Result	Amosite, Chrysotile	2
Product Type	Thermal Insulation	3
Condition	High Damage	3
Surface Treatment	Unsealed Insulation	3

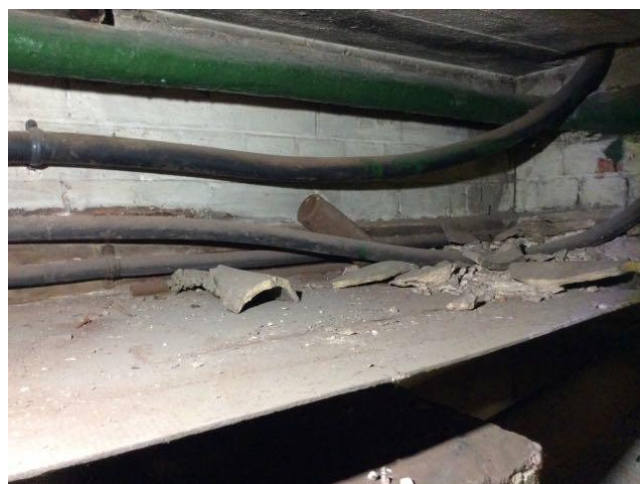
Building	Art Building
Floor	Basement
Room	B01 - Boiler Room
Description	Cement shelf
Sample Reference	S021
Quantity	2 m ²
Accessibility	Easy

Analysis Result	Chrysotile	1
Product Type	Cement	1
Condition	Low Damage	1
Surface Treatment	Unsealed Cement	1

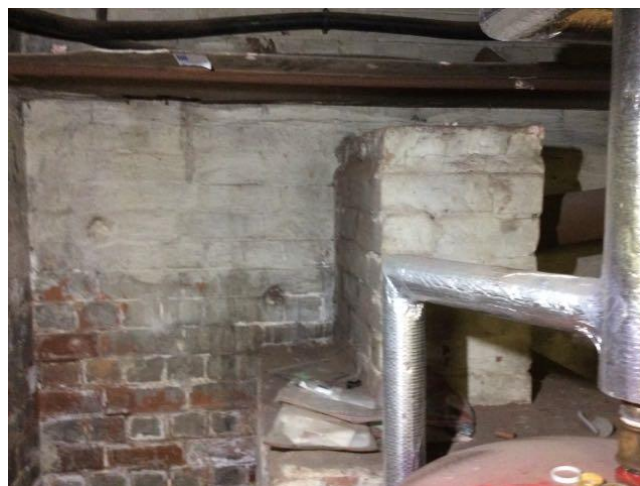
Building	Art Building
Floor	Basement
Room	B01 - Boiler Room
Description	Insulation debris to walls / cables. Presumed to all surfaces. Room area approx 50m ²
Sample Reference	S022
Quantity	50 m ²
Accessibility	Easy

Analysis Result	Amosite, Chrysotile, Crocidolite	3
Product Type	Thermal Insulation	3
Condition	High Damage	3
Surface Treatment	Unsealed Insulation	3

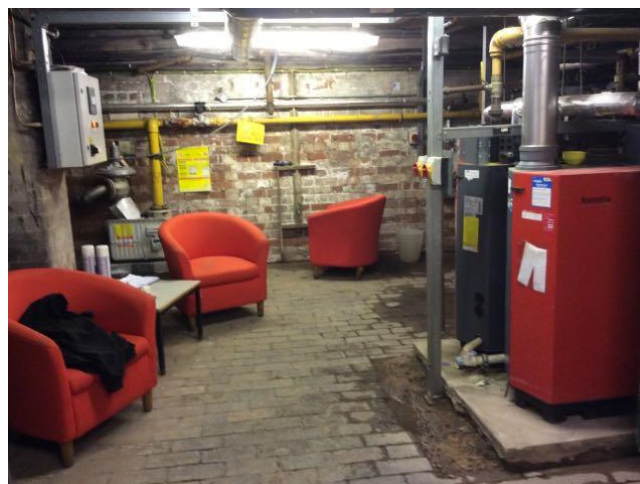
Building	Art Building
Floor	Basement
Room	B01 - Boiler Room
Description	Insulation debris to floor. Presumed to all surfaces. Room area approx 50m ²
Sample Reference	S023
Quantity	50 m ²
Accessibility	Easy

Analysis Result	Amosite, Chrysotile, Crocidolite	3
Product Type	Thermal Insulation	3
Condition	High Damage	3
Surface Treatment	Unsealed Insulation	3

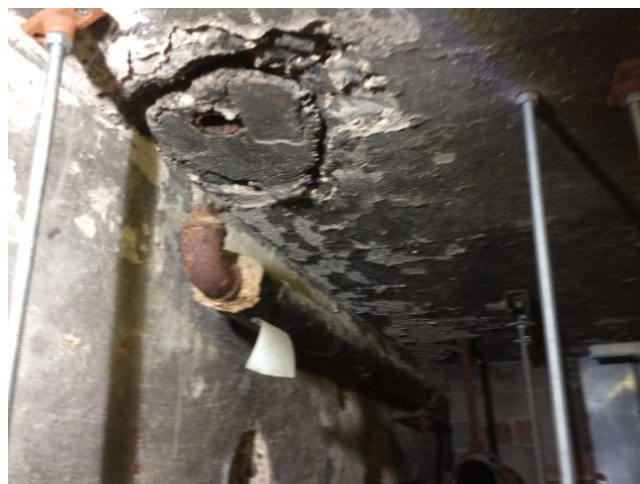
Building	Art Building
Floor	Basement
Room	B01 - Boiler Room
Description	Insulation to pipework. Presumed to all surfaces. Room area approx 50m ²
Sample Reference	S024
Quantity	50 m ²
Accessibility	Easy

Analysis Result	Chrysotile	1
Product Type	Thermal Insulation	3
Condition	High Damage	3
Surface Treatment	Unsealed Insulation	3

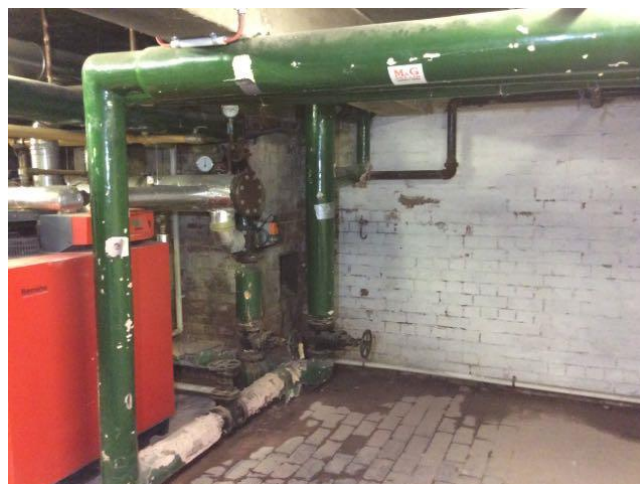
Building	Art Building
Floor	Basement
Room	B01 - Boiler Room
Description	Insulation to pipework. Presumed to all surfaces. Room area approx 50m ²
Sample Reference	S025
Quantity	50 m ²
Accessibility	Easy

Analysis Result	No Asbestos Detected	0
Product Type	Thermal Insulation	3
Condition	High Damage	3
Surface Treatment	Unsealed Insulation	3

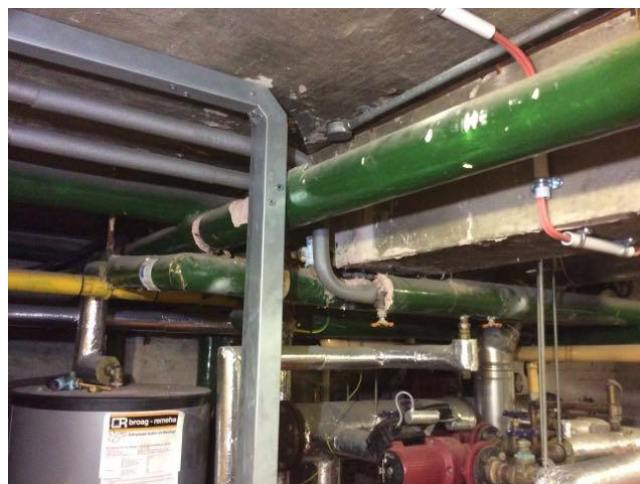
Building	Art Building
Floor	Basement
Room	B01 - Boiler Room
Description	Insulation to pipework. Presumed to all surfaces. Room area approx 50m ²
Sample Reference	S026
Quantity	50 m ²
Accessibility	Easy

Analysis Result	No Asbestos Detected	0
Product Type	Thermal Insulation	3
Condition	High Damage	3
Surface Treatment	Unsealed Insulation	3

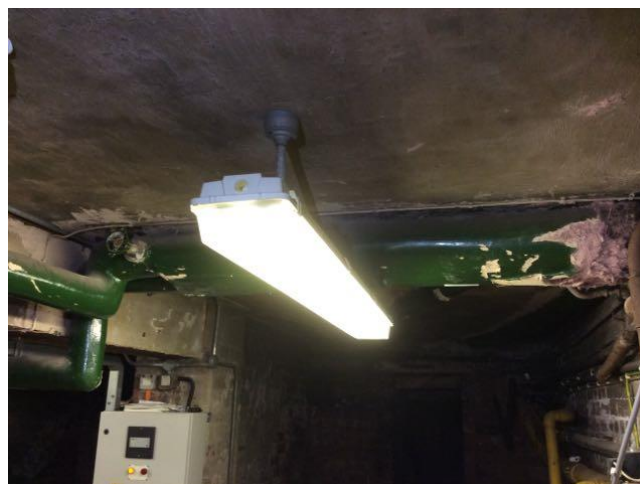
Building	Art Building
Floor	Basement
Room	B01 - Boiler Room
Description	Insulation to pipework. Presumed to all surfaces. Room area approx 50m ²
Sample Reference	S027
Quantity	50 m ²
Accessibility	Easy

Analysis Result	No Asbestos Detected	0
Product Type	Thermal Insulation	3
Condition	High Damage	3
Surface Treatment	Unsealed Insulation	3

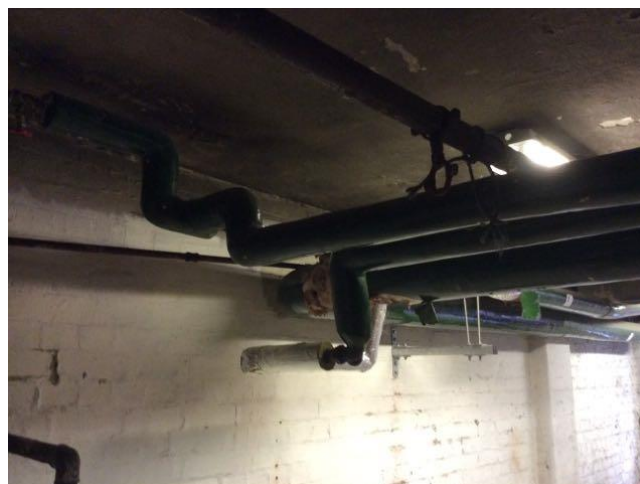
Building	Art Building
Floor	Basement
Room	B01 - Boiler Room
Description	Insulation to pipework. Presumed to all surfaces. Room area approx 50m ²
Sample Reference	S028
Quantity	50 m ²
Accessibility	Easy

Analysis Result	No Asbestos Detected	0
Product Type	Thermal Insulation	3
Condition	High Damage	3
Surface Treatment	Unsealed Insulation	3

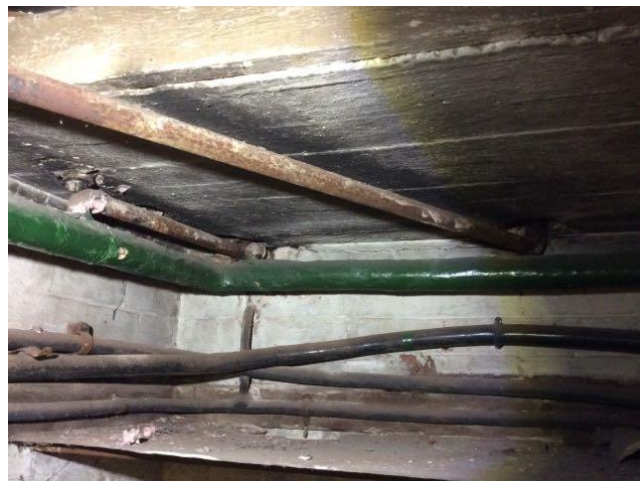
Building	Art Building
Floor	Basement
Room	B01 - Boiler Room
Description	Insulation to pipework to left and rear of calorifier
Sample Reference	S043
Quantity	5 m ²
Accessibility	Difficult

Analysis Result	Chrysotile	1
Product Type	Thermal Insulation	3
Condition	Low Damage	1
Surface Treatment	Sealed Insulation	2

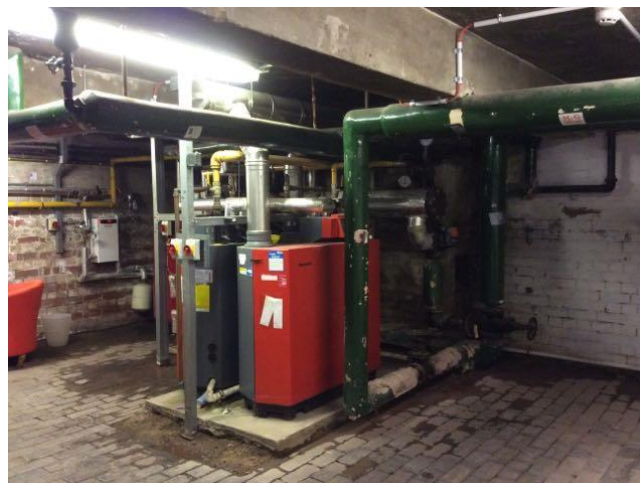
Building	Art Building
Floor	Basement
Room	B01 - Boiler Room
Description	Insulation debris should be presumed to all walls, ceilings, floor, pipework and pipe penetrations. Room area approx 50m ²
Sample Reference	Ref S023
Quantity	50 m ²
Accessibility	Easy

Analysis Result	Amosite, Chrysotile, Crocidolite	3
Product Type	Thermal Insulation	3
Condition	High Damage	3
Surface Treatment	Unsealed Insulation	3

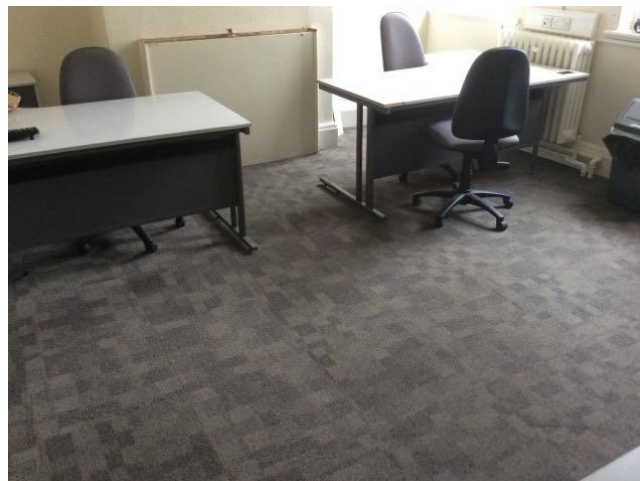
Building	Art Building
Floor	Ground Floor
Room	121 - Staff Room
Description	Resin panels to floor beneath carpet tiles
Sample Reference	Ref S005
Quantity	24 m ²
Accessibility	Easy

Analysis Result	No Asbestos Detected	0
Product Type	Resin	1
Condition	Good Condition	0
Surface Treatment	Composite (Self Sealed)	0

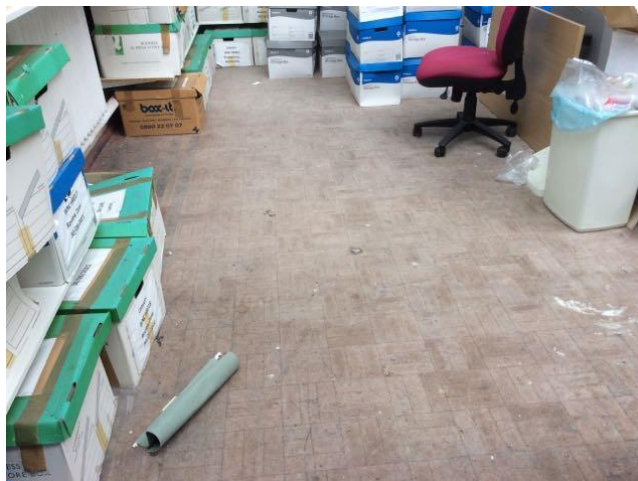
Building	Art Building
Floor	Ground Floor
Room	122 - Archive Store
Description	Resin panels to floor
Sample Reference	S005
Quantity	47 m ²
Accessibility	Easy

Analysis Result	No Asbestos Detected	0
Product Type	Resin	1
Condition	Good Condition	0
Surface Treatment	Composite (Self Sealed)	0

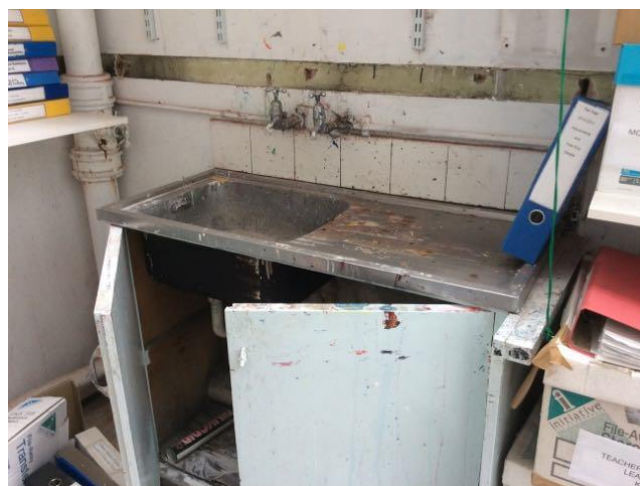
Building	Art Building
Floor	Ground Floor
Room	122 - Archive Store
Description	Bitumen paint to underside of sink unit
Sample Reference	S006
Quantity	1 Units
Accessibility	Easy

Analysis Result	No Asbestos Detected	0
Product Type	Bitumen	1
Condition	Good Condition	0
Surface Treatment	Composite (Self Sealed)	0

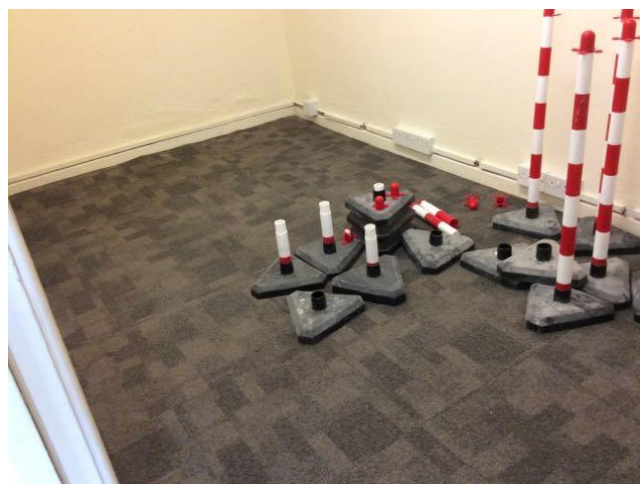
Building	Art Building
Floor	Ground Floor
Room	123a - Store
Description	Resin panels to floor beneath carpet tiles
Sample Reference	Ref S011
Quantity	7 m ²
Accessibility	Medium

Analysis Result	No Asbestos Detected	0
Product Type	Resin	1
Condition	Good Condition	0
Surface Treatment	Composite (Self Sealed)	0

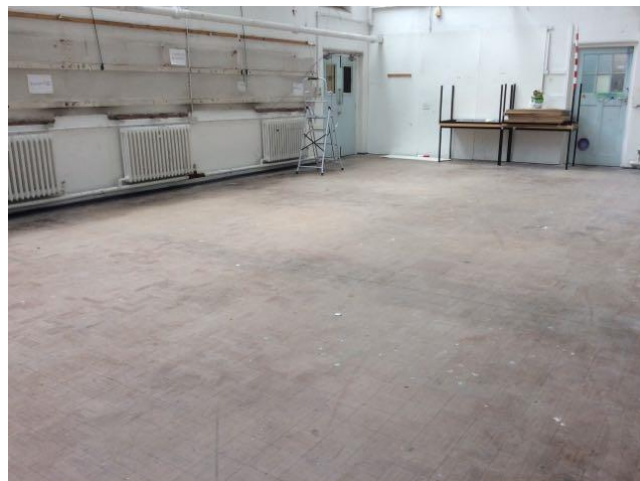
Building	Art Building
Floor	Ground Floor
Room	124 - Workshop
Description	Resin panels to floor
Sample Reference	Ref S005
Quantity	104 m ²
Accessibility	Medium

Analysis Result	No Asbestos Detected	0
Product Type	Resin	1
Condition	Good Condition	0
Surface Treatment	Composite (Self Sealed)	0

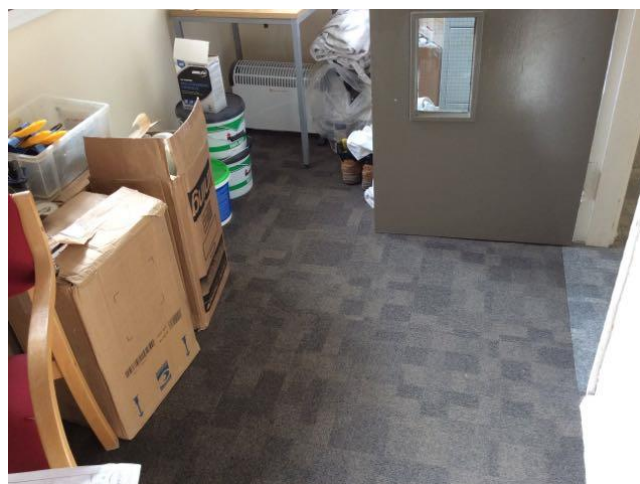
Building	Art Building
Floor	Ground Floor
Room	125 - Office
Description	Floor tiles and adhesive beneath carpet tiles
Sample Reference	S013
Quantity	19 m ²
Accessibility	Medium

Analysis Result	Chrysotile (Tile and Bitumen)	1
Product Type	Thermoplastic Tiles & Bitumen Adhesive	1
Condition	Good Condition	0
Surface Treatment	Composite (Self Sealed)	0

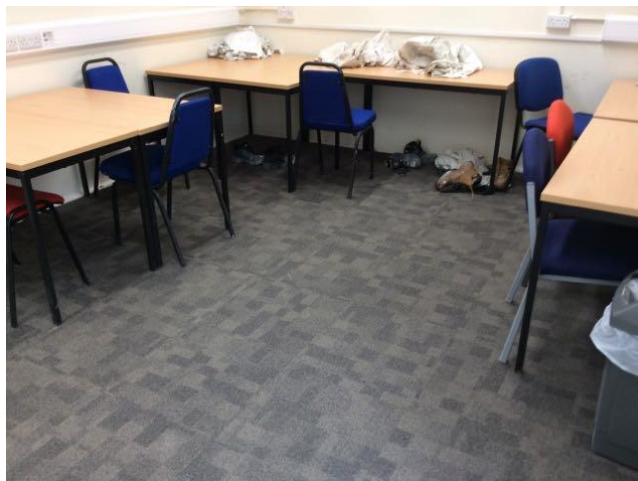
Building	Art Building
Floor	Ground Floor
Room	126 - Mess Room
Description	Resin panels to floor beneath carpet tiles
Sample Reference	Ref S011
Quantity	19 m ²
Accessibility	Medium

Analysis Result	No Asbestos Detected	0
Product Type	Resin	1
Condition	Good Condition	0
Surface Treatment	Composite (Self Sealed)	0

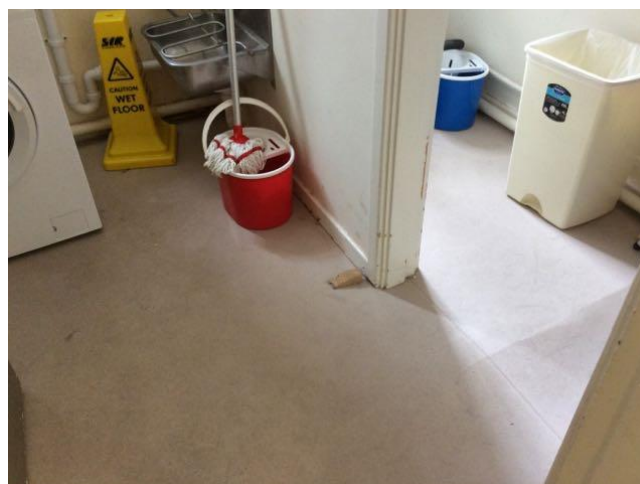
Building	Art Building
Floor	Ground Floor
Room	127 - Cleaners Store
Description	Resin panels to floor beneath modern vinyl
Sample Reference	Ref S011
Quantity	5 m ²
Accessibility	Medium

Analysis Result	No Asbestos Detected	0
Product Type	Resin	1
Condition	Good Condition	0
Surface Treatment	Composite (Self Sealed)	0

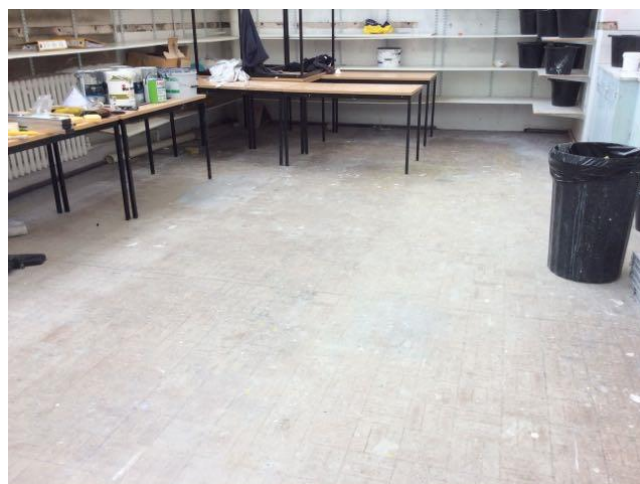
Building	Art Building
Floor	Ground Floor
Room	128 - Paint Store
Description	Resin panels to floor
Sample Reference	S011
Quantity	45 m ²
Accessibility	Medium

Analysis Result	No Asbestos Detected	0
Product Type	Resin	1
Condition	Good Condition	0
Surface Treatment	Composite (Self Sealed)	0

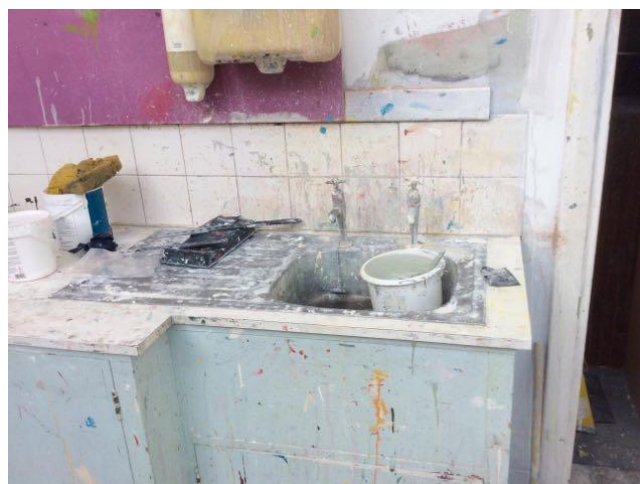
Building	Art Building
Floor	Ground Floor
Room	128 - Paint Store
Description	Pads to underside of sink unit
Sample Reference	S012
Quantity	1 Units
Accessibility	Medium

Analysis Result	No Asbestos Detected	0
Product Type	Bitumen	1
Condition	Good Condition	0
Surface Treatment	Composite (Self Sealed)	0

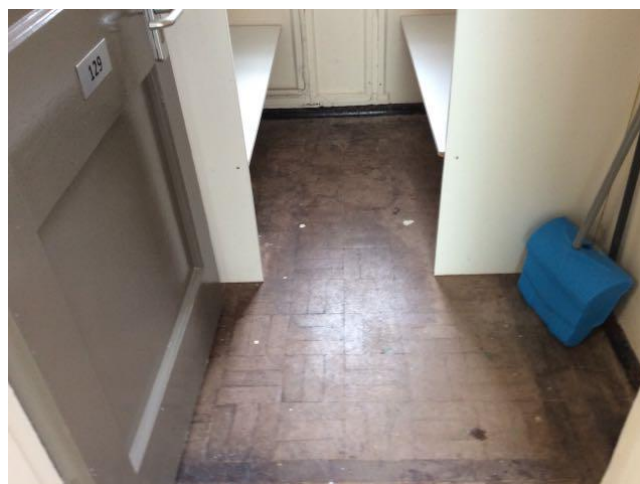
Building	Art Building
Floor	Ground Floor
Room	129 - Store
Description	Resin panels to floor
Sample Reference	Ref S011
Quantity	3 m ²
Accessibility	Medium

Analysis Result	No Asbestos Detected	0
Product Type	Resin	1
Condition	Good Condition	0
Surface Treatment	Composite (Self Sealed)	0

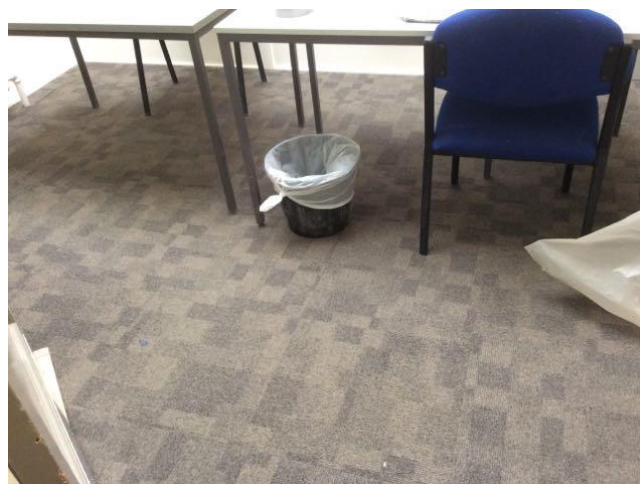
Building	Art Building
Floor	Ground Floor
Room	130 - Study Room
Description	Resin panels to floor beneath carpet
Sample Reference	Ref S005
Quantity	18 m ²
Accessibility	Medium

Analysis Result	No Asbestos Detected	0
Product Type	Resin	1
Condition	Good Condition	0
Surface Treatment	Composite (Self Sealed)	0

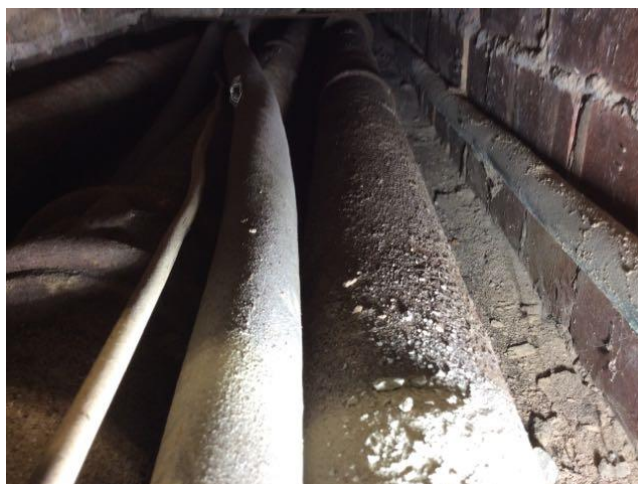
Building	Art Building
Floor	Ground Floor
Room	130 - Study Room
Description	Insulation debris to pipework and throughout floor trench from corridor C02
Sample Reference	Ref S038
Quantity	3 Lin M
Accessibility	Difficult

Analysis Result	Amosite, Chrysotile, Crocidolite	3
Product Type	Thermal Insulation	3
Condition	High Damage	3
Surface Treatment	Unsealed Insulation	3

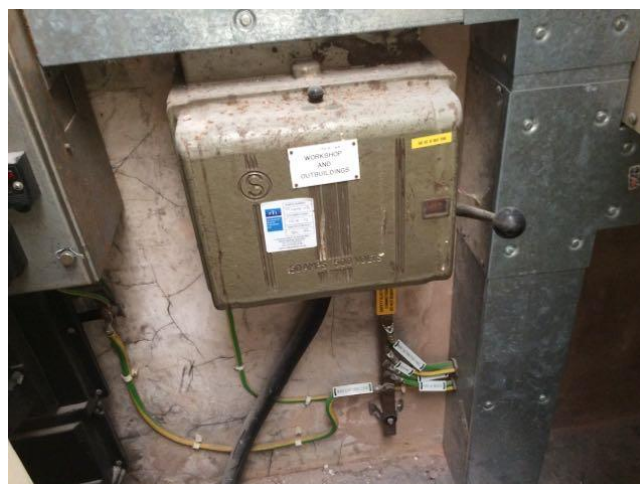
Building	Art Building
Floor	Ground Floor
Room	130 - Study Room
Description	Presumed ACMs within switch box in cupboard
Sample Reference	P
Quantity	1 Units
Accessibility	Difficult

Analysis Result	Chrysotile	1
Product Type	Woven Textile	2
Condition	Good Condition	0
Surface Treatment	Sealed Woven	1

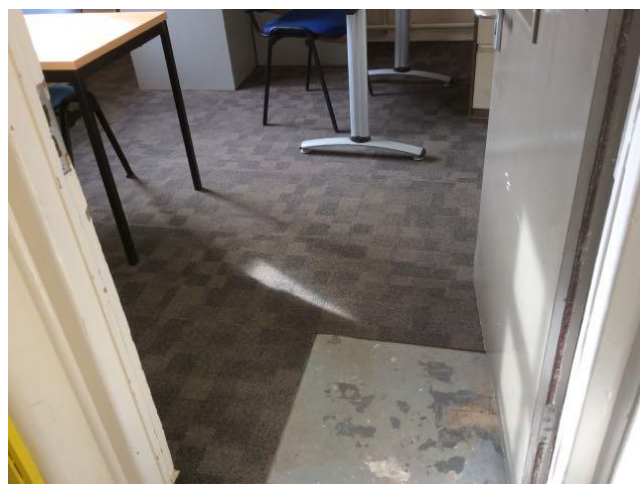
Building	Art Building
Floor	Ground Floor
Room	131 - Office
Description	Resin panels to floor beneath carpet
Sample Reference	Ref S005
Quantity	11 m ²
Accessibility	Medium

Analysis Result	No Asbestos Detected	0
Product Type	Resin	1
Condition	Good Condition	0
Surface Treatment	Composite (Self Sealed)	0

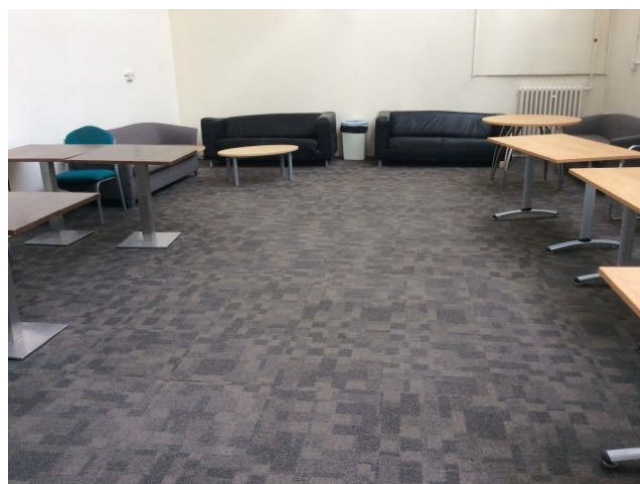
Building	Art Building
Floor	Ground Floor
Room	132 - Common Room
Description	Floor tiles and adhesive beneath carpet tiles
Sample Reference	S009
Quantity	73 m ²
Accessibility	Medium

Analysis Result	Chrysotile (Bitumen Only)	1
Product Type	Thermoplastic Tiles & Bitumen Adhesive	1
Condition	Good Condition	0
Surface Treatment	Composite (Self Sealed)	0

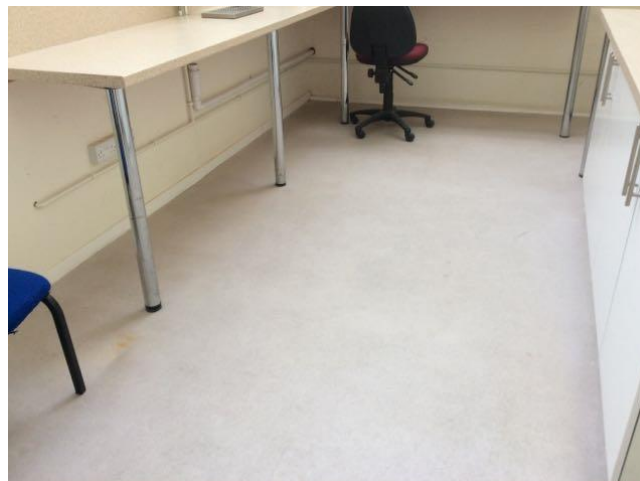
Building	Art Building
Floor	Ground Floor
Room	132a - Common Room Kitchen
Description	Bitumen adhesive beneath modern floor vinyl
Sample Reference	S010
Quantity	15 m ²
Accessibility	Medium

Analysis Result	Chrysotile	1
Product Type	Bitumen	1
Condition	Good Condition	0
Surface Treatment	Composite (Self Sealed)	0

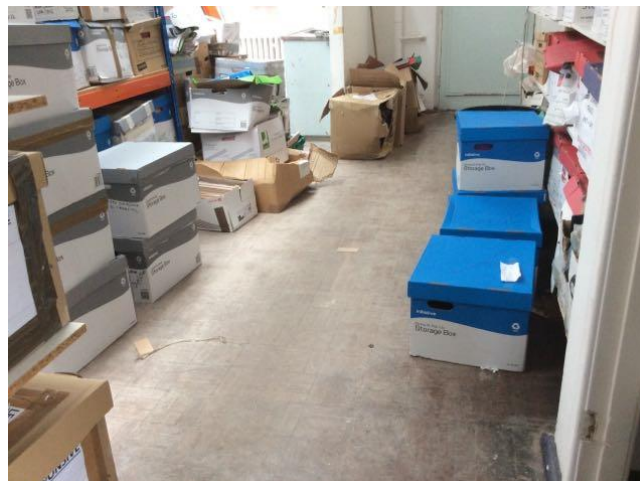
Building	Art Building
Floor	Ground Floor
Room	134 - Archive
Description	Resin panels to floor
Sample Reference	Ref S005
Quantity	53 m ²
Accessibility	Medium

Analysis Result	No Asbestos Detected	0
Product Type	Resin	1
Condition	Good Condition	0
Surface Treatment	Composite (Self Sealed)	0

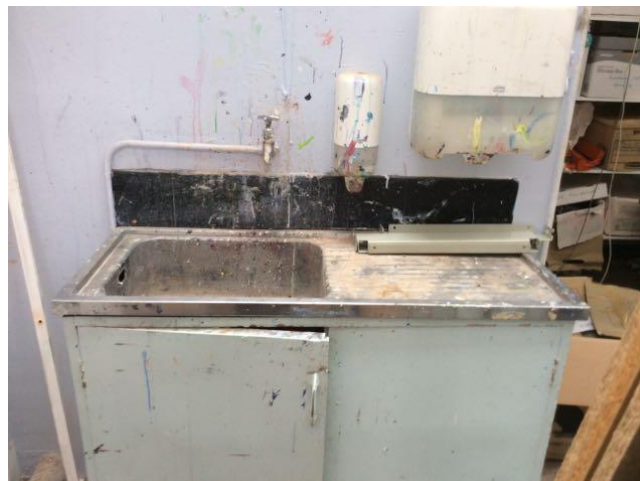
Building	Art Building
Floor	Ground Floor
Room	134 - Archive Store
Description	Bitumen paint to underside of sink unit
Sample Reference	Ref S006
Quantity	1 Units
Accessibility	Easy

Analysis Result	No Asbestos Detected	0
Product Type	Bitumen	1
Condition	Good Condition	0
Surface Treatment	Composite (Self Sealed)	0

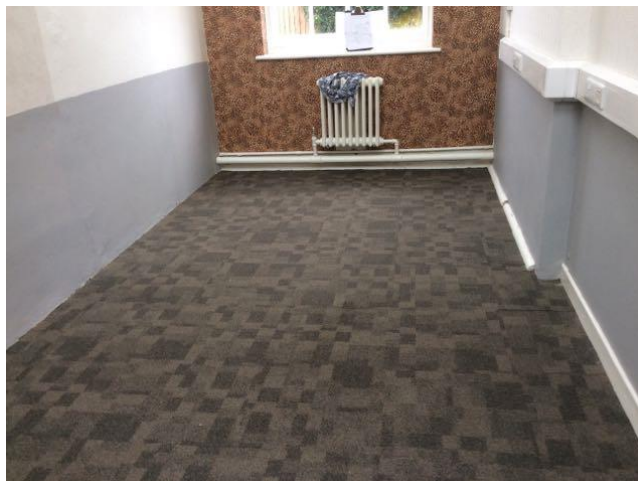
Building	Art Building
Floor	Ground Floor
Room	135 - Office
Description	Resin panels to floor beneath carpet
Sample Reference	Ref S005
Quantity	15 m ²
Accessibility	Medium

Analysis Result	No Asbestos Detected	0
Product Type	Resin	1
Condition	Good Condition	0
Surface Treatment	Composite (Self Sealed)	0

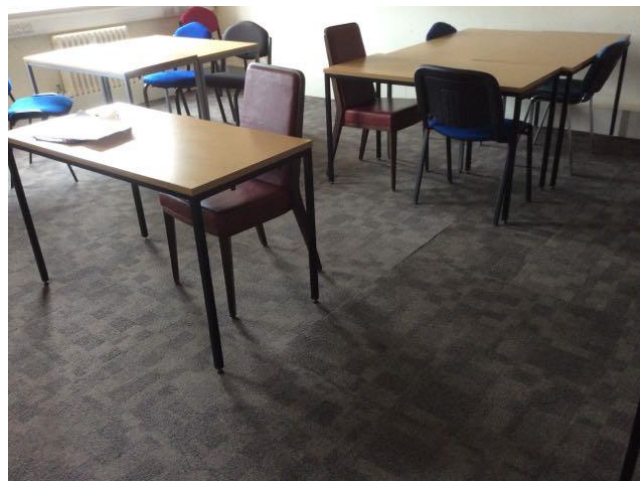
Building	Art Building
Floor	Ground Floor
Room	137 - Classroom
Description	Resin panels to floor beneath carpet
Sample Reference	Ref S005
Quantity	37 m ²
Accessibility	Medium

Analysis Result	No Asbestos Detected	0
Product Type	Resin	1
Condition	Good Condition	0
Surface Treatment	Composite (Self Sealed)	0

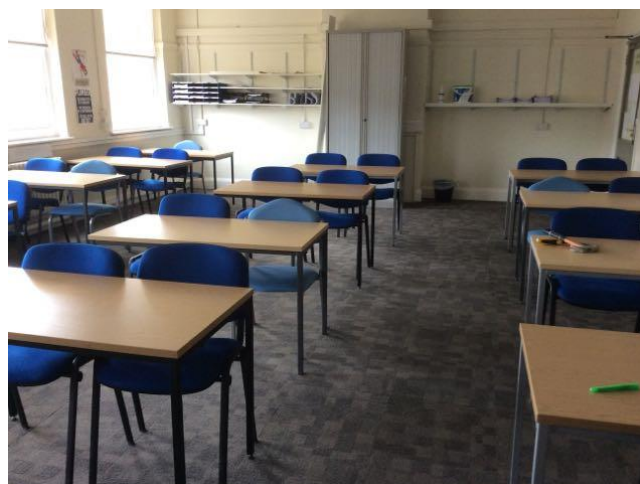
Building	Art Building
Floor	Ground Floor
Room	139 - Classroom
Description	Resin panels to floor beneath carpet
Sample Reference	Ref S005
Quantity	57 m ²
Accessibility	Medium

Analysis Result	No Asbestos Detected	0
Product Type	Resin	1
Condition	Good Condition	0
Surface Treatment	Composite (Self Sealed)	0

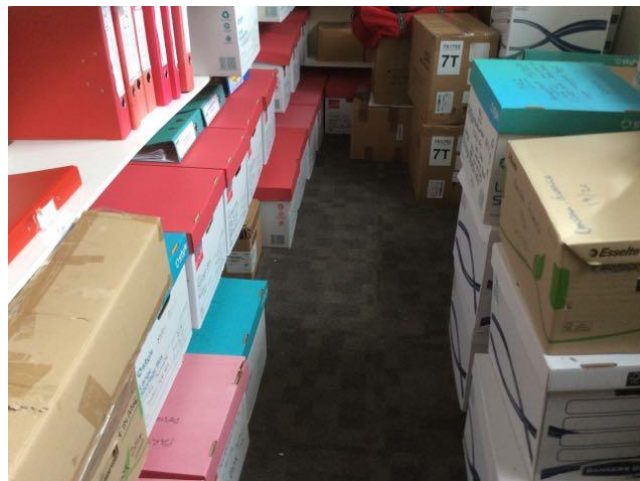
Building	Art Building
Floor	Ground Floor
Room	141 - Archive Store
Description	Resin panels to floor beneath carpet
Sample Reference	Ref S005
Quantity	13 m ²
Accessibility	Medium

Analysis Result	No Asbestos Detected	0
Product Type	Resin	1
Condition	Good Condition	0
Surface Treatment	Composite (Self Sealed)	0

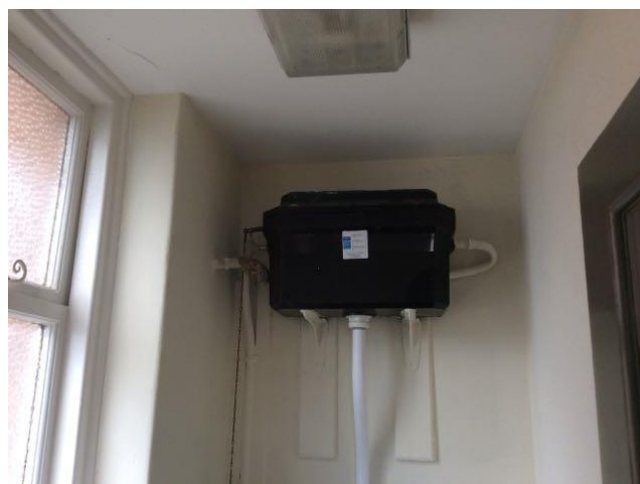
Building	Art Building
Floor	Ground Floor
Room	143 - First Aid
Description	Toilet cistern within cubicle
Sample Reference	S007
Quantity	1 Units
Accessibility	Easy

Analysis Result	Amosite	2
Product Type	Resin	1
Condition	Good Condition	0
Surface Treatment	Composite (Self Sealed)	0

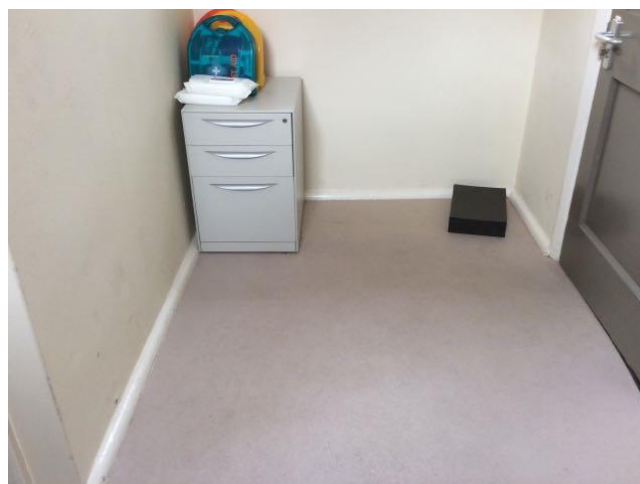
Building	Art Building
Floor	Ground Floor
Room	143 - First Aid
Description	Resin floor panels beneath modern vinyl flooring
Sample Reference	Ref S005
Quantity	9 m ²
Accessibility	Difficult

Analysis Result	No Asbestos Detected	0
Product Type	Resin	1
Condition	Good Condition	0
Surface Treatment	Composite (Self Sealed)	0

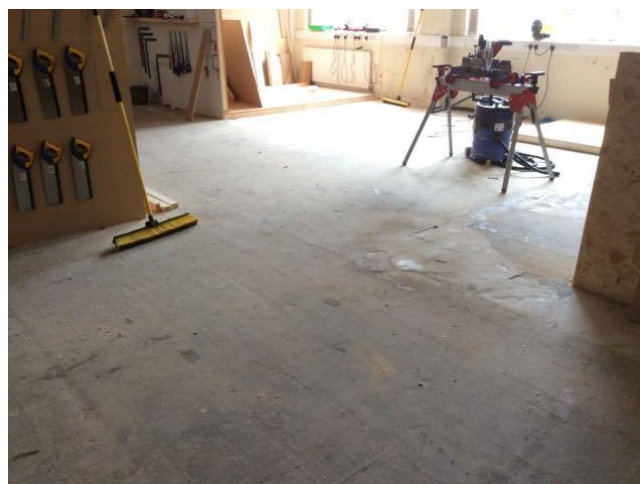
Building	Art Building
Floor	Ground Floor
Room	6 - Workshop
Description	Bitumen adhesive beneath screed
Sample Reference	S016
Quantity	84 m ²
Accessibility	Difficult

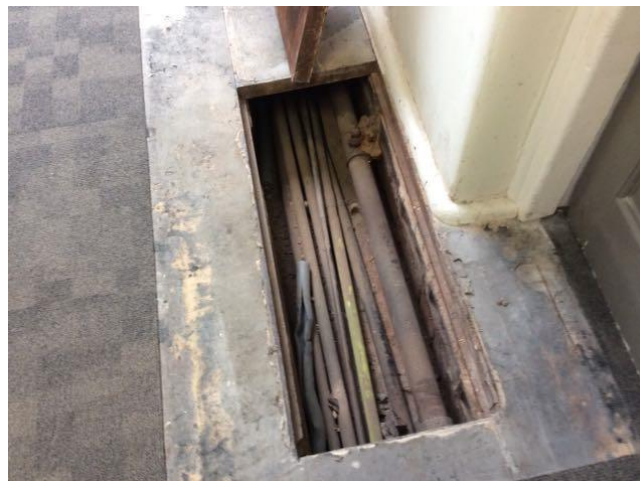
Building	Art Building
Floor	Ground Floor
Room	C01 - Corridor
Description	Insulation debris within floor trench
Sample Reference	S033
Quantity	13 m ²
Accessibility	Difficult

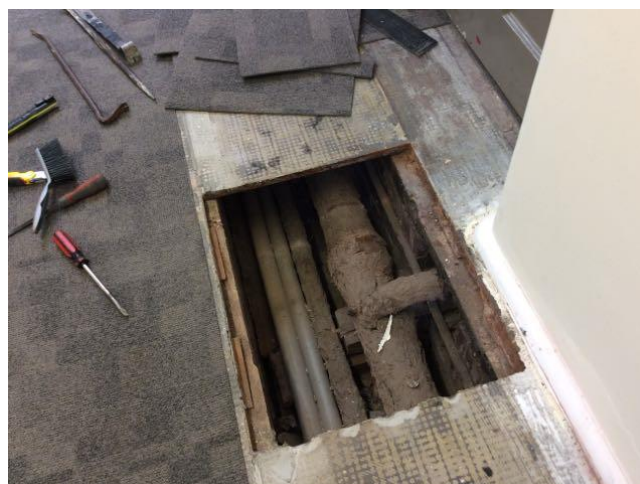
Building	Art Building
Floor	Ground Floor
Room	C01 - Corridor
Description	Insulation to pipework and debris within floor trench
Sample Reference	S040
Quantity	10 m ²
Accessibility	Difficult

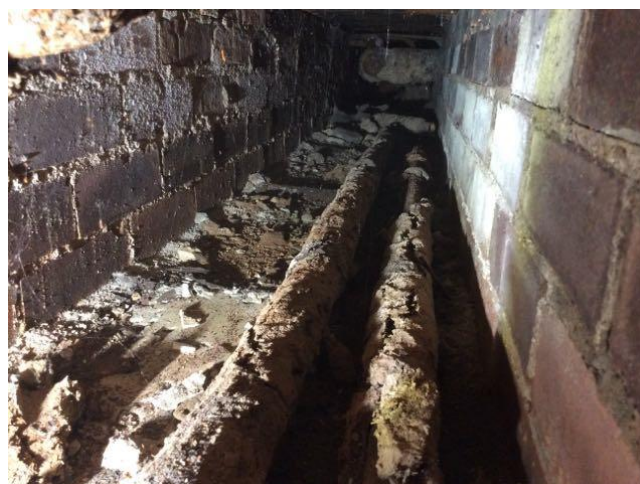
Building	Art Building
Floor	Ground Floor
Room	C01 - Corridor
Description	Insulation to pipework and debris within floor trench
Sample Reference	S041
Quantity	10 m ²
Accessibility	Difficult

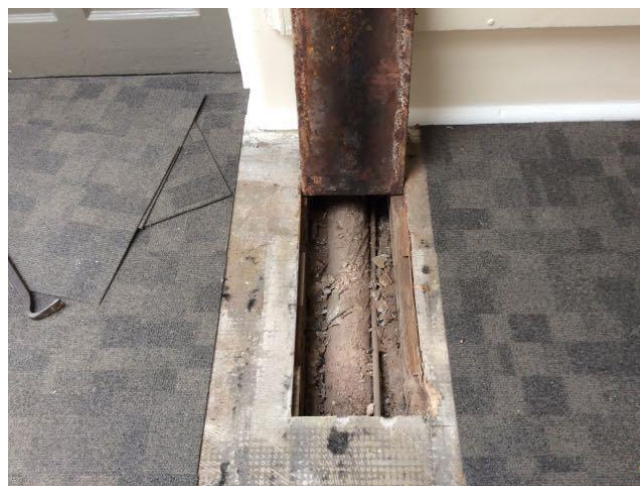
Building	Art Building
Floor	Ground Floor
Room	C01 - Corridor
Description	Insulation to pipework and debris within floor trench across corridor into Room 122 Archive Store
Sample Reference	S042
Quantity	2 m ²
Accessibility	Difficult

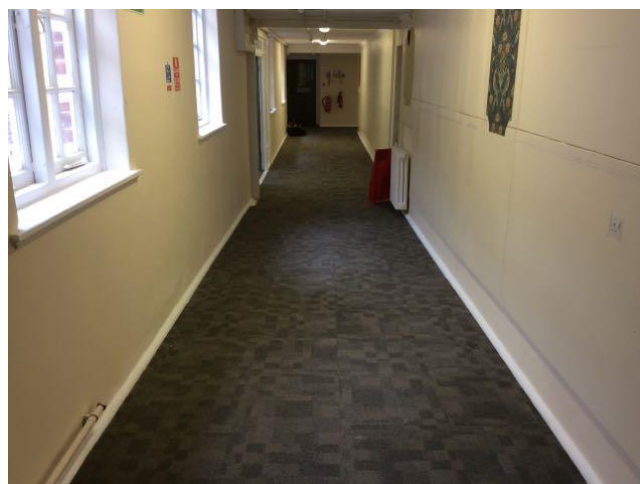
Building	Art Building
Floor	Ground Floor
Room	C01 - Corridor 1
Description	Resin panels to floor beneath carpet tiles
Sample Reference	Ref S005
Quantity	85 m ²
Accessibility	Medium

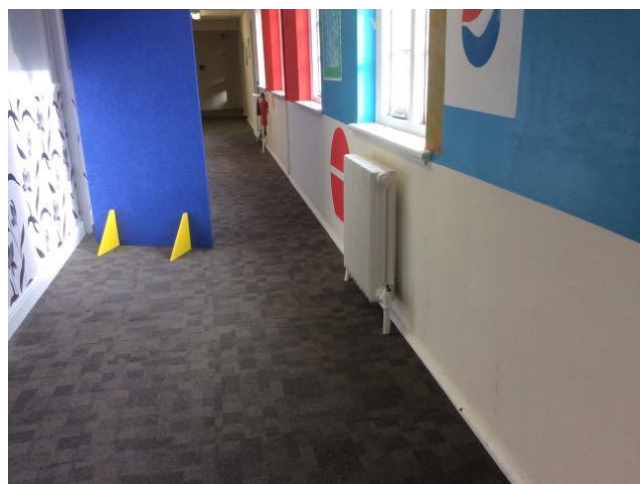
Building	Art Building
Floor	Ground Floor
Room	C02 - Corridor
Description	Insulation debris within radiator pipework trench
Sample Reference	S008
Quantity	50 Lin M
Accessibility	Difficult

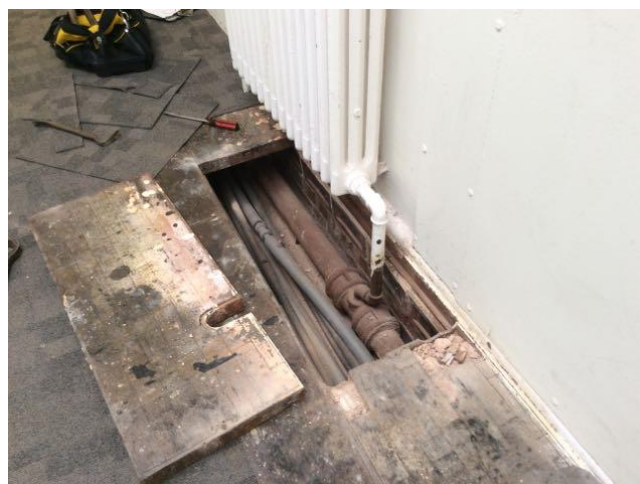
Building	Art Building
Floor	Ground Floor
Room	C02 - Corridor
Description	Insulation debris within floor trench
Sample Reference	S034
Quantity	16 m ²
Accessibility	Difficult

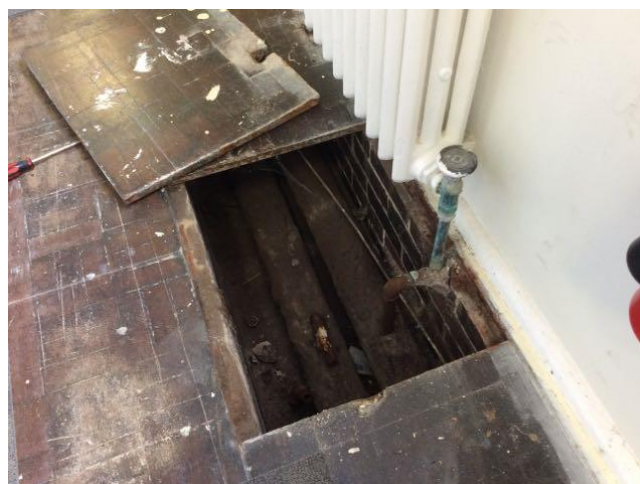
Building	Art Building
Floor	Ground Floor
Room	C02 - Corridor
Description	Insulation to pipework and debris within floor trench
Sample Reference	S035
Quantity	2 Lin M
Accessibility	Difficult

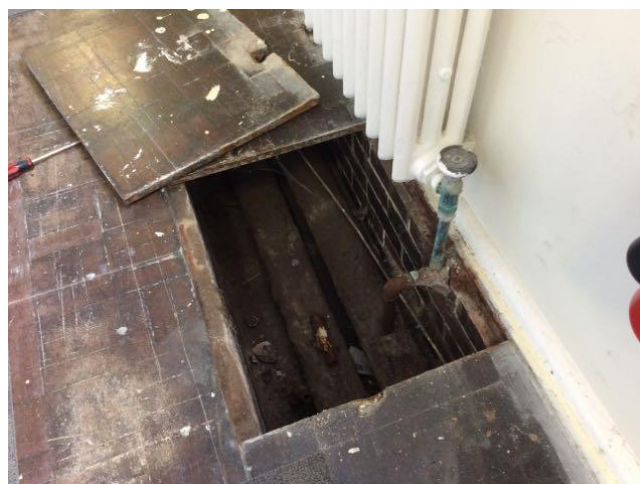
Building	Art Building
Floor	Ground Floor
Room	C02 - Corridor
Description	Insulation to pipework and debris within floor trench
Sample Reference	S036
Quantity	2 m ²
Accessibility	Difficult

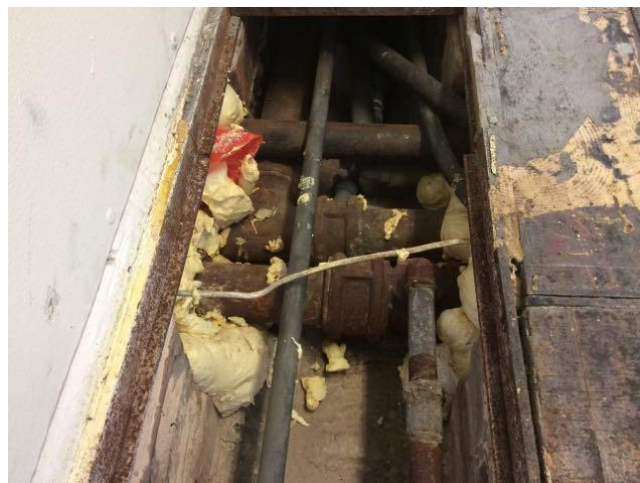
Building	Art Building
Floor	Ground Floor
Room	C02 - Corridor
Description	Insulation to pipework / wall penetration and debris within expanding foam in floor trench. Continues into Room 130 Study Room
Sample Reference	S037
Quantity	10 m ²
Accessibility	Difficult
