## Asbestos Demolition Survey

**C15 / C16 Building  
West Nottinghamshire College  
Chesterfield Road  
Mansfield  
NG19 7BB**

**AA Projects Limited**

| Project Number: | Survey Date: | Issue Date: |
|---|---|---|
| B-36546 | 07 April 2022 | 22 April 2022 |

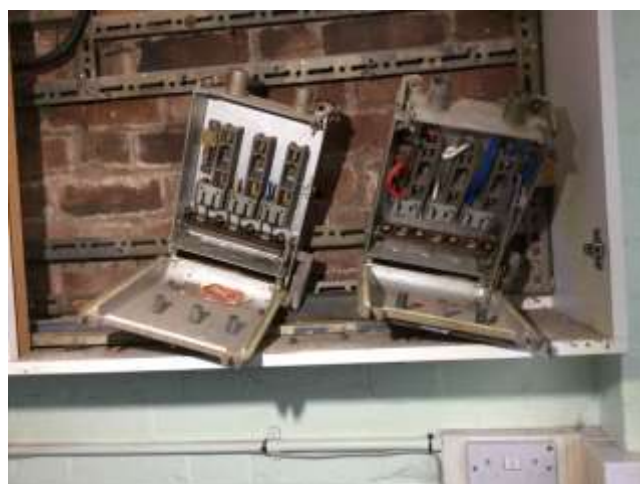
| <b>Sample Reference</b> | S003 |

| <b>Description</b> | Woven residues from fuse tapes within redundant electric boxes |

| <b>Analysis Result</b> | Chrysotile | 1 |
| <b>Product Type</b> | Woven Textile | 2 |
| <b>Condition</b> | Medium Damage | 2 |
| <b>Surface Treatment</b> | Unsealed Woven | 2 |

| <b>7</b> |
| <b>Medium Risk</b> |

The asbestos containing material should be removed and disposed of in full accordance with current and relevant legislation.

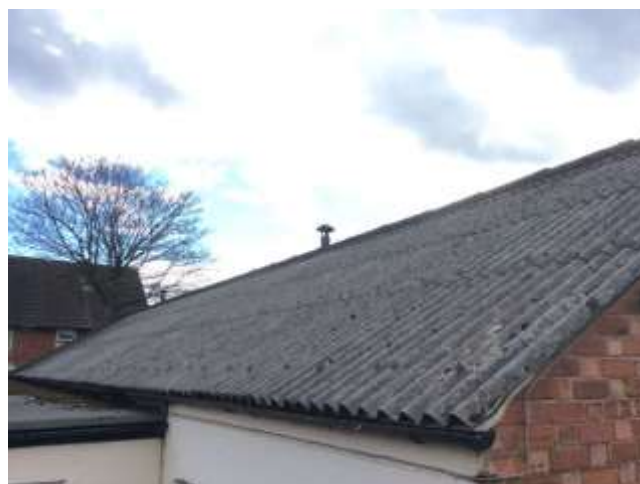
| <b>Sample Reference</b> | S001 |

| <b>Description</b> | Profiled cement roof, ridge tiles and cowls |

| <b>Analysis Result</b> | Chrysotile | 1 |
| <b>Product Type</b> | Cement | 1 |
| <b>Condition</b> | Low Damage | 1 |
| <b>Surface Treatment</b> | Unsealed Cement | 1 |

| <b>4</b> |
| <b>Very Low Risk</b> |

The asbestos containing material should be removed and disposed of in full accordance with current and relevant legislation.

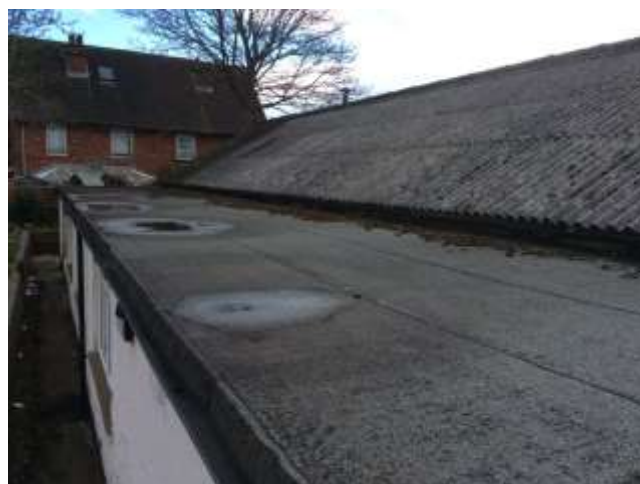
| <b>Sample Reference</b> | S002 |

| <b>Description</b> | Felt over flat roof areas |

| <b>Analysis Result</b> | No Asbestos Detected | 0 |
| <b>Condition</b> | Good Condition | 0 |

| <b>No ACMs Detected</b> |

No asbestos was detected within the sample collected and as such no further action is required.
