Asbestos Refurbishment Survey

**BDU Building
West Nottinghamshire College
Chesterfield Road
Mansfield
NG19 7BB**

AA Projects Limited

Project Number:	Survey Date:	Issue Date:
B-36549	08 April 2022	22 April 2022

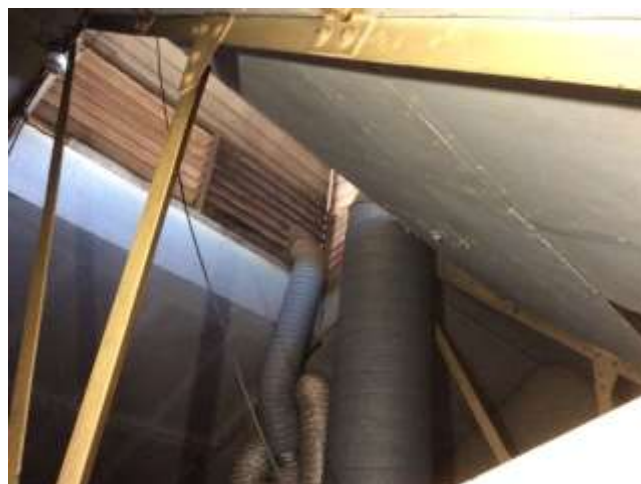
Building	BDU Building
Floor	Ground Floor
Room	202 - Classroom
Description	Cement underlining to roof accessed via skylight door. Continues over Lobby and WCs
Sample Reference	S004
Quantity	60 m ²

Analysis Result	
Chrysotile	1
Product Type	
Cement	1

Condition	
Low Damage	1
Surface Treatment	
Sealed Cement	1

Whilst the asbestos containing material continues to remain undisturbed, no immediate action is required. However a system of ongoing management should be implemented which includes routine condition inspections.

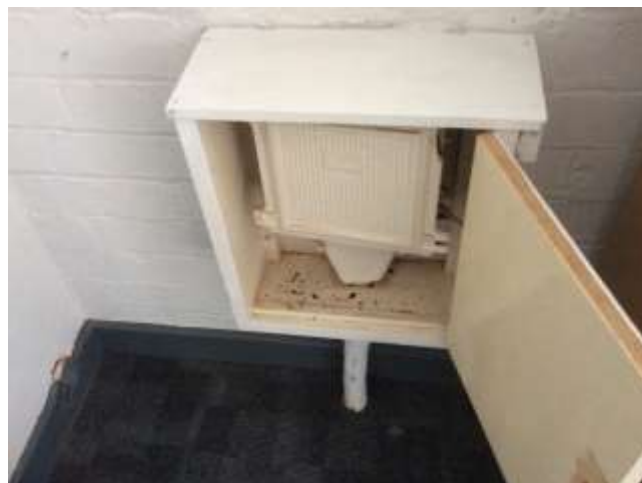
Building	BDU Building
Floor	Ground Floor
Room	203 - Classroom
Description	Woven door seal to electric box
Sample Reference	S001
Quantity	1 Unit

Analysis Result	
No Asbestos Detected	0
Product Type	
Woven Textile	2

Condition	
Good Condition	0
Surface Treatment	
Sealed Woven	1

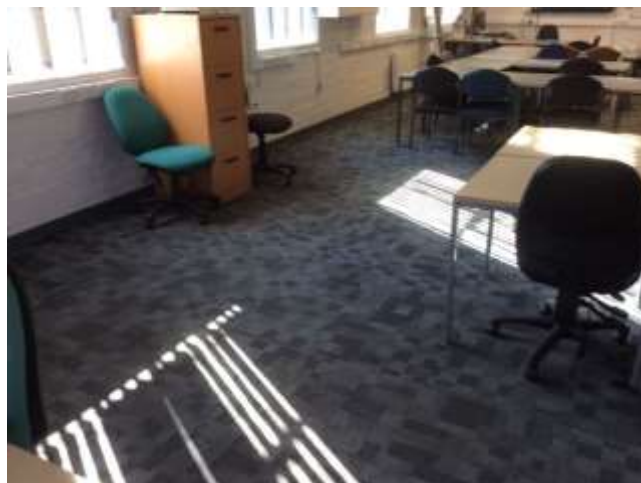
Building	BDU Building
Floor	Ground Floor
Room	203 - Classroom
Description	Vinyl flooring beneath carpet
Sample Reference	S002
Quantity	85 m ²

Analysis Result	
No Asbestos Detected	0
Product Type	
Vinyl	1

Condition	
Good Condition	0
Surface Treatment	
Composite (Self Sealed)	0

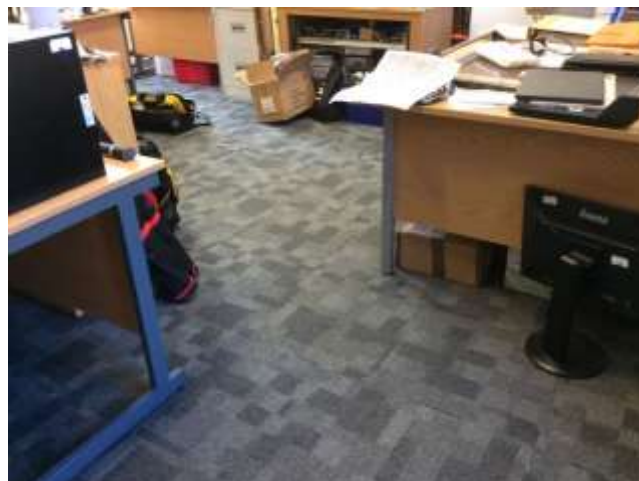
Building	BDU Building
Floor	Ground Floor
Room	205 - Office
Description	Floor tiles and adhesive beneath carpet and screed
Sample Reference	S003
Quantity	35 m ²

Analysis Result	
Chrysotile (Tile and Bitumen)	1
Product Type	
Thermoplastic Tiles & Bitumen Adhesive	1

Condition	
Good Condition	0
Surface Treatment	
Composite (Self Sealed)	0

Whilst the asbestos containing material continues to remain undisturbed, no immediate action is required. However a system of ongoing management should be implemented which includes routine condition inspections. Although not a legal requirement, labelling the material as asbestos should be considered to reduce the risk of accidental disturbance. If however the asbestos containing material is likely to be disturbed during the refurbishment works then it should be removed and disposed of in full accordance with current and relevant legislation prior to the refurbishment works being undertaken.

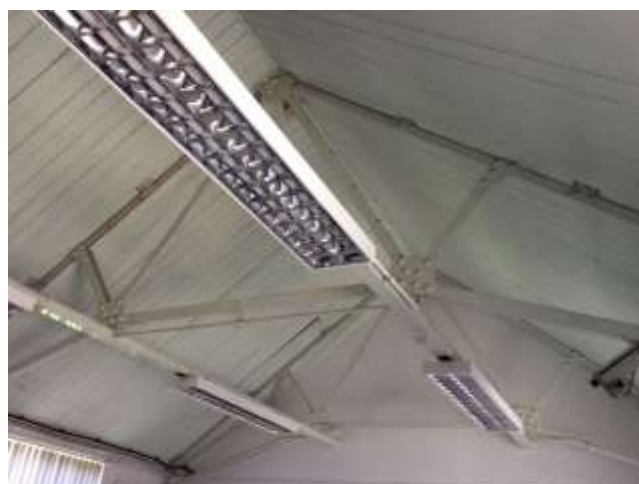
Building	BDU Building
Floor	Ground Floor
Room	205 - Classroom
Description	Textured coating to wood underling to roof
Sample Reference	Ref S006
Quantity	65 m ²

Analysis Result	
No Asbestos Detected	0
Product Type	
Textured Coating	1

Condition	
Good Condition	0
Surface Treatment	
Composite (Self Sealed)	0

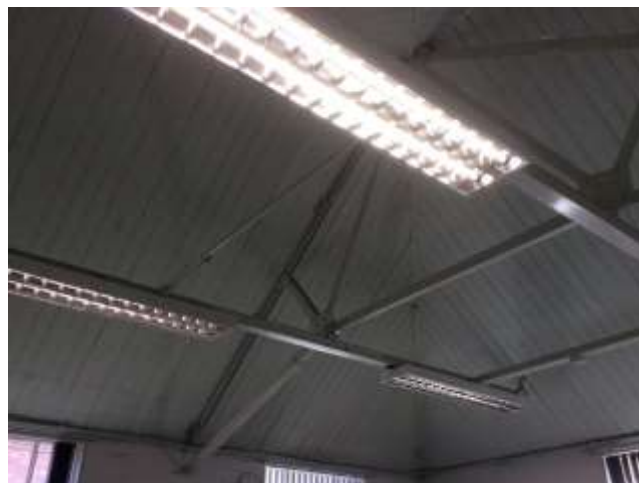
Building	BDU Building
Floor	Ground Floor
Room	206 - Classroom
Description	Textured coating to wood underling to roof
Sample Reference	Ref S006
Quantity	65 m ²

Analysis Result	
No Asbestos Detected	0
Product Type	
Textured Coating	1

Condition	
Good Condition	0
Surface Treatment	
Composite (Self Sealed)	0

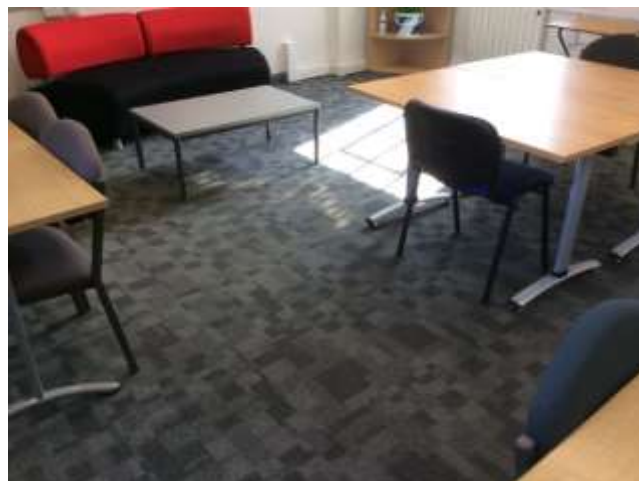
Building	BDU Building
Floor	Ground Floor
Room	207 - Classroom
Description	Bitumen adhesive beneath carpet
Sample Reference	S005
Quantity	48 m ²

Analysis Result	
Chrysotile	1
Product Type	
Bitumen	1

Condition	
Good Condition	0
Surface Treatment	
Composite (Self Sealed)	0

Whilst the asbestos containing material continues to remain undisturbed, no immediate action is required. However a system of ongoing management should be implemented which includes routine condition inspections.

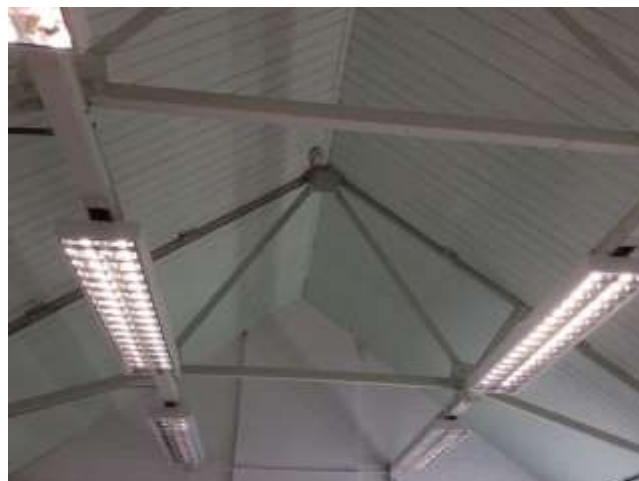
Building	BDU Building
Floor	Ground Floor
Room	207 - Classroom
Description	Textured coating to wood underling to roof
Sample Reference	S006
Quantity	65 m ²

Analysis Result	
No Asbestos Detected	0
Product Type	
Textured Coating	1

Condition	
Good Condition	0
Surface Treatment	
Composite (Self Sealed)	0

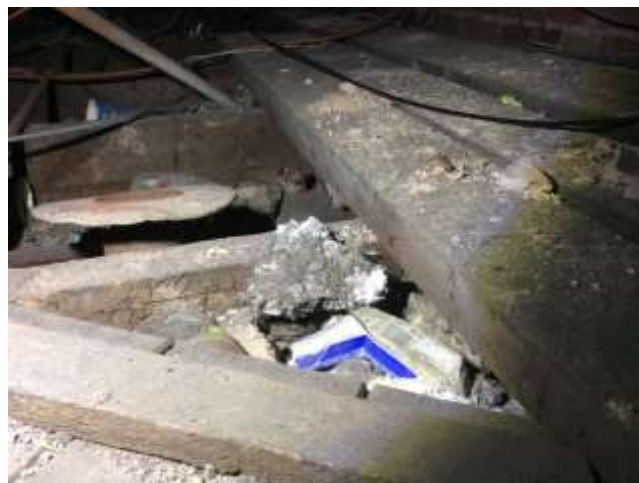
Building	BDU Building
Floor	Ground Floor
Room	Ext 1 - External 1
Description	Thermal insulation debris within void. Void area approx 14m ²
Sample Reference	S007
Quantity	15 m ²

Analysis Result	
Amosite, Chrysotile	2
Product Type	
Thermal Insulation	3

Condition	
High Damage	3
Surface Treatment	
Unsealed Insulation	3

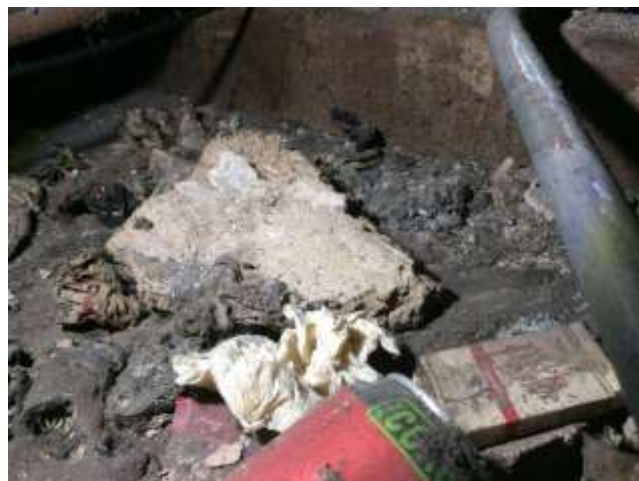
Building	BDU Building
Floor	Ground Floor
Room	Ext 1 - External 1
Description	Thermal insulation debris within void. Void area approx 14m ²
Sample Reference	S008
Quantity	15 m ²

Analysis Result	
Amosite	2
Product Type	
Thermal Insulation	3

Condition	
High Damage	3
Surface Treatment	
Unsealed Insulation	3

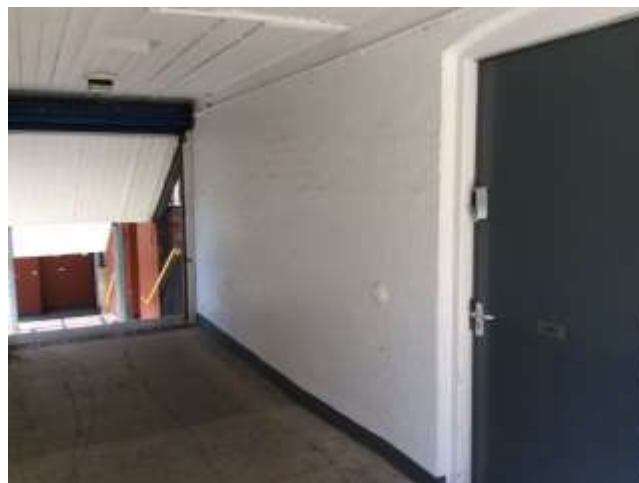
Building	BDU Building
Floor	Ground Floor
Room	Ext 1 - External 1
Description	Textured coating to brick walls
Sample Reference	S009
Quantity	26 m ²

Analysis Result	
No Asbestos Detected	0
Product Type	
Textured Coating	1

Condition	
Good Condition	0
Surface Treatment	
Composite (Self Sealed)	0

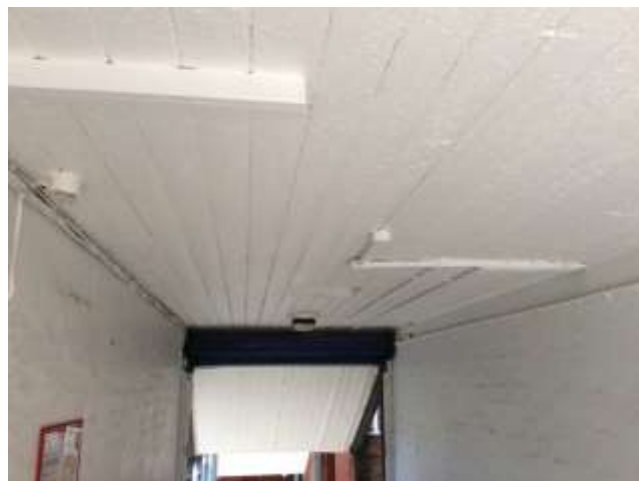
Building	BDU Building
Floor	Ground Floor
Room	Ext 1 - External 1
Description	Textured coating to wood ceiling panels
Sample Reference	S010
Quantity	15 m ²

Analysis Result	
No Asbestos Detected	0
Product Type	
Textured Coating	1

Condition	
Good Condition	0
Surface Treatment	
Composite (Self Sealed)	0

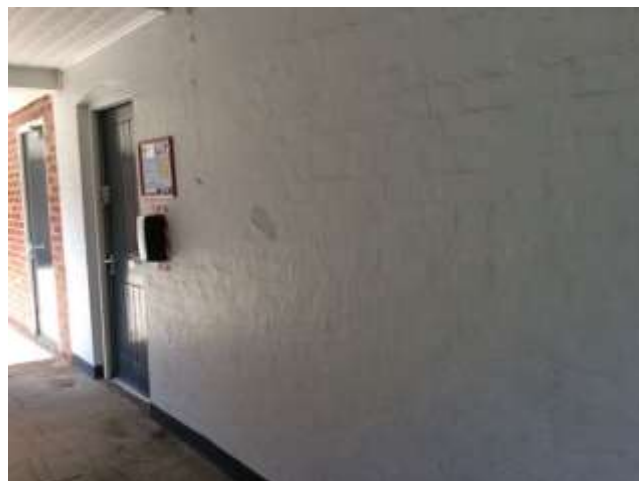
Building	BDU Building
Floor	Ground Floor
Room	Ext 2 - External 2
Description	Textured coating to brick walls
Sample Reference	Ref S009
Quantity	26 m ²

Analysis Result	
No Asbestos Detected	0
Product Type	
Textured Coating	1

Condition	
Good Condition	0
Surface Treatment	
Composite (Self Sealed)	0

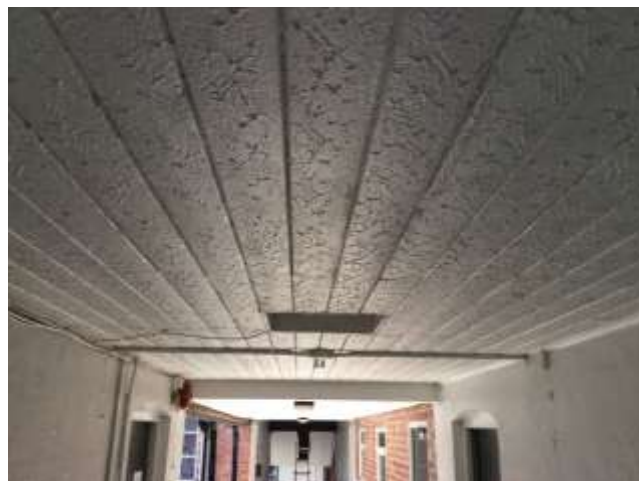
Building	BDU Building
Floor	Ground Floor
Room	Ext 2 - External 2
Description	Textured coating to wood ceiling panels
Sample Reference	Ref S010
Quantity	15 m ²

Analysis Result	
No Asbestos Detected	0
Product Type	
Textured Coating	1

Condition	
Good Condition	0
Surface Treatment	
Composite (Self Sealed)	0

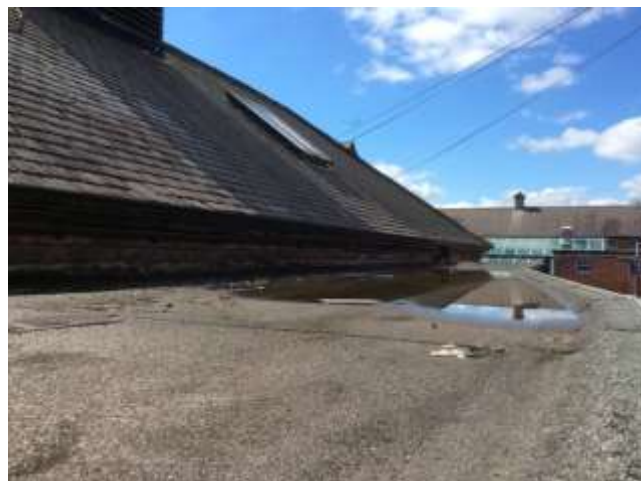
Building	BDU Building
Floor	External
Room	99 - External
Description	Felt to flat roof over front entrance and part Female WC
Sample Reference	S011
Quantity	20 m ²

Analysis Result	
No Asbestos Detected	0
Product Type	
Felt	1

Condition	
Good Condition	0
Surface Treatment	
Composite (Self Sealed)	0
