# Arboricultural Appraisal Report

## Subsidence Damage Investigation at:

7 Farrants Way  
Hornsea  
East Riding  
HU18 1DG

CLIENT:	360Globalnet
CLIENT REF:	LIV-SN-23-006837
MWA REF:	SUB230921-14279
MWA CONSULTANT:	Richard Percival (TechArborA)
REPORT DATE:	17/10/2023

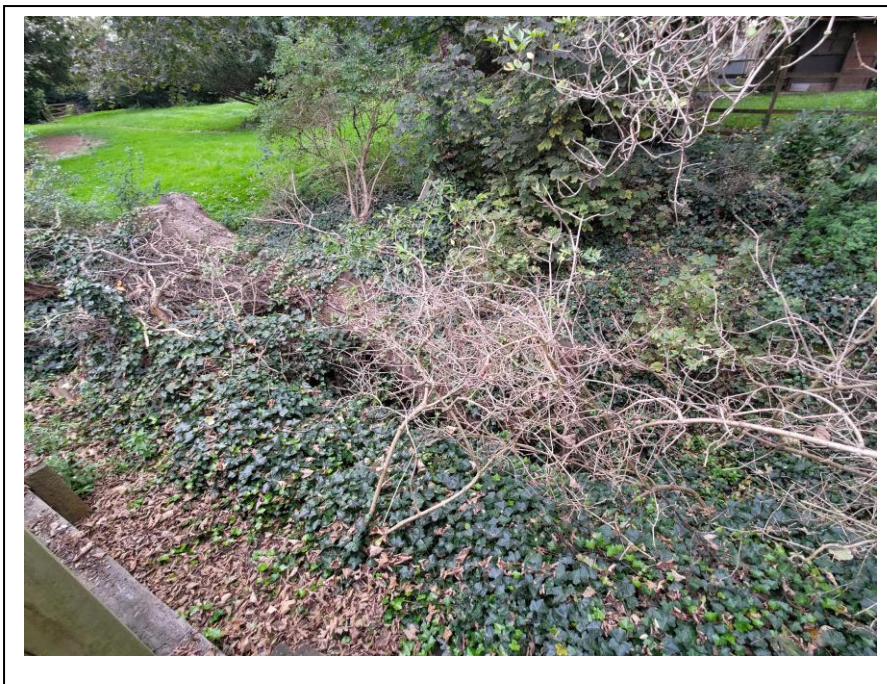
It was noted during our visit that a large Sycamore tree was once growing between the property and T1. We are informed that this tree fell during strong winds sometime between 1 and 2 years ago. It is highly likely that the roots of this tree extend below the foundations of the extension, and their influence has now been eliminated or at least greatly reduced. We were unable to visually locate the stump but recommend that any regrowth should be managed regularly to stop the tree from reestablishing.

View of windthrown Sycamore stem
