EXISTING SEPTIC TANK &
ASSOCIATED DISCHARGE INSPECTION
PROPOSED ALTERATIONS & EXTENSION
TO DWELLINGHOUSE
WOODEND COTTAGE
POTTERTON
ABERDEENSHIRE
AB23 8UR

Client: Mr and Mrs Copley
Architect: Annie Kenyon Architecture
Contract No.: 3481/23
Report Issued : 13 November 2023

EXISTING DISCHARGE INSPECTION & RECOMMENDATIONS PROPOSED ALTERATIONS AND EXTENSION WOODEND COTTAGE, POTTERTON, ABERDEENSHIRE, AB23 8UR

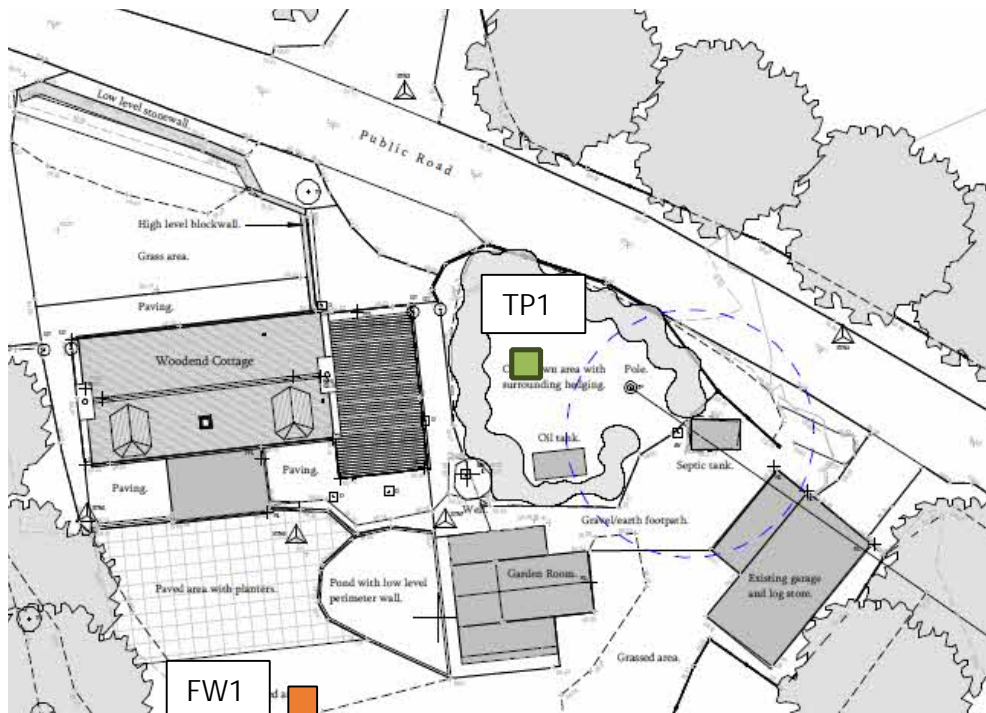
The locations of the trial pit were decided on site and are indicated on Fig. 2. Proposed Site Layout & Test Location Plan in Appendix A.

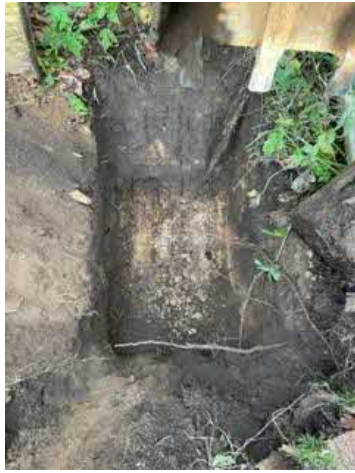
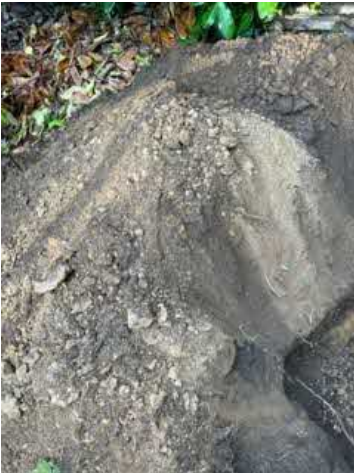
S.A. MCGREGOR <small>GEO TECHNICAL & ENVIRONMENTAL ON SITE SERVICES</small>				Site Woodend Cottage, Potterton		Trial Pit Number TP1	
Excavation Method Tracked excavator with 0.30m bucket		Dimensions 0.60 x 1.00		Ground Level (mOD)		Client Mr & Mrs Copley	
Location		Dates 28/09/2023		Architect Annie Kenyon Architect		Job Number 3481/23	
Depth (m)		Water Depth (m)		Level (mOD)		Sheet 1/1	
Sample / Tests		Field Records		Depth (m) (Thickness)		Description	
						Legend	
						Water	
					0.50	Grass onto TOPSOIL

0.50 (0.20)	Firm friable dark orange slightly sandy slightly gravelly CLAY

0.70 (0.50)	Firm friable light orange pink brown very sandy very gravelly CLAY HSV @ 0.70m - 120

1.20	Complete at 1.20m
