Internal Decay Assessment of Holm Oak T3

Parsonage Court
Church Road South
Portishead
BS20 6PH

October 2023

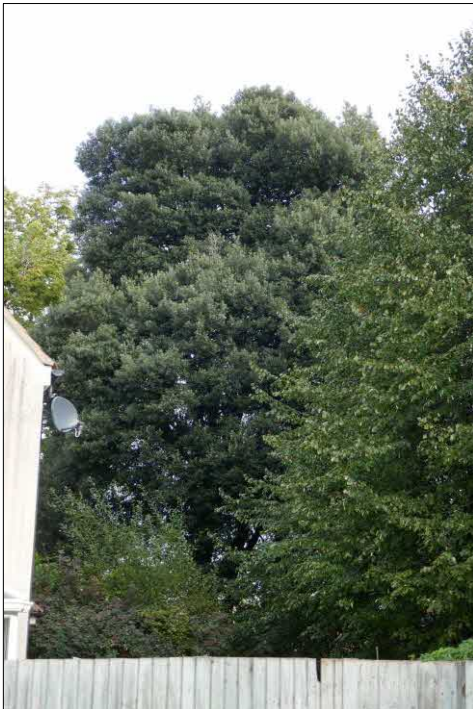
Pl. 1 – Holm oak T3

Growing 10m east of building. Overhanging adjacent garden.
 Damage to buttress roots. Basal epicormics. Ingrown metal.
 Acute fork at approx. 2m above ground level (agl) to 3x stems; divides again at 4m agl.
 North stem -
 Bark death/decay/hollow sounding from 1.5m-3m agl on east and north aspects.
 Cavity/decay on southwest aspect from 2m-3.5m agl - decay extends through to east aspect with rib of live growth to south (resistograph test R4).
 Adaptive growth - 4x functional columns of sound wood between decayed zones.
 South stem - secondary stem at 3.5m agl.
 East stem - decay from union to 3m agl on northeast aspect.
 2x Cobra braces at approx. 10m agl.
 Water pocket in crevice on north aspect.
 Past pruning wounds. Major deadwood and squirrel damage.
 Crown thinning on north aspect.

- 5.12 Management recommendations:
Reduce crown height by 3-4m.
Reduce lateral growth by up to 2m.
Retain all internal growth.
Reshape and balance to natural outline as feasible ensuring that all pruning cuts are made at healthy lateral branches of sufficient size and foliar bearing capacity.
All work to be carried out in accordance with BS 3998:2010 Treework - Recommendations and/or industry best practice.

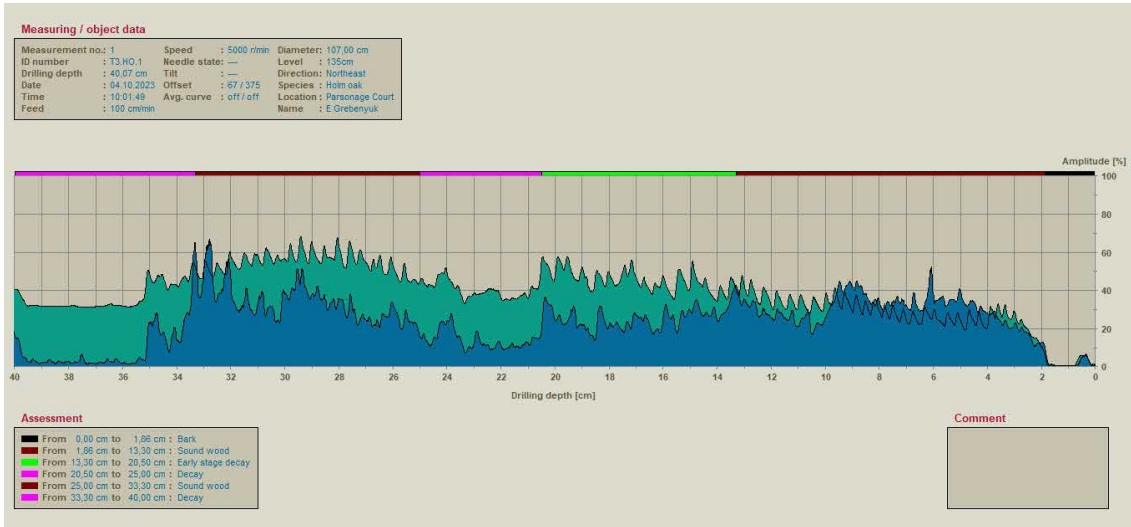
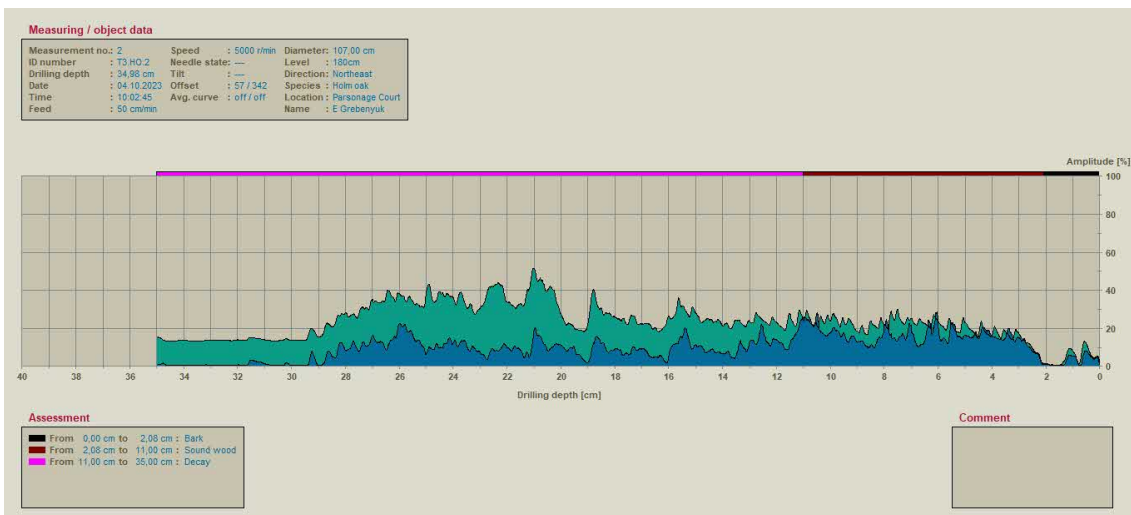
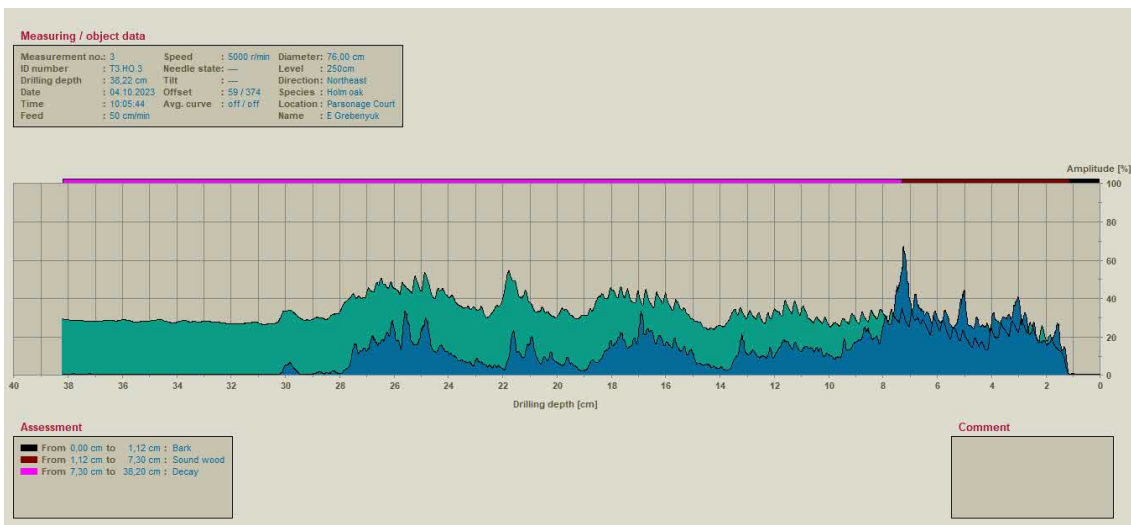
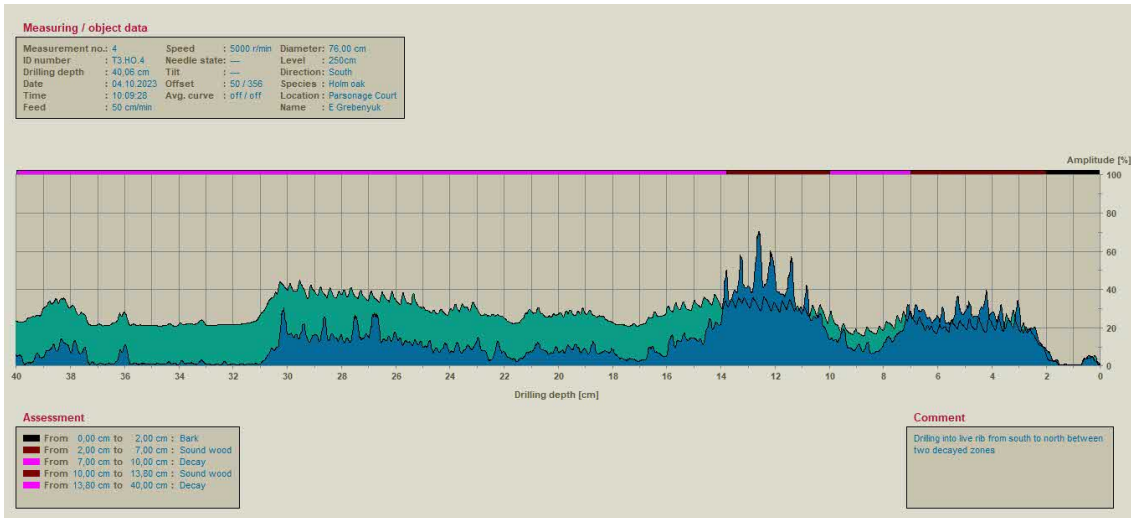
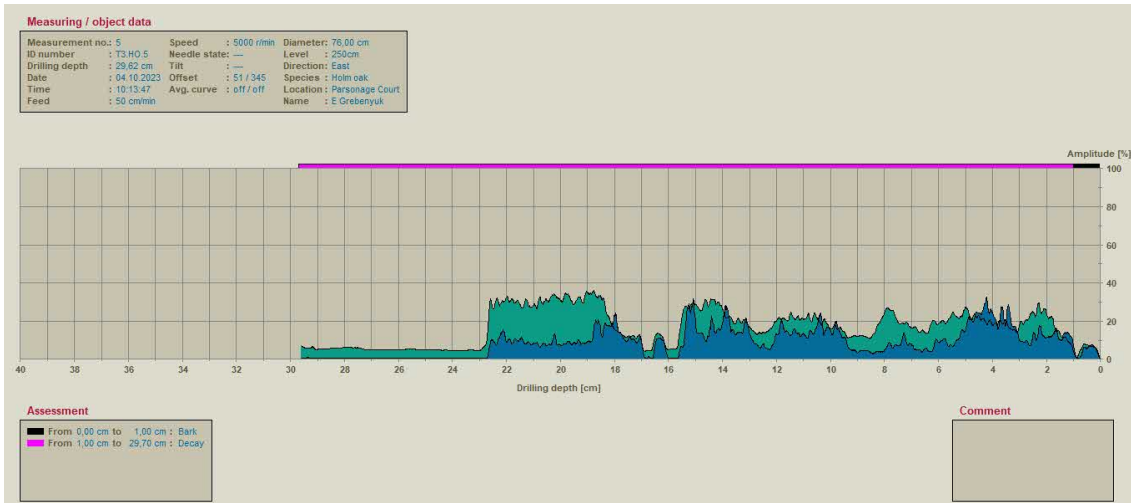
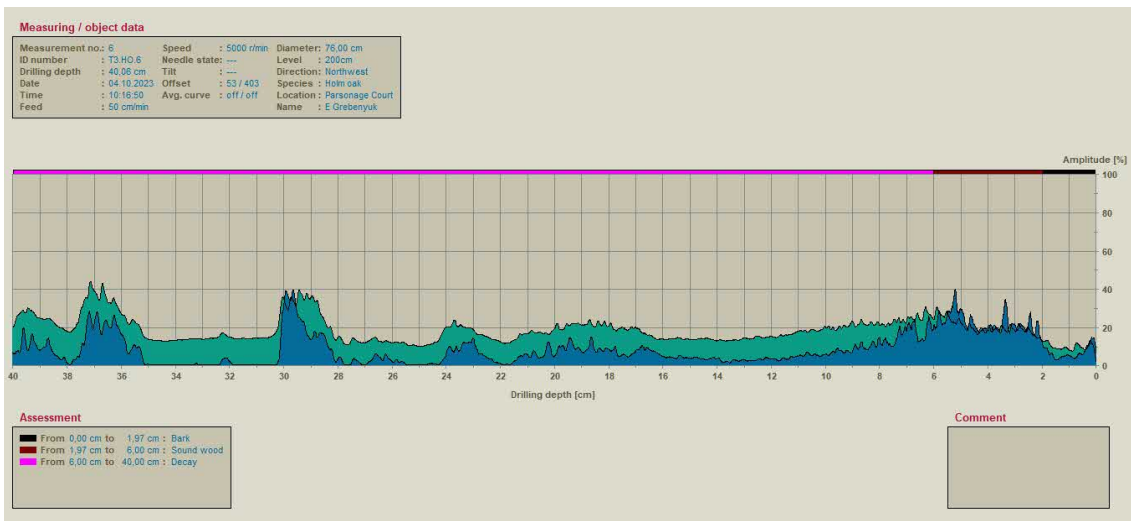
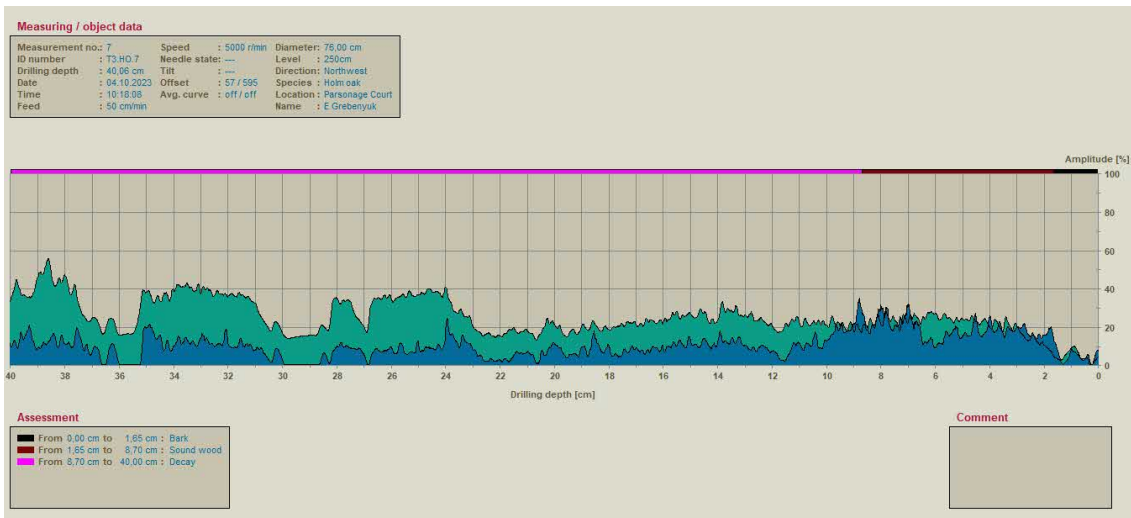
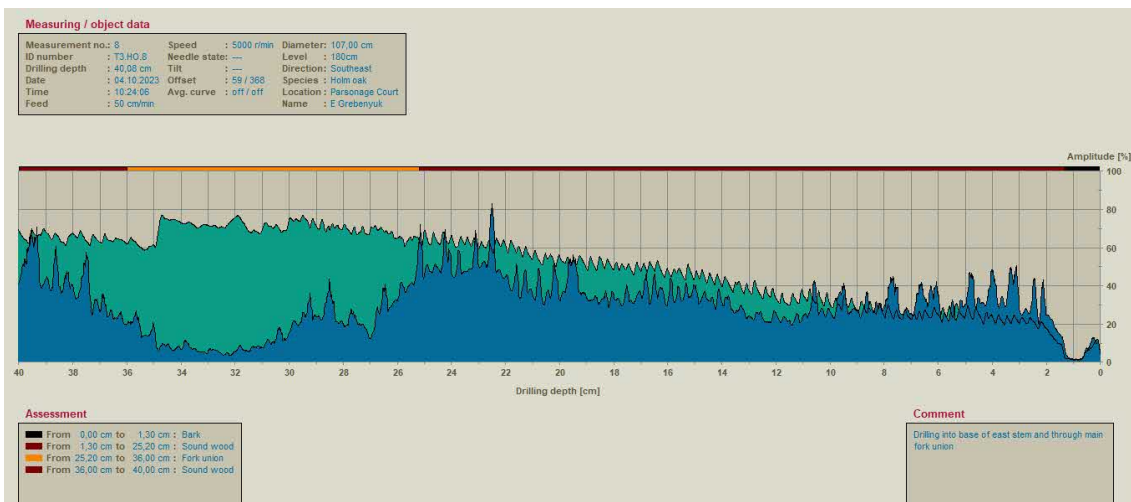
6.0 Resi-PD400 Resistograph results

Drill no.	Cardinal pt.	Height (cm) agl	Stem Radius (cm) R	Radial depth of sound wood including bark (cm)	Radial depth of sound wood excluding bark (cm) t	t/R ratio
R1	Northeast	135	53.5	13.5	11.5	0.21
R2	Northeast	180	53.5	11.0	9.0	0.17
R3	Northeast	250	38.0	7.5	6.5	0.17
R4	South	250	38.0	7.0	5.0	0.13
R5	East	250	38.0	1.0	0.0	0.00
R6	Northwest	200	38.0	6.0	4.0	0.10
R7	Northwest	250	38.0	8.5	7.0	0.18
R8	Southeast	180	53.5	25.0	23.5	n/a

- 5.1 The findings indicate extensive decay of the north stem between 135cm and 250cm agl.
- 5.2 The ratio of residual wall on the northeast aspect (readings R1, R2 and R3) ranges between 6.5cm and 11.5cm (17% to 21% of the stem radius).
- 5.3 R4 taken into the live rib of growth on the south aspect, between the two decayed zones, reveals only 5cm of sound wood.
- 5.4 R5 taken into the dysfunctional bark on the south aspect identifies no residual wall indicating that the decay bisects the stem at this point from east to west.
- 5.5 R6 and R7 taken on the northwest aspect identify only 4cm and 7cm of sound wood respectively (10% and 18% of the stem radius).
- 5.6 R8 taken into the base of the east stem and through the main fork union indicates 23.5cm of sound wood before encountering some decay on either side of the union.

- 5.7 The combined findings suggest that the ratio of sound wood to decay is on the borderline of accepted safety margins to avoid compression (bending) failure in high winds. The tree is of good vitality and responding to the increased stresses with compensatory incremental growth. However, the relatively thin outer wall combined with bisection of the stem by decay increases the risk of stem failure.

- 5.8 In my opinion, the tree may be retained dependent on a crown reduction to ease wind loading and mechanical stress on the decayed northern scaffold stem and fork union. Holm oak generally tolerates quite severe pruning; therefore, dependent on its response, the tree could be maintained at a reduced scale within tolerable safety margins.

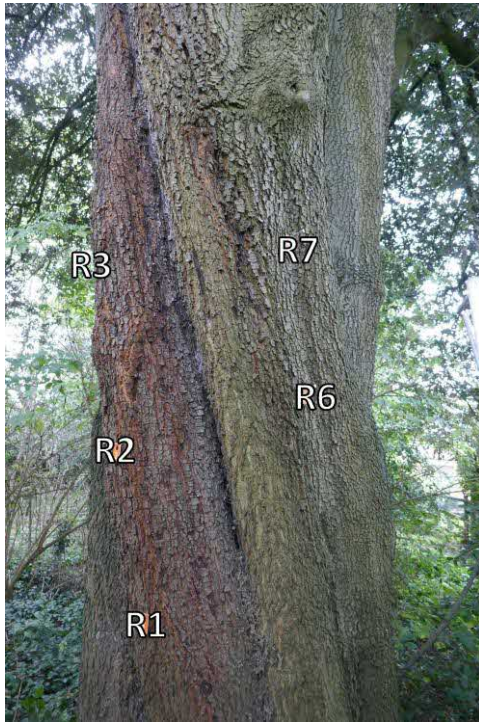
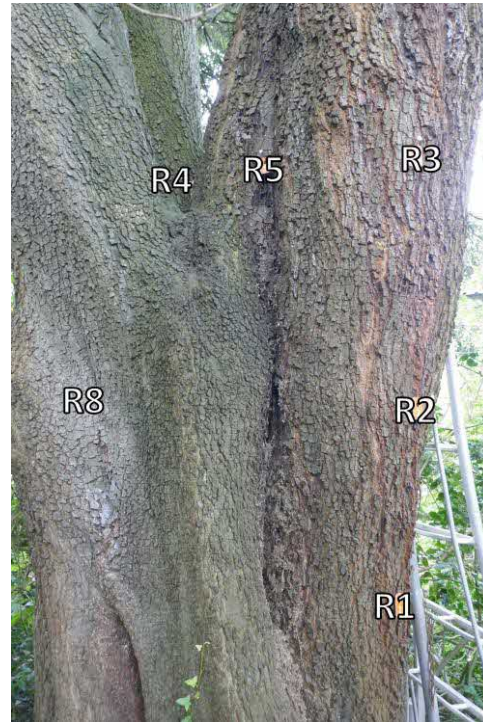
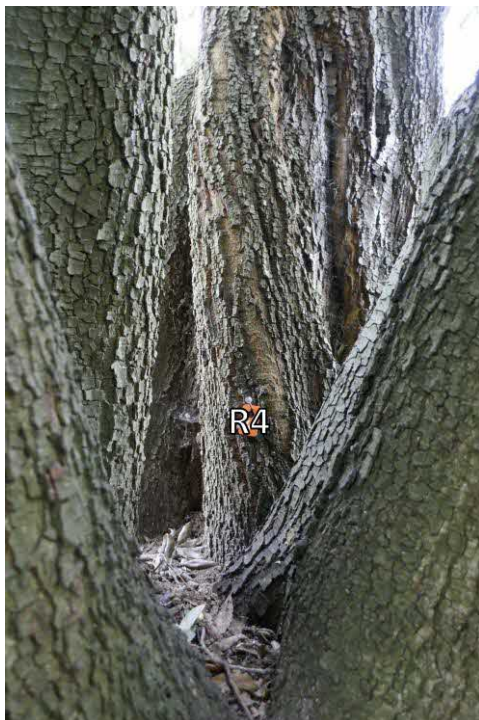
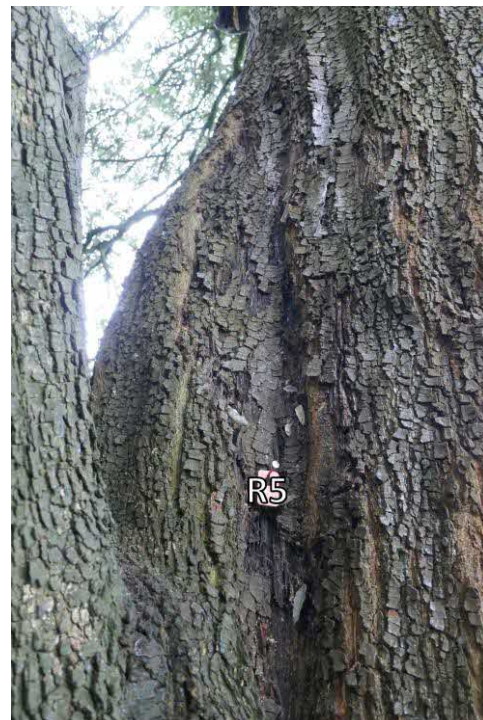
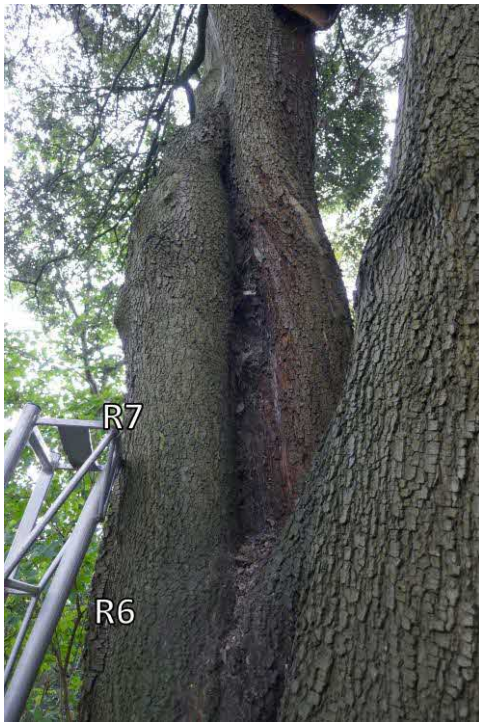
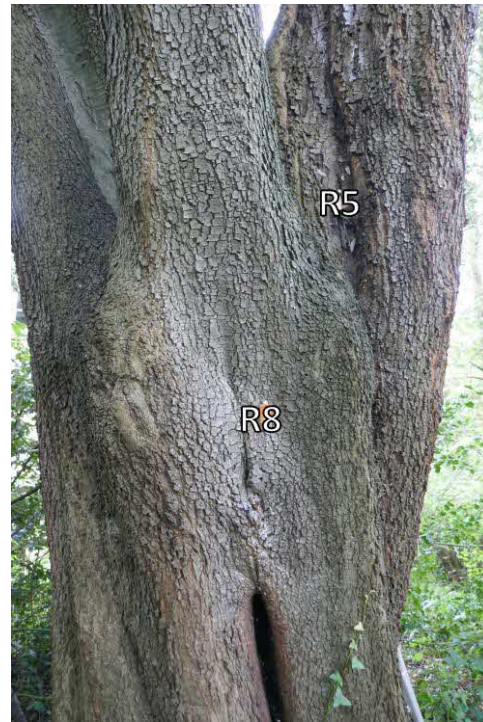
Showing resistograph drill points R1 to R8.
