**STRUCTURAL REPORT IN SUPPORT OF LISTED BUILDING CONSENT**

**61 ROYAL HILL, GREENWICH**

**LIFT ENABLING WORKS**

**PROJECT REF: 23-118**

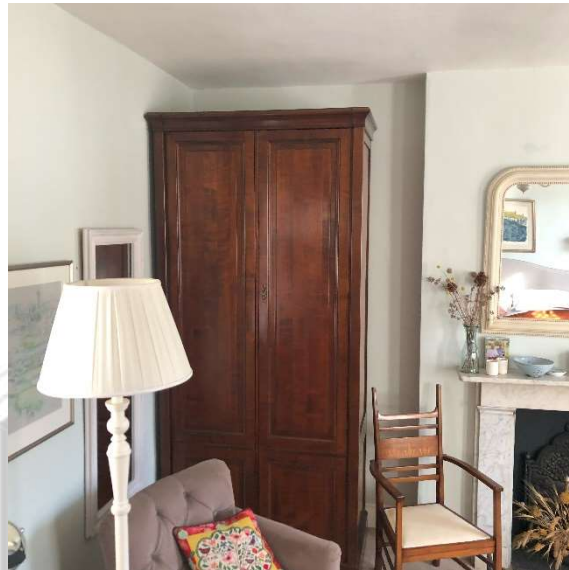
Location of proposed lift at First Floor

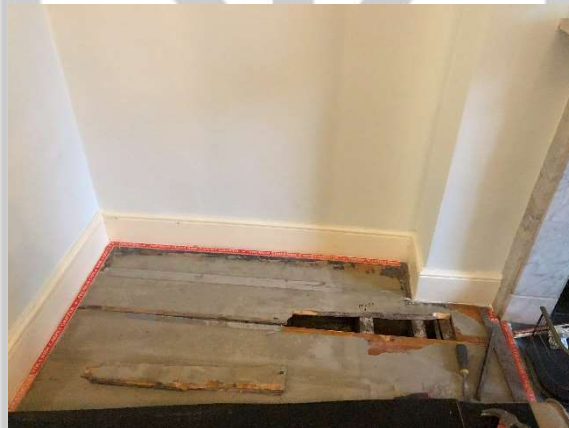
Joists to the Bedroom were seen to be 50x200 deep, at around 380 centres, with a span of approximately 4.9m.

Floor structure in proposed location

The 2 No. existing joists would be cut, and re-supported on new timber trimmers running between the adjacent joists. These supporting joists would need to be strengthened, and it is proposed that this is done by creating Fitch Beams. The existing joists would remain in place, with a new timber bolted to the side, with a steel plate sandwiched between. This strengthening would inflict minimal damage to the existing joists, and could be undone in the future if required. It may also be possible to carry out this work from First Floor, which would hopefully avoid damage to the Lounge ceiling.

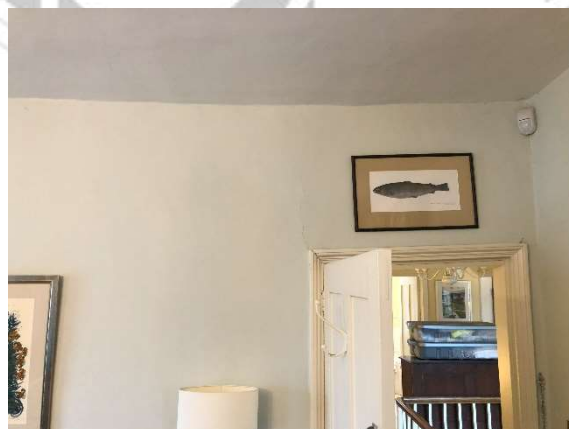
Slight cracking to corner of door at opposite end of room

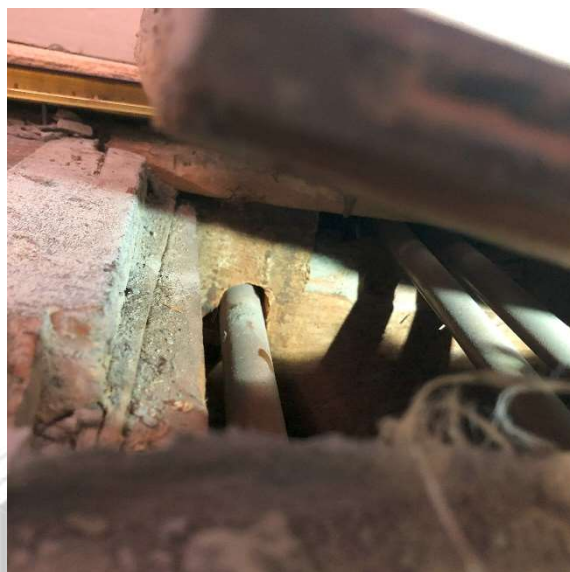
timber supporting both the wall and the joists. The Lounge wall below is offset from this line so this timber is load bearing. Opening up was very limited so it was not possible to obtain the size of the timber, or to assess its condition. This should be done if the proposed lift installation goes ahead as better access would be available. Currently the cracking to the Lounge ceiling is slight, and not a cause for immediate concern unless it should worsen.

Limited view of timber beam below Bedroom wall

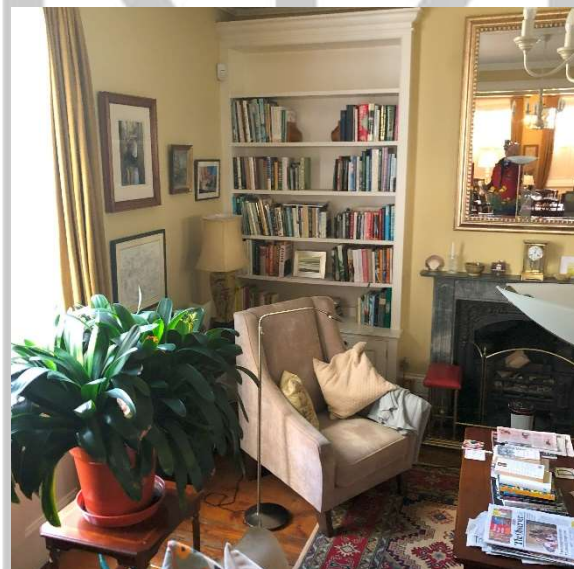
Location of proposed lift at Ground Floor

At Ground Floor, where the weight of the lift will need to be supported, the existing joists will need to be strengthened. It is proposed to do this by doubling up the existing joists. Again this will inflict minimal damage to the existing floor, and could be undone in the future if required.

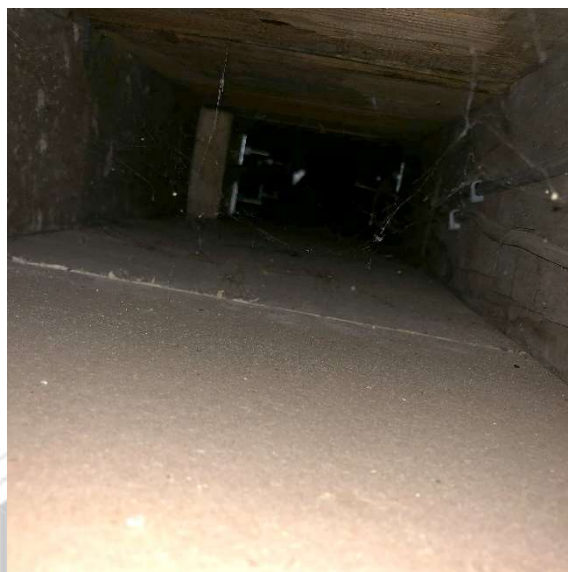
Joists to the Lounge were seen to be 50x150 deep, again at around 380 centres, but with a shorter span of approximately 2.7m. The shorter span is due to a supporting basement wall below. Opening up to the floor was limited, but it was just possible to see what appeared to be some previous repair works, with bolts visible, suggesting timber may have been spliced.

Ground Floor structure with previous repair works just visible

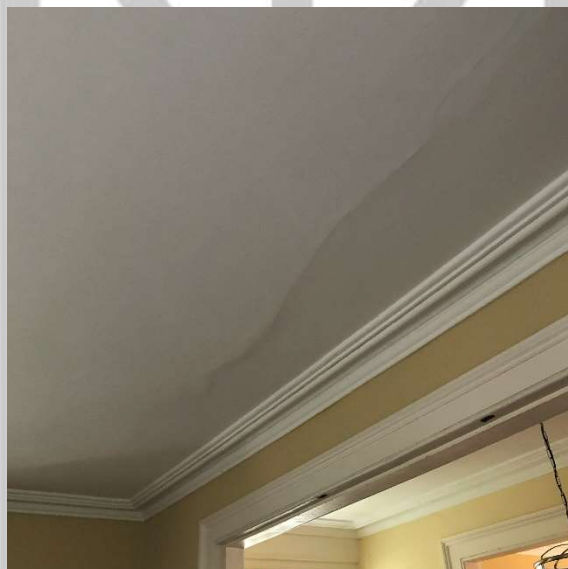
It is also worth mentioning that, while carrying out investigations to the floor, the support at the far end of the First Floor joists was investigated. This was due to a slight crack being visible to the Lounge ceiling in this area. Directly below the Bedroom wall it was possible to see a

Cracking to Lounge ceiling below line of Bedroom wall above
