## 2/1 9 Princes Terrace, Glasgow G12 9JP

We propose replacing the existing sash and case window with newly manufactured timber sash and case windows that will be manufactured in a like for like formation. Horn detail would be lifted from the existing windows to the lower properties preserve the established style.

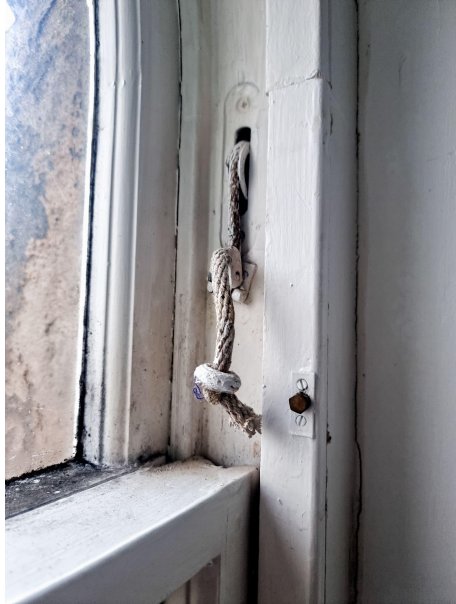
The first photo shows a broken rope and pulley wheel. The second photo shows a “dead horn”, this shows that the window is not original as the horn does not match the windows on the lower floors of the building. There are also sharp moldings to the windows which show they are not original windows.

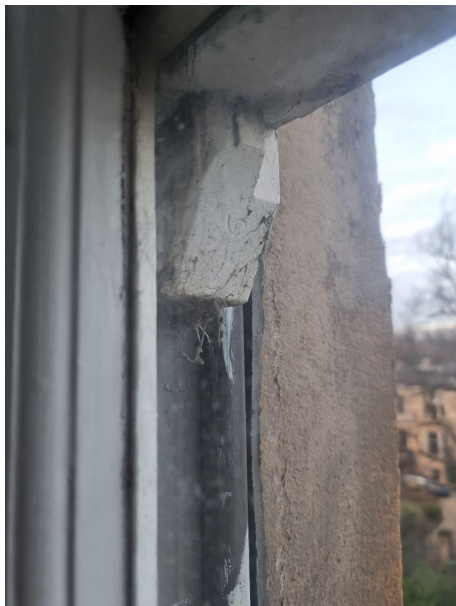
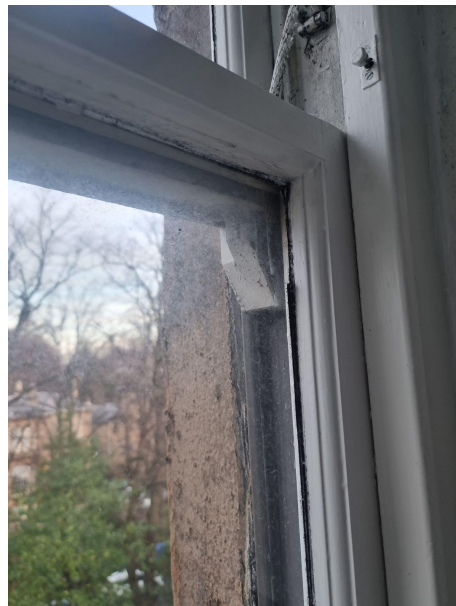
Further photos of the dead horns to windows on the front elevation, along with sharp moldings to the sashes internally.

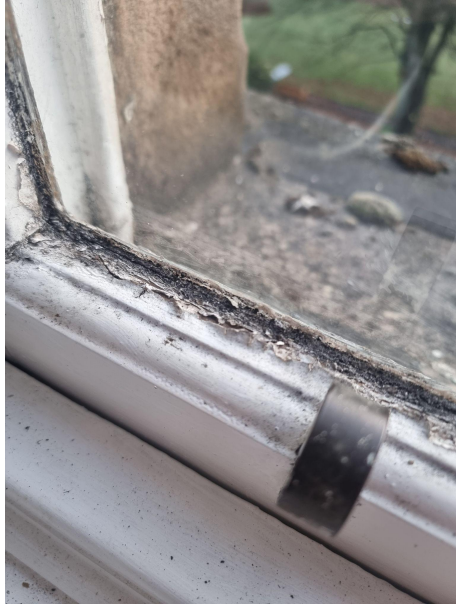
Seals are coming away from the glass internally due to water collecting on the bottom rail of the sash and wood rot becoming present. The second photo show a rotting sill.

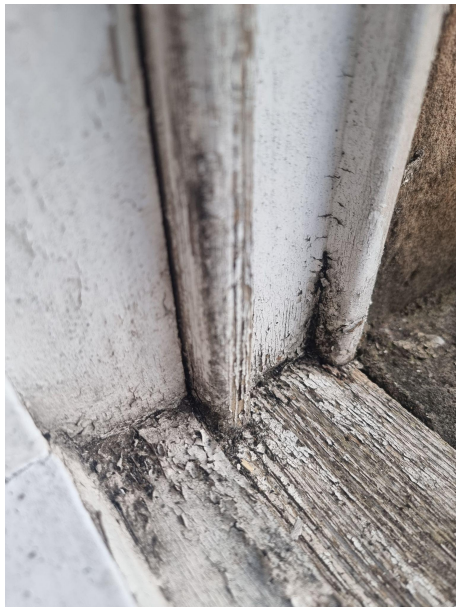
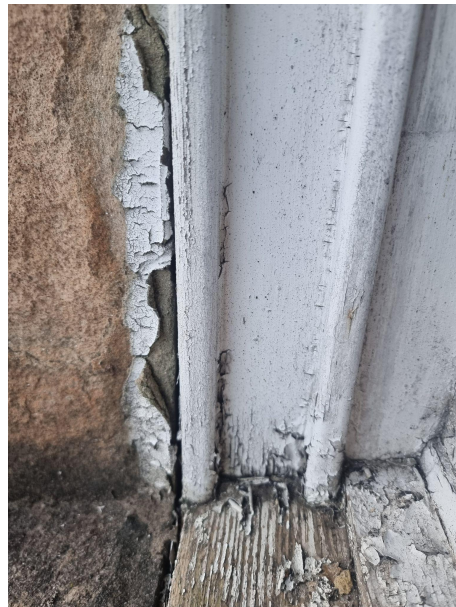
Further photos of rotting rills and the second photo shows the mastic is no longer flush against the casement which is allowing water to enter the woodwork. The windows have been replaced with softer pine therefore the woodwork has deteriorated quickly.

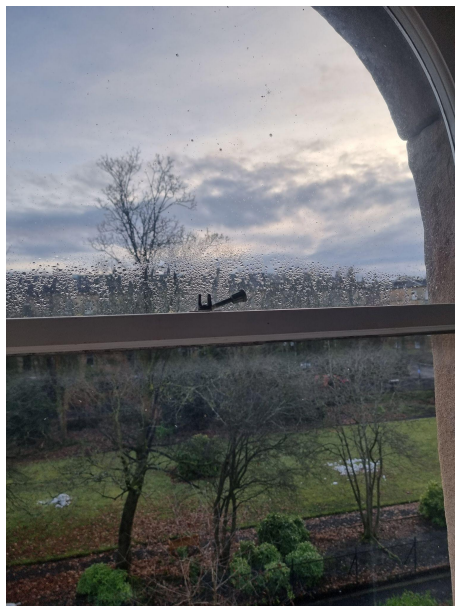
Internally condensation is present throughout the windows in the property showing poor insulation and the water is causing damage to the woodwork.

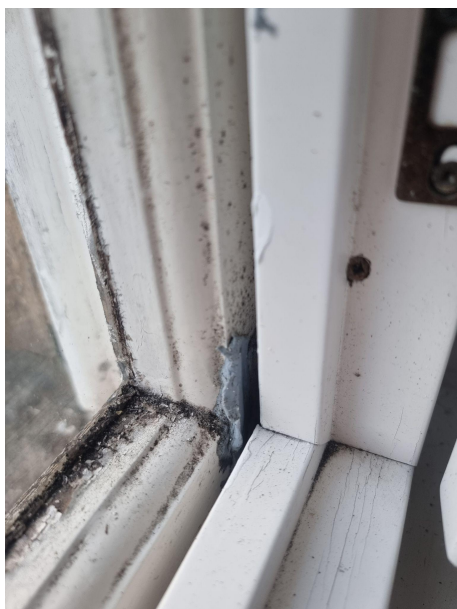
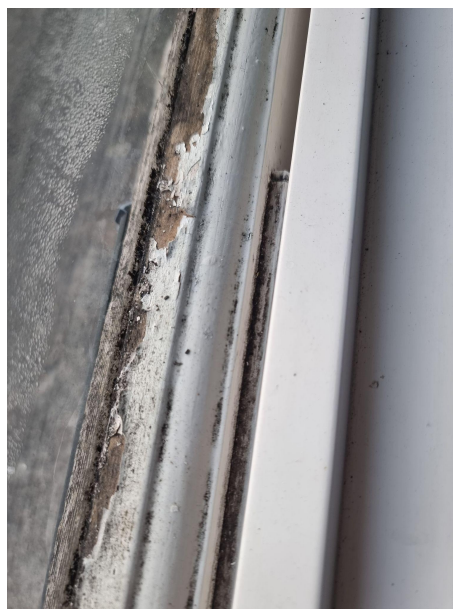
The above photos show molding and rotting woodwork to the bottom rails.

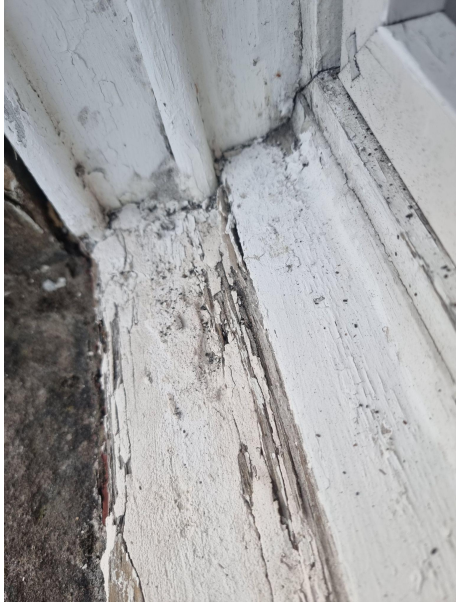
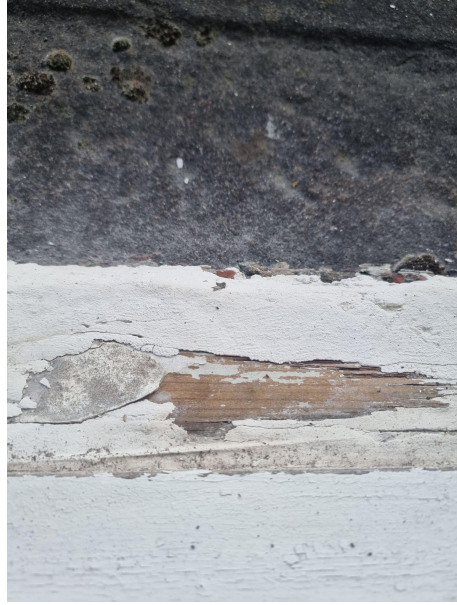
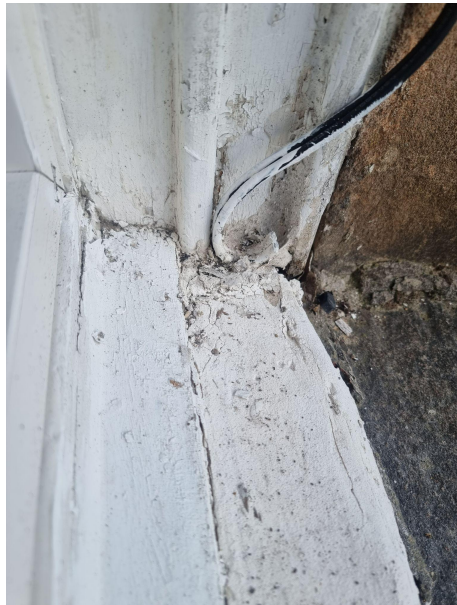
The above photos shows poor repairs to one of the sills on the rear elevation which has been carried out due to rotting and bare woodwork beneath.

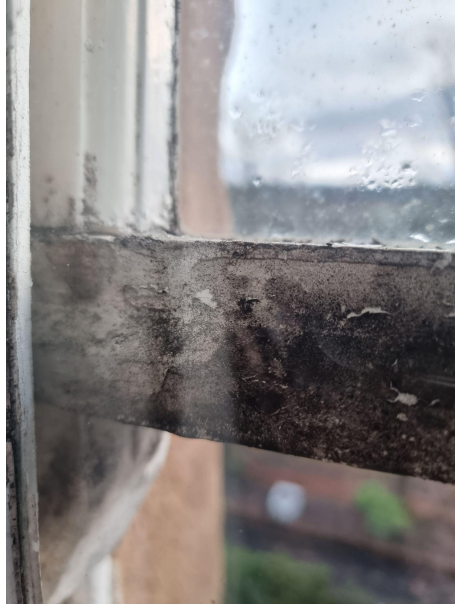
Rotting midrail woodwork.

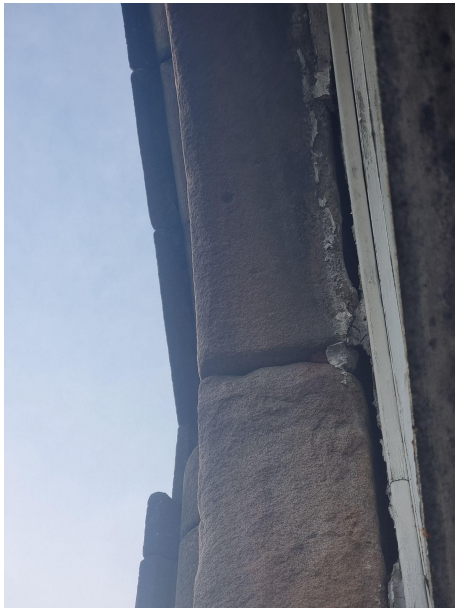
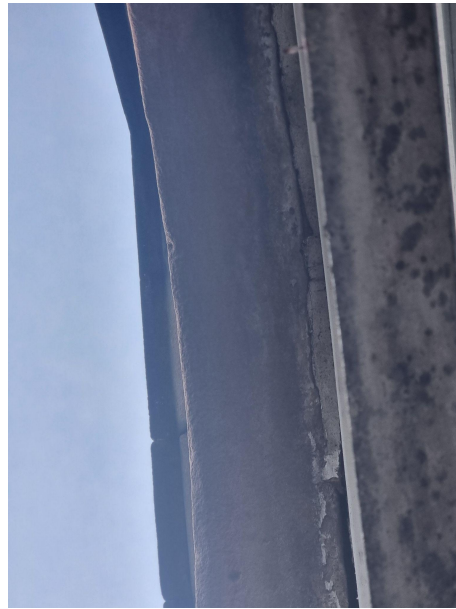
These photos shows the large case present around the arched windows. The windows are no longer flush with the stonework and all of the mastic has come away which is allowing water to enter the casement and property.

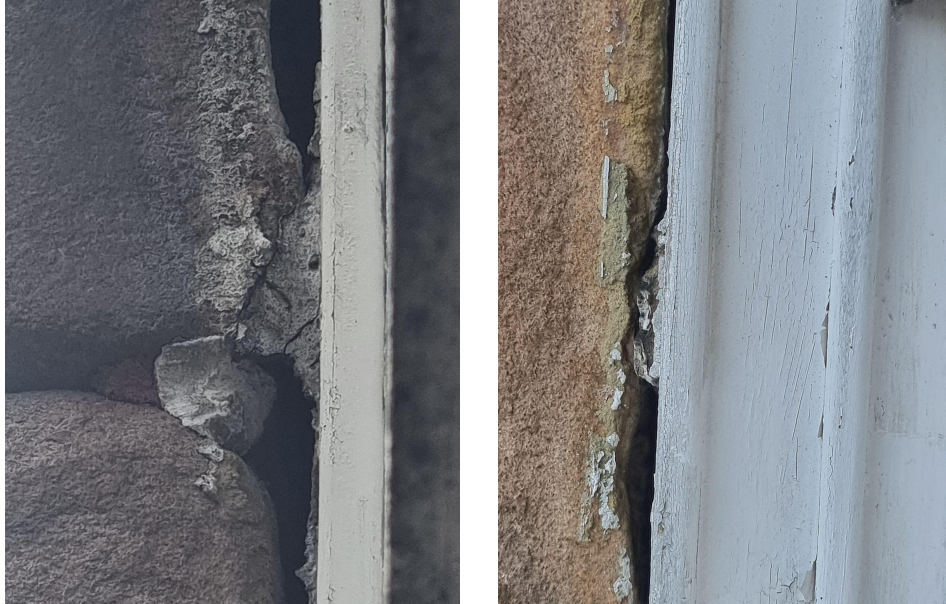
Large gaps around the windows which are allowing water to enter the casement and property.

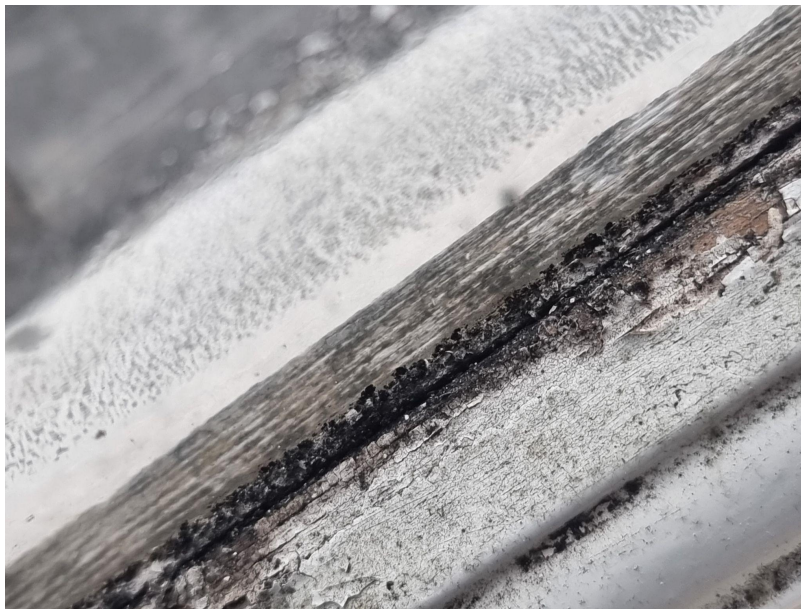
Bare and rotting woodwork internally and externally to the bottom rail where seals and putty have failed.

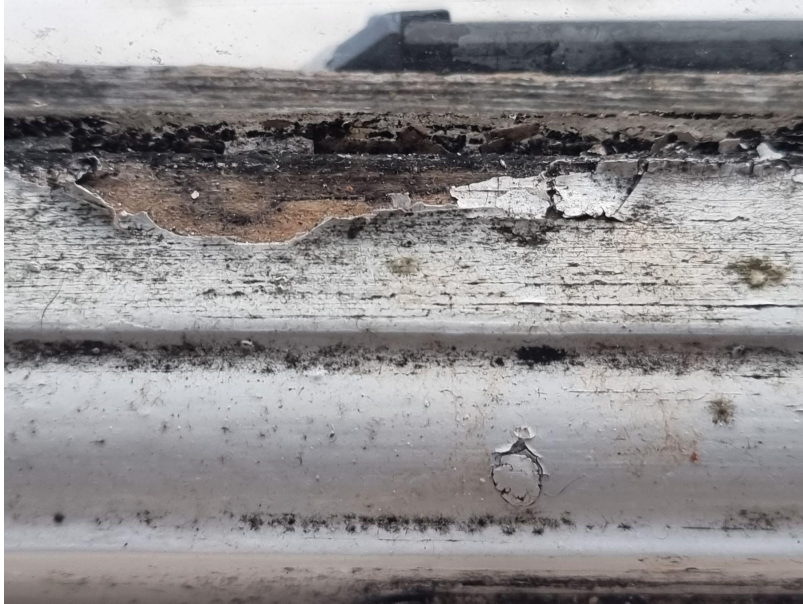
Bare and rotting woodwork internally and externally to the bottom rail where seals and putty have failed.

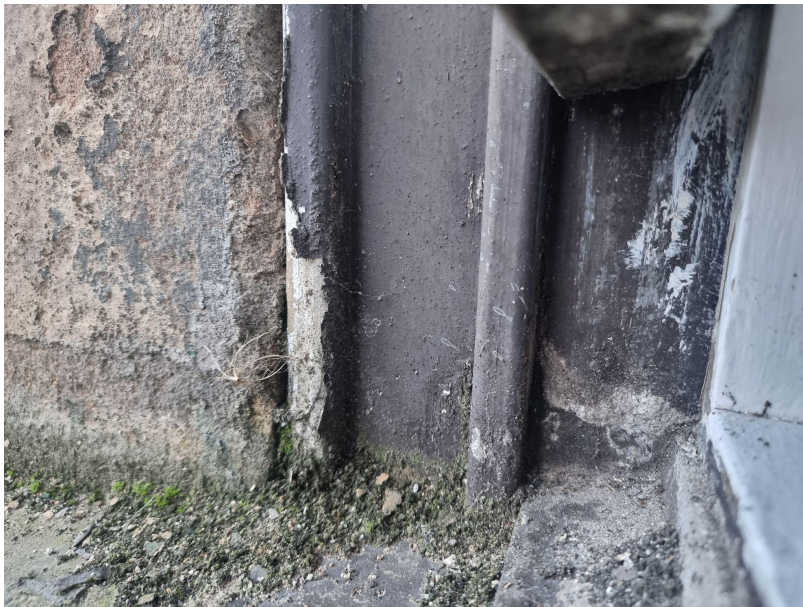
The above photo shows rotting woodwork to the casement and internal pulley pockets.
