# **ARBORICULTURAL REPORT**

### **to BS 5837:2012 at:**

***Enright Lodge,  
Enright Close,  
Newark,  
NG24 4EB***

Reference: *AWA5779*

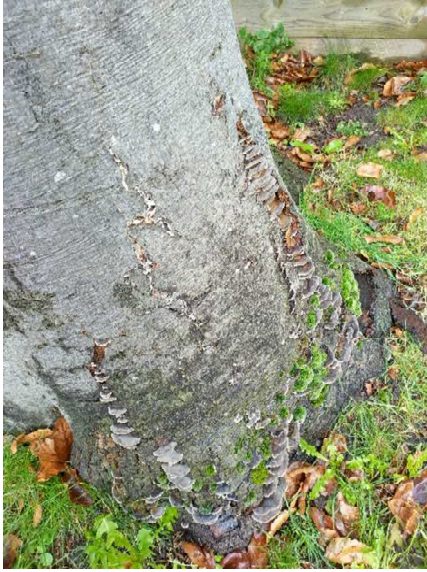
- 3.2.8 T9 is an early-mature Beech which has also been heavily pruned as part of past management works. Numerous fungal brackets, likely to be Turkey Tail (*Trametes versicolor*) were present on the stem at the time of survey. The presence of this fungal pathogen can indicate vascular dysfunction and physiological decline and suggests that T9 has limited future prospects. As such it is recommended that T9 is removed regardless of development at the site.

Photo 1: Fungal bracket on T9.

T9	Beech <i>Fagus sylvatica</i>	17	1	500	No	3	1.5	2	2.5	2	Fungus	Single stemmed. Vertical. Epicormic growths. Old pruning wounds. Stubs	Old pruning wounds. Minor dieback. Minor deadwood	Heavily pruned resulting in stubs with epicormic regrowth. Fungus on stem with signs of decay - likely Turkey Tail ( <i>Trametes versicolor</i> ). Indicative of vascular dysfunction and physiological decline	Poor	Fair	>10 yrs	U	Recommended for removal regardless of development
T10	Apple <i>Malus sp.</i>	3	1	80	No	1	1	1	1	1	No visual defects	Single stemmed. Vertical. Old pruning wounds. Epicormic growths	Old pruning wounds. Minor dieback. Minor deadwood	Heavily pruned resulting in stubs with epicormic regrowth	Good	Good	20 to 40 yrs	C	No works required
T11	Pear <i>Pyrus sp.</i>	9	1	220	No	2	1	1	1	1	No visual defects	Single stemmed. Significant lean. Old pruning wounds. Epicormic growths. Stubs	Old pruning wounds. Minor dieback. Minor deadwood	Heavily pruned resulting in stubs with epicormic regrowth. Leaning south east.	Fair	Fair	10 to 20 yrs	C	No works required

- 3.2.10 T9 was found to have defects and requires felling regardless of any new

4.2.4 In addition to the required removals, T9 is recommended for removal regardless of development due to its poor overall condition.

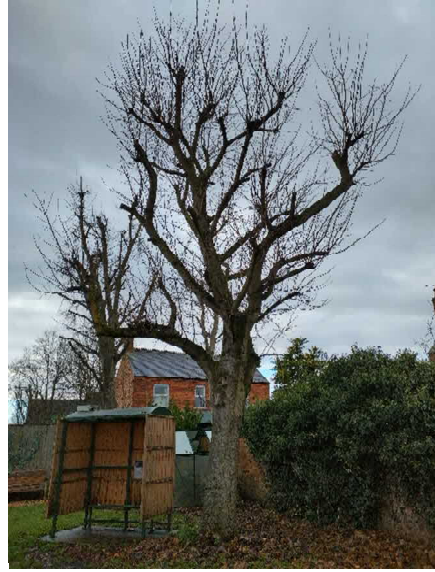
- 3.2.5 Many of the trees within the site have been heavily pruned in the past, resulting in stubby crowns with epicormic regrowth at the pruning wounds. These historical works have negatively impacted the long-term amenity potential of these trees, including Lime T7, T19 and T22, Norway Maple T12 and T21, and Beech T13 and T23. As a result of these past management works these trees are low value overall.

Photo 2: T12 from northeast.

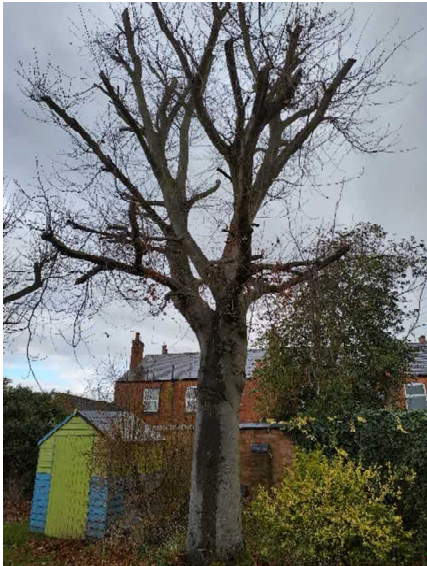
Photo 3: T13 from northeast.

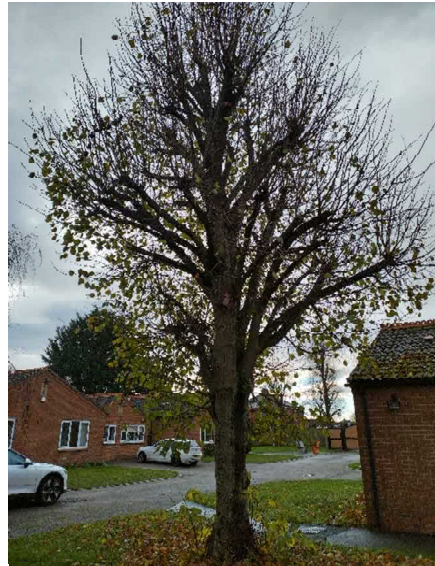
Photo 4: T16 from north.

4.3.3 New hard standing encroaches close to and into the edge of the RPA of T6 and T16. The construction of hard surfaces within the RPA can have negative impacts on tree roots, however the encroachment is very minor, and as such it is unlikely that significant roots will be within these areas.

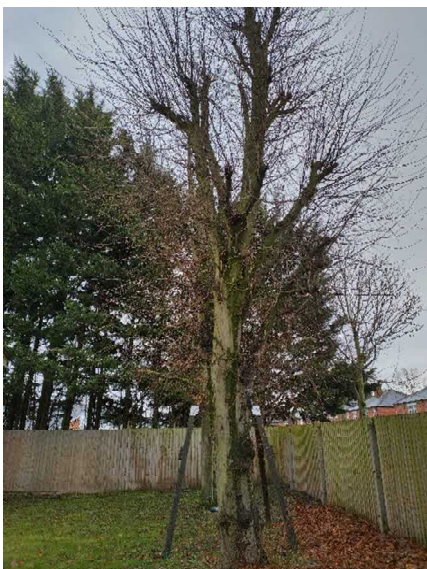
Photo 5: T23 from west.

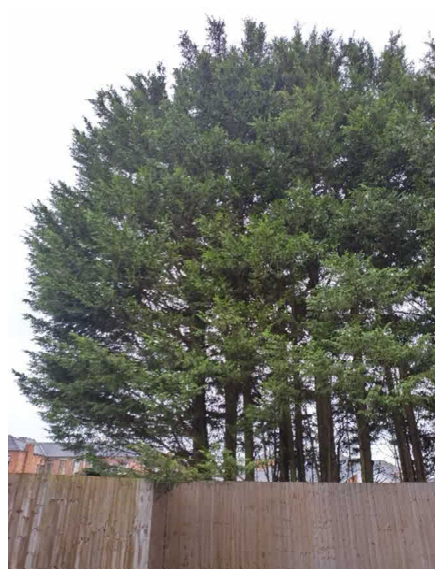
- 3.2.7 Dense Ivy on the stem and growing within the crown of adjacent Silver Birch T6 prevented detailed inspection. Cypress group G24 is in good condition and provides effective screening of the site from the adjacent hospital. T6 and G24 are low value retention category 'C'.

Photo 6: G24 from southwest.
