20<sup>th</sup> November 2023

**Ref: KCS-2311-TR**

## Tree Survey

## Kirklands of Cluny, Sauchen

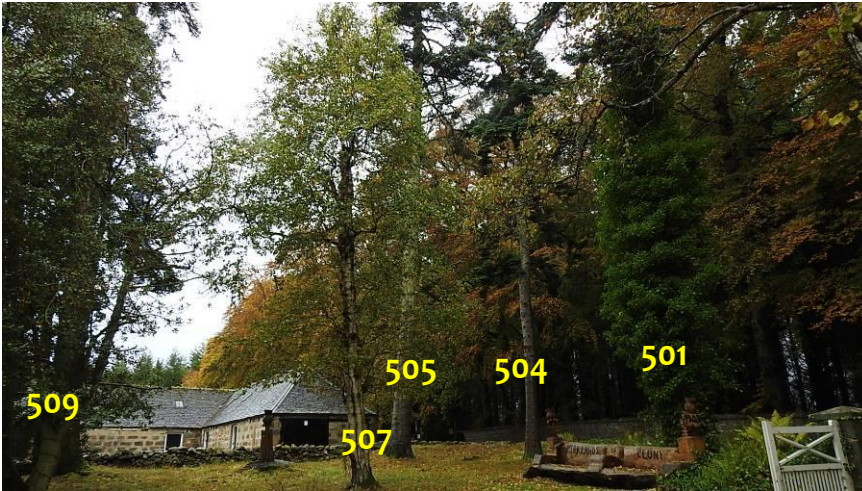
Tree 501 has low bat roosting potential. It is not to be felled for the proposals or management and no further action is necessary.

Photo 1:  
View north of trees 501, 504, 505, 507 and 509. Tree 501 has extensive ivy growth from base to 18m. It is recommended that the ivy is cut at the base and allowed to die.

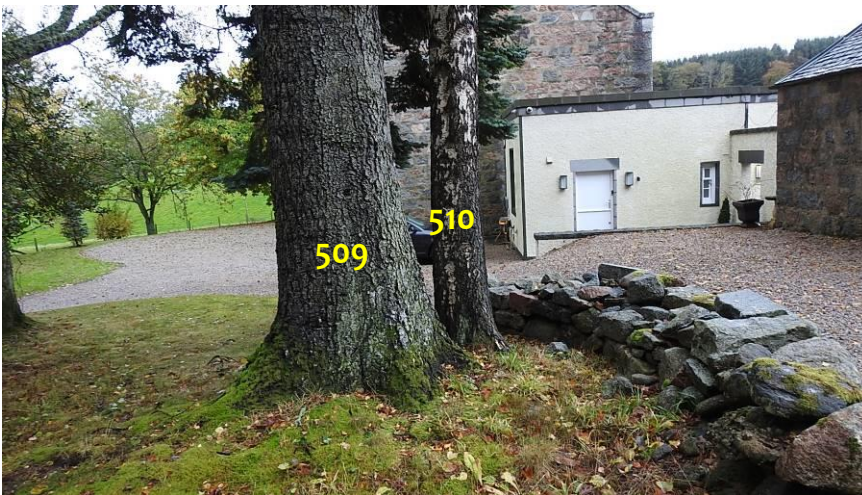
Silver Birch 510 is recommended to be felled as it is so heavily suppressed by Noble Fir 509. There is not much room for growth and some rot has started to occur in a wound where a branch has snapped off in the past.

Photo 2:  
Silver Birch 510 growing to the west of Noble Fir 509 to the south of the retaining wall. Tree 510 is heavily suppressed with a one-sided canopy to the west and is recommended to be felled for management.

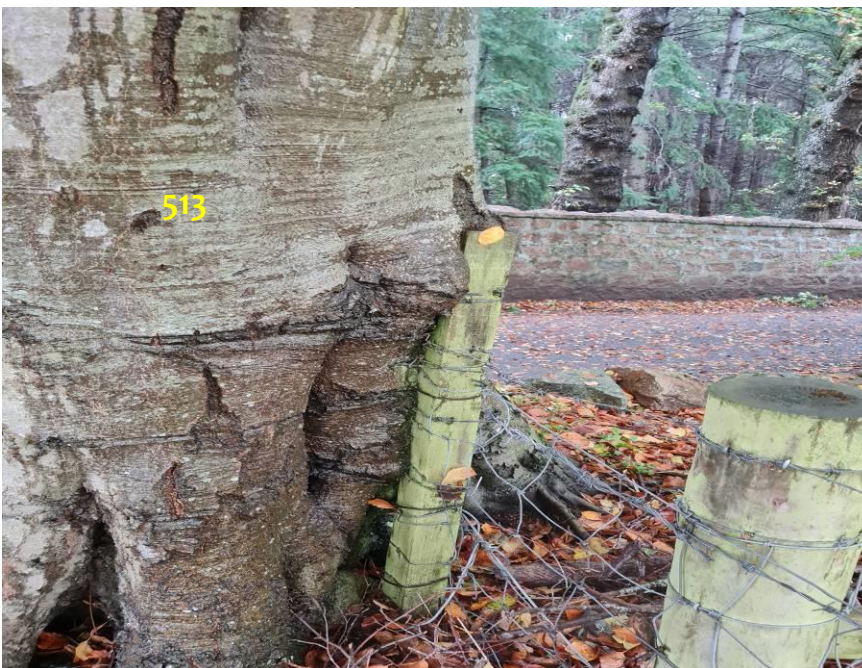
Photo 3:  
Tree 513 engulfing a fencepost to the south. The tree grows on a retaining wall to the east. It is recommended that the fencepost is removed.

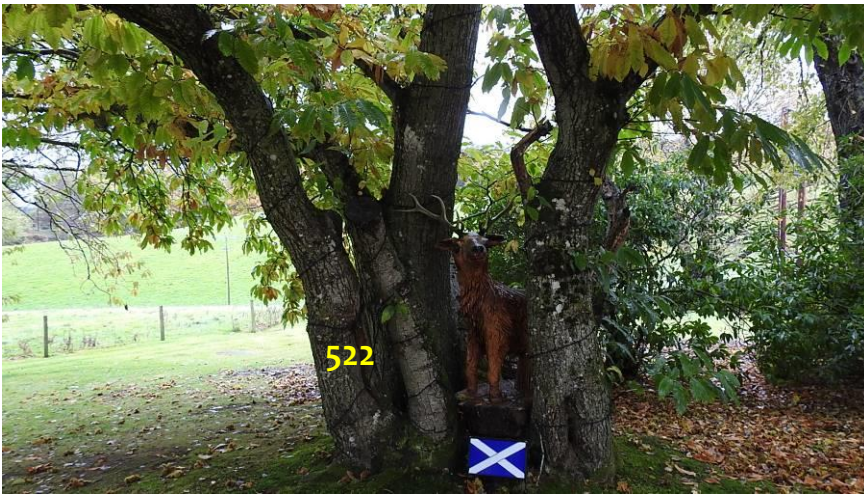
Photo 4:  
Tree 522 with a deer sculpture on top of one of the stems which has been removed. Many of the trees in this area have lights wrapped around them with electricity sources attached to them.

522	Sweet Chestnut	53, 39, 37, 38, 16	5	6	6	4	10	9.7	M	C	No	Five stems from base, sixth stem has been removed and has deer carving placed onto stump. One limb is dead but remains, one limb dead and has been cut at 2m. Some signs of rot in bark wounds. Power source attached on north and east elevations. Deadwood and snags apparent but tree appears healthy.	Retain and inspect every 18 months.
523	Lime	83	5	5	6	4	16	10.0	M	B	No	Twin-stemmed from 4m. Cavity at divergence angle rotting but upwards-facing hollow thus no bat roost potential. There is adventitious growth at base. Some snags and deadwood in canopy but tree appears healthy. Rabbit burrows around base.	Retain.
524	Beech	150	8	7	8	7	15	18.0	M	C	No	Multi-stemmed from 1.75m. Large impressive wide spreading canopy, with some deadwood and snags. Many flush cut branches on east and southwest sides which are starting to occlude. A limb has snapped off on the southwest side at base, with rot apparent, northeastern roots are overburdened due to a boulder pile.	If the stones were placed there in the last 5 years, remove them. Otherwise, it may cause more damage. Retain and inspect every 18 months

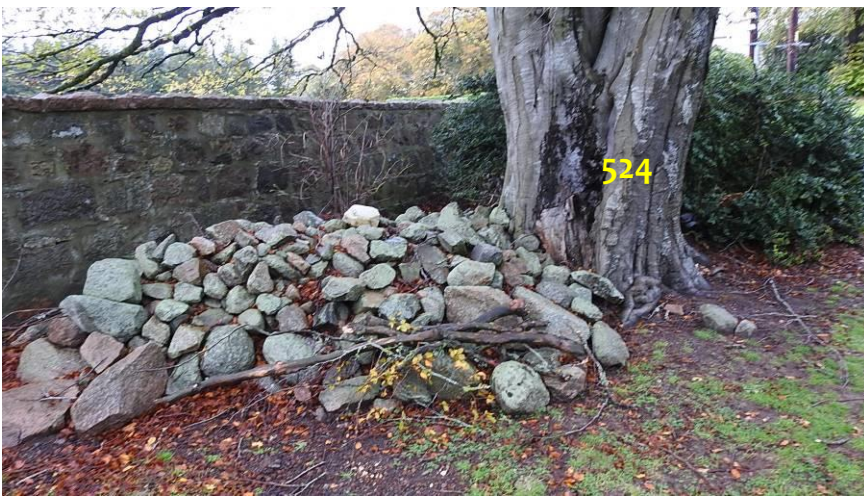
Photo 5:  
Pile of stones stacked over roots of tree 524, overburdening them. These stones should be removed if they were placed there within the last five years.

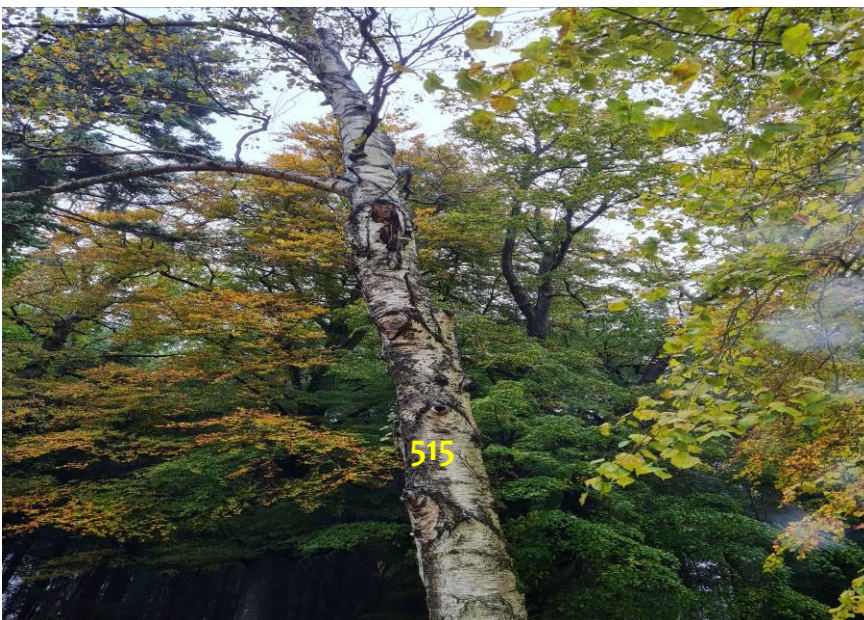
Photo 6:  
Tree 515 with a large hollow on the south side, hollow with no bat roost potential. It is unclear how deep any of these cavities go. Tree is to be retained.

515	Silver Birch	28	5	1	3	3	15	6.4	M	C	No	Tree leans southwest, large hollow at 4m on south side, appears wet and is angled upwards thus no bat roost potential. Tree is missing top of its canopy, has been topped in past. Suppressed by neighbouring tree to south, mainly one-sided canopy to north and northwest. A sign is nailed to tree is on its north side at 1m.	Retain and inspect every 18 months.
516	Cherry	32	3	3	3	3	14	7.4	M	B	No	Twin-stemmed from 4m. Southwest stem is dominant. There is some damage to surface roots from lawn mower activity. Tree appears healthy.	Retain.
517	Western red cedar	74	4	4	4	4	18	17.0	M	B	No	Twin-stemmed from 3m. Power source box on south stem at 0.2m.	Retain.
518	Poplar	40	3	2	2	2	14	9.2	M	B	No	Twin stem from 4m with east stem dominant. Tree leans north. A branch has been removed at 4m on west side, wound has occluded with no signs of rot. Some deadwood but tree appears healthy.	Retain
