20 September 2023

## 23.1213 - Kirklands of Cluny - Steading Conversion –Structural Survey

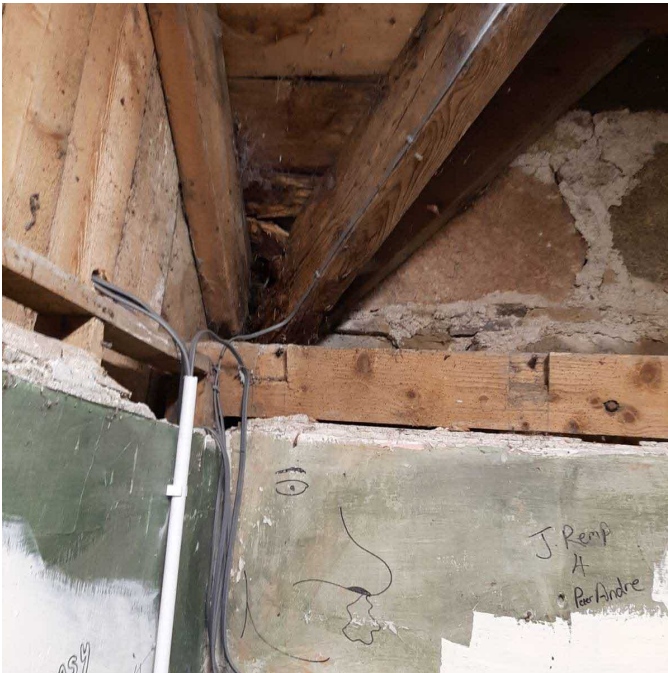
Roof valley showing rotten end

It is recommended that roof repairs are carried out to prevent further damage to the existing structure, and a timber rot and infestation specialist is appointed to carry out a full report on timber elements, with remedial works to be carried out in line with the findings of this report. It is likely this report will advise some timber joist and rafter end repairs, however this is not expected to be wide spread throughout the building. To ensure longevity of the structure post conversion, it is recommended the mortar is scraped out and

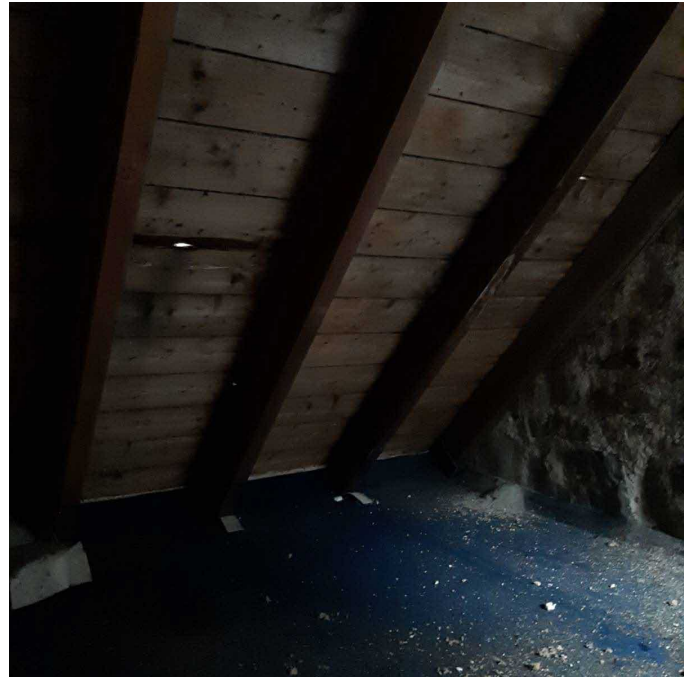
Holes in roof allowing water ingress

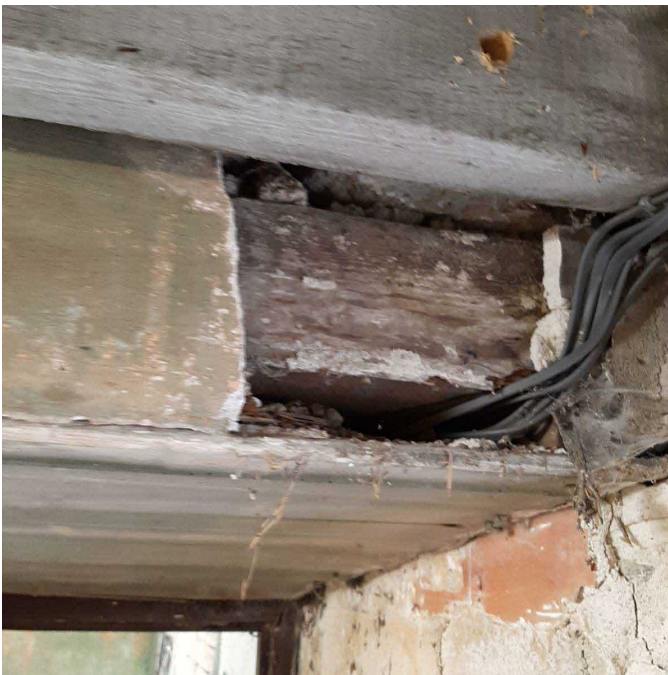
Softening timbersafe lintel

repointed with lime mortar. As part of the works, all timber safe lintels are inspected and either retained or replaced with prestressed concrete lintels. An allowance of 10% of lintels is recommended based on this survey. All drainage lines should be tied up to a formal drainage system, all piped away from the building to a SUDS drainage system. The type and location of this system can be confirmed with a site investigation to confirm soil types, and depths of existing foundations.

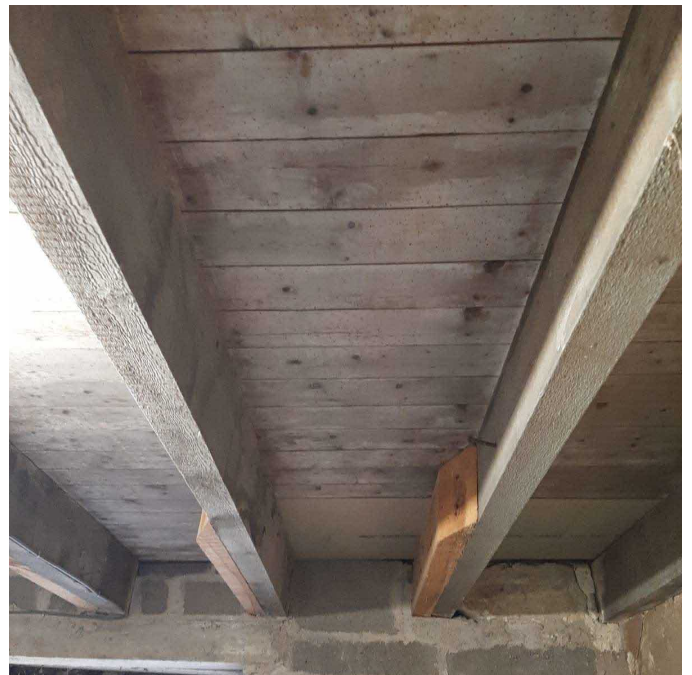
Historically repaired joist ends

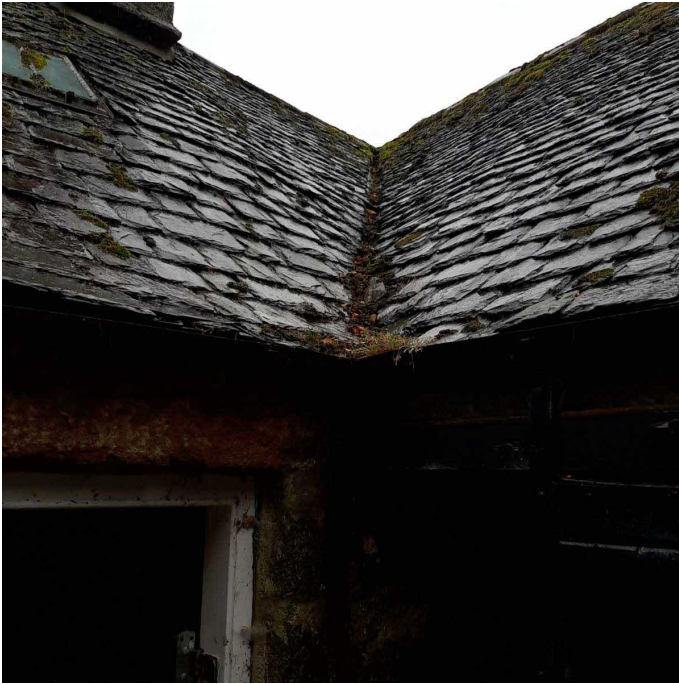
Clogged valley and vegetation on roof

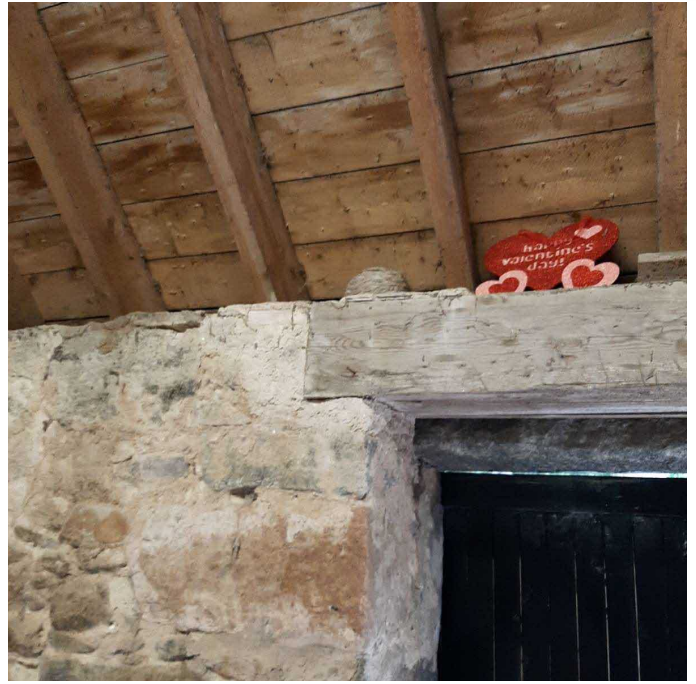
Timbersafe lintel in good condition

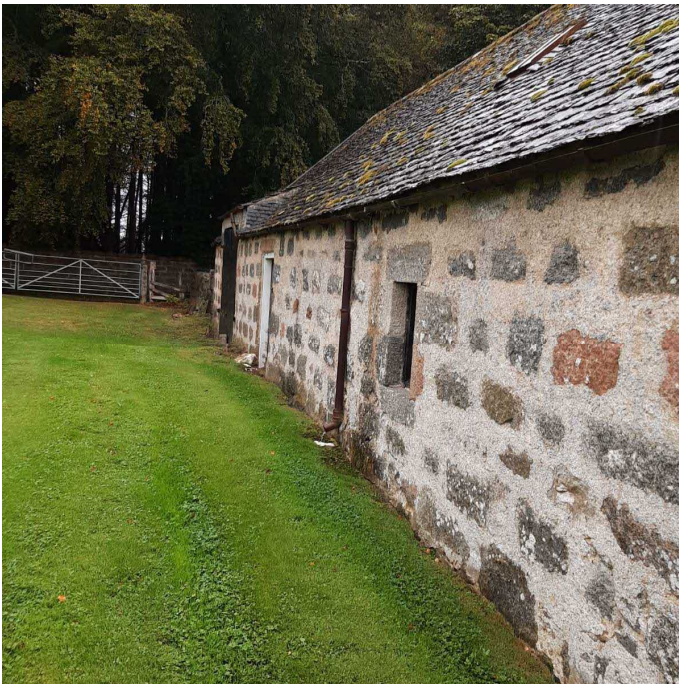
Elevation showing damaged and unconnected drainage

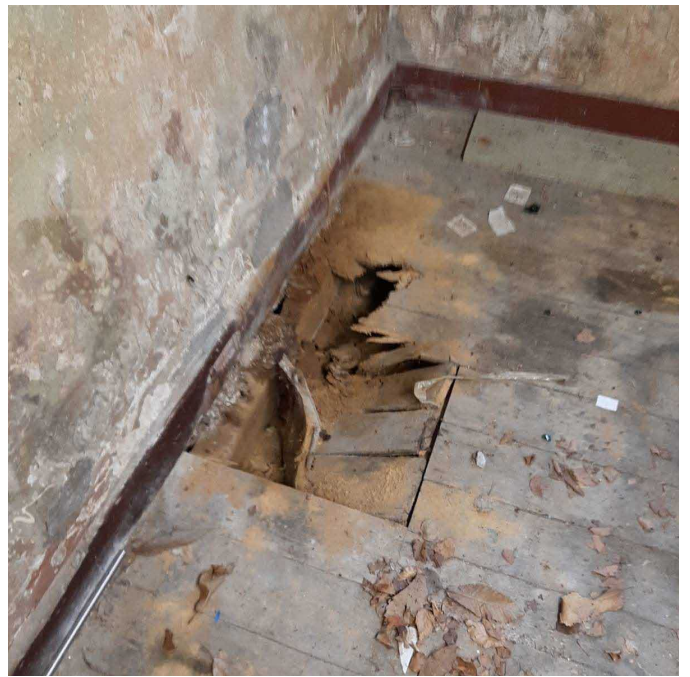
Soft and rotten flooring failed to show timber ground floor joists
