## *Structural Inspection*

Client:	Everards of Leicestershire
Project:	Barn 1, Greendale Oak, Cuckney
Project No:	23-20714
Document No:	0-030
Issue:	2
Date:	22 December 2023
Engineer:

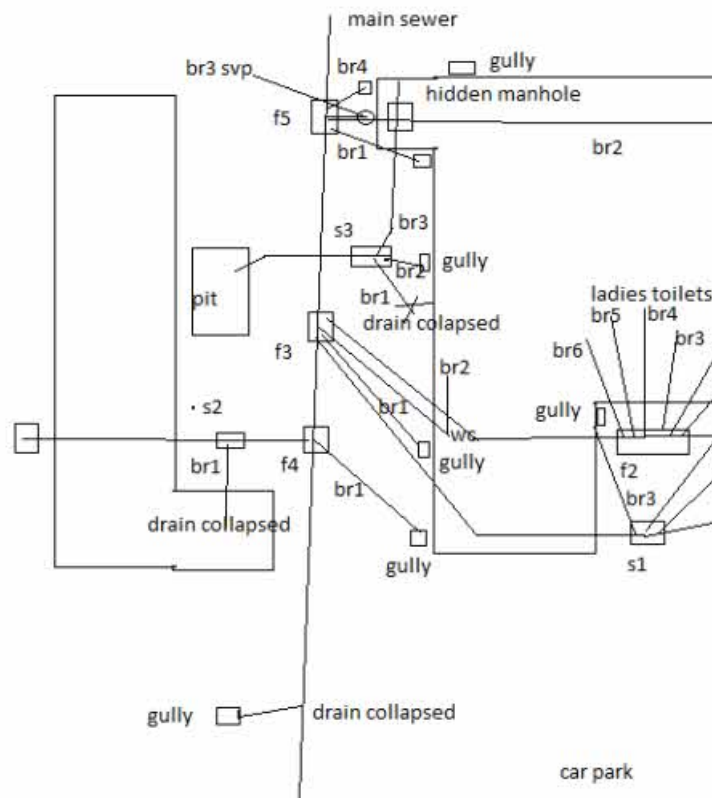
- 2.6. There has been a CCTV survey of the drains in the courtyard that shows that there are a number of broken and leaking drains near to Barn 1. This includes a collapsed drain under the concrete slab and multiple fractures & breaks near F4. This water entering the subsoils near to the existing foundation for extended periods of time, softens the subsoils under the foundation and causes the subsidence seen.

- 3.1. The drains need to be fully renovated to prevent the issues developing in the subsoils and stop further movement.
- 3.2. A trial hole will need to be excavated next to the foundation to inspect the subsoils to ensure that underpinning is not required.
- 3.3. Crack stitching in the form of Heli-bars are required to repair the corner crack and to tie the stonework into Barn 3. This is to be carried out in accordance with the details provided on drawing 23-20714-1-001P3.
