## Additional 1

Document to support tpo application at 43 castle oak, Usk, NP151SG.

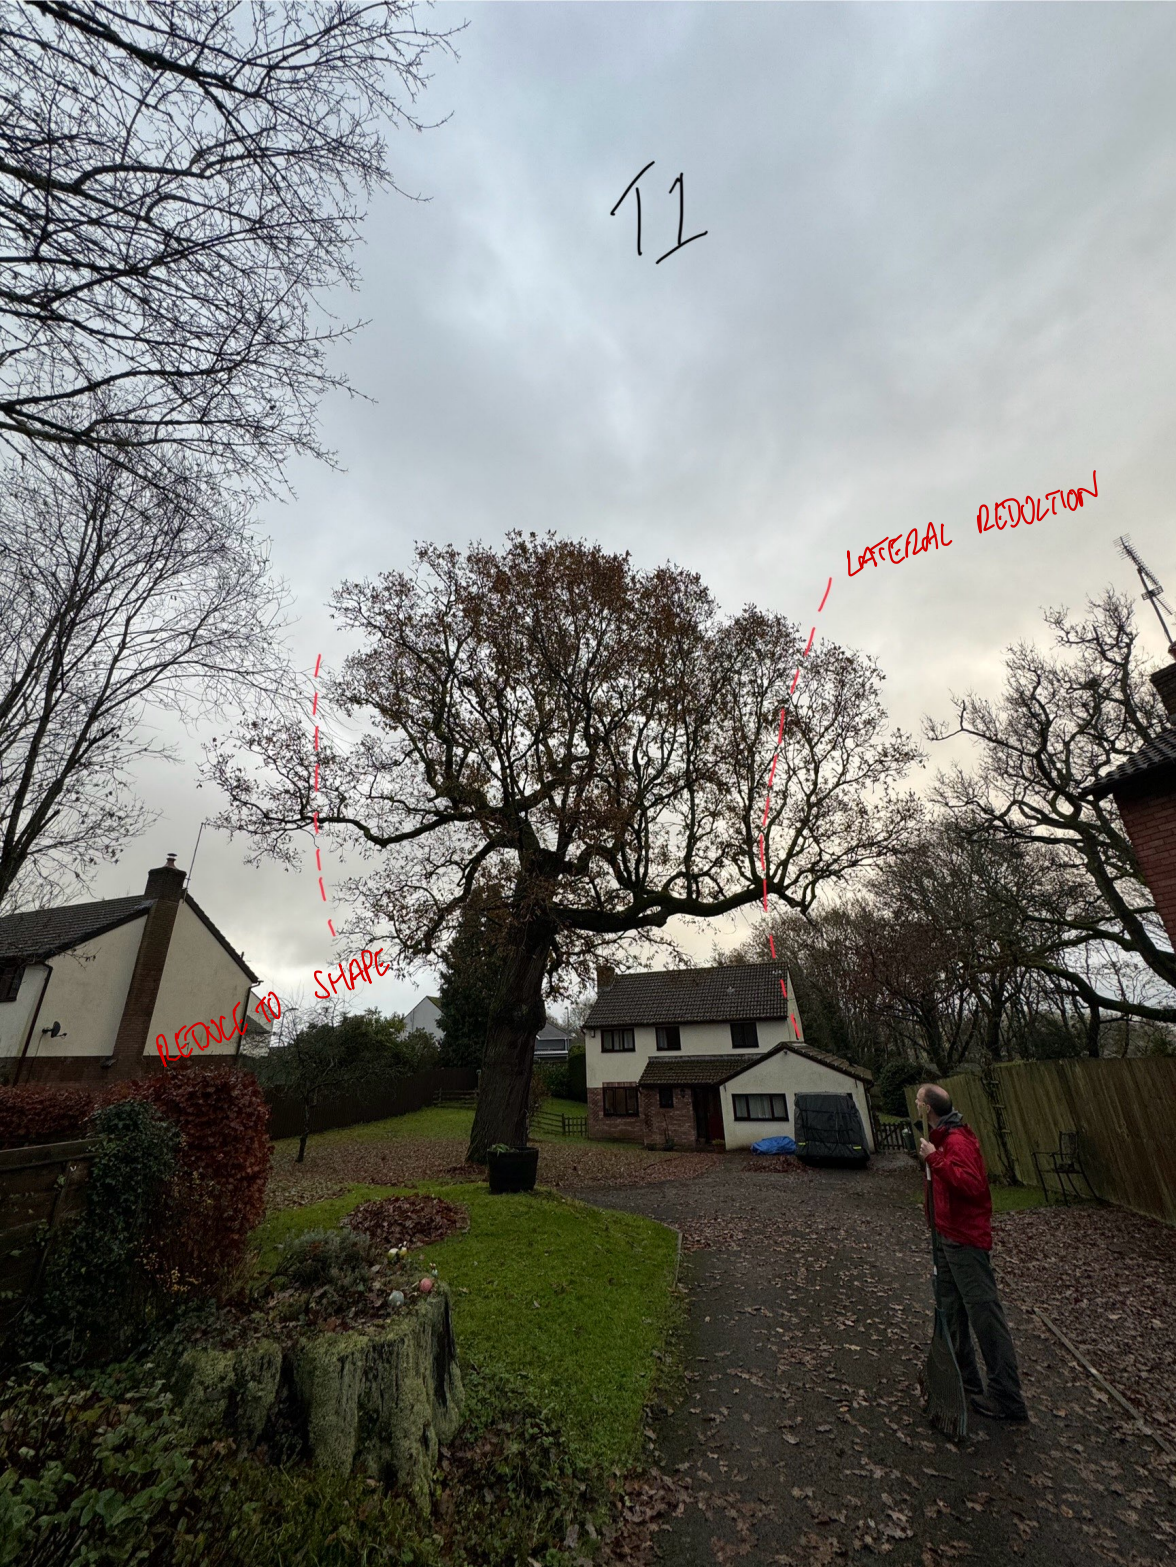
11

T1 - Deadwood, lateral branch reduction and general shape

REDUCE TO  
SHAPE

LATERAL REDUCTION

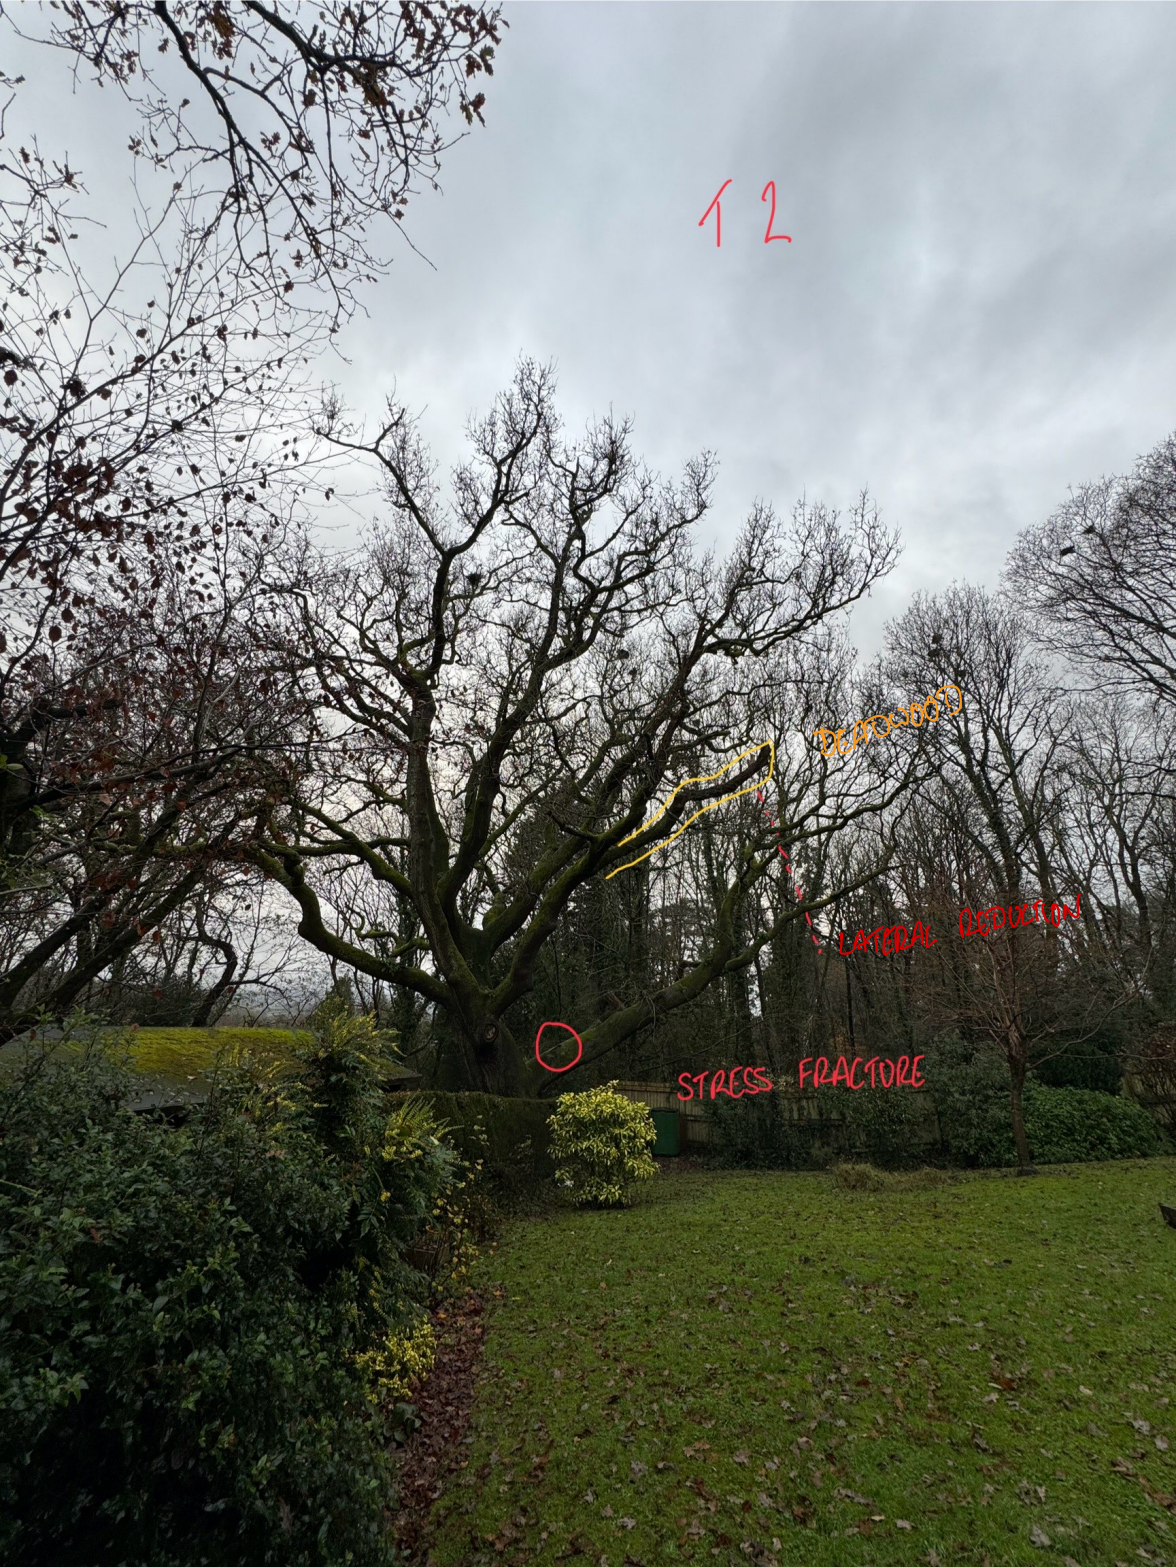
12

T2 - Remove major deadwood, heavy lateral branch reduction. Slight decay forming at base to be observed periodically.

DEPRESSION

LATERAL REDUCTION

STRESS FRACTURE

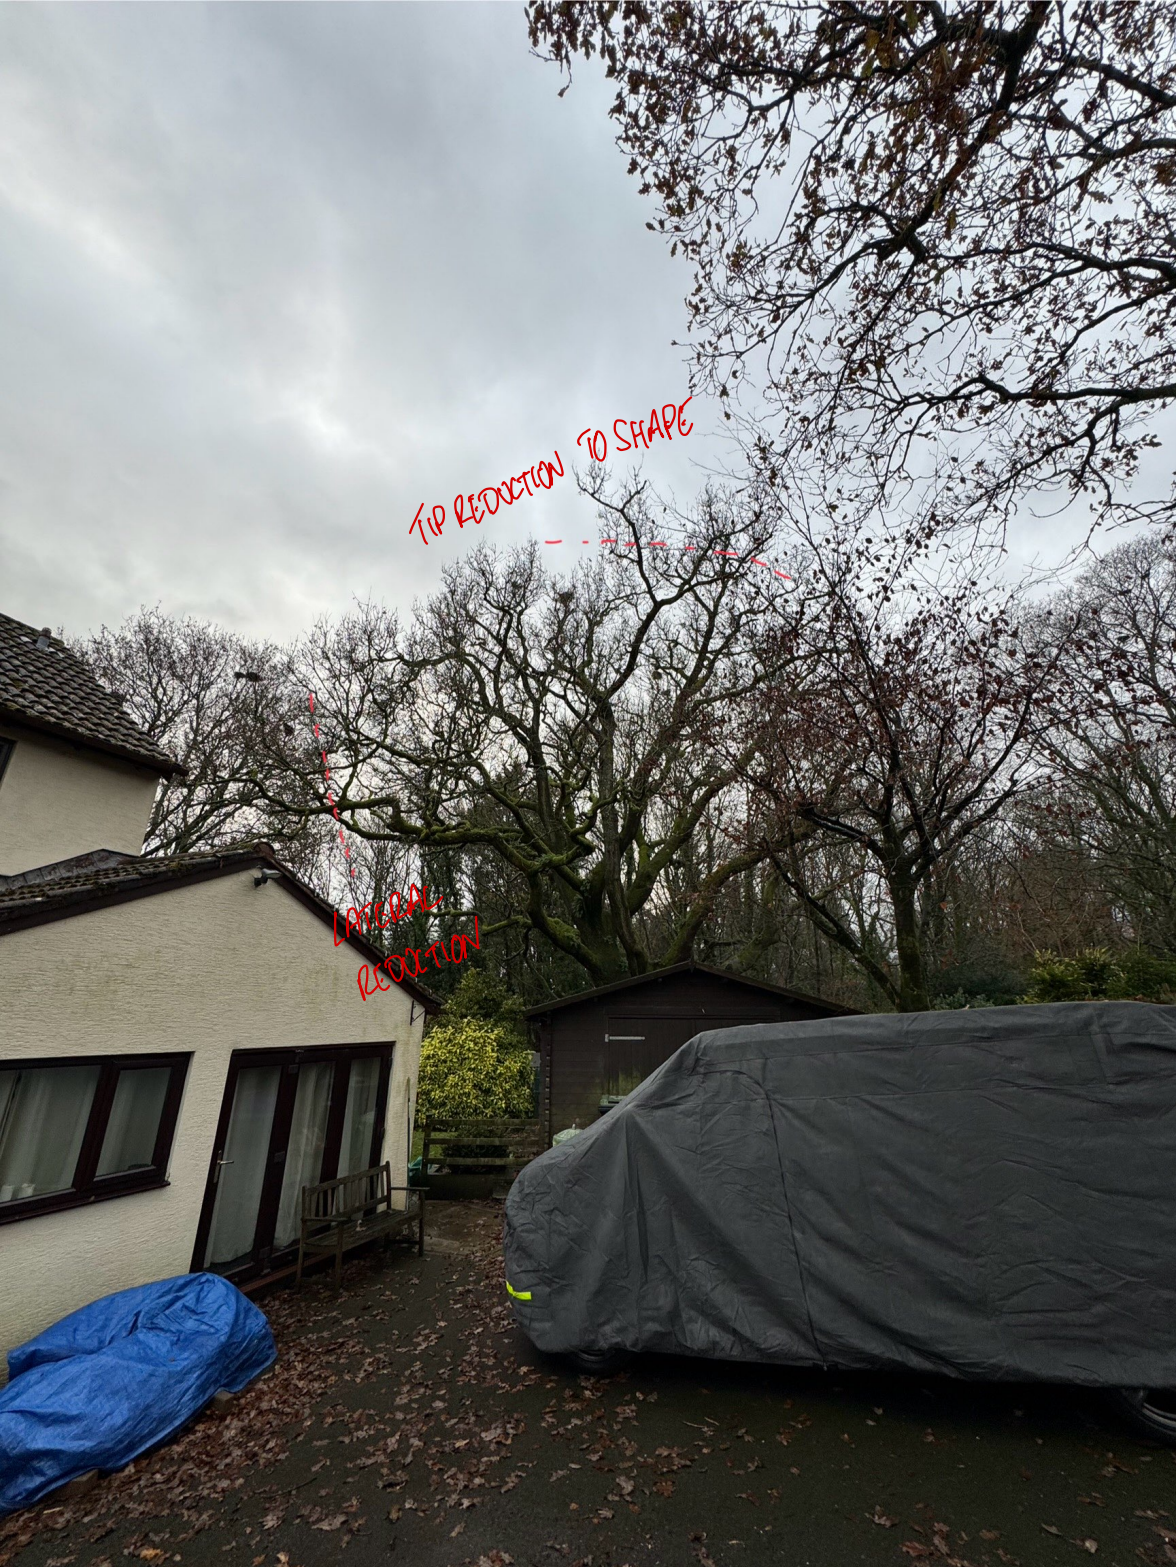
TIP REDUCTION TO SHAPE

LATERAL REDUCTION

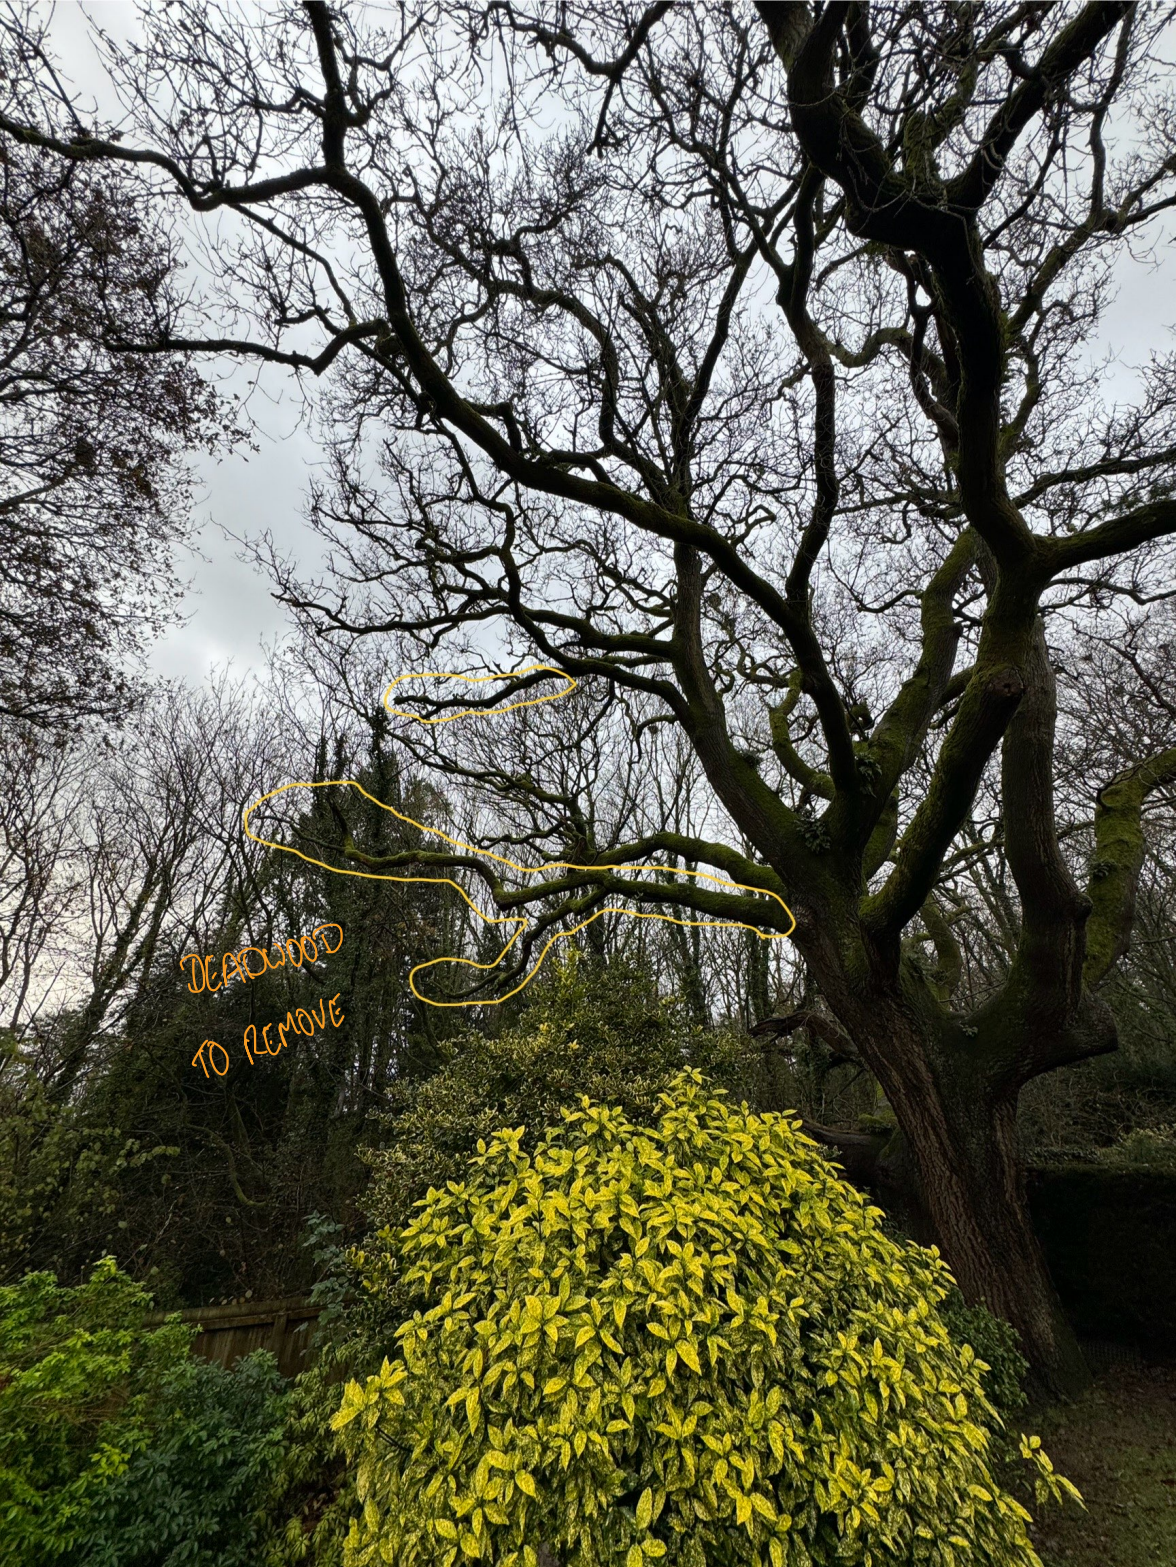
DEADWOOD  
TO REMOVE
